## MARINE SAFETY INVESTIGATION REPORT

**SHIP NAME** : FG SEVIL  
**IMO NO** : 9548665  
**FLAG OF THE SHIP** : Panama  
**CASUALTY EVENT** : Fire  
**LOCATION OF CASUALTY** : Southeast of İstanbul / Büyükada  
**DATE and TIME OF CASUALTY** : 31 October 2024 - 11:13 (GMT+3)  
**FATALITY / INJURY** : 2 / -  
**DAMAGE DEGREE** : The ship's engine room has caught fire.  
**ENVIRONMENT POLLUTION** : N/A

Board Decision No: 04 / D-01 / 2026

Date: 05 February 2026

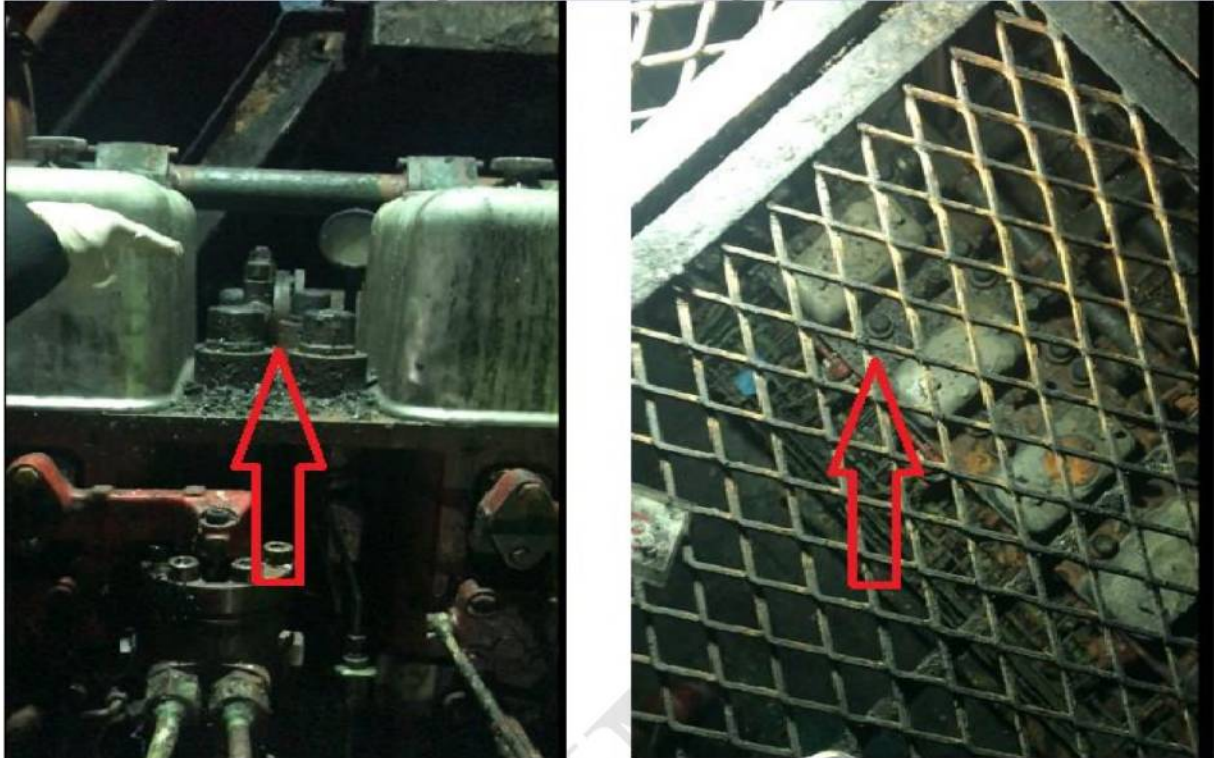
**Image 5** Main engine compartment – front and top view of the fire location

The engineer officer, returning to the engine room from the accommodation where they had gone to get drinking water, was on the stairs of the engine room at 11:13 when flames were observed coming from the area of cylinders 7 and 8 of the main engine.

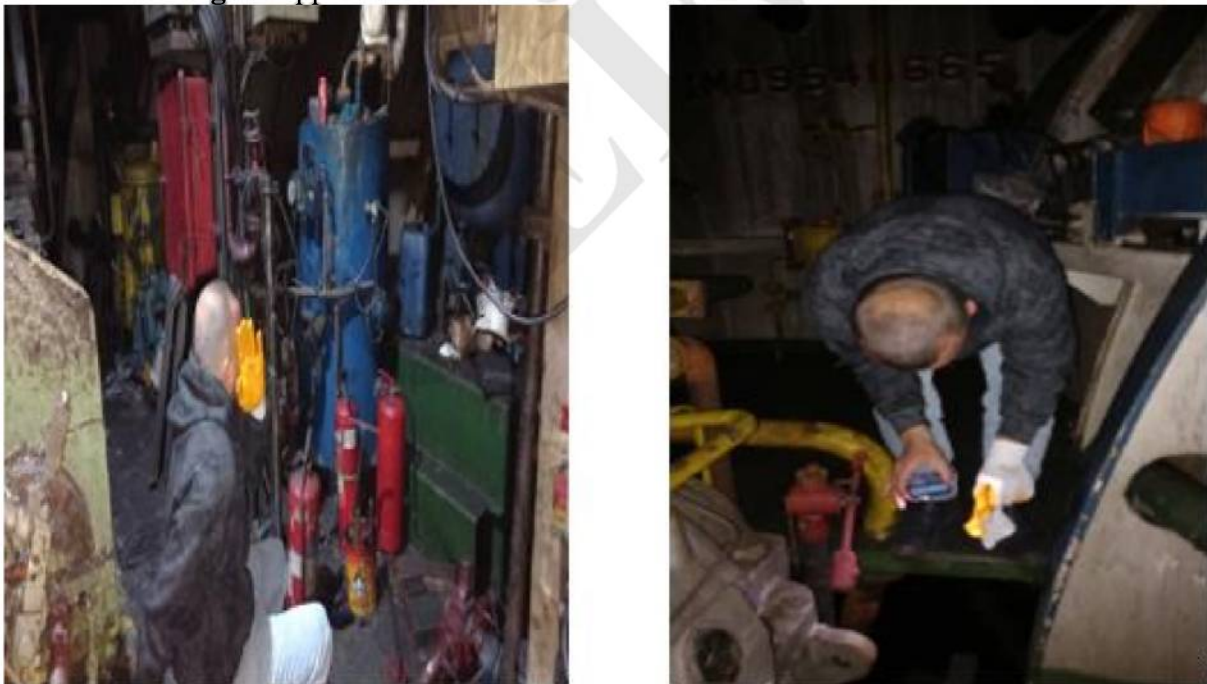
**Image 6** Approximate locations of the deceased subcontractor workers

Following the activation of the fixed fire-extinguishing system, entry was made into the engine room and as a result of the inspection: one of the two company employees who lost their lives was on the engine room floor, on the platform plate at the eighth cylinder line of the main engine head, the other one was on the platform plate near the main engine end reduction gear<sup>11</sup>, both bodies were found intact.

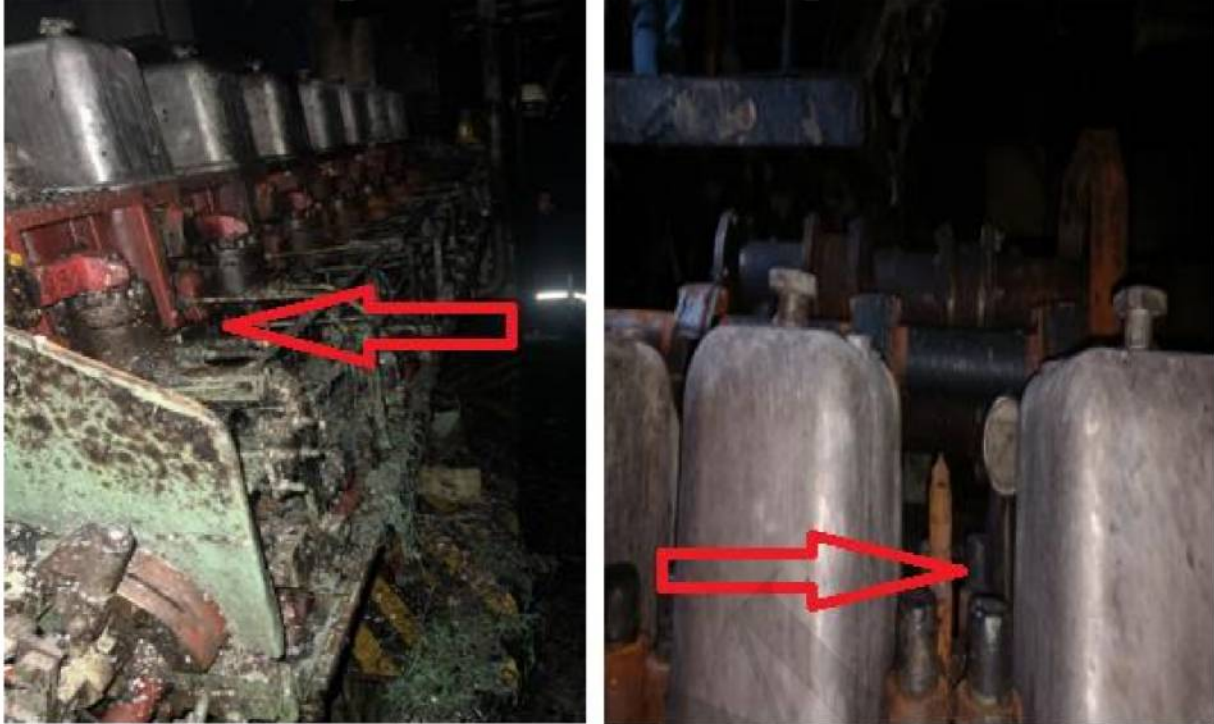
**Image 8** Start location of fire in main engine room

Considering, in particular, the burnt and damaged condition of the main engine and eyewitness statements, it was understood that the fire originated in cylinders the 7<sup>th</sup> and 8<sup>th</sup> of the main engine and spread to other components, ultimately developing into a general fire in the engine room.

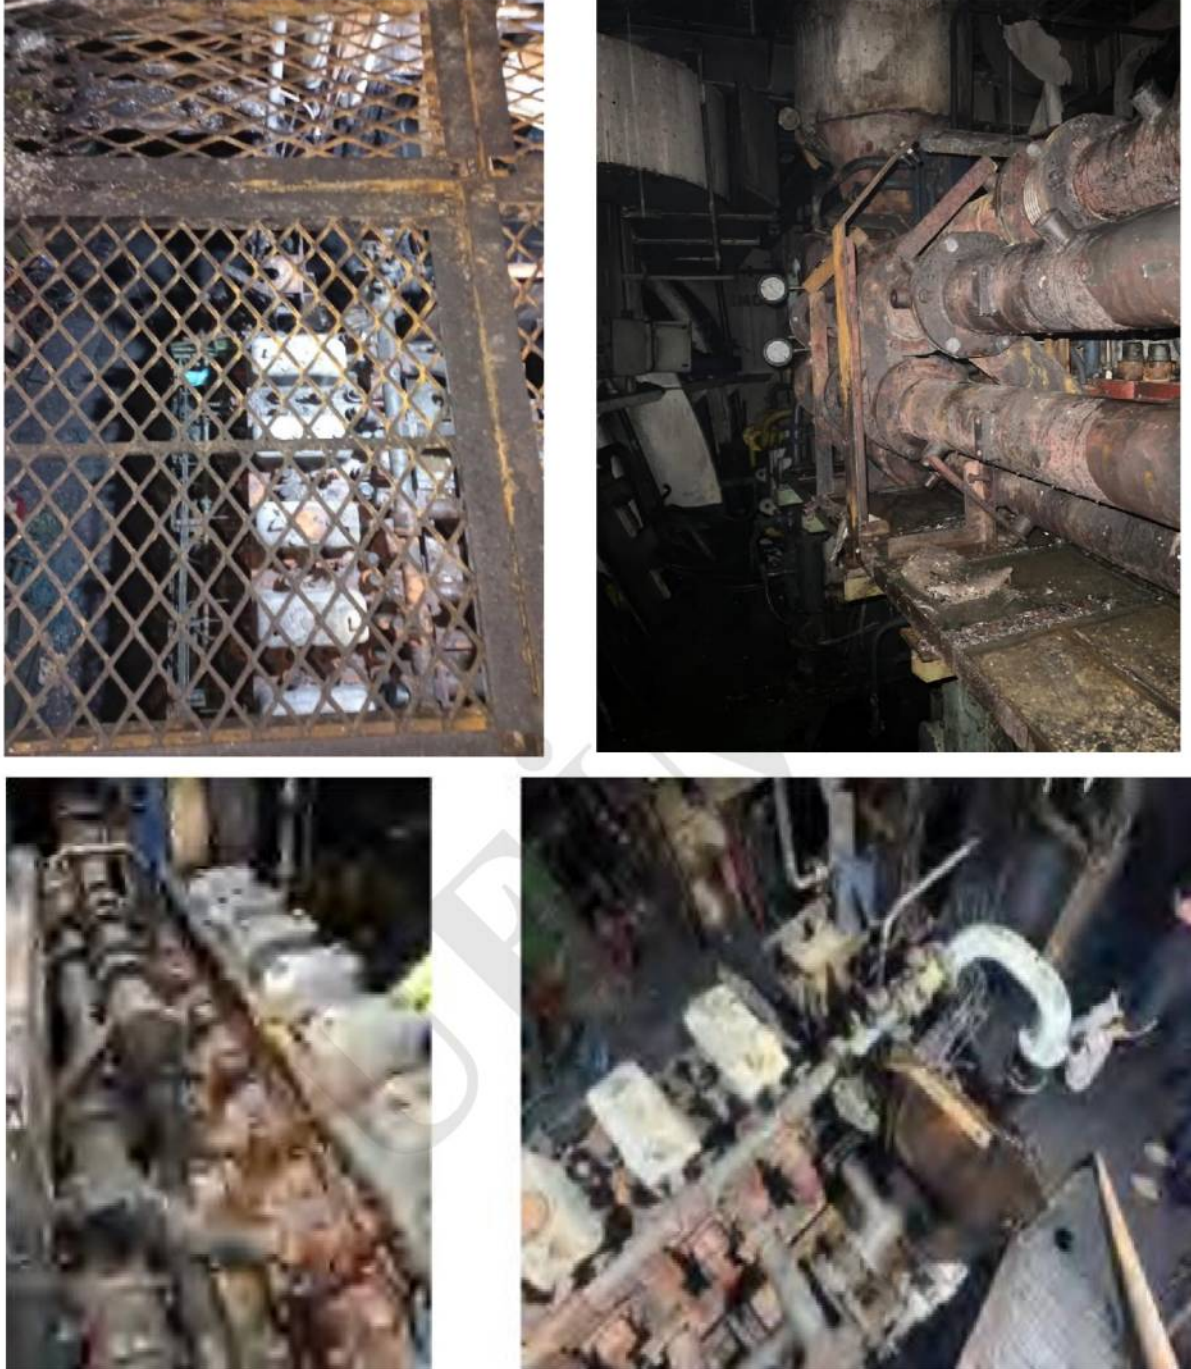
**Image 10** Uninsulated condition of main engine and manifolds

However, it was determined that the exhaust circuit insulation of the main engine, of the ship, which was proceeding its normal voyage, had not been installed at all, the exhaust pipe circuits were completely exposed, and the manifold guard plates that should have been present on the exhaust circuits were also missing.

4.4 It was determined that the main engine exhaust circuit isolations are missing, and the manifold guard plates that should have been present on the engine circuits are also missing during the investigation conducted onboard after the casualty. The probable cause of the fire was a fuel leak and insufficient insulation of the main engine's exhaust manifold. The fire most likely caused by fuel leaking onto the uninsulated exhaust manifold.

**04/01-26** At the end of the five-year special survey periods, particularly during the shipyard process and afterwards, once maintenance & repair, overhauls and alterations have been fully completed and without omission, inspections and certifications shall be conducted and this safety investigation report shall be communicated to the surveyors,

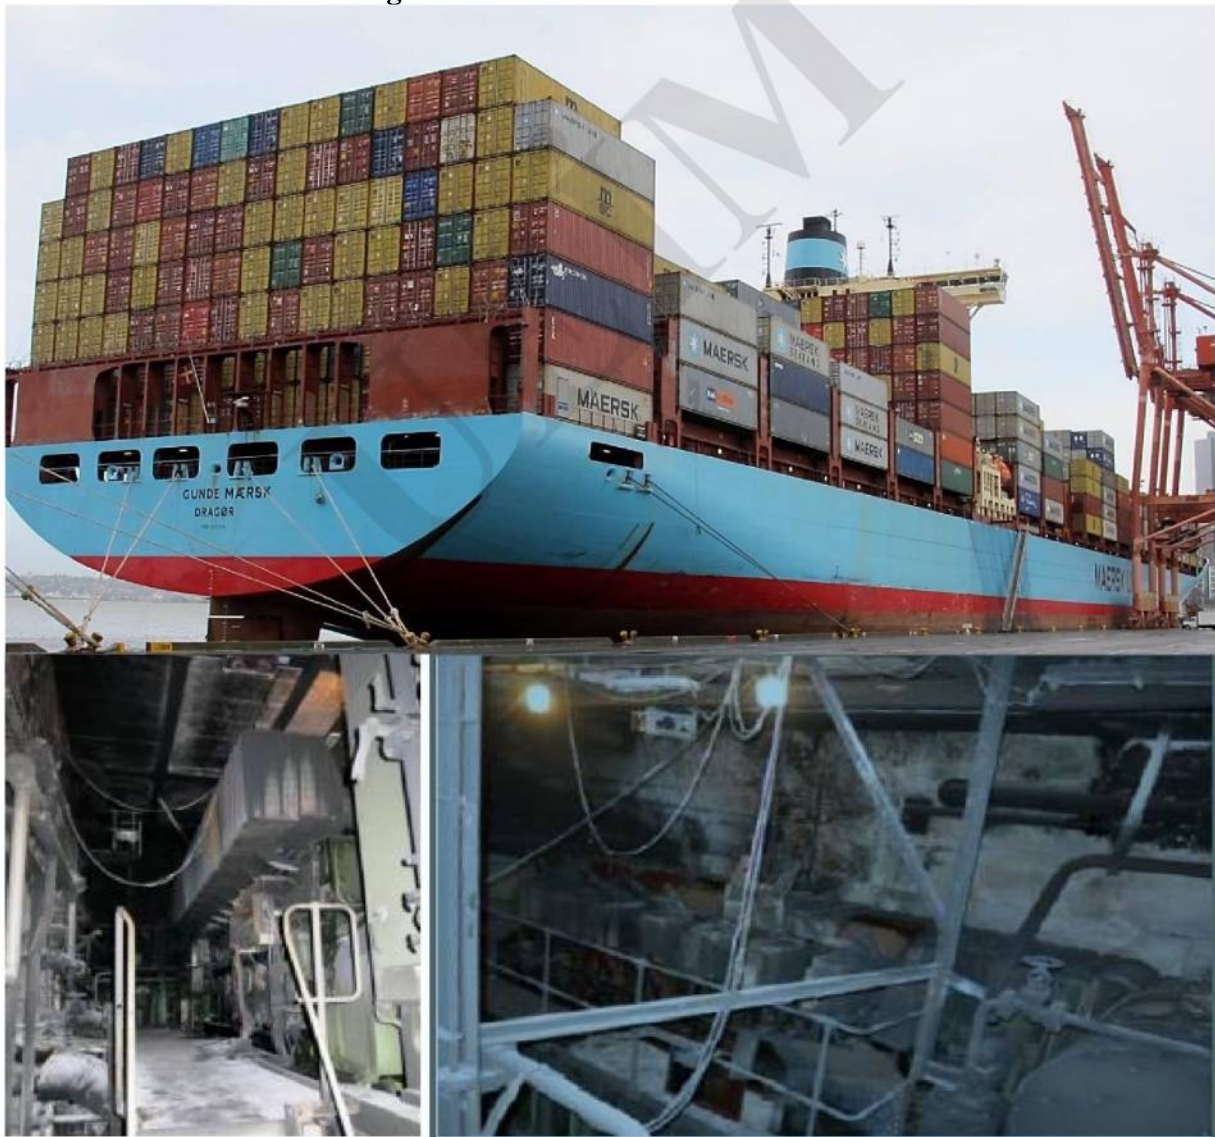
**Image 11** Fire scene of GUNDE MAERSK

The container ship, GUNDE MAERSK, departed from Terminal 46 in Seattle, Washington, at 05:09 local time on 08 December 2015. Shortly thereafter, a fire broke out in the No 1 auxiliary engine room. The fire was quickly extinguished by the ship's high-pressure water mist system, resulting in a loss of propulsion and the ship anchoring off berth.

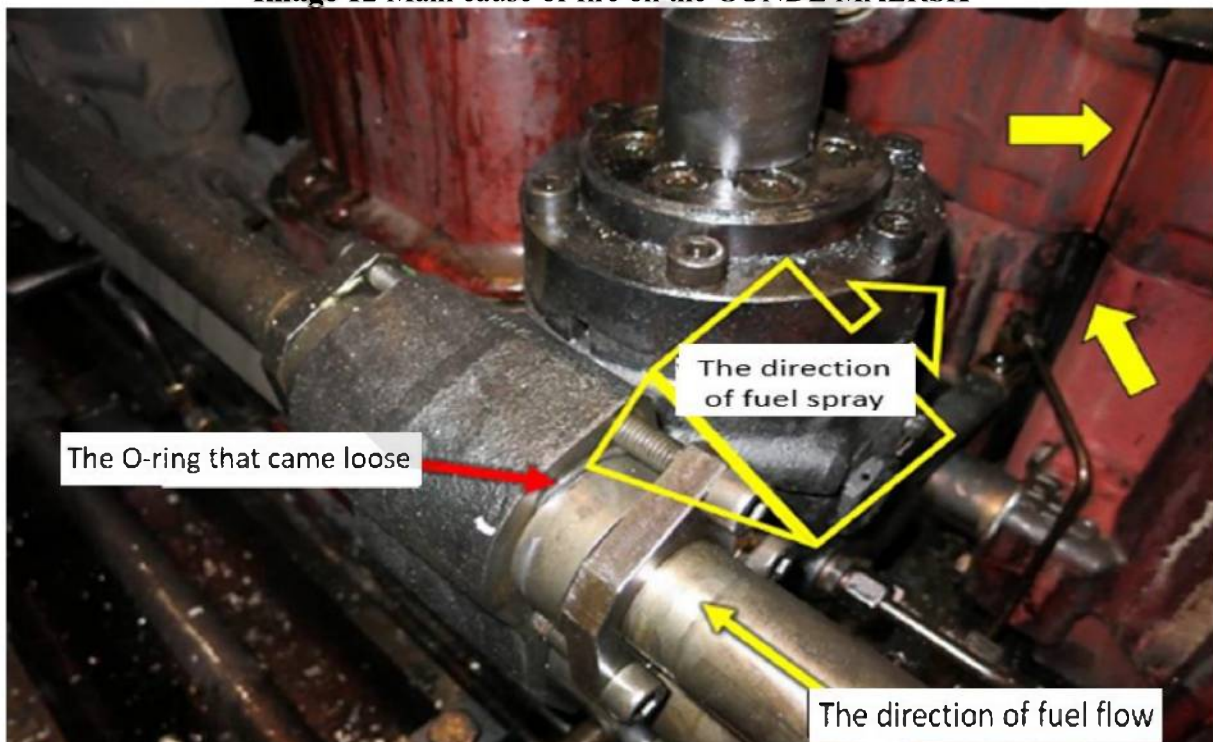
**Image 12** Main cause of fire on the GUNDE MAERSK

Investigations determined that the fire was caused by fuel leaking from a 1.5-inch diameter O-ring that had become loose in the fuel feed line leading to the No 3 cylinder fuel injection pump, located near the top of the No 1 generator, in the investigations conducted. Fuel in the feed line, at a pressure of 87 pounds per square inch (psi), sprayed around the O-ring, some of the sprayed fuel hit the blockers designed to prevent pulverized fuel from splashing into the engine room, while the rest entered the engine exhaust side through the gap between the cylinder heads.

It was determined that the probable cause of the fire on the container ship, GUNDE MAERSK, was an incorrectly fitted connection piece on the fuel line supplying the fuel injection pump for No 1 generator.
