FINAL MARINE SAFETY INVESTIGATION REPORT

OWNER	: BASIC ETERNITY LINE SA
MANAGER	: MINAMOTO KISEN CORP LTD.
NAME of SHIP / IMO No	: M/V CAPE HENRY (9648879)
FLAG	: PANAMA
SCENE of ACCIDENT	: Martas Marmara Ereglisi Port Facilities / Tekirdag-Turkey
DATE and TIME of ACCIDENT	: 5 December 2017 / 15:06 (GMT +3)
FATALITY / INJURY / LOSS	: 1 / - / -
DAMAGE / POLLUTION	: -

Board Resolution No: 22 DNZ - 02 / 2020

Date: 10/02/2020

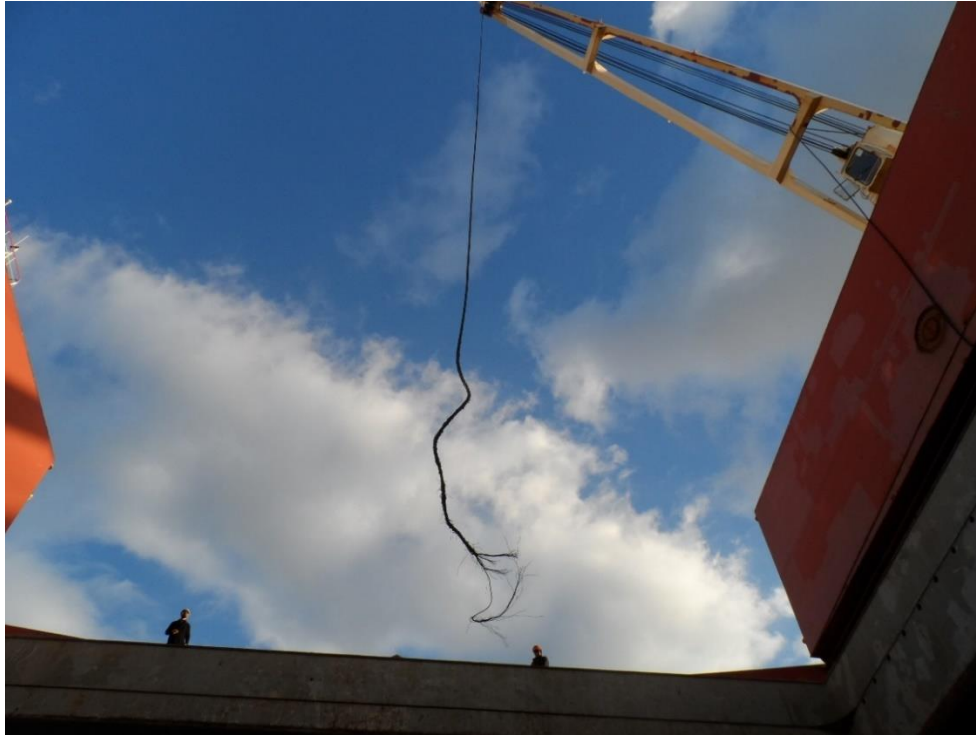
Figure 4: Photograph of the crane no. 4 and parted wire rope after the accident

In the photographs taken after the accident, the condition of the wire rope of the vessel is shown in Figures 4, 5 and 6.

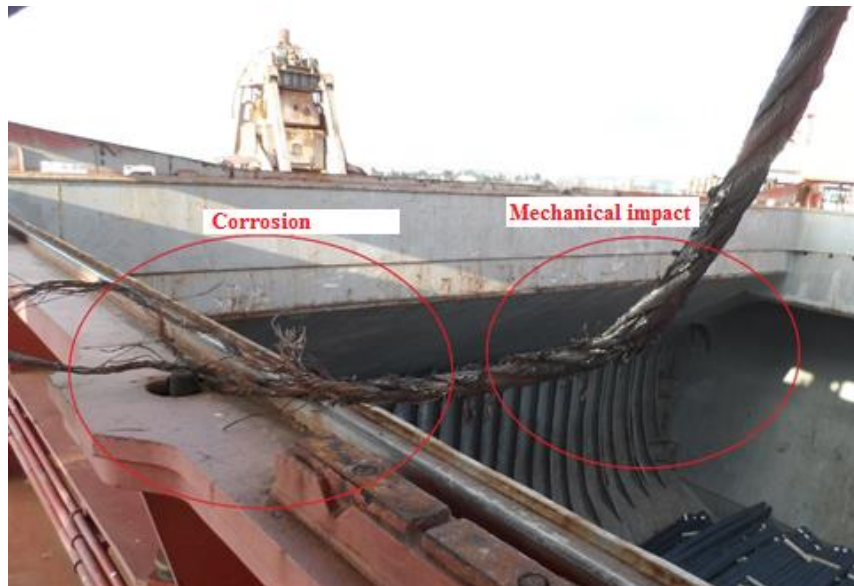
Figure 11: Parts of the Parted Wire Rope Exposed to Corrosion and Mechanical Impact

When the parted wire rope was examined after the accident, rust formation was observed on it. It is considered that this rust formation is caused by atmospheric corrosion, i.e., reaction of metal with oxygen or effect of seawater.

It draws attention that the image of a rope that parted due to corrosion in the Figure 10 bears a resemblance to the post-accident image of the wire rope that parted onboard CAPE HENRY below, and the wires of the rope show a tendency to be scattered.

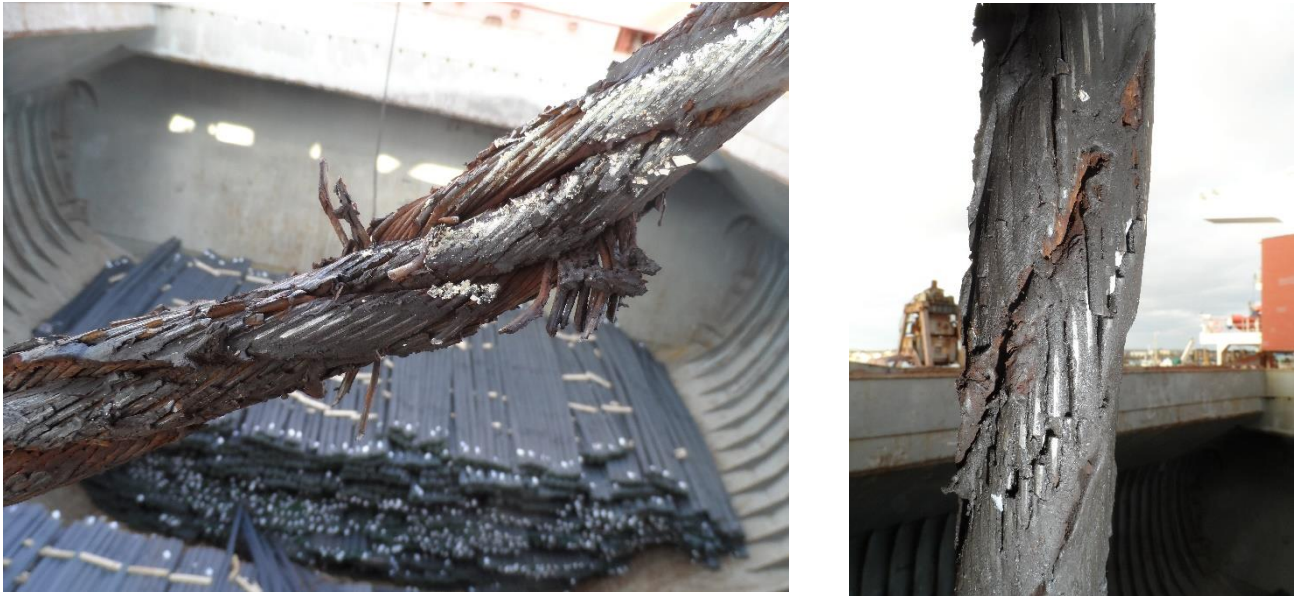
Figure 12,13: Photographs Showing Outer Lubrication and Inner Corrosion and Rusting of the Wire Rope

The amount of corrosion can be reduced by reducing the exposed surface. This can be done by galvanizing³ the rope wires. A steel core can also be protected by a plastic coating. An internal and external lubrication will also reduce or prevent corrosion. Especially static ropes and ropes operating in a marine environment should be galvanized and well lubricated. A plastic coating between the steel core and the outer strands will protect internal rope elements. Steel expands when it corrodes. Therefore sometimes an increase in rope diameter over time might be an indication that the rope is corroding internally.⁴

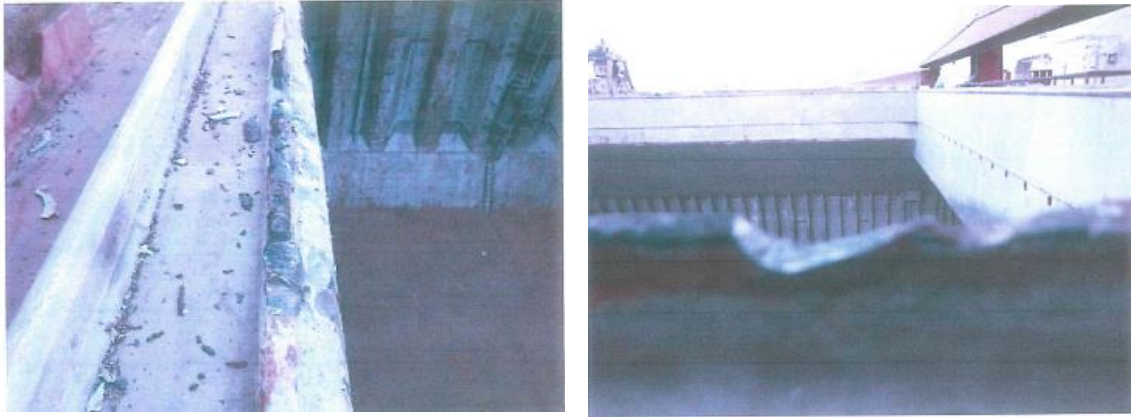
Figure 17,18: Photograph of the Aft Part of the Drain Channel

As can be seen in Figures 17, 18 and 19, the steel parts of the hatch coaming have ruptures and metal/paint scratches as a result of the fact that the rebar hit and rubbed the coaming while lowering them inside the hold. It is considered that these impacts and rubbings impose more load and tensile on the wire rope attached to the crane of the vessel, resulting in a decrease in the strength of the wire rope.

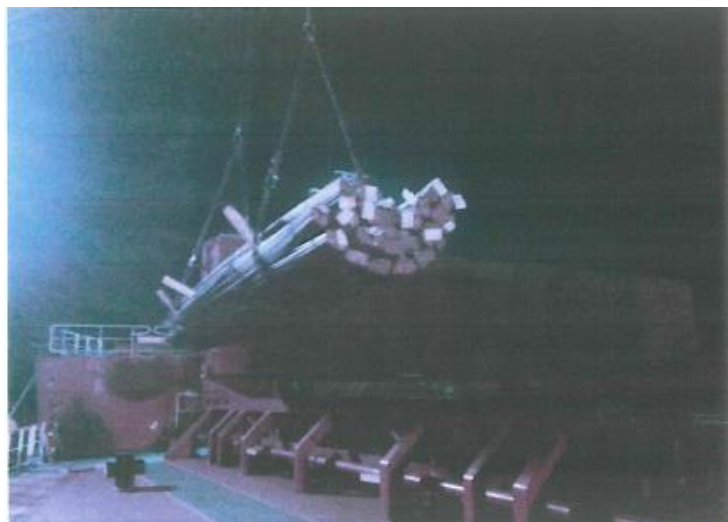
Figure 22: Photograph of overload situation claimed in the Master's and Chief Officer's interview

During the accident investigation, the master claimed that the crane operator sometimes lifted loads heavier than the lifting limit in the interview with him. He stated that there was a photograph in the damage report regarding this issue. In the damage reports taken from the vessel, the photograph which is thought to document this issue is shown in Figure 22.

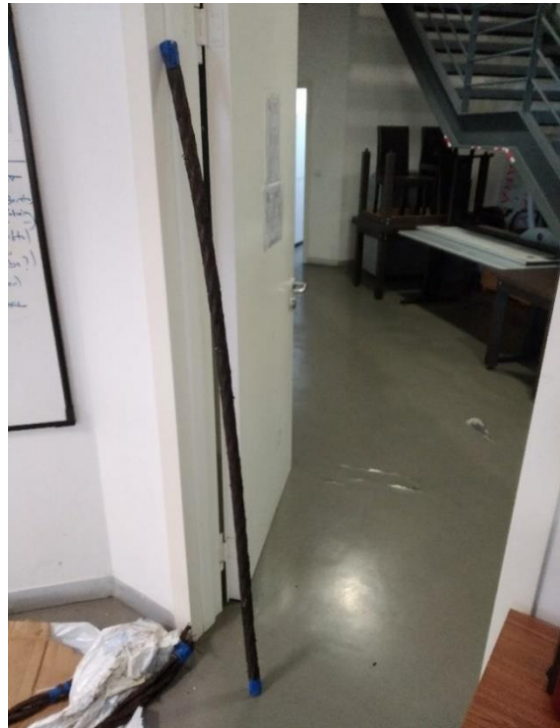
Figure 27: A sample piece of 184 cm. which is taken from the intact part of the parted wire rope

Examination on the sample wire showed that the wires on the strands were parted. In order to understand the situation better, the wire rope was cleaned by washing with detergent water. When the clean wire rope was examined, it was seen that interestingly, more than one wire was parted on each strand and there were breaks on the same strand with intervals.

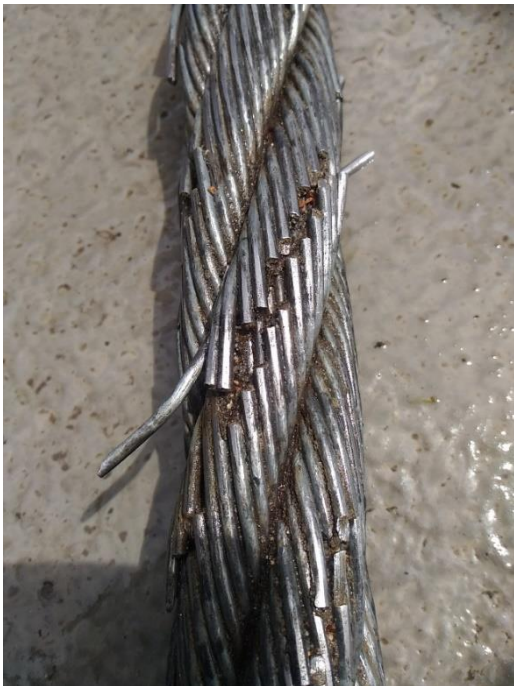
Figure 30: Apparent breaks on the cleaned wire rope

Parted rope yarns on the wire are noticeably detected. As shown in Figure 30, 10 wires are parted on a single strand, and a large number of breaks are detected on the other strands as well. Despite such broken rope yarns, the wire rope parted at 47,64 tons. An estimation could be done about how strong the wire rope would be if there were no breaks.

The fact that 25-30 wires are broken within one-turn length on adjacent strands on the sample wire rope, and that these breaks continue at intervals along the entire wire rope indicate that the wire rope is worn to a level that it definitely can not be used.

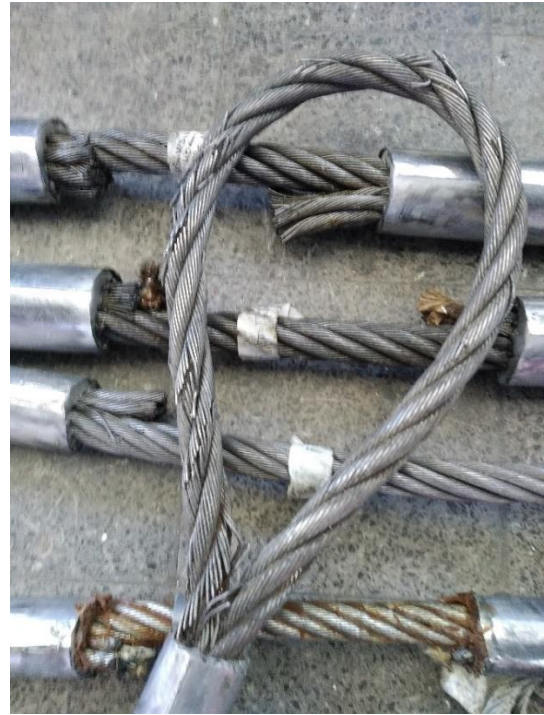
Figure 33: Photograph of the sent sample wire rope (breaks are apparent)

Figure 32 shows the fixed eye made on the additional wire rope, and Figure 33 shows the fixed eye made on sample wire rope. When the sample rope was twisted to eye splice, the broken wires were exposed apparently.

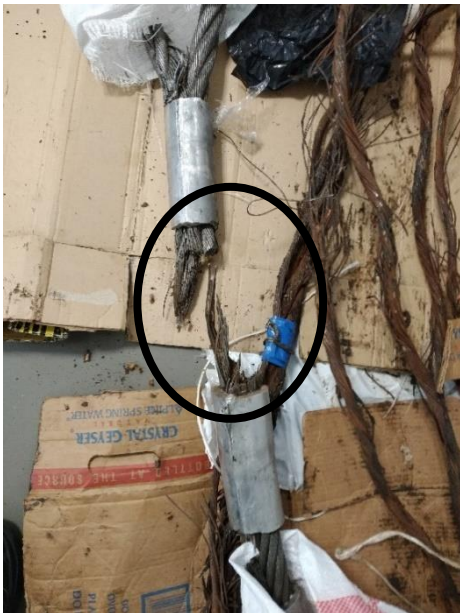
Figure 36: Section where the wire rope parted at the end of the test

In the test carried out at TSE, the breaking load was measured as 467,17 kN, approximately corresponding to 47,64 tons, however, as the wire slipped out of thimble, it was noted in the TSE report that it did not break in accordance with the standard when it got free. As there were many broken wires on the wire rope, many cut wires corresponded under the alloy pressed for making the eye splice (case). As these wires slipped out during tensioning, no uniform parting occurred, but the wire rope eventually parted. The note in the TSE report indicates this condition.

Figure 36 shows that the wire rope parted. It is observed that it is well below the tensile breaking force of a similar wire rope in general.
