REPUBLIC OF TURKEY
MINISTRY OF TRANSPORT, MARITIME AFFAIRS AND
COMMUNICATIONS
ACCIDENT INVESTIGATION BOARD

Accident Investigation Report On
The Collision between AKEL and SENGUL K

ISTANBUL, off the Coast of Riva
22nd of July 2015

Board Resolution No: 15/5.Dnz/2016

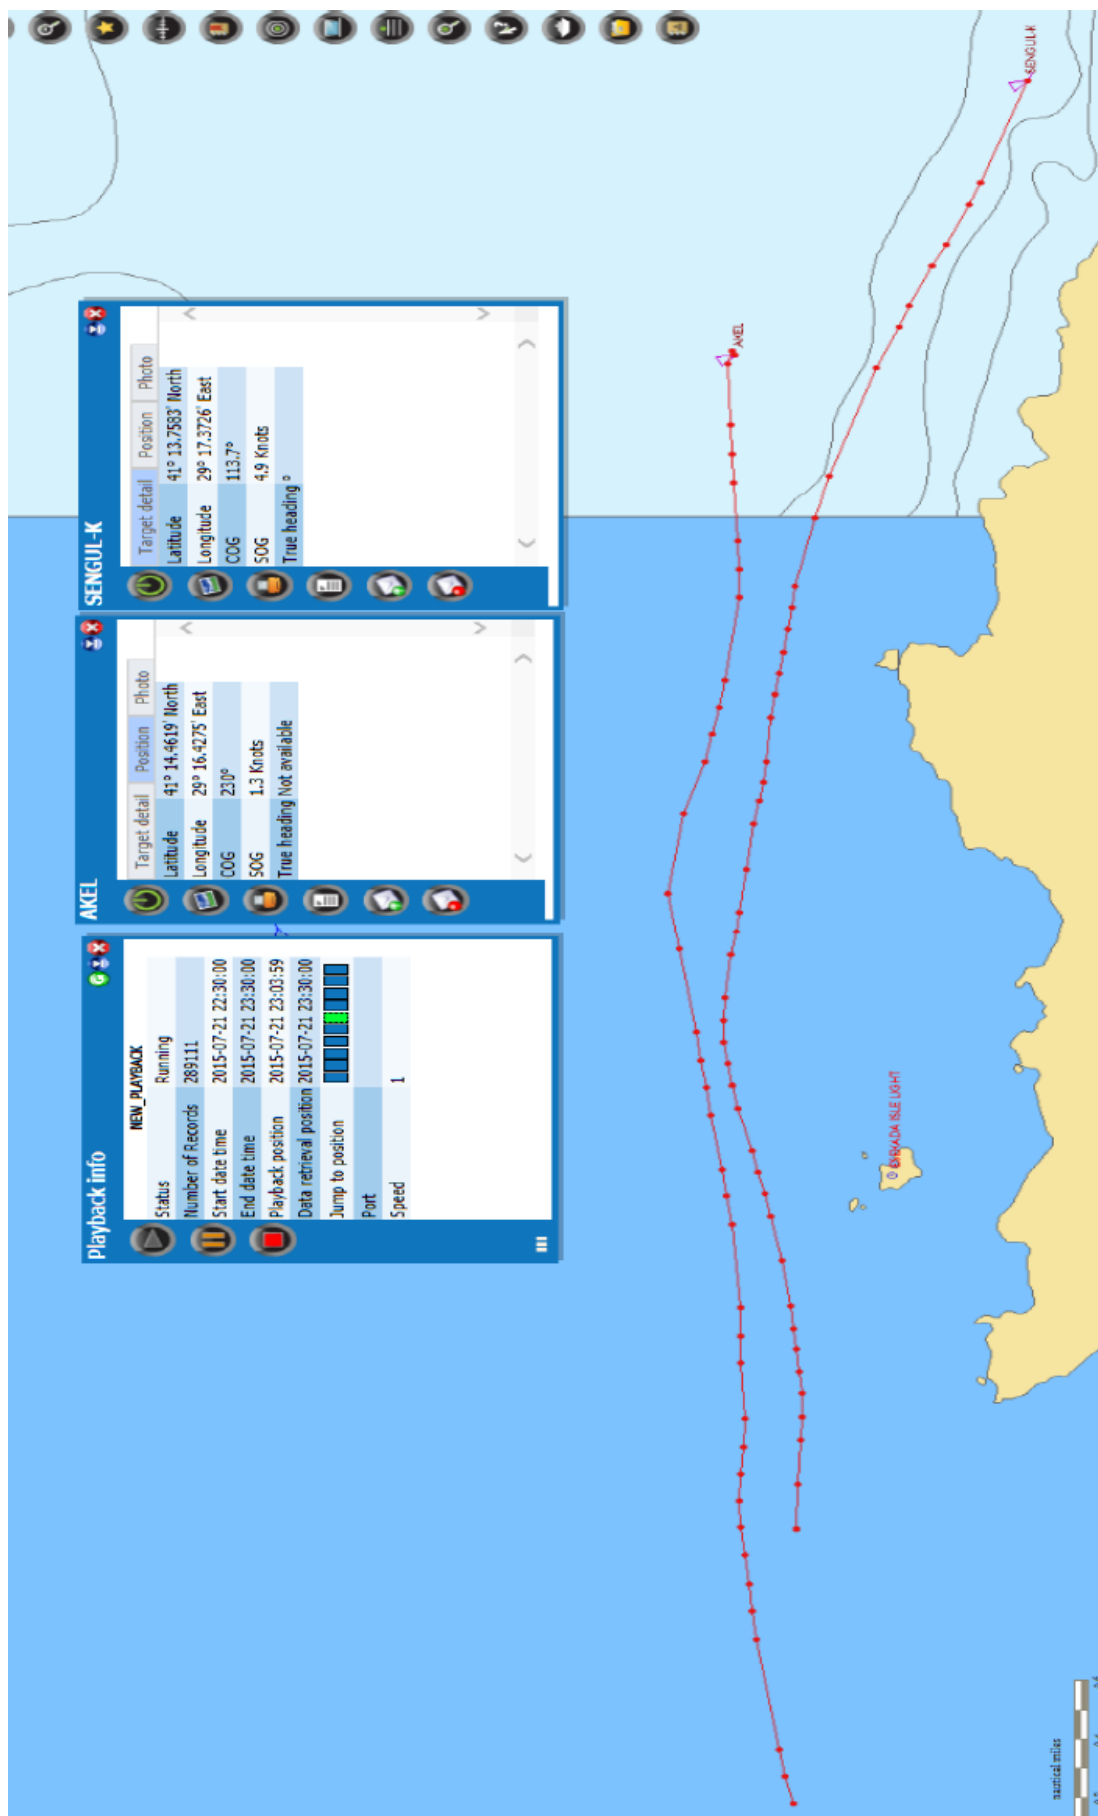
Figure 2. Courses followed by the ships

In Figure 2, the courses followed by the ships after 00:30 are shown. When the courses of the ships are taken into account, it can be seen that SENGUL K navigated closer to shore and continuously ahead of AKEL and they continued their navigation at a distance of changing 0,4 to 1 nautical mile between each other which can be regarded as a close distance.

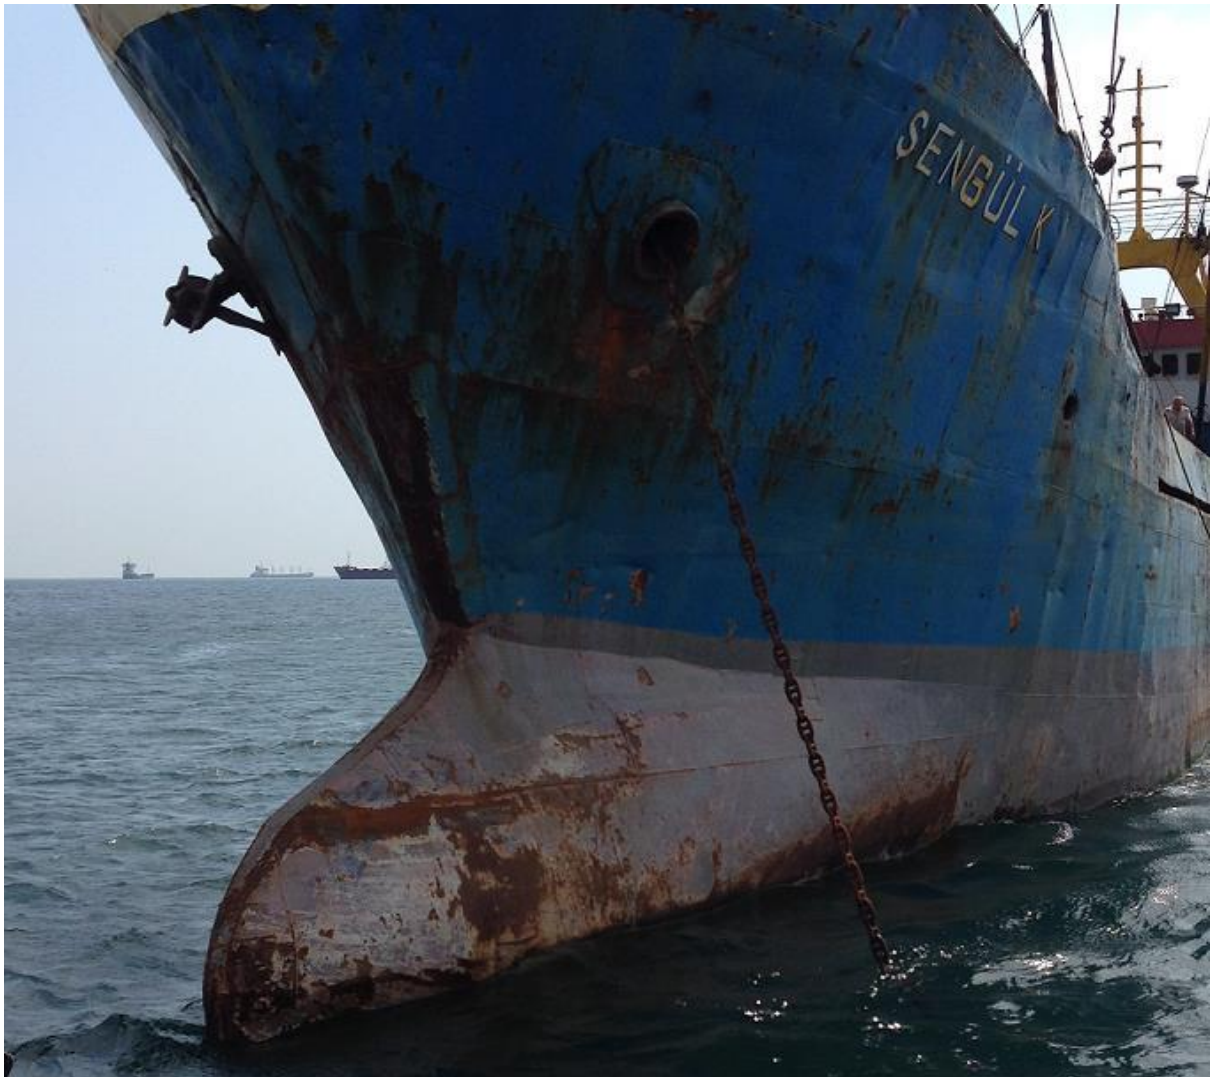
Figure 5. Damage on SENGUL K

After the accident there was no serious damage on the SENGUL K. Scratches occurred on the bulb and port bow of the ship.

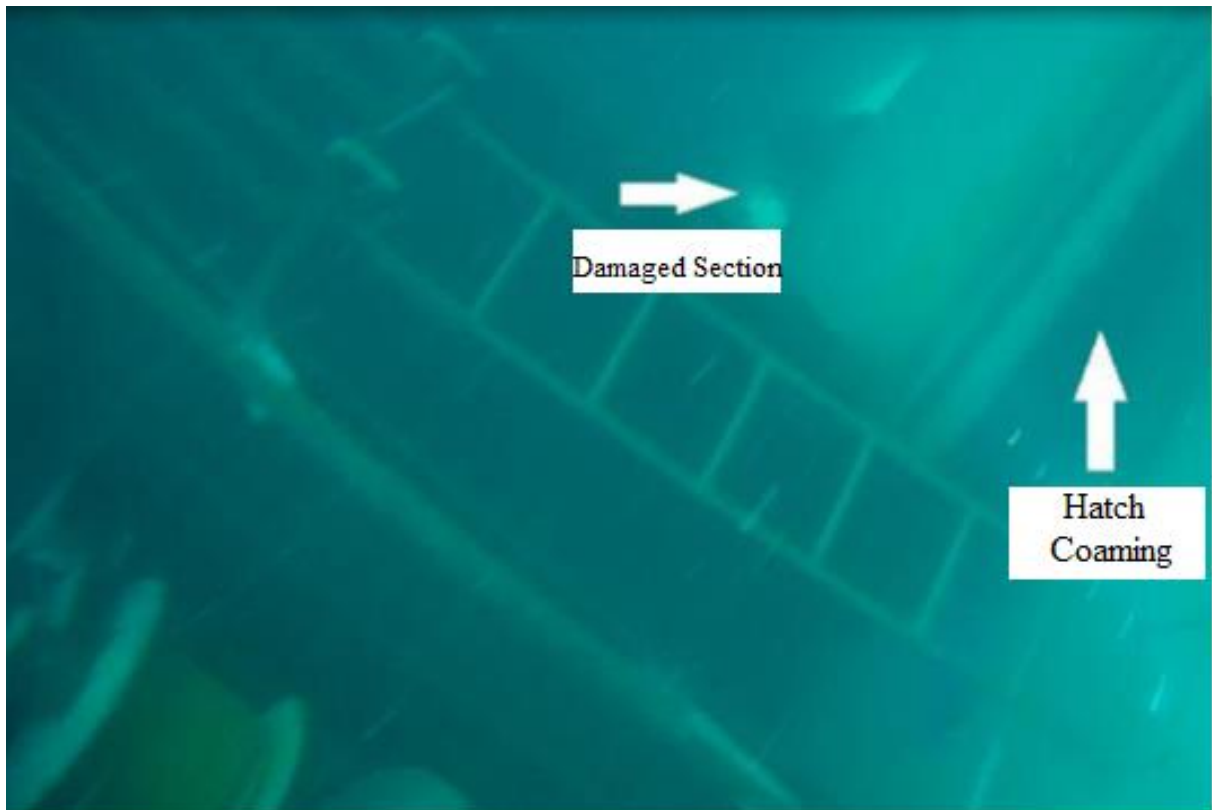
Figure 6. Damage on AKEL

But AKEL suffered serious damage, rupture occurred on the starboard side on the region of aft hold side close to the engine room bulkhead and on the double bottom and consequently the ship flooded and foundered.

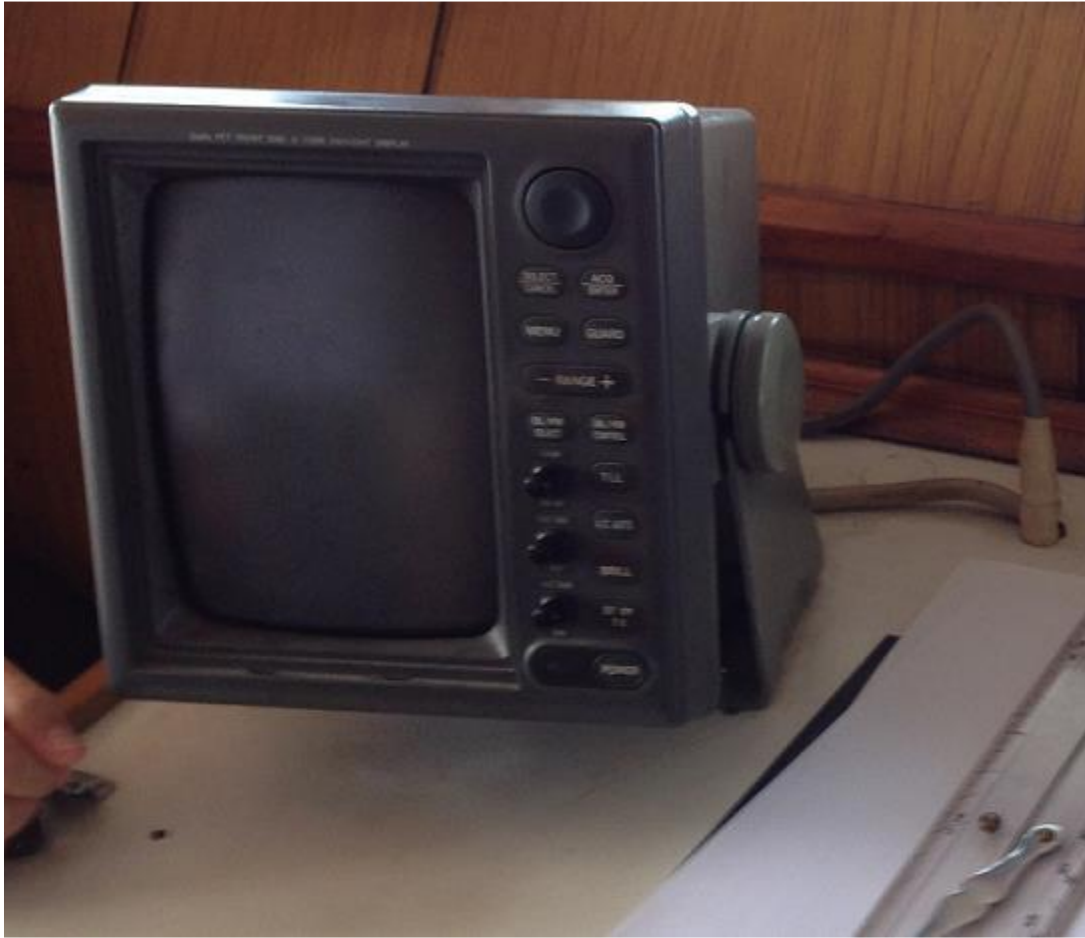
Figure 8. Radar of SENGUL K

Ships are equipped with radar and AIS equipment. The master of AKEL stated that he had set the radar to the value of 0,7 cable before the accident and added that while he was looking to the plotted the position over AIS, the accident happened. The master of SENGUL K stated that he had seen AKEL on 0,5 cable on the radar and he had communicated with the master of AKEL via mobile phone 45 minutes before the accident.

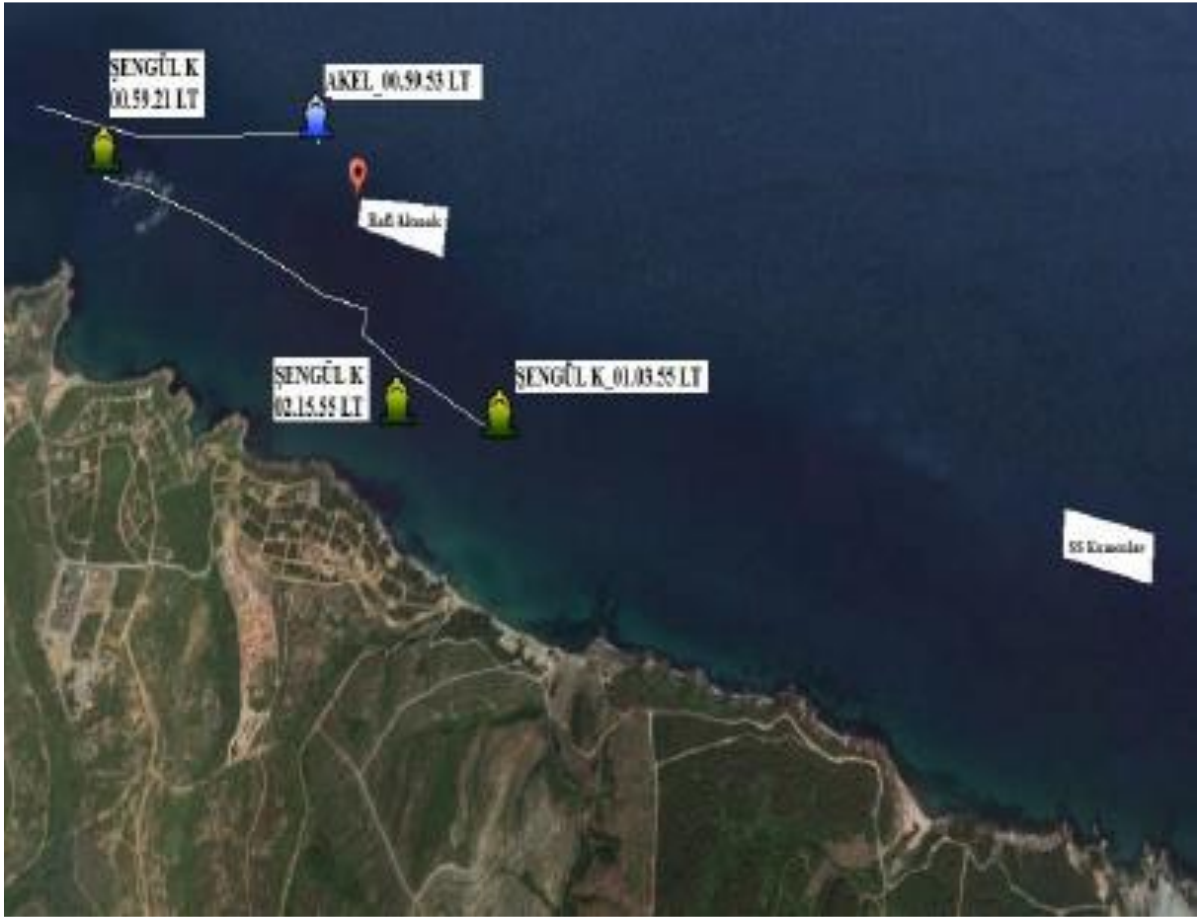
Figure 10. Position of the ships before the accident and the sand regions

Collision occurred approximately on $41^{\circ}13'N$ $29^{\circ}16'E$. This point is located approximately 0,4 nautical miles south of sand loading region assigned to Rafî Altınok and 2 nautical miles east of sand loading region assigned to Kumcular cooperative. Although both ships were around the sand loading regions that they got dispatch ticket approximately 1,5 hours before the accident, instead of carrying out loading operation at the sand regions, AKEL was under way towards south and SENGÜL K was loading sand 2 miles east of its' permitted region. Accordingly, it is thought that, the accident happened like while SENGÜL K was

stationary to load sand approximately 2 miles east of its' permitted region and AKEL was under way approximately 0,4 nautical miles south of its' permitted sand loading region, AKEL collided with SENGUL K.
