**REPUBLIC OF TURKEY  
MINISTRY OF TRANSPORT  
AND INFRASTRUCTURE**

**FINAL REPORT ON VERY SERIOUS MARINE ACCIDENT**

**NAME / IMO No. OF THE VESSEL** : ALİ OSMAN E / 8218378  
**FLAG OF THE VESSEL** : TURKISH  
**ACCIDENT LOCATION** : DERİNCE PORT/ KOCAELİ  
**ACCIDENT DATE / TIME** : 10.01.2018 / 15:30 UTC  
**CONDITION OF CASUALTIES (DEAD / INJURED)** : 1/-  
**CONDITION OF DAMAGE: / ENVIRONMENTAL POLLUTION** : -/-

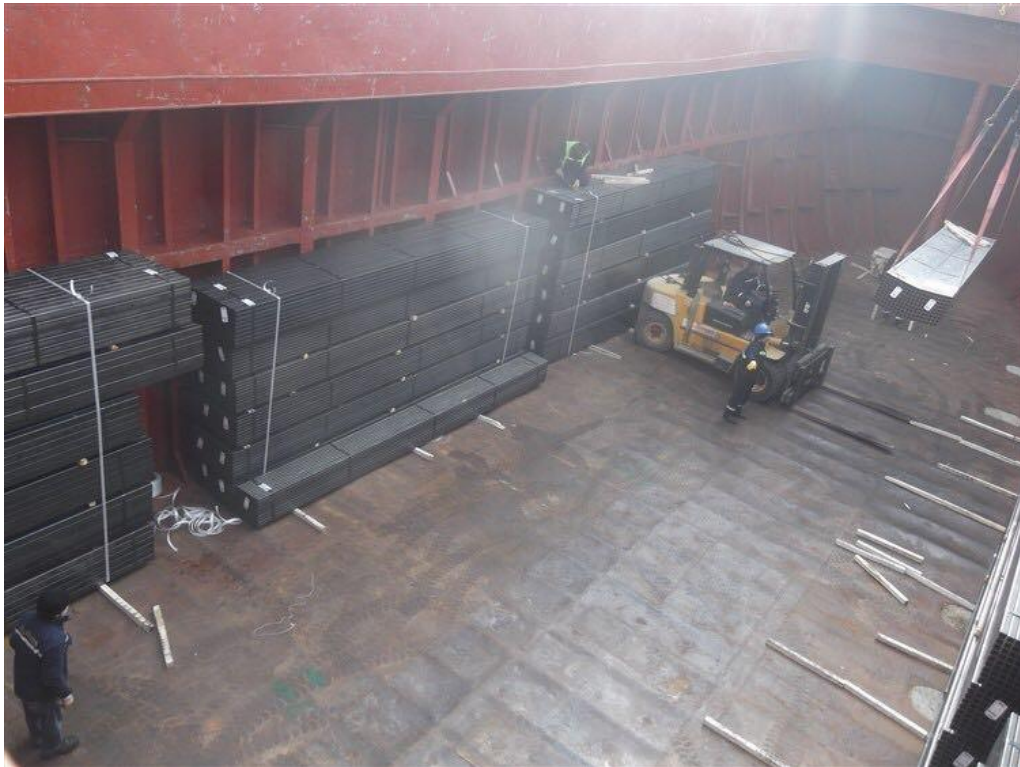
**Figure 3:** Lashing Continues While Loading on the Vessel ALİ OSMAN E.

In the meantime, two bundles of tubes were being placed in the middle of the hold by the shore crane during the loading operation, and from there, the loading continued as those were taken by the forklift from there, to be with the height of 3 full size and 6 bundles one on the other, and to be from the port side towards the starboard side within the hold. After 6 bundles are stacked one on the other on one side, the load is tied down to itself, and the load is carried on the other side while the load tying down/lashing process continues (Figure 3).

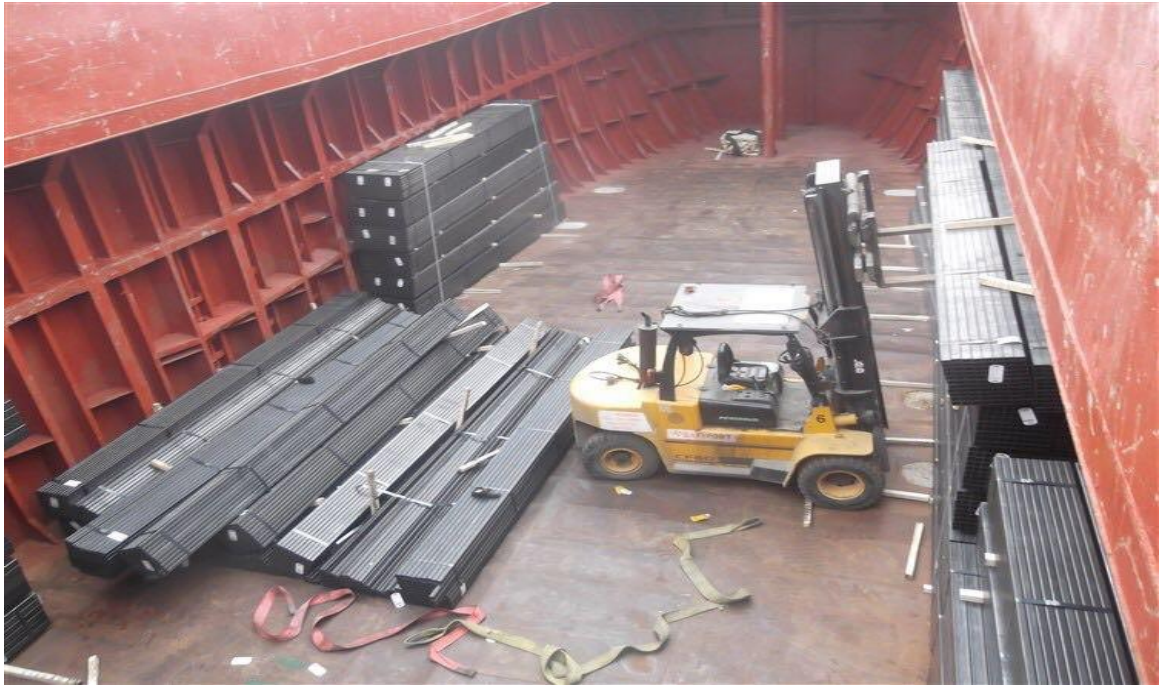
**Figure 4: After the Accident**

After the operator put 3 rows of 6 bundles of shaped tubes one on the other, the shaped tubes that were stacked in the middle of the port side fell at 15:30 while the 7th rows of shaped tubes was being placed on the stack in the middle of the starboard side with the instruction of the shipping officer (Figure 4).

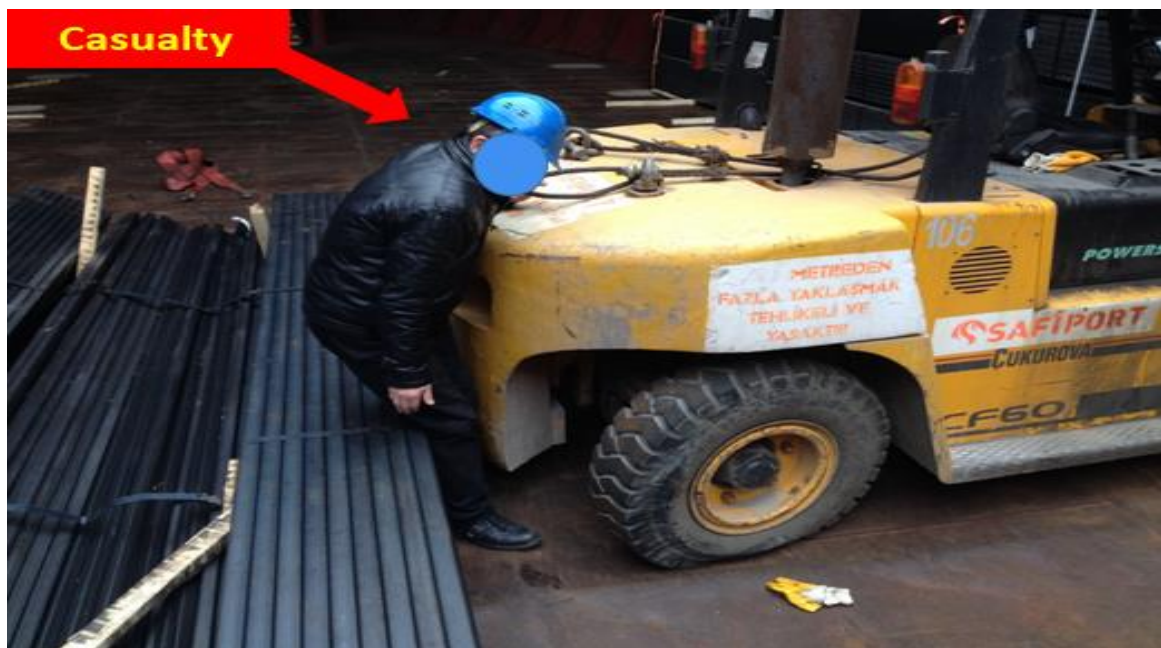
**Figure 5: Victim Stuck Between Shaped Tubes and Forklift<sup>1</sup>**

In the meantime, the slinger (victim) located near the forklift was injured as a result of being stuck between the fallen stack and the forklift (Figure 5). 3 packs of shaped tubes on the victim were taken by a shore crane using sling. Approximately 15-20 minutes later, the medical team arrived at the scene. During this time, the victim was conscious and his pulse

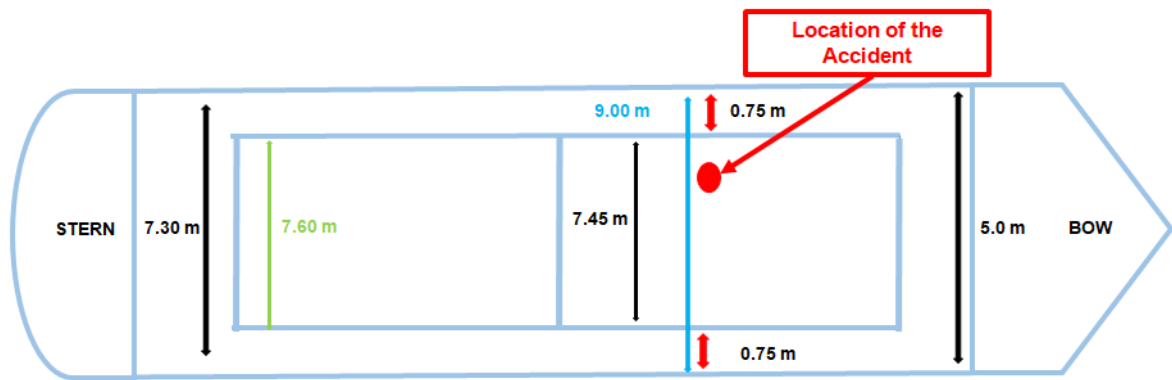
**Image 1: Hold Cover and Hold Dimensions where the Loading was done**

The widest part of the hold No. 1 of the vessel Ali Osman-E is 9.50 meters and the narrowest part is 5 meters. Cover width of the hold No. 1 is 7.45 meters. The hold width at the part in the hold where the accident occurred is 9 meters. The hold cover width is 7.45 meters. There is a distance of approximately 0.775 meters from the end of the hold cover on the port and starboard side of the vessel to the wings (Figure 1).

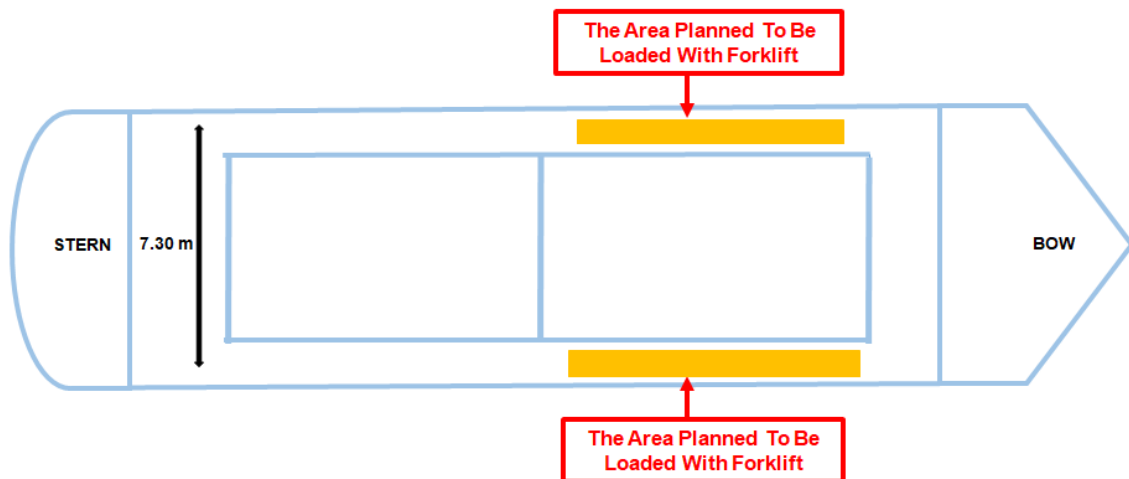
**Image 2: Area in which it is planned to use forklift for loading**

Due to this distance, the shipping officer of the cargo requested that the forklift is used for the area outside the area under the hold covers (Figure 2) so that the cargo is not damaged and the loading can be done quickly. The Ship Master stated that he had loaded the same loads in the same port before and did not want the loading to be done with a forklift. It acted in accordance with the request of the shipping officer of the cargo in regards to using the forklift. The forklift was put down into the hold No. 1 of the vessel at 13:00 and the loading to the vessel started at 13:15.

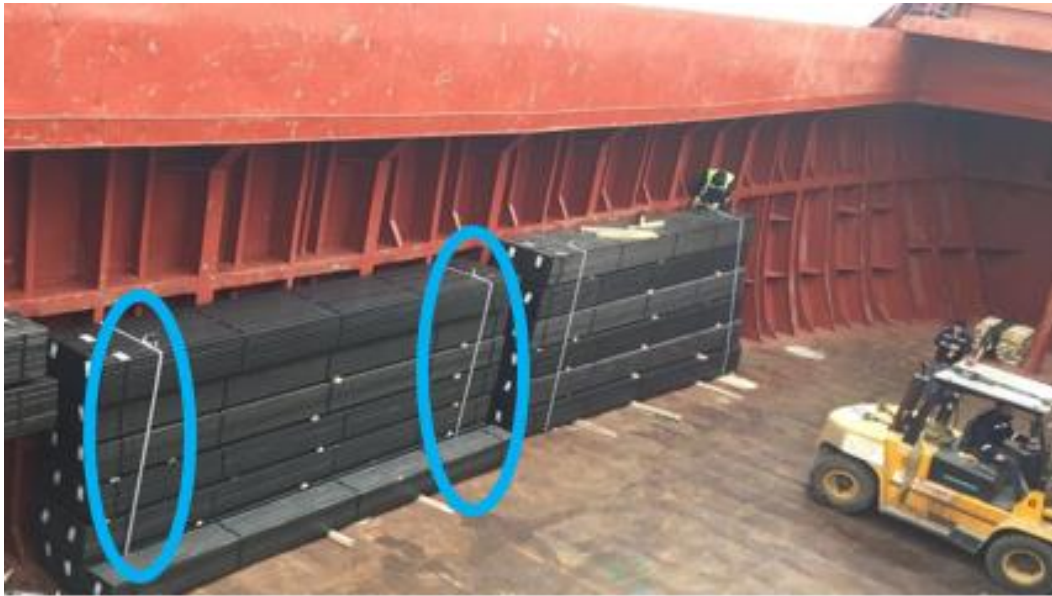
Figure 6: Fallen Stack

After loading to the starboard and port sides of the vessel with a forklift as to reach a height with 4 rows of 6 bundles one on the other, load tying down/lashing is started. When the photographs related to loading just before the moment of the accident are investigated (Figure 6), it is seen that the loads on the port side are tied down to each other.

On the other hand, after the forklift operator put 6 bundles one on the other, the shaped tubes that were stacked in the middle row on the port side fell at 15:30 while the 7th rows of shaped tubes was being placed on the stack in the middle row on the starboard side with the instruction of the shipping officer. The worker engaged in unfastening the slings of the load put down into the hold in the meantime got stuck between the load and the forklift (Picture 7).

The probable cause of the accident is that the forklift used in the loading is large enough to affect the balance of the vessel, and thus it caused the loads to slip due to the fact that the vessel inclined toward the starboard side in parallel with the movement of the forklift

moving towards the starboard side. Another important factor causing the accident is that the load tying down/lashing was being carried out as the loading was in progress and that the loads tied down to each other were not tied down to the vessel's body.

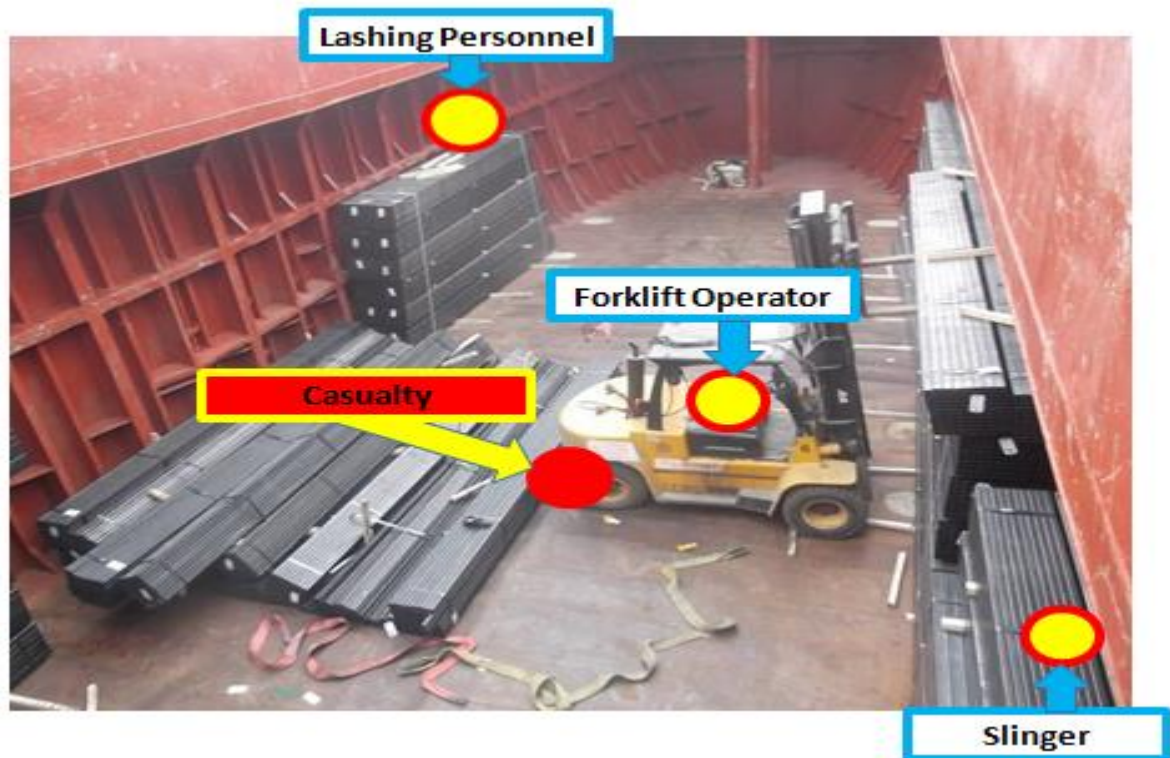
Figure 8: Locations of People in the Hold at the Time of Accident

The shift appointed for the loading of the vessel ALİ OSMAN E consists of a crane operator, a forklift operator, two slingers and a foreman. Persons in the hold at the time of the accident are shown in figure 8 and the information on their locations is given below.

- Slinger was on the stack behind the row on which the loading was being carried out and which was on the starboard side of the vessel.
- Slinger (Victim) was close to the location where the right rear wheel of the forklift was.
- Forklift operator was on the forklift and was trying to load 7th row of shaped tubes on the stack in the middle on the starboard side of the vessel.
- Lashing personnel was lashing on the stack on the port side.
- Crane operator: The crane operator, who was on the shore crane, returned to the shore side to take a load on the truck on the shore by the crane.
- The foreman, who coordinated the loading process during the shift, was not onboard during the accident.

The Slinger (victim) got stuck between the cargo and the forklift due to the fallen cargo while he was in a position very close to the forklift and trying to load over the 6th row on the stack on the starboard side. On the other hand, the lashing personnel on the stack of

The fact that one of these three people in the hold was close enough to the truck forklift to pose a danger to him, and the other two people were on the stacks that are likely to fall during the loading shows that they were not able to evaluate the risks and dangers of their work and that they did not have the coordination to make them work in coordination.

- 10/03-20** Measures should be taken by making a risk assessment in order to identify the hazards related to the work carried out by the slinger and the personnel assigned in cargo lashing operations and to prevent/reduce risks,
- 11/03-20** Before the loading/unloading plans are implemented, a risk assessment should be made between the port management and the vessels considering the negative impact of the forklift to be used on the vessel's balance, including the determination, suitability of the equipment to be used and the methods of cargo lashing,
- 12/03-20** The port working organization structure should be revised to ensure full coordination among the people involved in ship loading/unloading operations,

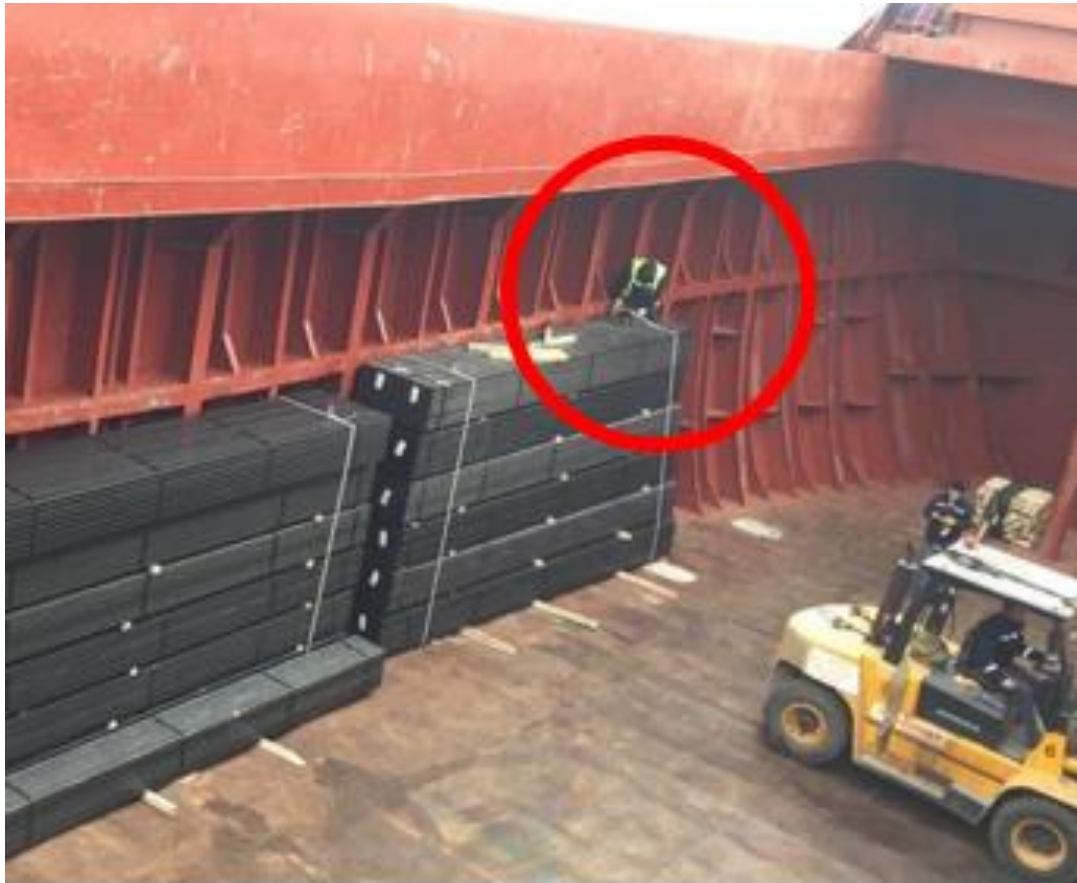
Figure 9: Lashing Personnel Engaged in Tying Down the Load to Itself

shaped tubes on the port side was trying to tie down the cargo to itself while the loading was continuing on the starboard side of the vessel, and in the meantime, another slinger personnel was on the stack which was tied down neither to itself nor to the vessel's body (Figure 8, Figure 9).

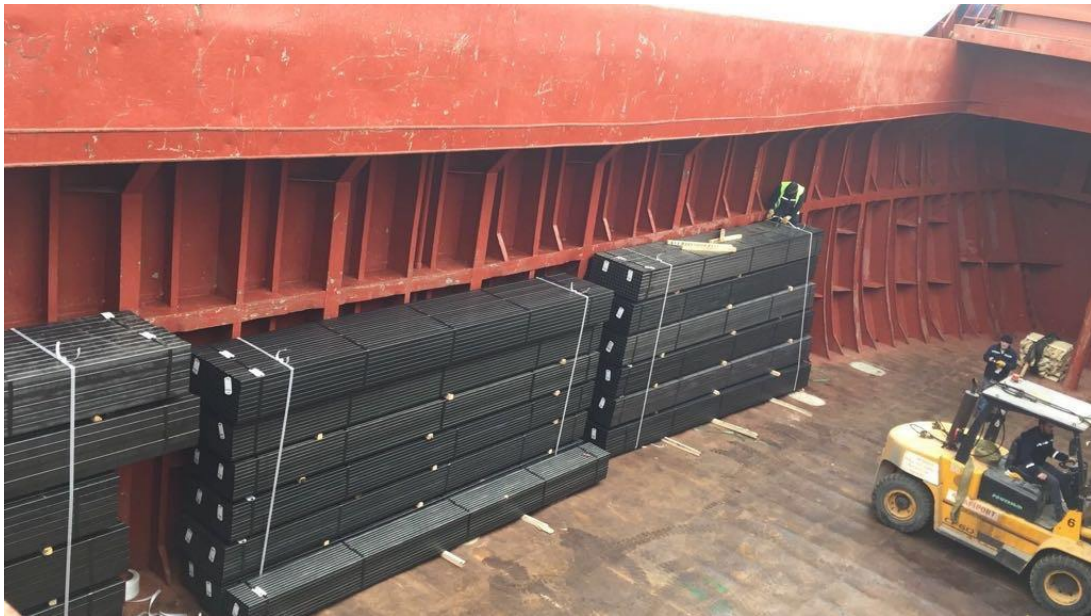
Figure 10: Cargoes of Which Lashing Continues

On the other hand, loading operation was started on the vessel ALİ OSMAN E, the cargo lashing was started after 6 bundles were put one on another on the port starboard side in the hold No. 1. When the photos related to the accident were investigated after the accident, it was determined that the fallen stack and other loads were tied down to each other but they were not tied to the vessel (Figure 10). For this reason, the risk of falling of the loads was faced, which may occur as a result of the vessel's inclination to the starboard or port side. This situation is considered as one of the safety factors causing the accident.
