REPORT ON SERIOUS MARINE CASUALTY

NAME & IMO No	: BENITAMOU / 9439046 BC VANESSA / 9426855
FLAG	: Panama Barbados
LOCATION OF ACCIDENT	: The Northern Entrance of Çanakkale Strait / Türkiye
DATE OF ACCIDENT	: 24.10.2021 / 06:07 LT
FATALITY&INJURY	: - / -
DAMAGE&POLLUTION	: Extensive damages on both vessels / NIL

Board Decision No: 13 /D-6 /2023

Date: 19 / 06 / 2023

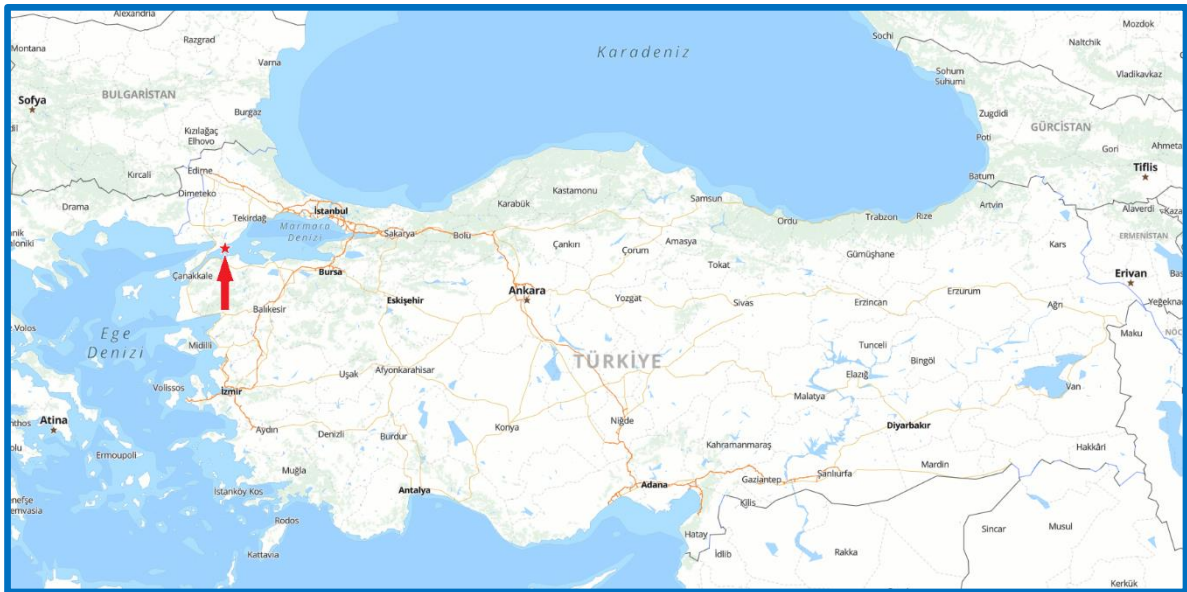
Figure 1: Accident Scene

On 24 October 2021, the Panama registered bulk carrier **BENITAMOU** collided with the Barbados registered general cargo **BC VANESSA** in southbound lane of the Turkish Straits TSS in Marmara Sea, Türkiye (**Figure 1**). **BENITAMOU** was proceeding at a speed of around 8 knots while started to cross TSS southerly due to the suspension of her transit. **BC VANESSA** was a southbound vessel, as well and proceeding at a speed 12 knots in the TSS. Both vessels suffered major structural damages but there were no injuries or pollution.

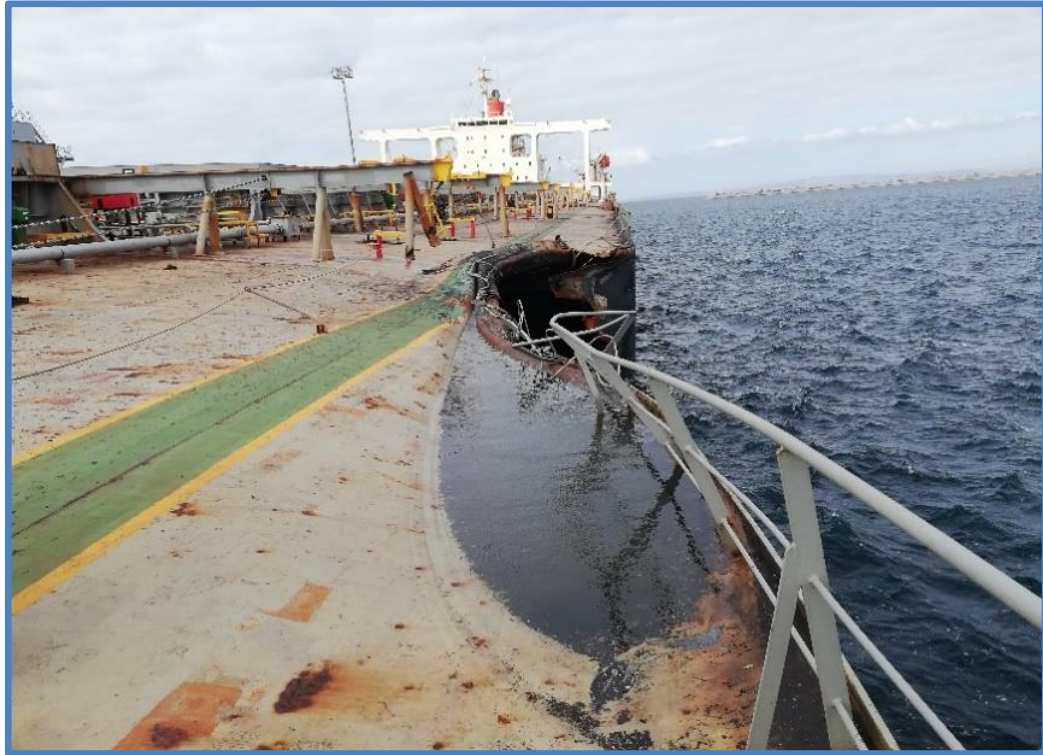
Figure 7: BENITAMOU Damage Snapshot – 1

“The punctures were fixed at No.3 WBT’s (Water Ballast Tank) exterior shell plate and the extensive tears and deformations were fixed No.4 Hold’s longitudinal shell plate. No.4 Hatch Cover was damaged after collision, as well as, a deformation was compromised beneath the starboard side accommodation ladder during the contact of both vessels.”

“12 meter longitudinal and 17 meter vertical a V-formed split was compromised amid from the No.4 Hold’s port side shell plate”

Referring to the both reports and the views, a flooding was observed inside to the No.4 Hold and No. 3 WBT due to the variable sounding values and damaged shell plates. However, The Maritime Authority tendered an exemption to BENITAMOU for navigating to the nearest repair facility by her own engine.

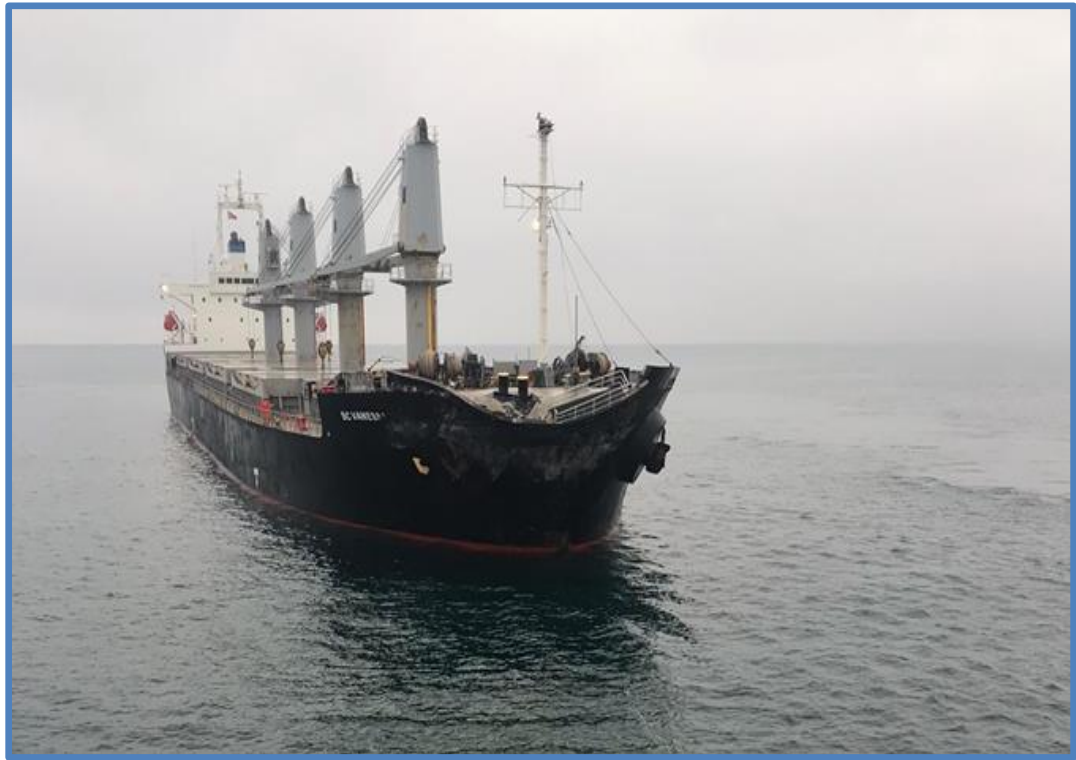
Figure 10: BC VANESSA Damage Snapshot – 1

“A 60x3 cm-sized crack was compromised on the bulbous and the bulbous was deformed to inside on either side”

Referring to the both reports, The Maritime Authority tendered an exemption to BC VANESSA for navigating from anchorage to Tuzla Shipyard.

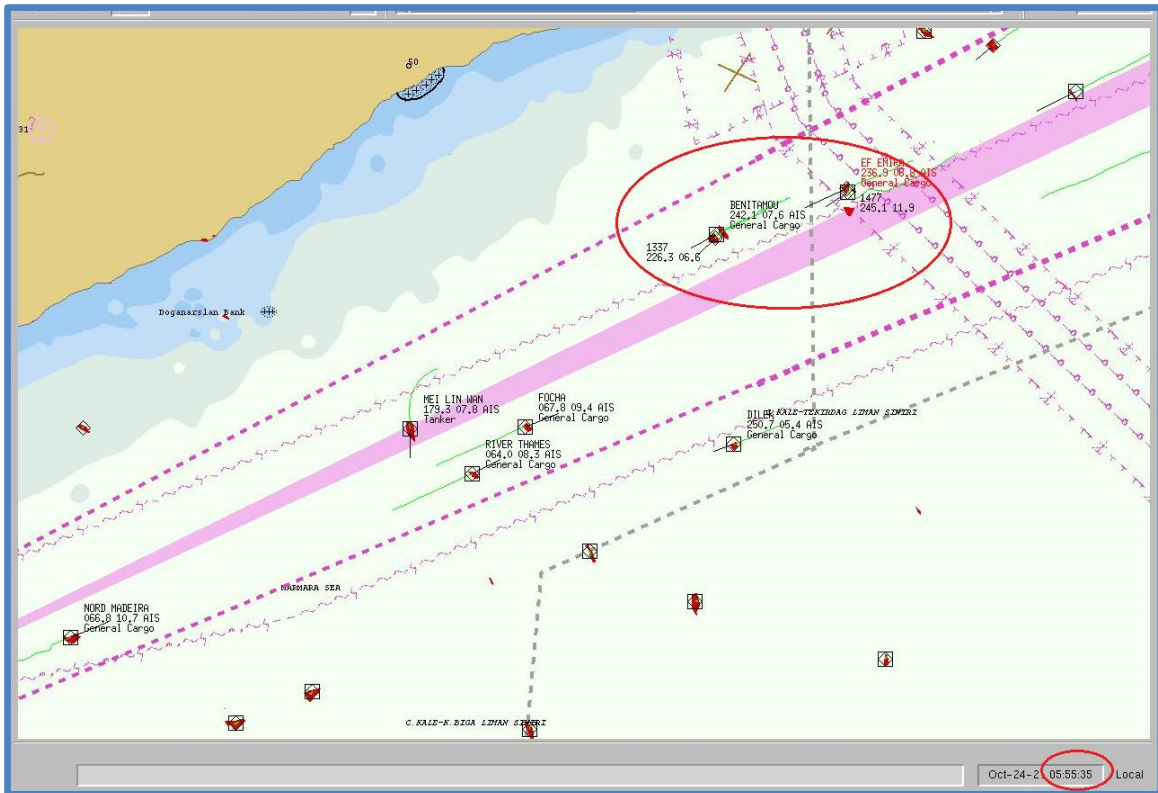
Figure 12: VTS Monitor Snapshot Pre-Accident – 1

06:07:16	BENITAMOU and BC VANESSA collided

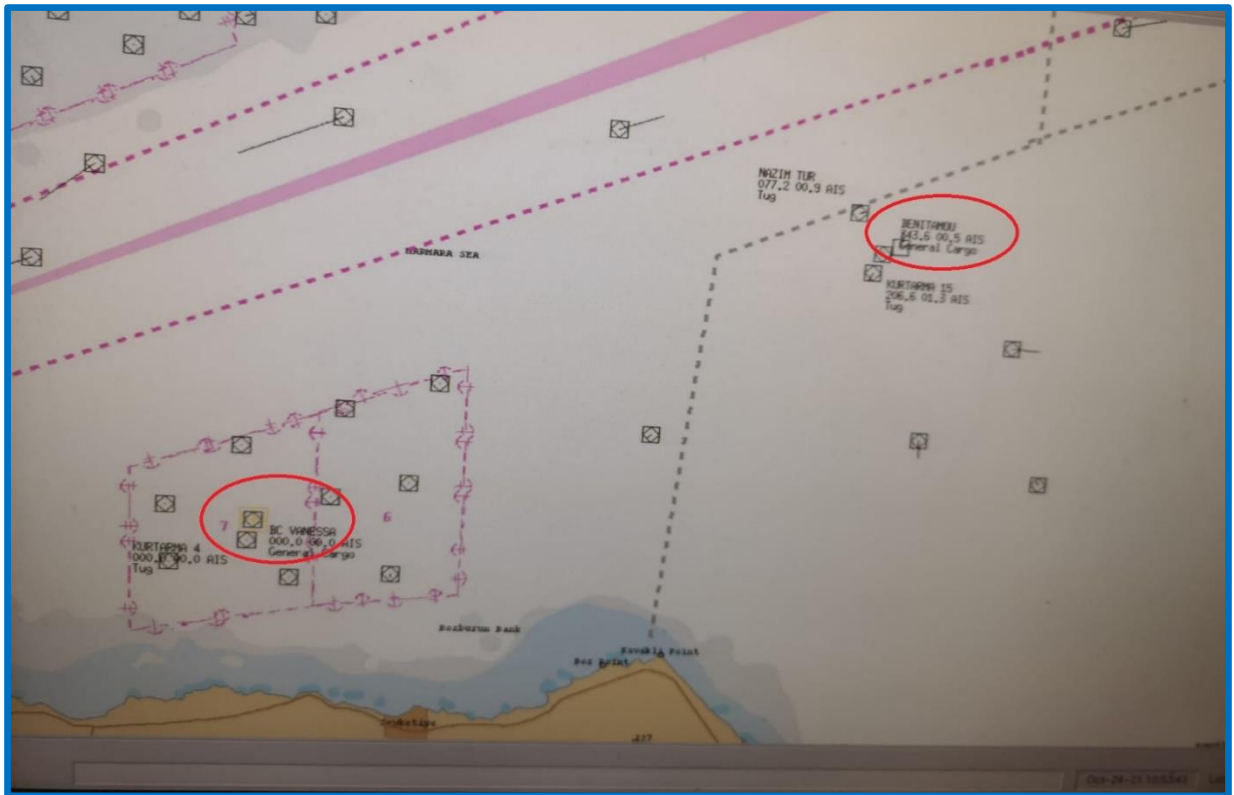
Figure 18: VTS Monitor Snapshot (Ship's Anchorage Positions Post-Accident)

As seen on the *Figure 18*, around half an hour later, the tugboats arrived on scene and waited for the immediate assistance if needed.

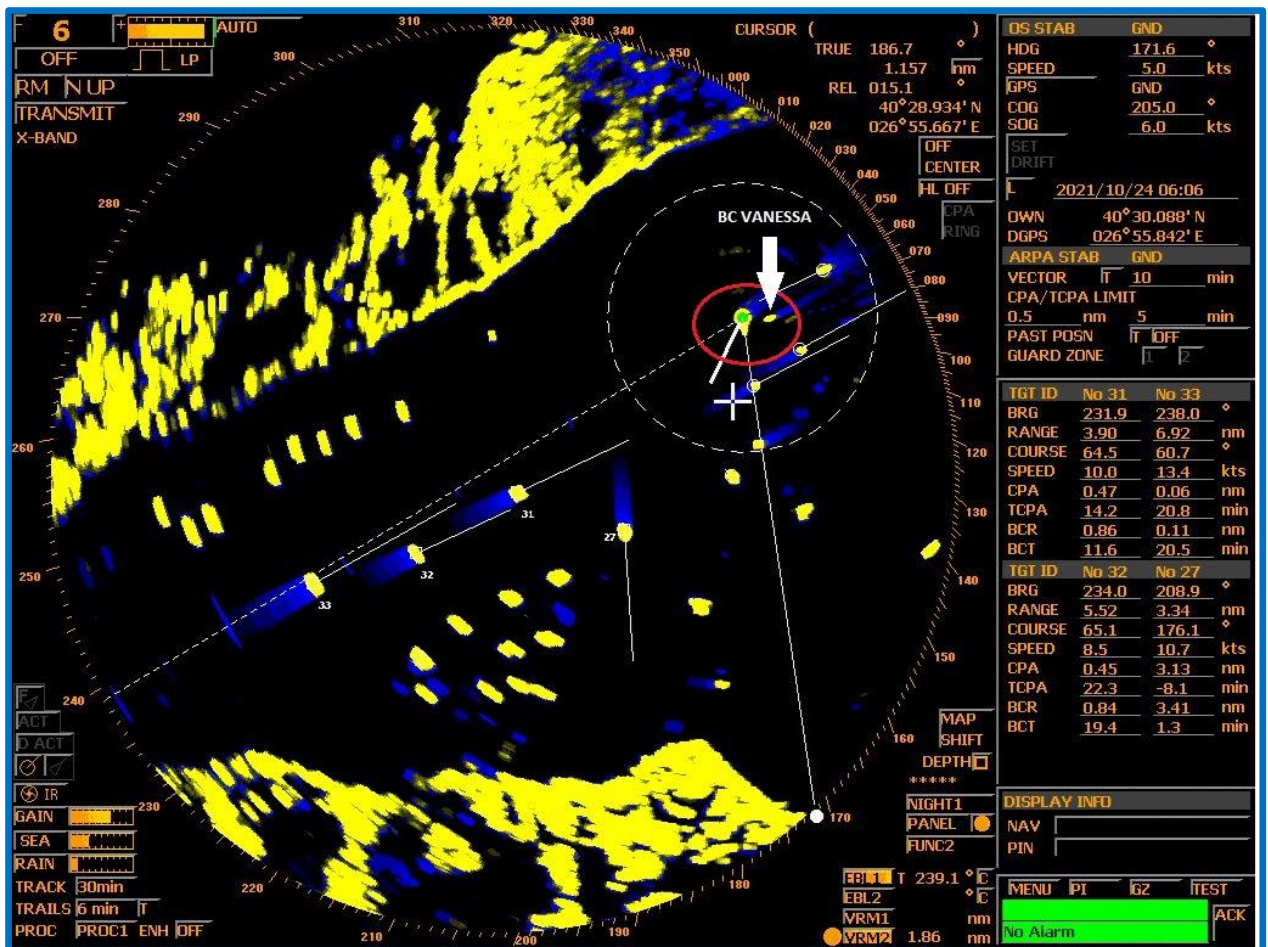
Figure 19: BENITAMOU VDR – ARPA Snapshot - Instant of The Vessel's Noticed Each Other

It is clear that the main reason for the circumstance is the lack of AIS data as to BC VANESSA and therefore, not being plotted as a target on the ARPA. In addition, the necessity of monitoring the vessels in vicinity only from the radar due to the restricted visibility and the fact that eye contact with the vessels in vicinity can be established in case of close range is the overriding reason affecting the situational awareness with respect to the lookout.

At BC VANESSA, the similar consequences were considered. The maneuvers as VTS callings to suspend transits and BENITAMOU's cross passing TSS were not monitored accurately. Therefore, effective look out was not maintained at BC VANESSA's bridge in terms of VHF Radio listening and radar targets monitoring.

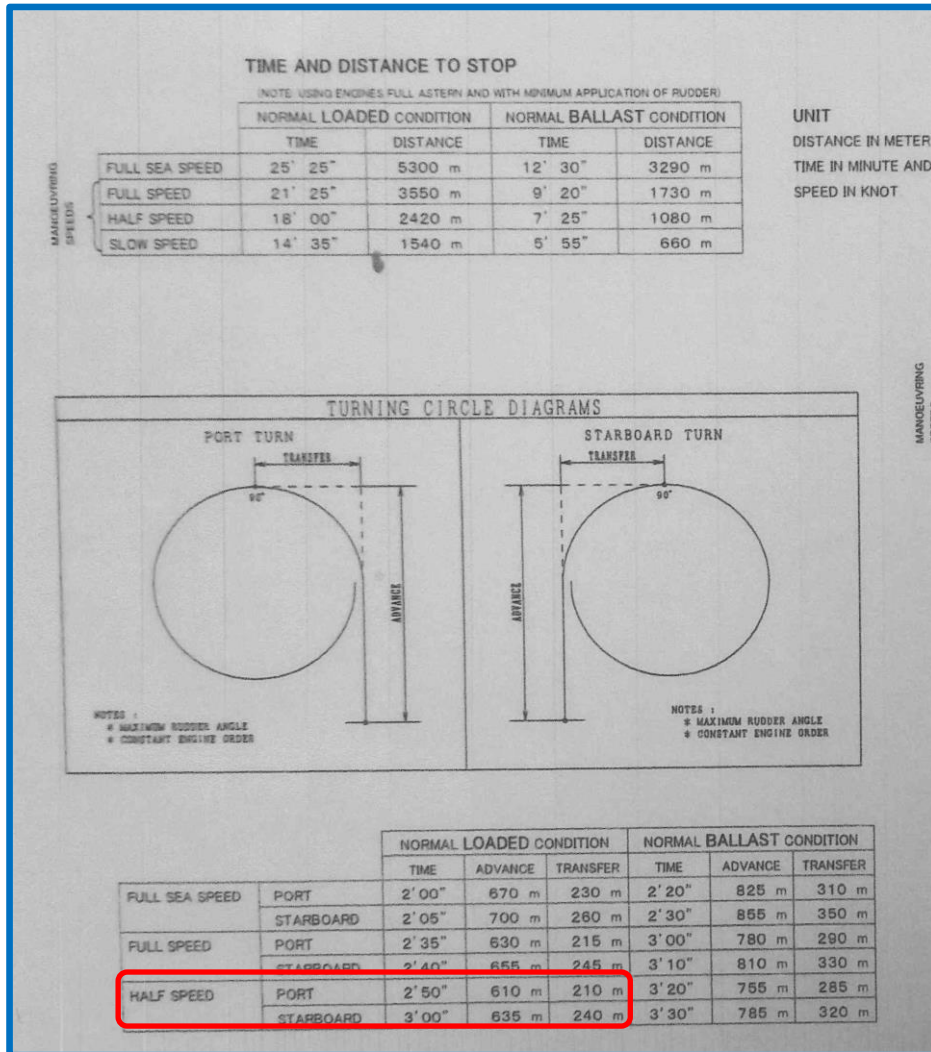
Figure 20: BENITAMOU – Turning Circle Diagram

Turning circle diagrams of BENITAMOU can support the abovementioned conviction. (**Figure 20**) As indicated in the figure, BENITAMOU was in laden and the engine speed was half ahead. Under the stated conditions, BENITAMOU’s bridge team spotted BC VANESSA at a distance of two cables and on hard to port maneuver. Indeed, the Master immediately ordered the helm hard to starboard in order to avoid or lessen the effect of collision. However, naturally, a laden cape-sized vessel did not come to the reverse side in a short time as indicated in the figure. Therefore, the collision occurred despite the mentioned steering maneuver.
