**Accident Investigation Report On**  
**The Fatal Man Overboard From The Fishing Vessel**  
**BURHAN KAPTAN 1**

**Off the Rumeli Lighthouse / Istanbul**  
**23<sup>rd</sup> of September 2014**

**22/DNZ-03/2017**

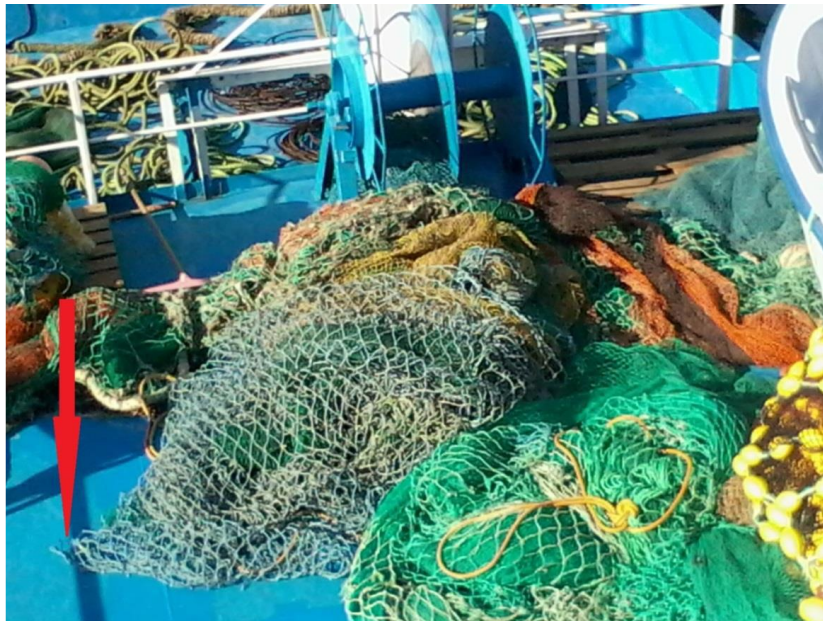
***Figure 6: The Position of Crew Member D at the Upper Deck***

The wind threw around the crew member D, who went up to scatter the nets to prevent them from falling into the sea on the upper deck, towards the pillars and squeezed him between. Meanwhile, the nets that were tangled to the head of crew member D, prevented him to fall overboard.

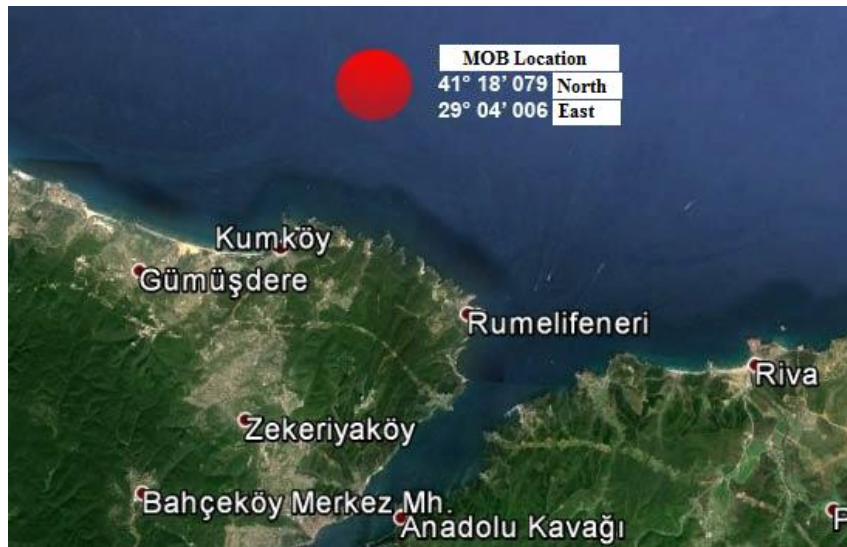
**Figure 7:** Man Over Board Location of the Casualty

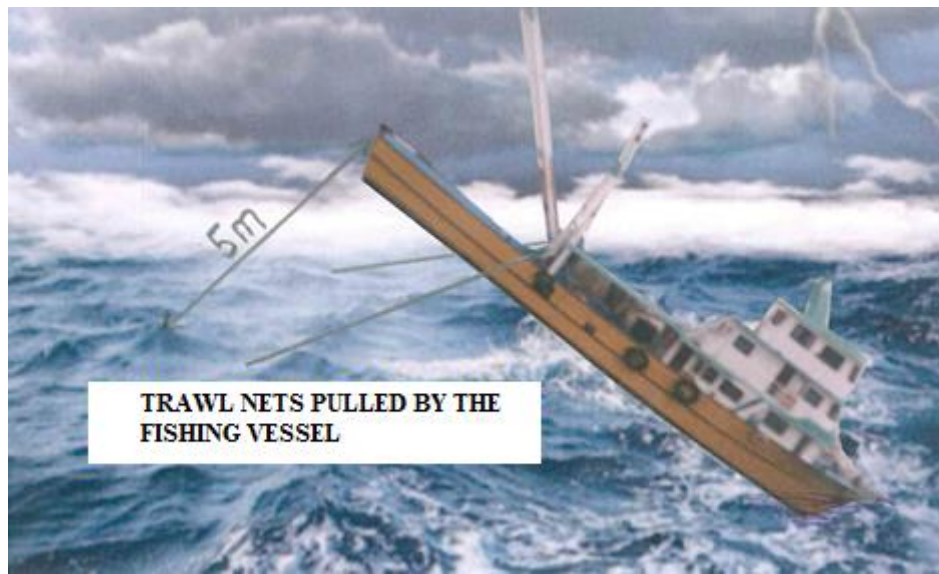
With the effect of generated wind and waves and as a result of rising the aft of the vessel 5 meters (**Figure 8**), windlasses normally used to pull the nets, tightened backwards and damaged the pipes behind by moving approximately 2 centimeters from its' original position. (**Figure 10**)

*Figure 8: Representation of the Rising Aft of the Vessel With the Effect of Waves*

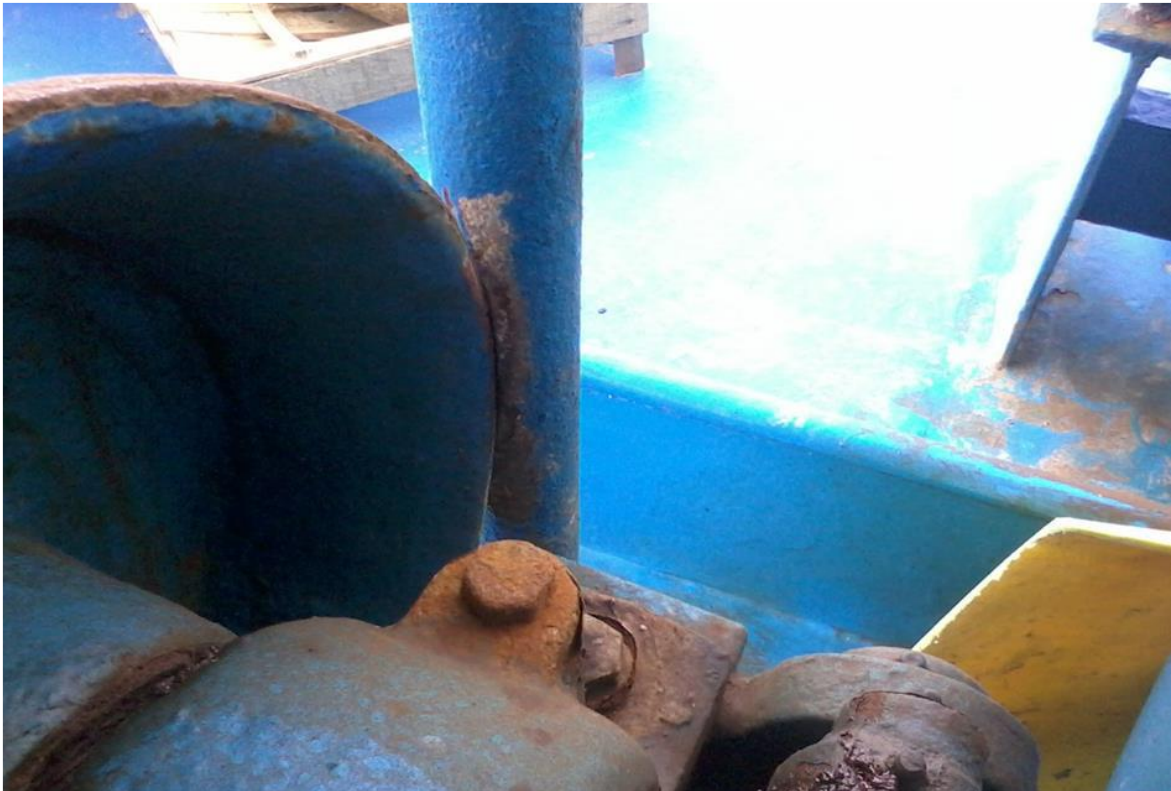
***Figure 10: Damage on the Windlass***

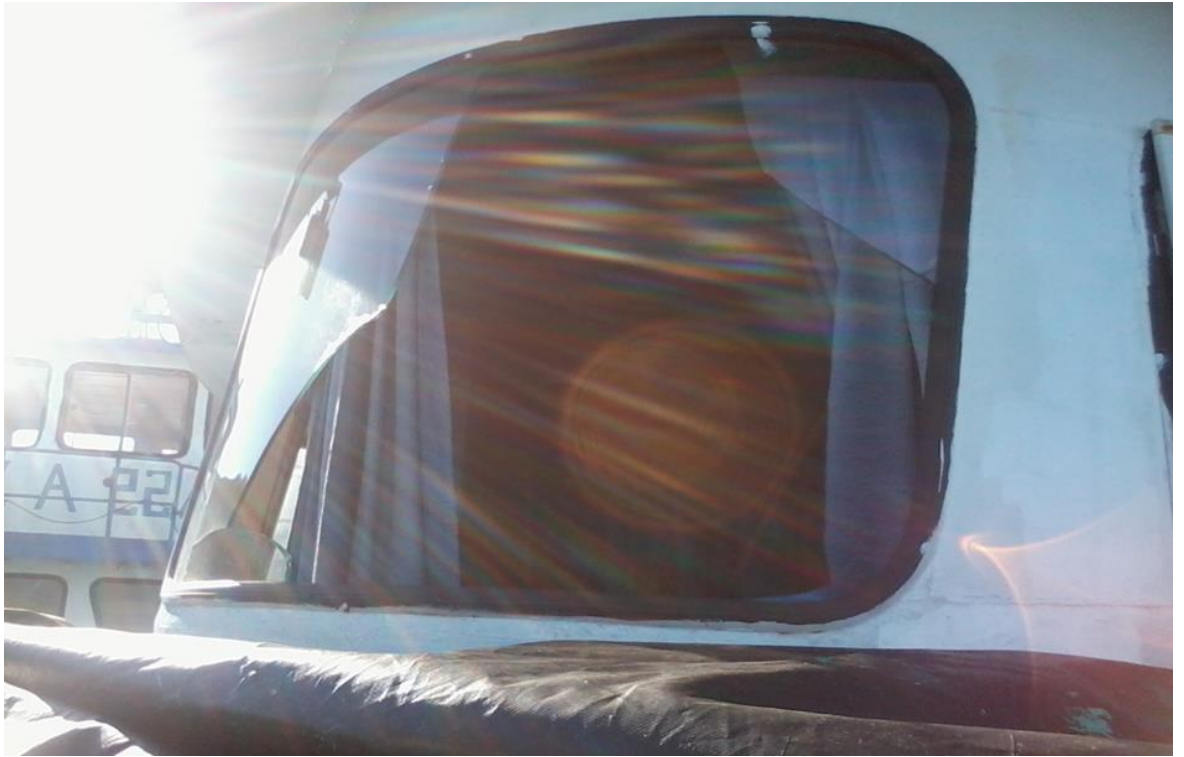
Besides, with the effect of sea water rised by the tornado and the waves, journals, papers, electronical equipments and other stuff on the bridge got wet by the strong spray. Porthole glasses of master cabin towards port bow, which was located one floor below the bridge and w.c.'s which was located at the entrance of starboard deck, door hook and AIS<sup>6</sup> antenna located at the flying bridge was broken. (***Figure 11 and 12***)

***Figure 11: Damage on the Window of the Skipper's Cabin***

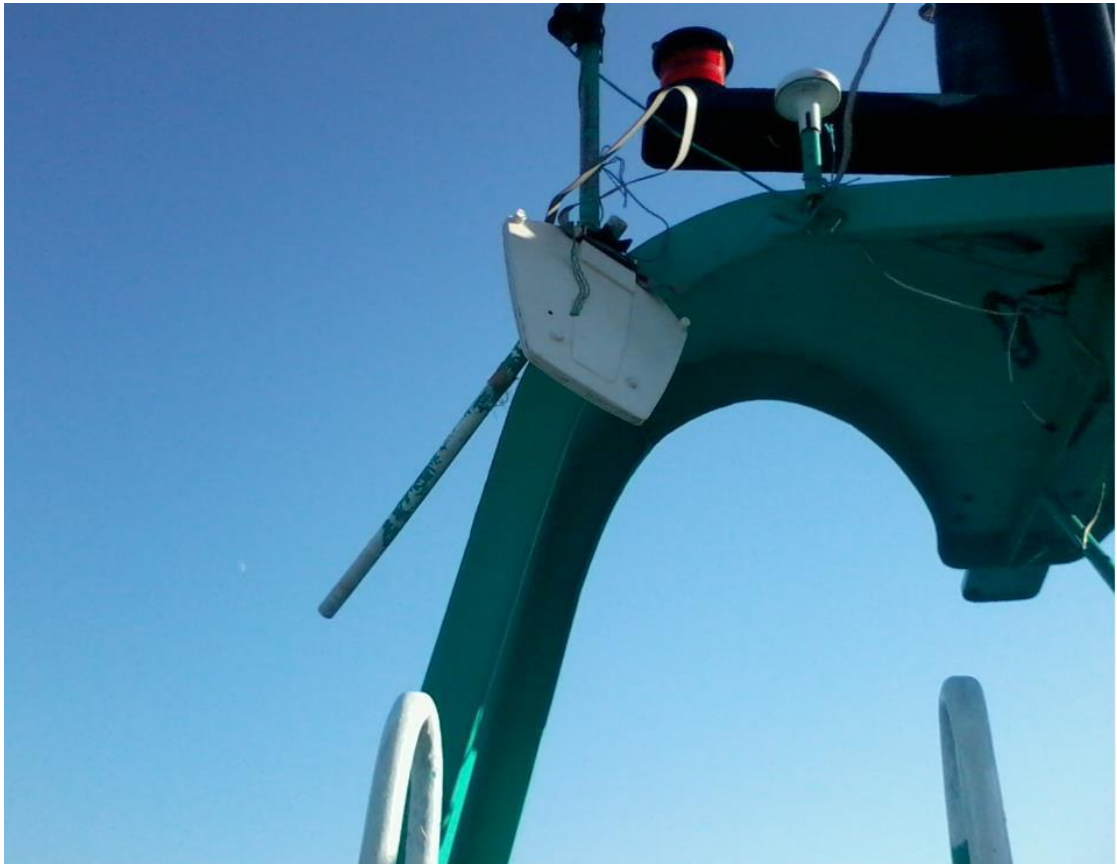
***Figure 12: Damage on the AIS Antenna***

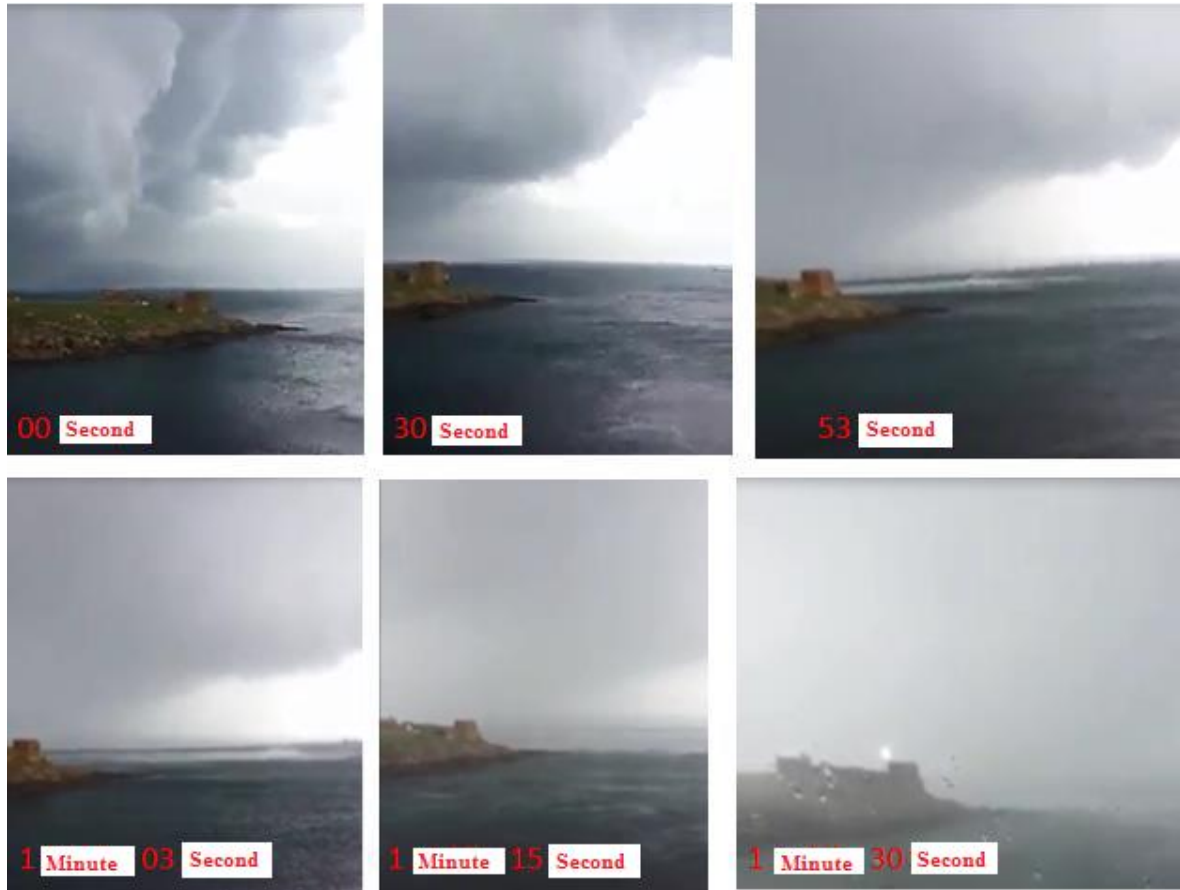
It is seen from the video footage (**Figure 15**) that were taken from Rumeli Lighthouse that sea and weather conditions changed in seconds.

**Figure 15:** Snapshot taken from a place close to Rumeli Lighthouse
