REPUBLIC OF TURKEY
MINISTRY OF TRANSPORT, MARITIME AFFAIRS AND
COMMUNICATIONS
Accident Investigation Board

Accident Investigation Report On
The Collision of Boats of LADY COPPELIA & SEYYALE

MUĞLA/Marmaris, off the Coast of Bozburun
11th September 2014

Report Number: 03/2015

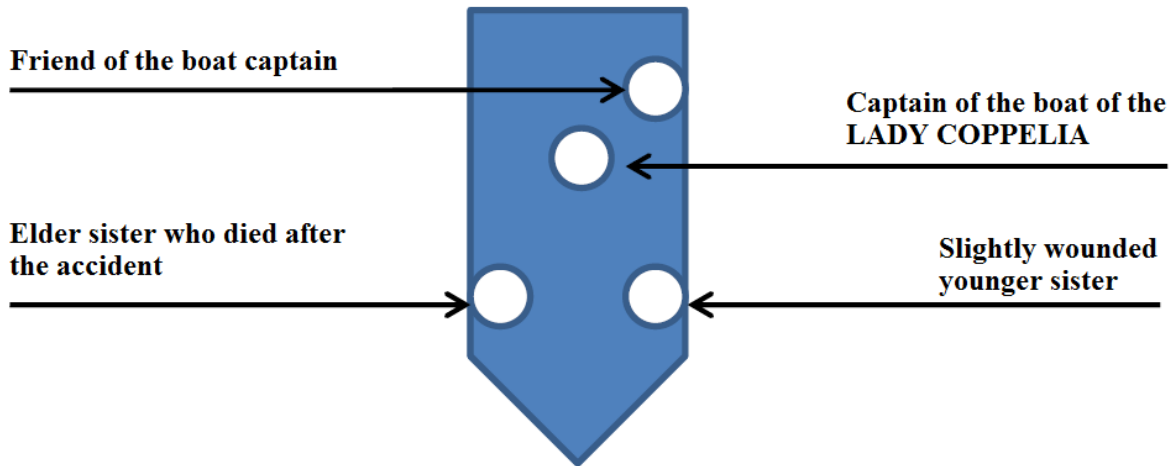
Figure 2. Sitting positions of the people onboard the Boat of LADY COPPELIA

The inflatable boat belonging to LADY COPPELIA was equipped with a bigger and more powerful engine than the inflatable boat belonging to REGINA. Therefore, total 4 people consisting of the boat owner and his friend and 2 sisters were on board the boat belonging to LADY COPPELIA, and 2 people consisting of the boat owner (father of the sisters) and his wife (mother of the sisters) were on board the other boat. Both boats were commanded by their owners. The inflatable boat belonging to REGINA started to proceed firstly and the boat belonging to LADY COPPELIA overtook the other boat with its navigations lights on. Because the engine power of the boat belonging to REGINA was small (3,5 HP), the boat belong to LADY COPPELIA slowed so that boat belonging to REGINA could catch it. Both boats were sailing at 3-4 knots with 25-30 m. distance between them. According to the seating positions on the boat belonging to LADY COPPELIA, the elder sister, victim of the accident, who died, was sitting at the starboard bow, younger sister was sitting at the port bow, owner of the boat was sitting on the control console and the other person (friend of the boat captain) was sitting at the port quarter.

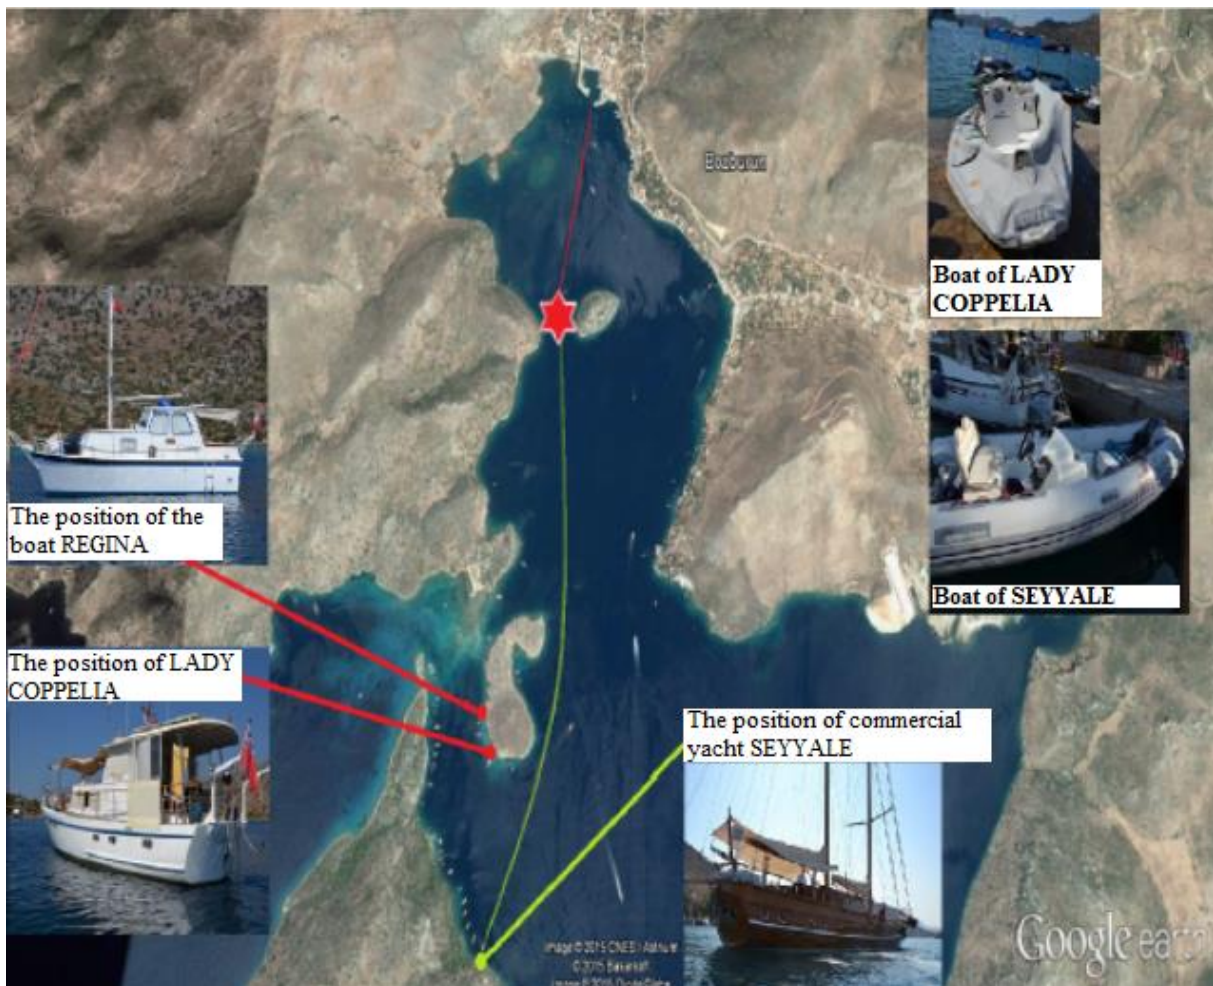
Figure 3. Sketch of the accident scene

While the inflatable boats which belonged to the LADY COPPELIA and SEYYALE were passing through the West of Yeşilada located at the South of Bozburun Port, around 20:45 hours they collided. As the result the collision the console of the inflatable boat belonging to LADY COPPELIA was broken up and separated from its position, rupture occurred on the starboard side of the boat and it capsized.

With the impact of collision the console of the boat belonging to LADY COPPELIA was broken up completely from its original place where it had been fixed with 4 bolts, and at the starboard side of the boat, ruptures were occurred and the boat floated on water at half sinking position. Scratches occurred at the starboard side of the boat belonging to SEYYALE and on the right wing of the outboard engine.

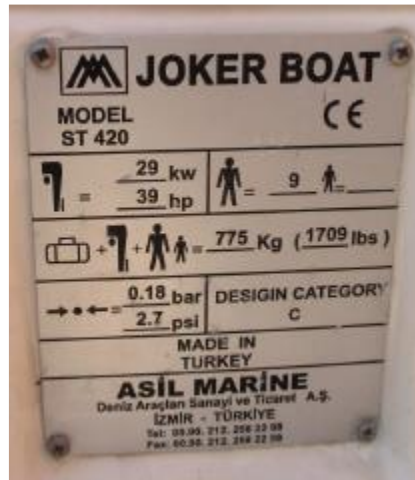
Figure 4. Craft identification plate of the boat of SEYYALE

On the other hand, manufacturer firm of the boat belonging to SEYYALE advised that an engine with 39 HP should be attached. The power of the outboard engine of the boat belonging to SEYYALE however was 50 HP. Therefore, the boat was equipped with an outboard engine, the power of which was higher than the power advised by the manufacturer firm.

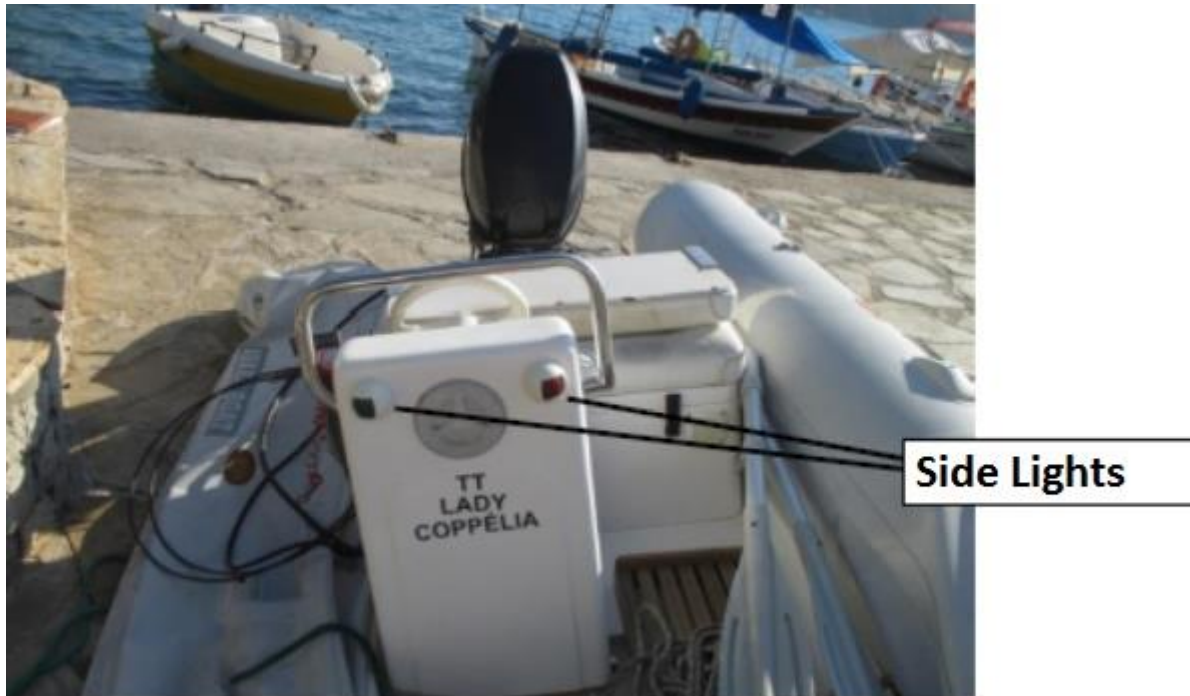
Figure 5. Inflatable boat of the private boat LADY COPPELIA

During investigations carried out on the boat belonged to LADY COPPELIA after the accident, it was witnessed that the boat had got sidelights, but did not have a light visible from all directions (Figure 5). The console on which the sidelights are installed was damaged due to collision therefore, whether the lights were working or not could not also be determined. On the other hand, if it is assumed that sidelights were on, taking into account the sitting positions of the casualty sisters who were sitting in front of the boat belonged to LADY COPPELIA before the accident, there would be the possibility that they could likely prevent the other vessels to see the sidelights.

1. To increase conformity inspections of navigation lights of boats/vessels cruising within the administrative borders of the Harbor Master according to COLREG and in terms of their cruising at safe speed in coordination with the Coast Guard Boat Commands on duty at the area.

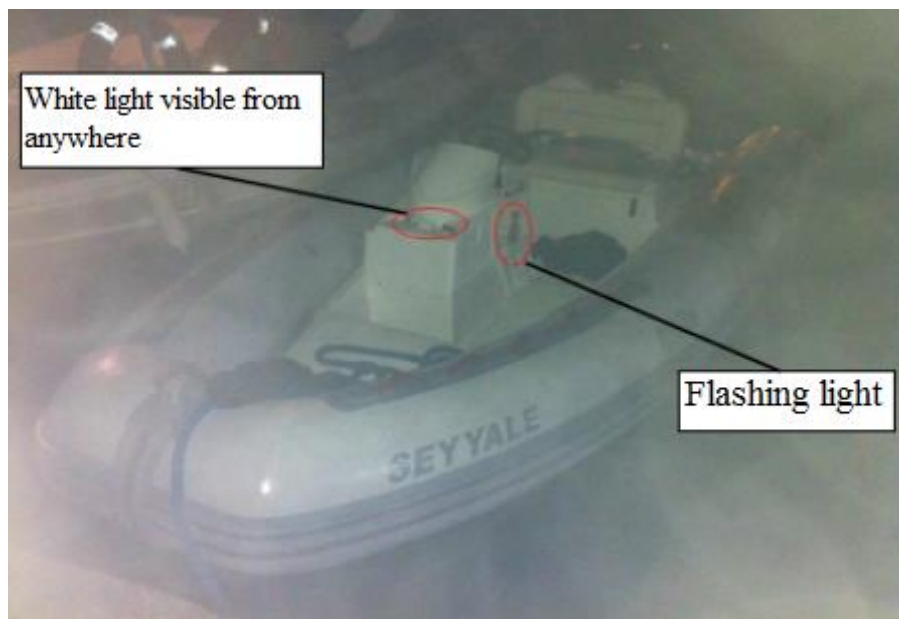
Figure 6. Inflatable boat of commercial yacht SEYYALE

Likewise, upon investigations conducted after the accident, it was seen that sidelights were not available on the boat belonging to SEYYALE, but there was a white light and a flashing light visible from anywhere (Figure 6). On the other hand, it has been observed that position of the white light visible from anywhere was not at least 1 meter higher from the sidelight in accordance with the requirements of Annex I: Positioning and Technical Details of Lights and Shapes, 2. Vertical positioning and spacing of lights (d) of COLREG.

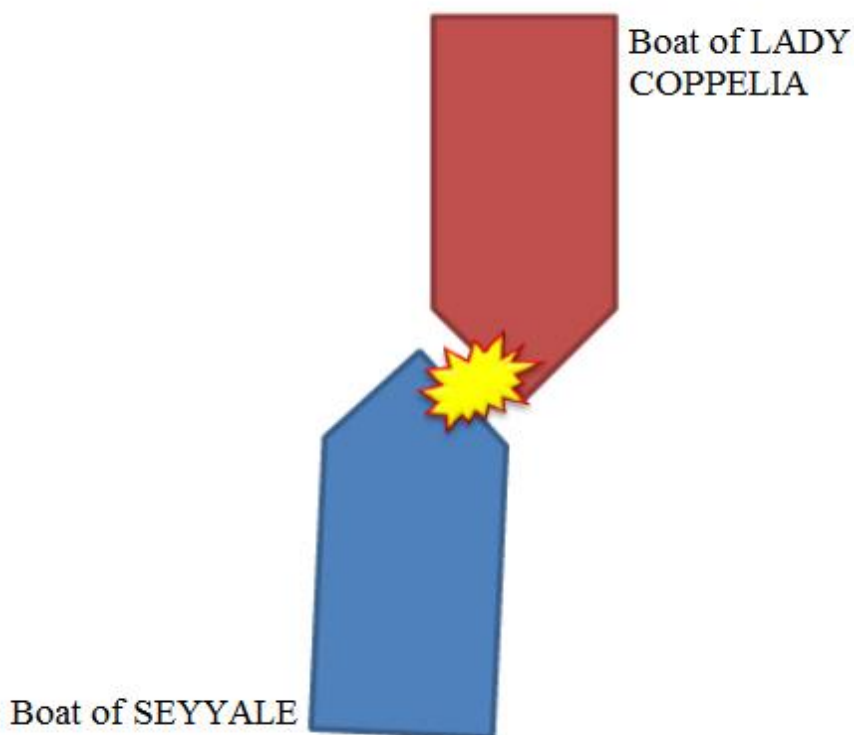
Figure 7. Estimated positions of the boats at the time of collision

The boat of SEYYALE and the boat of LADY COPPELIA collided while they were passing from the west of Yeşilada located at the south of Bozburun Port. The collision occurred along the starboard bow of the boat of LADY COPPELIA and along the starboard side, including starboard propeller of the outboard engine of the boat of SEYYALE.

In the light of the interviews carried out with passengers onboard the boats and the damages occurred on the boats, it has been guessed that the collision happened almost bow to bow to see one another at their starboard side.
