MARINE SAFETY INVESTIGATION REPORT

NAME OF SHIP AND IMO NUMBER : DÜZGİT ENDEAVOUR (9581007)
FLAG : TURKEY
LOCATION OF ACCIDENT : ANTALYA
DATE OF ACCIDENT : 11.09.2019 / 08:42 (LT)
CASUALTIES : 1 INJURED
DAMAGE/POLLUTION : -/-

**DÜZGİT ENDEAVOUR
Marine Safety Investigation Report**

**Deck Cadet Was Stuck Between The Rope And The Roller Fairlead Of The Ship
Off Port Akdeniz/Antalya**

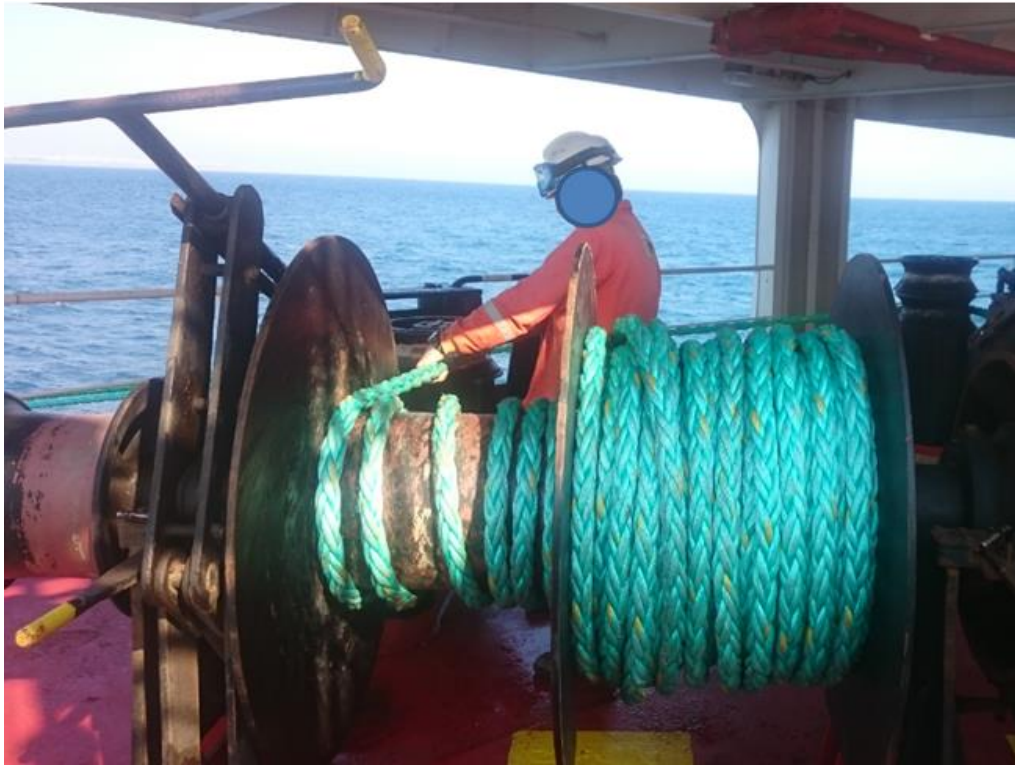
Picture 4: *Pulling Mooring Ropes That Rubbed the Drum Disk by the Seamen*

The Pilot, this time, instructed the mooring boat to make fast to the buoy by given in two mooring ropes that were hanged down from the port quarter towards the sea. The crew of the mooring boat took the mooring ropes in upon the instructions, checked them and made fast to the buoy that was located in the direction of the port quarter of the ship. Then, they informed the Pilot and started waiting for a new instruction. After the mooring ropes that were given from the port quarter of the ship made fast to the buoy, the Third Officer and the seamens took up the slacks of the mooring ropes. While taking in the slacks of the mooring ropes, as the rope on the drum close to the port stern became tense and touched/rubbed the drum disk, Third Officer took the place of casualty the casualty on the mooring winch control and the seamens continued to take up the slacks of the mooring ropes by pulling the rubbing mooring rope in the opposite direction of the drum disk (*Picture 4*).

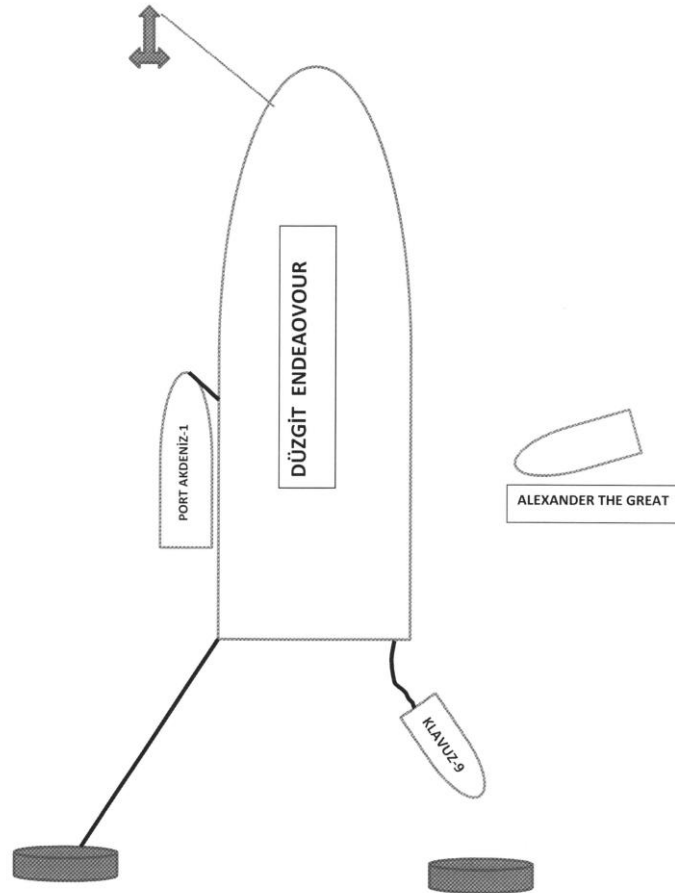
Figure 1: The Positions of the Ship, Tugboat and Mooring Boat at the Time of Accident

At around 8:42, while the ship took position to be moored to the buoy, the ship Captain informed the Pilot that the mooring ropes of the starboard stern were ready to be given by the ship crew. Thereupon, the Pilot instructed the mooring boat to take the ropes in and make fast to the buoy. The captain of the mooring boat reported that the mooring ropes were made fast on the boat and moved to carry the ropes to the buoy (*Figure:1*). Meanwhile, one of the cadets (the casualty) was on the left side and the other was on the right side of the roller fairlead where the ropes were given. The Third Officer and two able seamen continued to take up the slacks of the ropes that were previously given from the port stern.

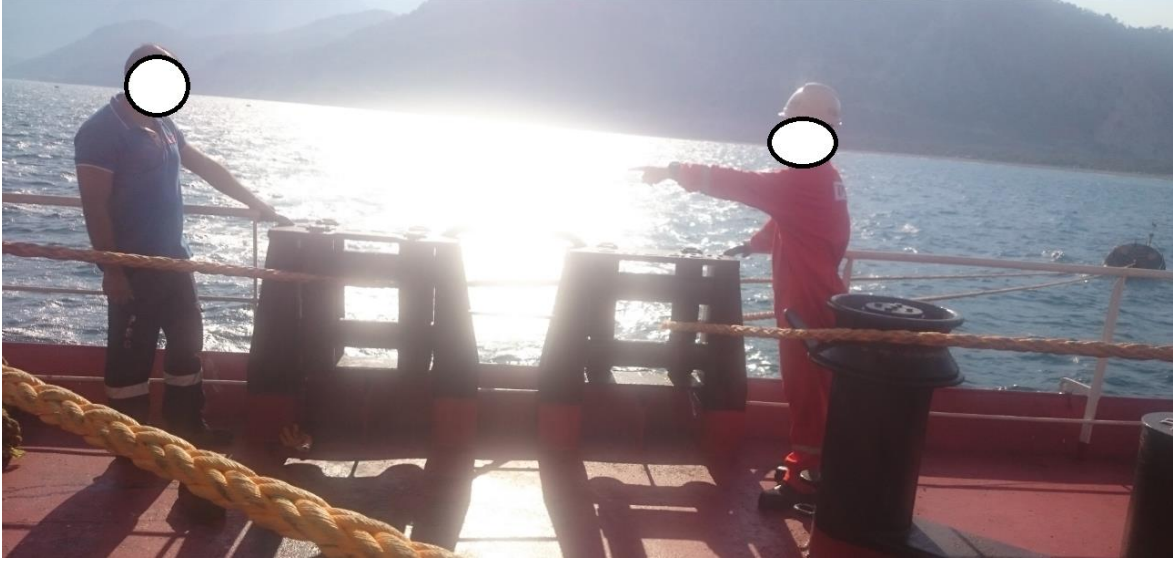
Picture 5: *Location of the Casualty and the Other Cadet Before the Accident*

As the Third Officer and two able seamen continued to take up the slack of the mooring rope that they given from the port quarter; the two cadets were assigned to give the two mooring ropes to the mooring boat from the starboard quarter of the ship. The Cadet hang down the two mooring ropes that were previously hauled in on the deck down to the sea from the roller fairlead of the ship to be given to the mooring boat. The crew of the mooring boat belayed the rope around its bollard on the poop deck of the mooring boat and moved towards the buoy to make fast. Meanwhile, one of the cadets (the casualty) was on the left side and the other was on the right side of the roller fairlead (Picture 5). The Observer Pilot and the Pilot was on the starboard bridge wing and the ship Captain was on the port bridge wing.

While the mooring ropes that were pulled to be taken to the buoy by the mooring boat were sliding out the roller fairlead rapidly, the Observer Pilot saw that the mooring rope got around the casualty's leg at the moment he stepped on it and dragged him inside the roller fairlead and got him into it. According to the Observer Pilot, the accident took place in a short span of time, like three seconds. The other cadet who was with the casualty at the time of the accident witnessed that the casualty's foot was chopped off above his ankle and fell into the sea due to being dragged by the roller fairlead with the rope and got into it however, he did not see how the rope got around the casualty's foot. The casualty stated that they hanged down the mooring ropes up to the water level with the other cadet, the mooring ropes began to slide down without clearing the rope location before he turned his back and suddenly his left foot stuck inside the rope.

Based on the information provided by the witnesses on the occurrence of the accident, it is understood that the casualty could not sufficiently clear the area of the mooring ropes. Moreover, it is considered that the mooring rope got around the casualty's foot and caused the casualty to be unfortunately injured due to the step/contact of the casualty on/with the mooring rope, sliding down rapidly.

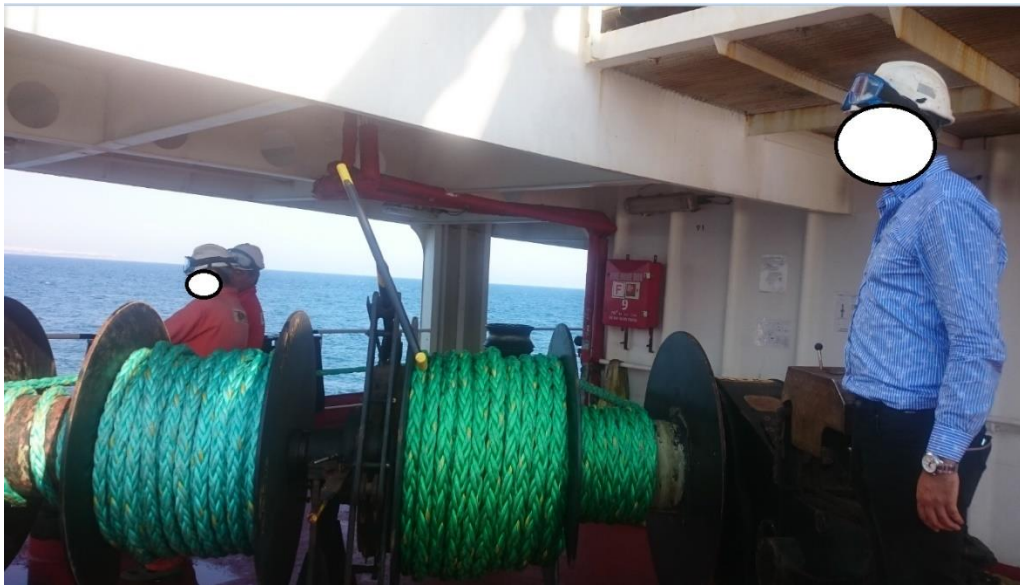
Picture 6: *The Location of Third Officer and the Other Two Seamen Before the Accident*

Four mooring ropes on the rope drums were planned to be used for poop deck mooring manoeuvre at the date of the accident. They hauled in about 50-60 meters of the mooring ropes that were onto the rope drums on the starboard and port of the aft castle as a part of the preparation for manoeuvring. When the Third Officer was instructed to lower the ropes to the buoys from the port stern side, he requested the attending seamen to lower the mooring ropes that were hauled in on the port poop deck down to the water line to be hang down to the mooring boat. Those mooring ropes were taken by the mooring boat and made fast to the buoy. Then, the ship's crew began to take up the slack of the mooring ropes through the mooring winch. Upon the Third Officer noticed that the mooring rope on the drum that was controlled by the mooring winch close the stern became tense and touched the drum disk and the disk damaged the rope, he took the place of the cadet (the casualty) on the mooring winch control. In the meanwhile, the two seamen tried to pull the rope in the opposite direction of the drum disk to avoid any damage to the rope that touched the disk (*Picture 6*).

According to the planning and practising mooring manoeuvre of the Third Officer before the accident, it is understood that he did not actively assign two attending cadets to take up the slacks of mooring ropes after the ropes had been hauled out to the mooring boat and made fast to the buoy. However, failure to haul the mooring ropes out from the rope drums properly from the right roller fairleads and usage of incorrect pedestal roller fairlead s caused one of the mooring ropes whose slack was being taken up to rub the drum disk. Therefore, the process of taking up the rope slack, which can normally be done by one or two crew, needed to be carried out more cautiously with three crew against any accident. It is considered that the latest situation, which was not previously planned, caused the Third Officer, the primary duty of whom to control and coordinate manoeuvre by monitoring the entire manoeuvring, to feel the necessity to take control of the mooring winch.

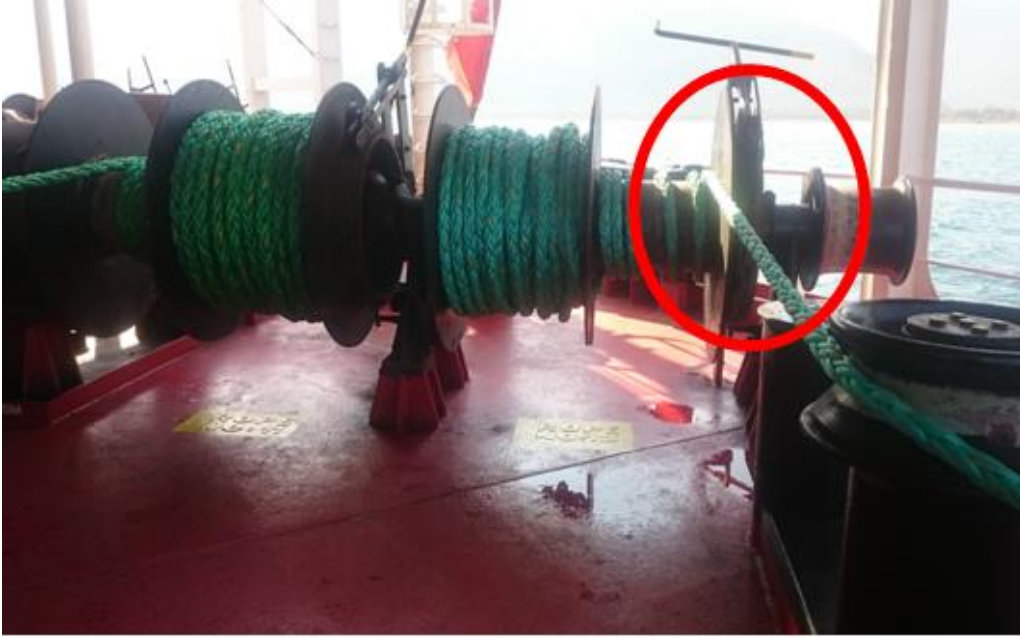
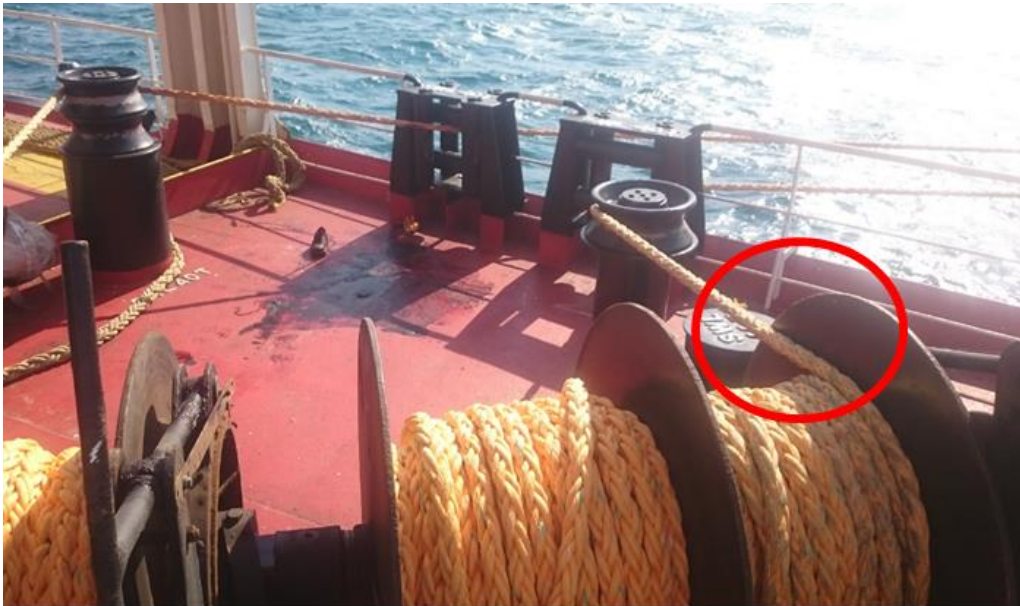
In the accident investigation conducted at the accident scene right after the accident, it is found that both the mooring ropes on the starboard and port stern drums touched/rubbed the rope drum disks (Picture: 7-8).

Picture 7: Rope Drum and the Pedestal roller fairlead Located on the Port Quarter of the Ship

Picture 8: Rope Drum and the Pedestal roller fairlead Located on the Port Quarter of the Ship

were given from the incorrect roller fairlead and incorrect pedestal roller fairleads were used and therefore, they failed to follow the mooring plan of the ship. Therefore, it is understood that the mooring ropes had rubbed on the rope drum disk during the manoeuvre before the accident and at the end of the manoeuvre after the accident.

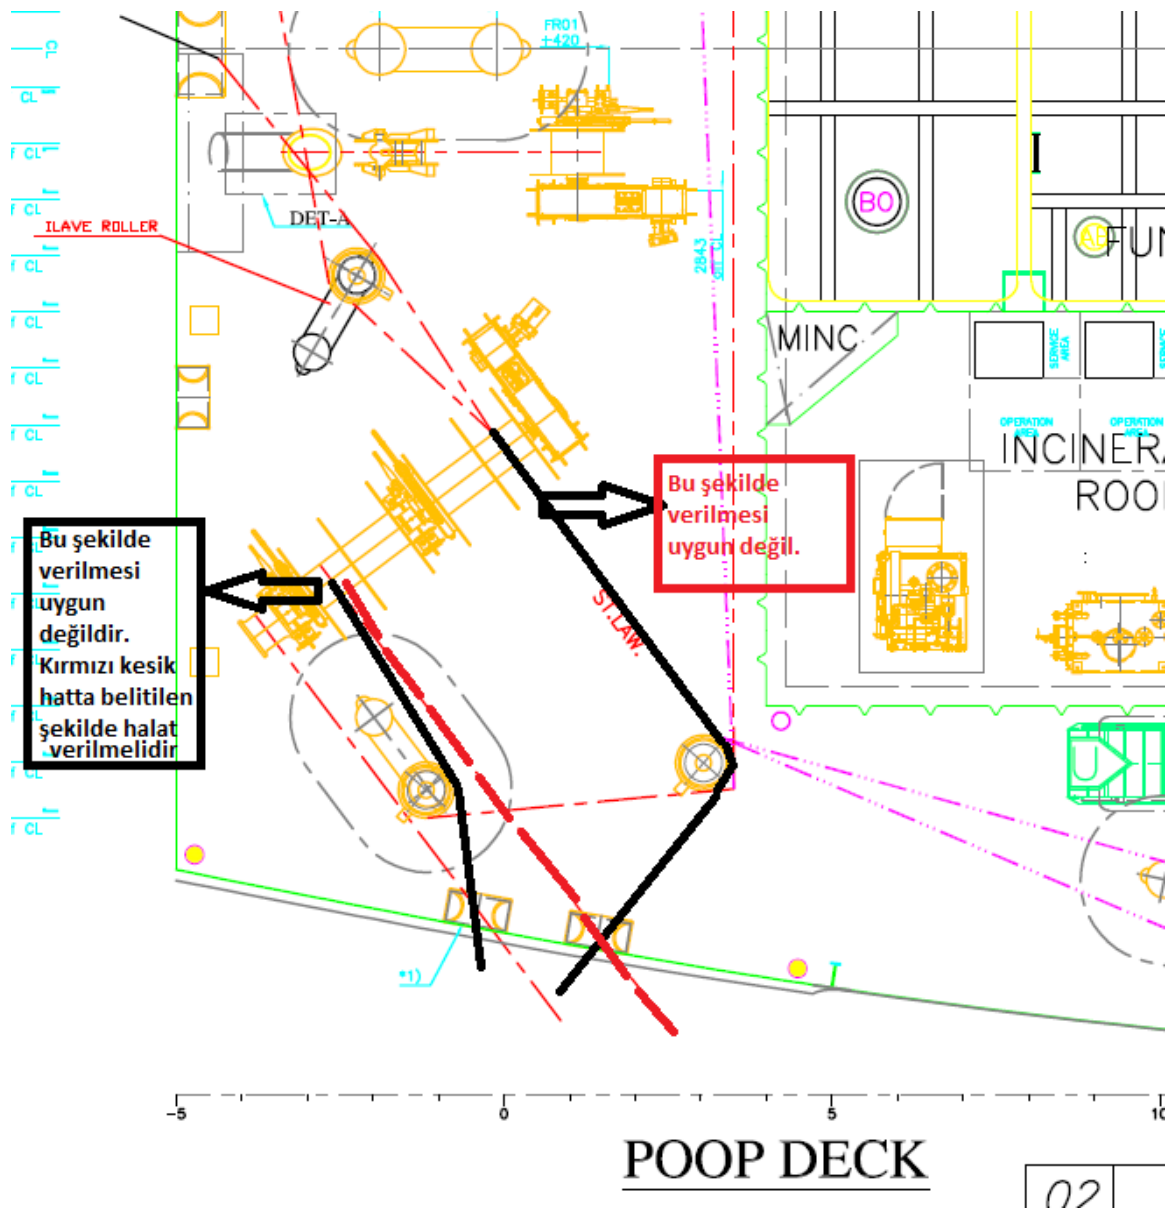
Figure 3: Giving Method of Mooring Ropes During the Accident (Black), Correct Giving Method of Mooring Ropes (Red)

Examining the layout of the ship's rope drum, mooring winch and pedestal roller fairlead pedestal roller fairlead (Figure 3), it is found that the mooring ropes from the rope drums

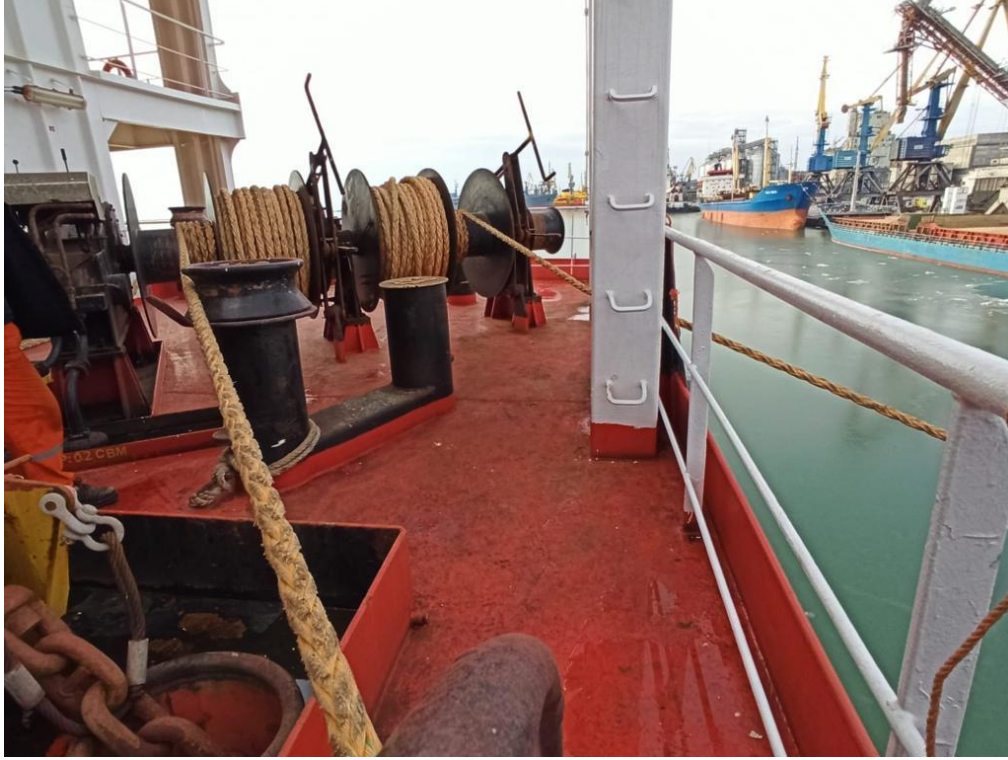
Picture 9: Hauling the Mooring Ropes Out According to the Mooring Plan

When the mooring ropes are not given in accordance with the mooring rope mooring plan of the ship (Picture 9), it is clear that the bodies of the mooring ropes may be damaged, more importantly they may break, and therefore serious accidents may occur.

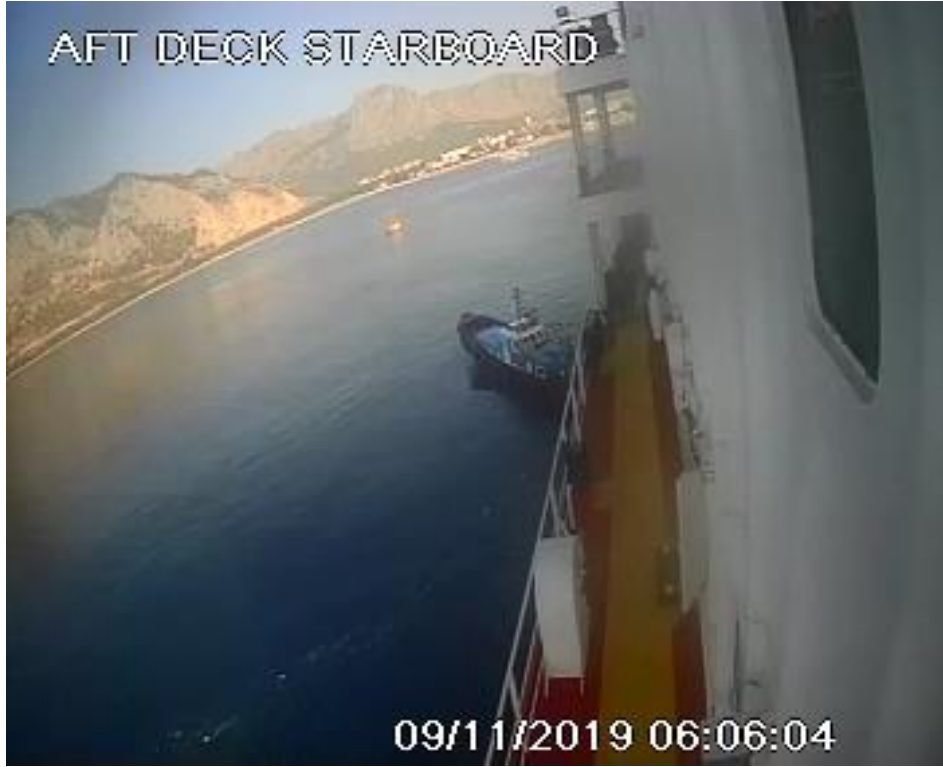
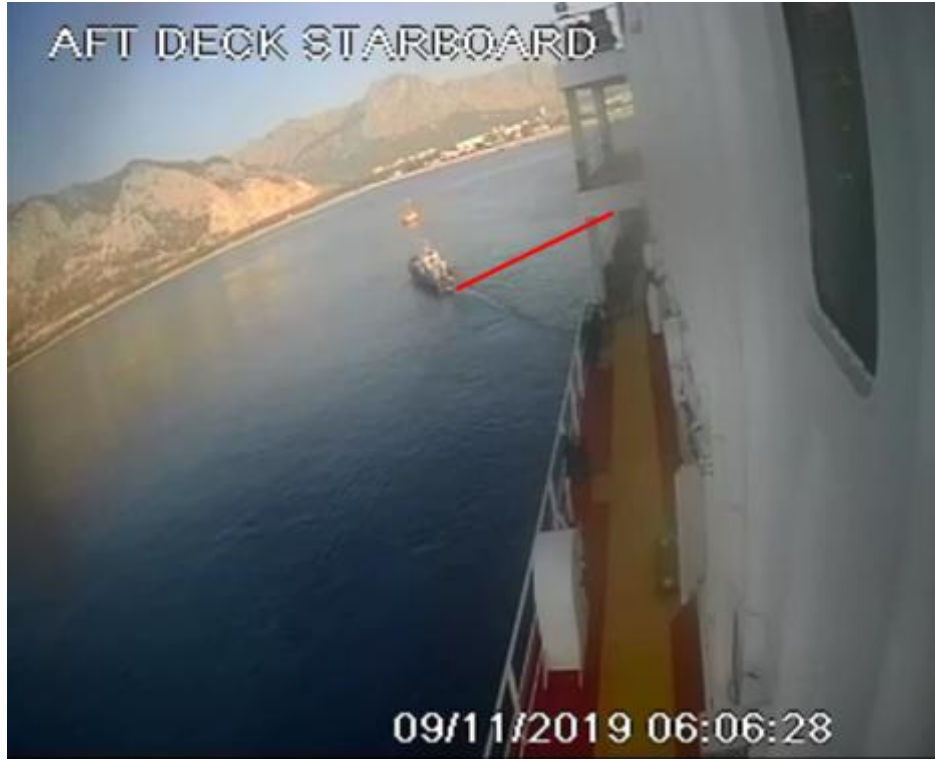
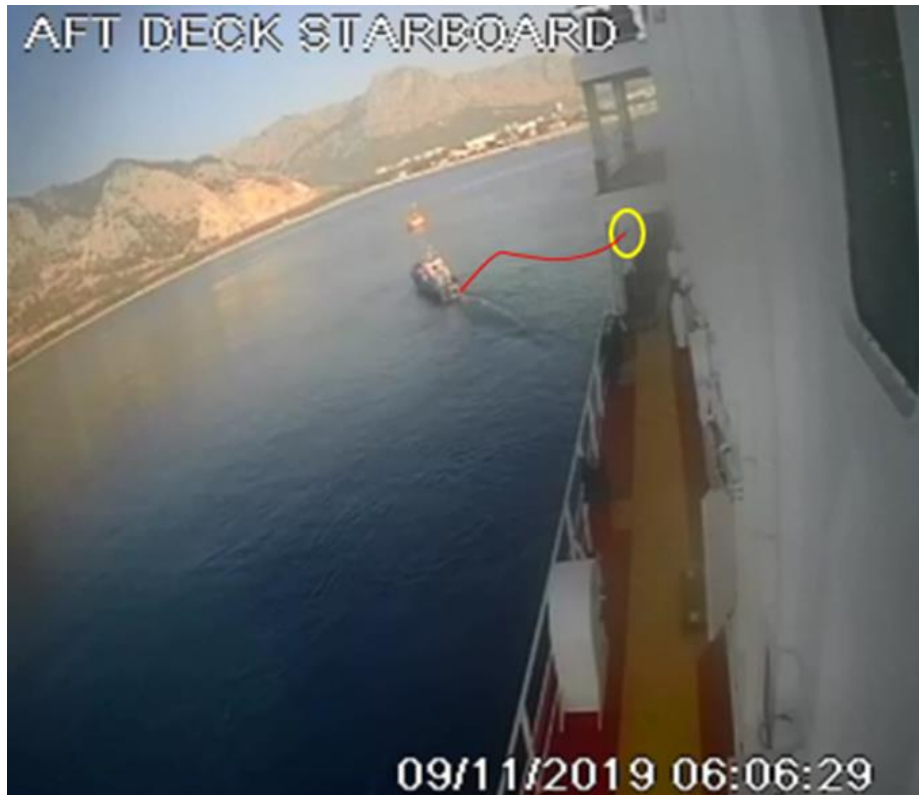
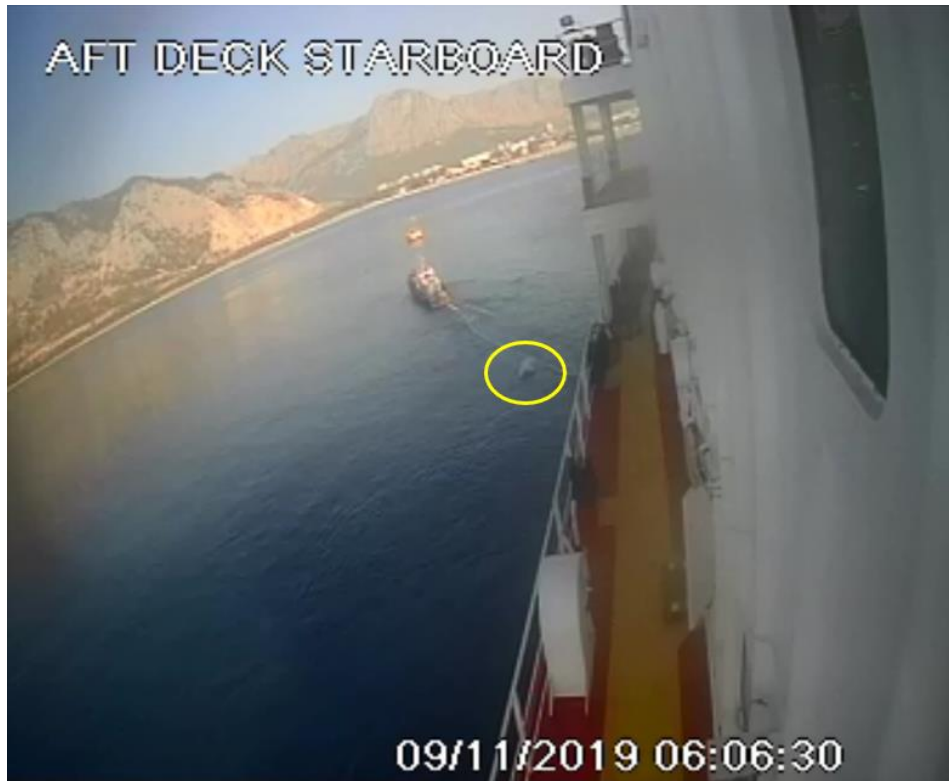
The chain of events from giving the mooring ropes in by the mooring boat until the time of the accident demonstrates that the crew of the mooring boat and the crew who attended the manoeuvre on the poop deck of the vessel, DÜZGİT ENDEAVOR, failed to establish the desired level of communication and coordination.

'boat captain's statement, it is evaluated that the boat captain gave way the engine of the boat ahead (500-600 RPM- minimum) when the mooring ropes first became tense and when they went slack he stopped the boat engine. No information is available on how many times the boat captain gave way the engine ahead and then stopped during that time. However, it is clear that the boat captain tried to adjust the speed of the boat by giving way the engine ahead and stopping. This shows that the minimum speed of the boat to proceed is greater than the speed at which the boat captain tried to get while towing the mooring ropes.

Picture 10: 08:42:04 Location of the Mooring Boat

Picture 11: 08:42:28 Condition of the Mooring Boat and Ropes

Picture 12: 08:42:29 Condition of the Mooring Boat and Ropes

Picture 13: 08:42:30 Condition of the Mooring Boat and Ropes
