**MARINE SAFETY INVESTIGATION REPORT ON A
VERY SERIOUS MARINE CASUALTY**

VESSEL NAME	: ENKİ / HÜRKUŞ
IMO NUMBER	: 9237864 / -
FLAG OF THE VESSEL	: SAINT KITTS&NEVIS / TURKISH
LOCATION OF ACCIDENT	: Anchorage Area C at the Southern Entrance of the Istanbul Strait
DATE and TIME OF ACCIDENT	: 03/03/2022-12:15 (GMT +3)
DEAD / INJURED	: 1/-
DAMAGE CONDITION and POLLUTION	: -/-

Board Decision No: 07 / D-03 / 2023

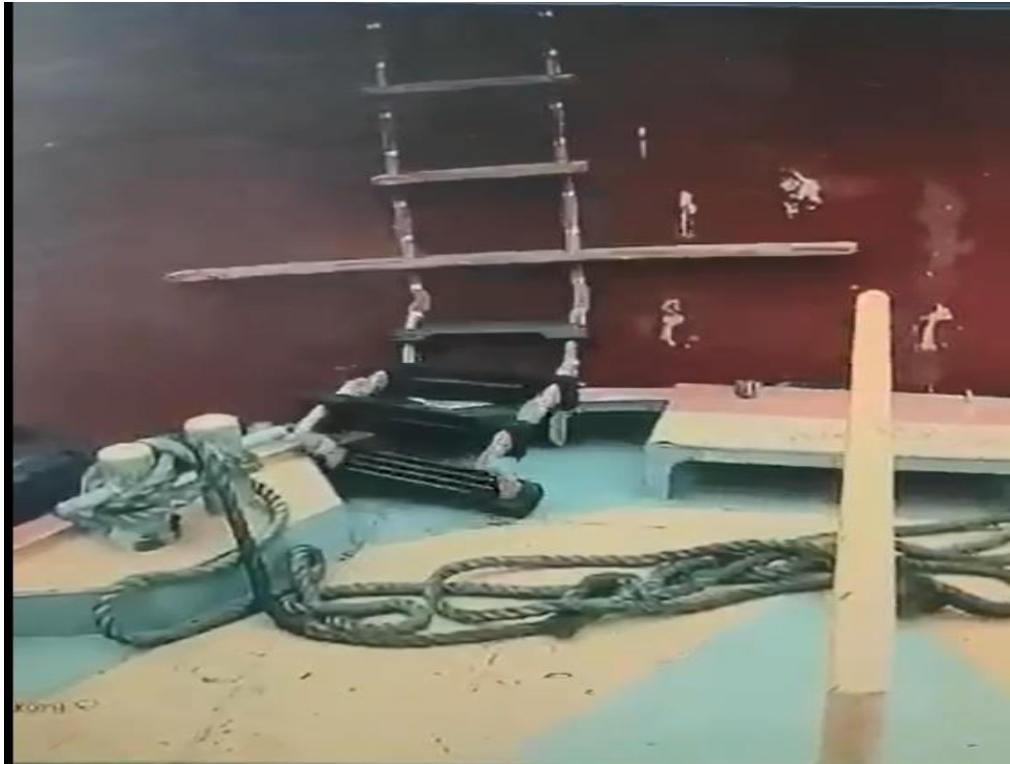
Image 5 The side ladder on the forecastle

At around 12:20, the agency service boat first tried to come alongside the tanker from the side, but with the effect of weather conditions and the belief that the crew would not be able to board the tanker, the service boat approached the tanker from the bow. The ordinary seaman aboard the boat took the lower end of the side ladder extending from the tanker ENKI to the forecandle of the boat (Image 5).

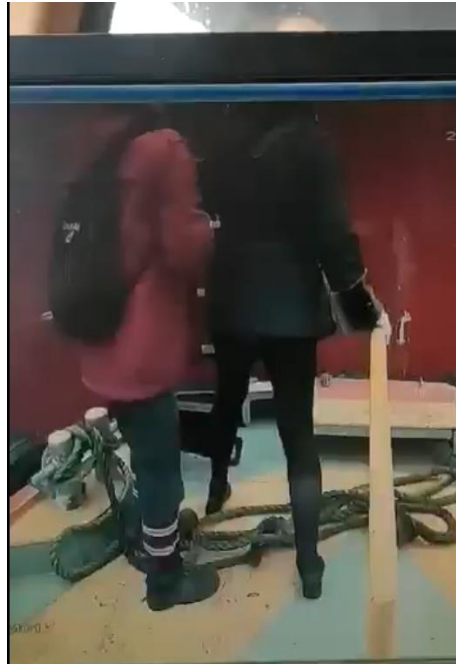
Image 6 When the ordinary seaman accompanied the casualty until she stepped on the side ladder

Thereafter, the ordinary seaman aboard the service boat accompanied the casualty until she stepped on the side ladder, (Image 6) and upon the casualty not to ask for help, he headed towards the bridge of the boat. Meanwhile, when the casualty stepped onto the third step from the second step of the side ladder, she went overboard the sea from the port side of the boat with a bag on her shoulder.

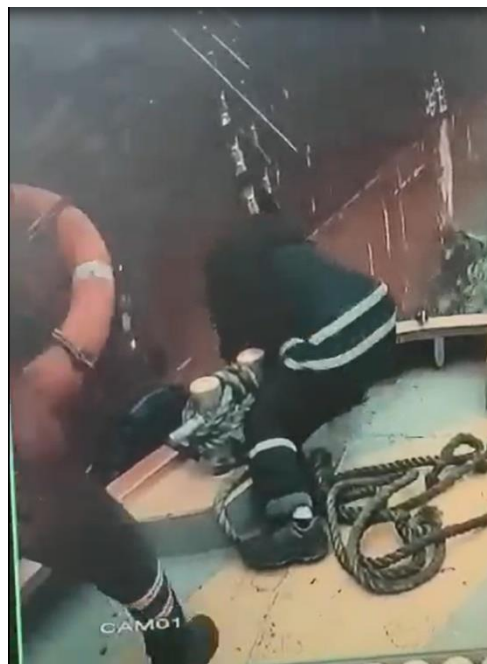
Image 7 Throwing a lifebuoy into the sea

After 13 seconds, a life jacket was thrown to the casualty by the ordinary seaman aboard the agency service boat (Image 7), and assistance was sought from the crew of the tanker and the boat. The second life jacket was thrown to the casualty 36 seconds after the casualty went overboard, and the life buoy with a hauling line was thrown to the casualty 87 seconds after the casualty was overboard.

The casualty was able to grab the hauling line of the life buoy thrown into the sea for a while and then released it after a while. The currents around the region drifted the casualty about 100 metres away from the tanker.

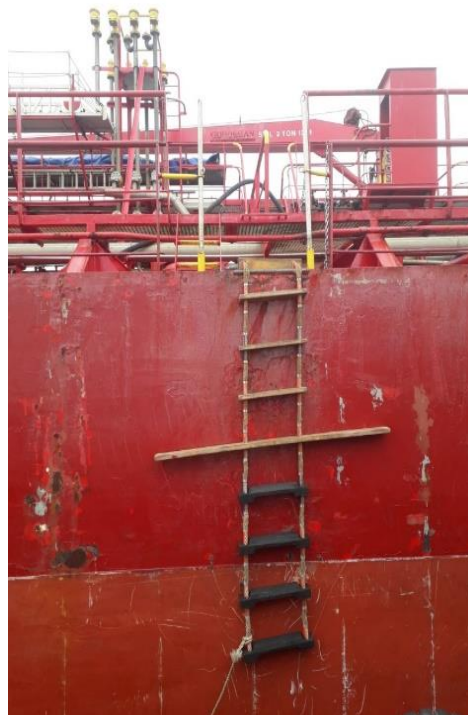
Image 11 Pilot's ladder lowered down to the sea, image taken 1 day after the accident

On the day of the accident, when the agency service boat transported the new seafarer on board, the side ladder was rigged on the starboard side. The freeboard of the tanker was 3,7 metres and the side ladder was approximately 1 metre above the sea surface. The freeboard of the service boat was 1,7 metres and the height of the side ladder required for the casualty to board was approximately 2 metres. When the tanker was visited for an accident investigation one day after the accident, the location of the side ladder was as shown in Image 11.

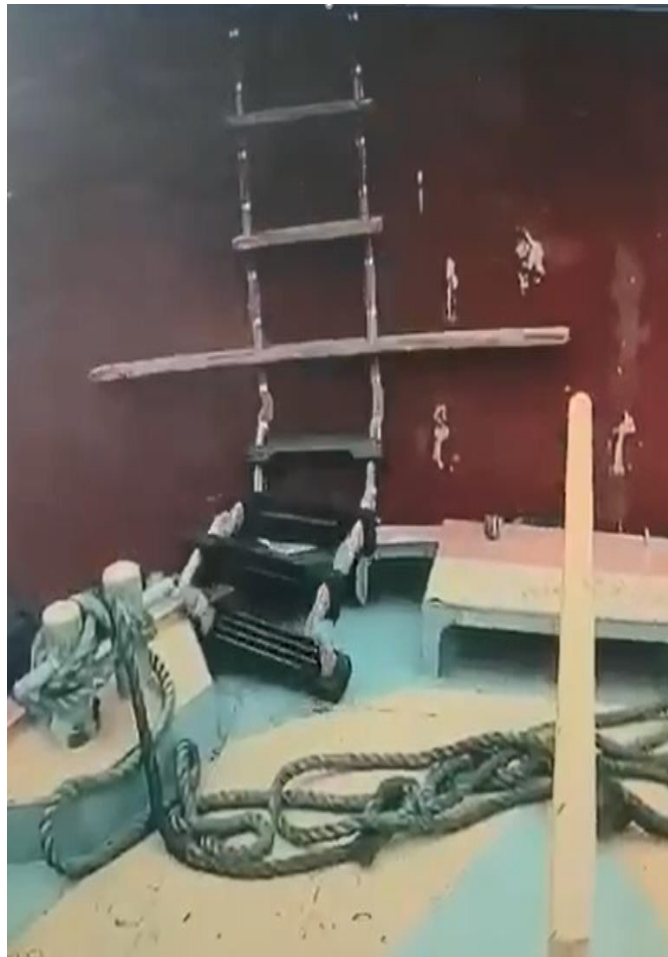
Image 12 Taking the side ladder on the forecastle of the agency boat

On the day of the accident, the agency service boat, having positioned herself with engine power at the side where the side ladder was rigged, began to prepare for the transfer of the seafarer on board. The ordinary seaman in charge on board the agency boat took the lower steps of the side ladder down the sea to the forecastle of the boat for a better alongside the tanker and to avoid any gap between the tanker and the boat (Image 12).

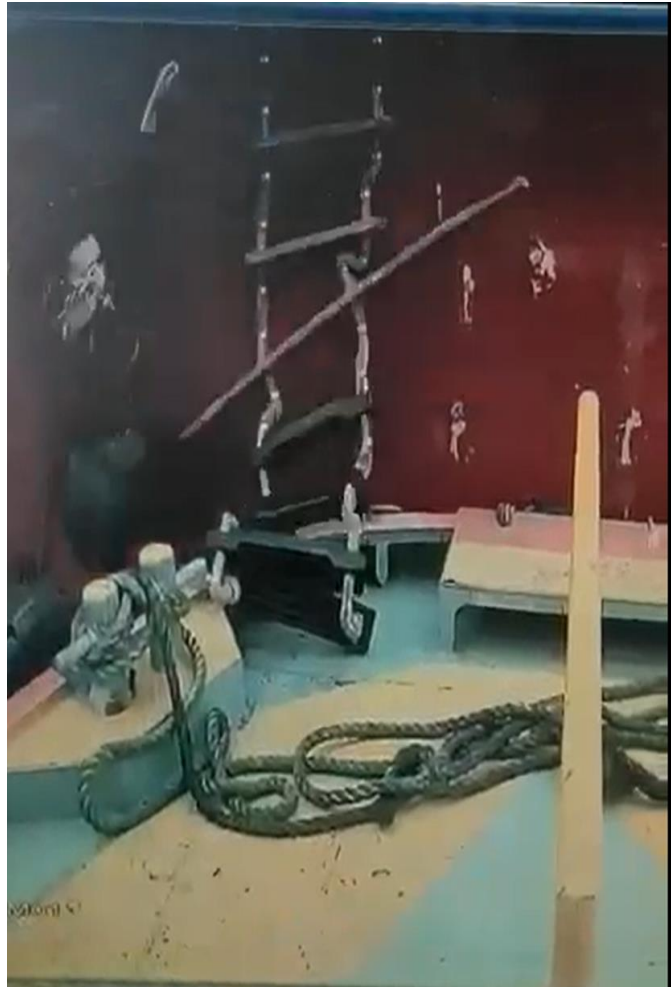
Image 13 The moment of Overboard of the Casualty from the Side Ladder

At the time of the accident, the agency service boat moved up and down relative to the tanker on the sea with 1-1.5-metre-high waves due to the effect of the wind that blew from the north-northwest with a force of 4-6 Beaufort. The sea conditions also affected the boat to move away from the tanker. The side ladder was rigged longer than required by the tanker and the excess of the ladder was taken to the forecastle of the boat by the boat crew. When the excess of the side ladder was placed on the forecastle of the boat, it prevented all the steps of the side ladder from resting on the ship's side and rendered the side ladder unstable. Also, the boat crew did not maintain the stability of the side ladder by holding it until the seafarer began to climb safely up the side ladder. Based on the statement of the boat crew,

the casualty refused the assistance offered to climb the side ladder. Thereupon, the boat crew headed towards the accommodation of the lifeboat. When the casualty left the agency boat and began to climb the side ladder, she went overboard the sea from the unstable side ladder from the fore port side of the boat (Image 13).

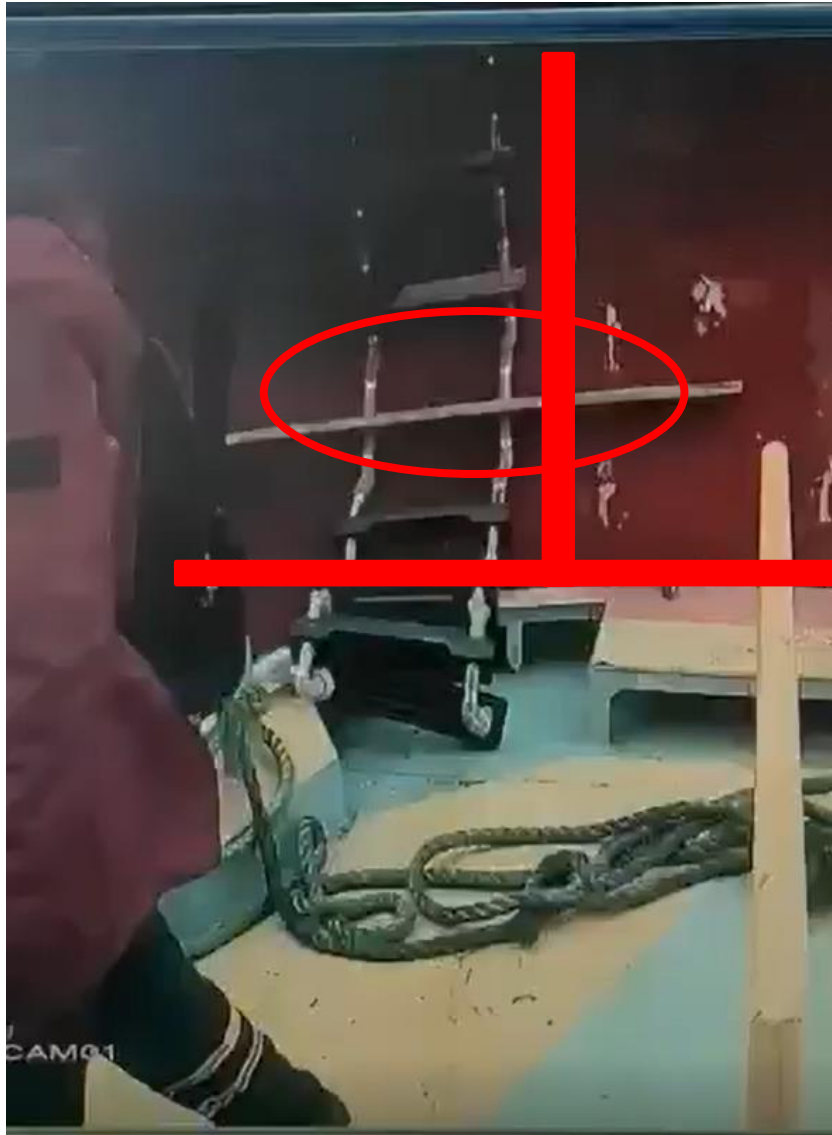
Image 14 The condition of the side ladder at the time when the casualty went overboard

It is clearly visible in the video footage on the boat related to the moment of the accident that while the ordinary seaman in charge of the boat was trying to help the casualty immediately after she went overboard, the side ladder, which was on the fore-castle of the boat before the accident, was affected by the sea conditions and could not maintain its vertical position, lost its balance and shifted its direction (Image 14, Image 15). In addition, it is important for the safety of crew transfer that the ordinary seaman in charge of the boat tries to stabilise the side ladder as much as possible by holding side ladder during the climb of the seafarer.

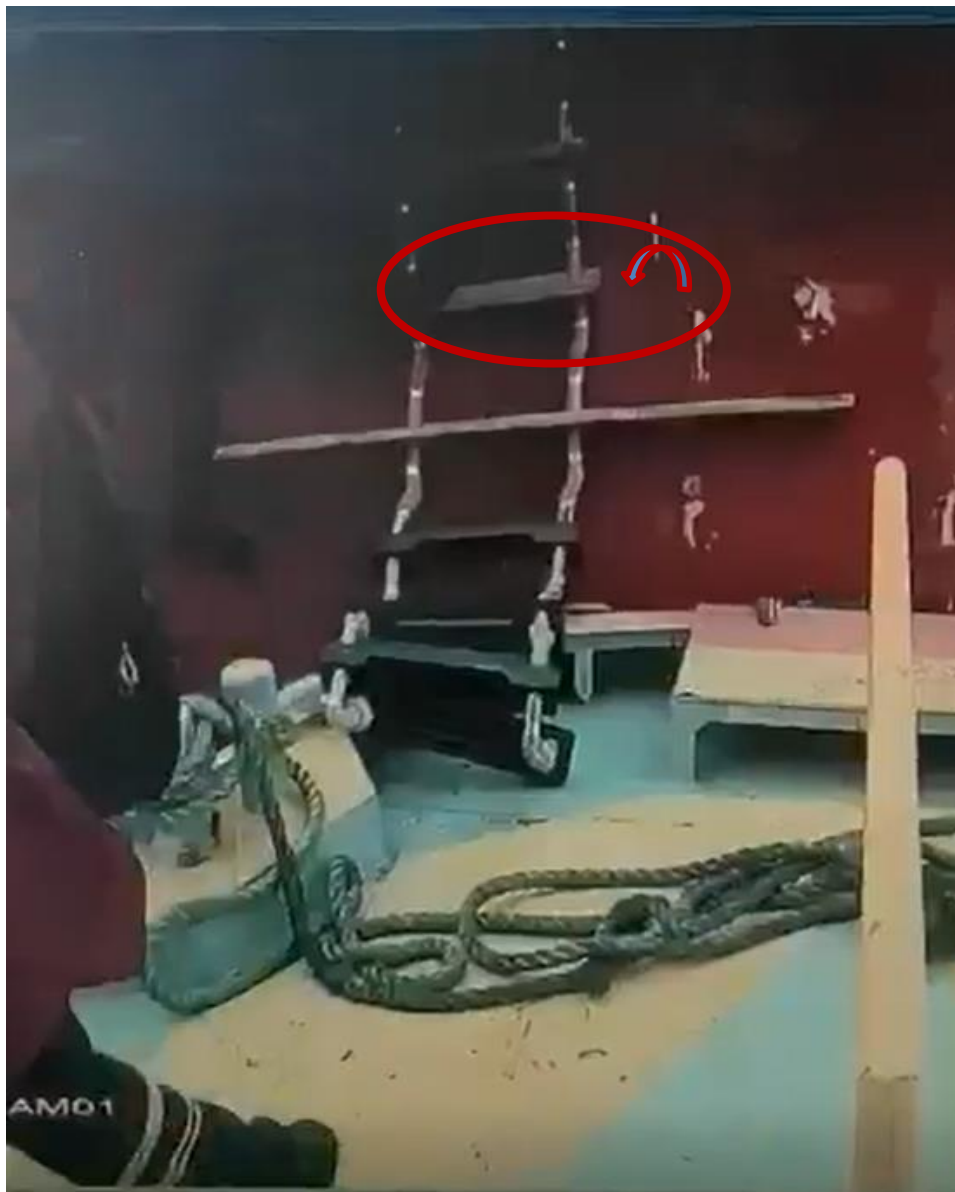
Image 15 The condition where the step of the side ladder rotates at the time when the casualty went overboard

Based on the above analysis, it is considered that there were no suitable conditions for the transfer of the crew to the tanker since the side ladder was not rigged in accordance with the requirements of IMO Resolution A.1045(27) and the lower steps of the side ladder were placed on the forecastle of the boat and the boat crew could not maintain the stability of the side ladder during the transfer. This is considered to be first of the factors that caused the casualty to go overboard.

- 4.3 There was a lack of communication and coordination between the tanker and the boat when it came to adjusting the height of the side ladder.
- 4.4 As the side ladder of the tanker was rigged longer than required, the ordinary seaman on the boat took the excess part onto the forecastle of the boat. This impeded the full resting of the steps of the side ladder on the tanker side.

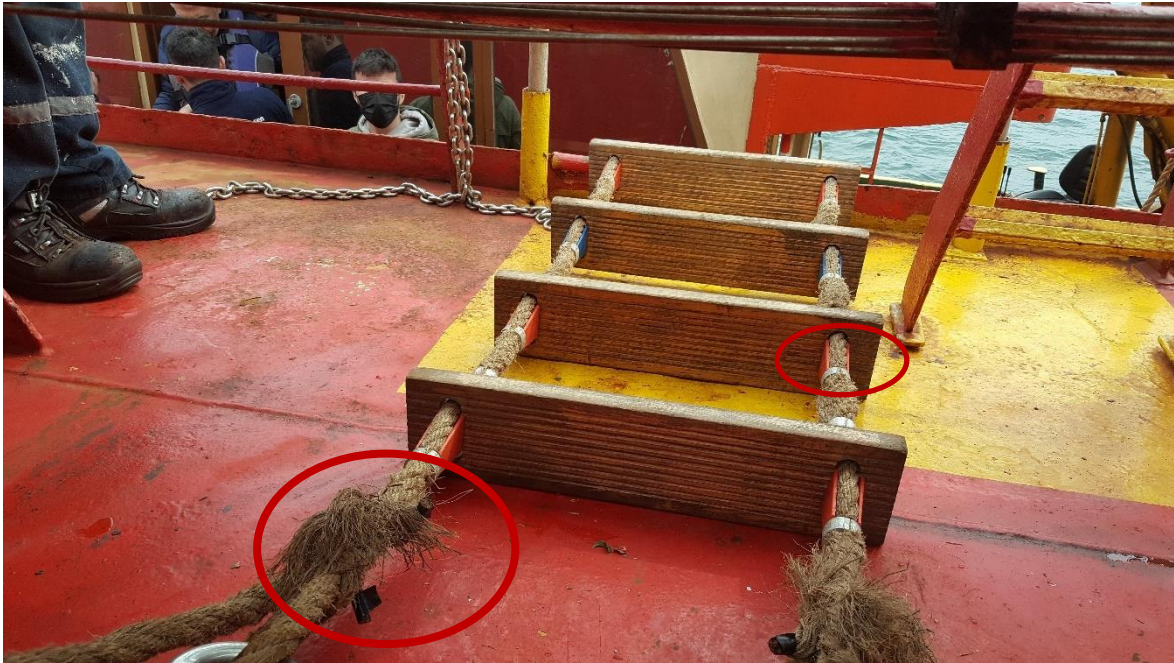
Image 16 General condition of the step of the side ladder

It was observed that the side ladder control was valid until 01/12/2022 and that there were logs indicating that the periodical inspection was performed. However, the images of the side ladder taken after the accident show that the ropes of the side ladder were locally fagged out and the side ladder was worn out (Image 16). Both the rotation of the step of the side ladder while the casualty stepped on the side ladder as seen in Image 15 and the images that give an idea about the condition of the side ladder indicate a lack of maintenance on the side ladder.

- 4.6 The boat crew did not maintain the stability of the side ladder by holding it until the seafarer began to climb safely up the side ladder.
- 4.7 The ropes of the side ladder were observed to have been fagged out, and the side ladder was worn out.

- 8/03-23 To plan again the Man Overboard drills, which are routinely exercised within the scope of ISM on the ships in the company fleet, based on effective scenarios taking into account the consequences of such accidents, and to make sure that the drills are exercised in a way to raise awareness among the crew in accordance with the planning;
- 9/03-23 To replace the existing side ladders and effectively inspect them for any signs of wear and tear using a checklist to be prepared before each use.

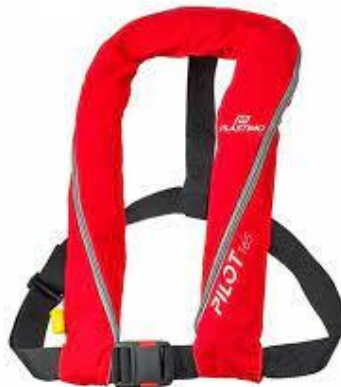
Image 17 Life Jacket

The casualty was not wearing a life jacket on the day of the accident. The casualty, who was also observed to be rather anxious from the video footage, climbed up the side ladder with a bag on her shoulder without wearing any life jacket (Image 17) although the tanker-boat oscillated by rolling and pitching. It is considered that boarding the tanker with a bag on her shoulder and no life jacket affected being overboard of the seafarer and her inability to survive in the sea.

After the accident, the boat crew tried to throw a life jacket but not a life buoy to the casualty who went overboard. It was observed that the casualty was unable to put on the life jackets thrown to her and hold on in the sea. Therefore, it is considered that it would be beneficial for the persons who will embark or disembark from the vessel to use life jackets during the transfers by side ladders.

On the other hand, it is also clear that there was a high risk of going overboard when considering that the ordinary seaman intervened from the port side of the boat and alongside in positions that may pose a danger. Despite the regulation in Turkish national legislation³ that the boat crew should always wear life jacket on the boat against the risk of going overboard since they are on a boat which is highly exposed to wave and wind conditions, the video footage of the accident shows that the boat crew did not wear life jackets.
