RETROSPECTIVE MARINE SAFETY INVESTIGATION REPORT

VESSEL NAME	: EREN TURGUT
IMO NO	: 9422342
FLAG OF THE VESSEL	: Turkish
LOCATION OF CASUALTY	: Strait of Dover
DATE and TIME OF ACCIDENT	: 24.11.2010 – 15:55 (GMT+0)
FATALITY / INJURY	: 1 Dead - 2 Injured
DAMAGE DEGREE	: Damage to the engine room
ENVIRONMENT POLLUTION	: Not reported.

Board Decision No: 20 / DNZ – 08 / 2023

Date: 23.10.2023

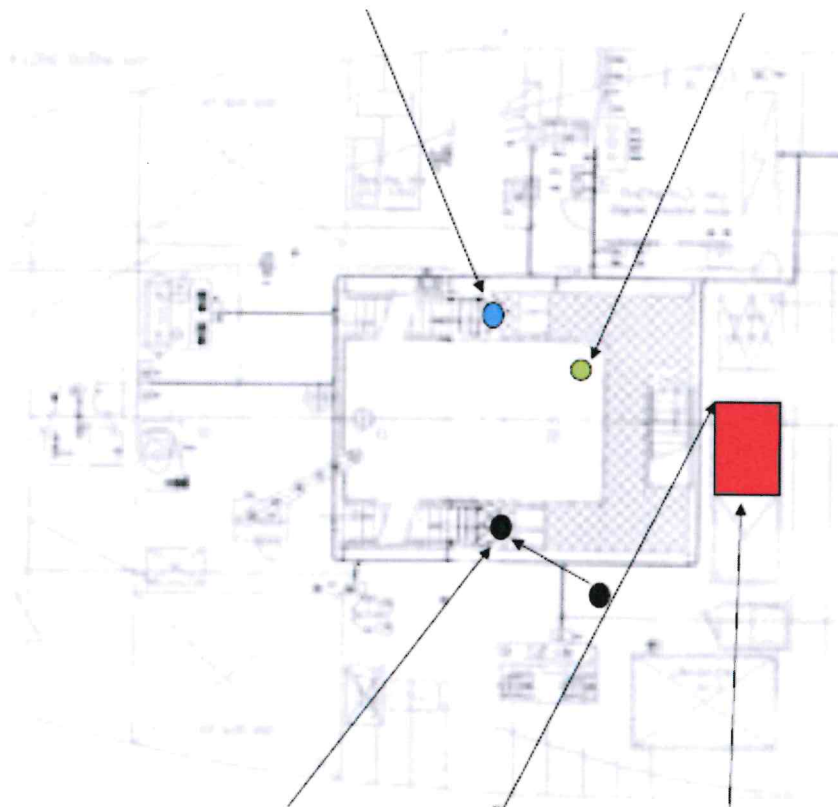
Image 4 Location of Engine Room Personnel After the Explosion

Fuel Tank

Explosion of fuel tank through vertical weld seam

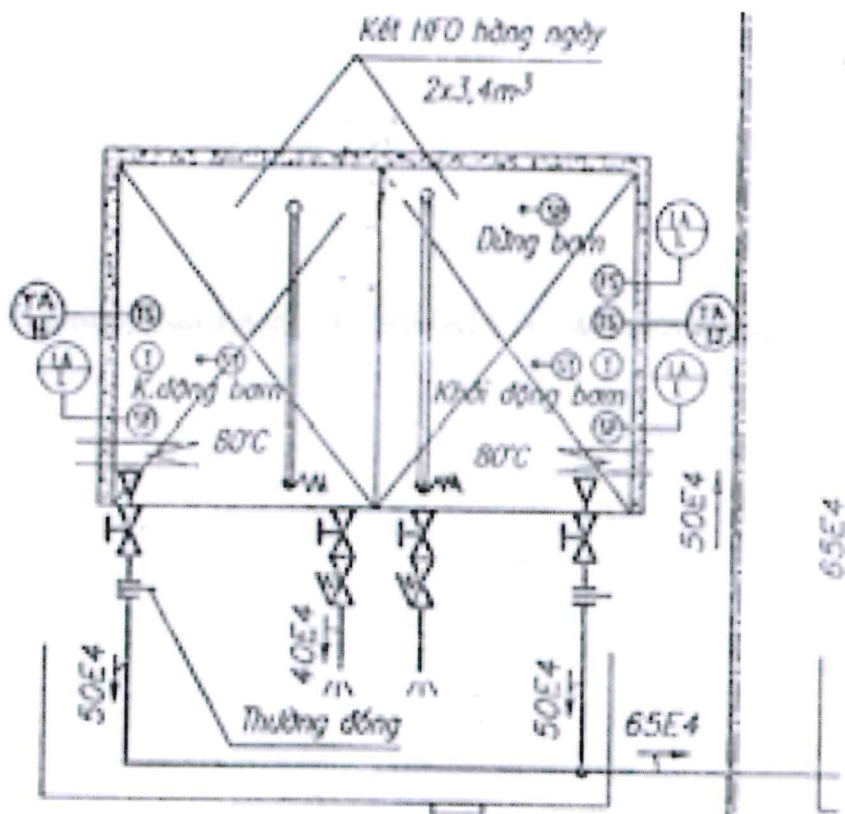
Image 5 Exploding Fuel Tank in EREN TURGUT

During the investigation, no detailed tank plan other than the schematic on the image belonging to the fuel tank was found. During the investigation, it was realized that there were many pipe circuits on the fuel tank and entering the fuel tank, but these circuits were not shown in the drawing.

Due to the darkness of the engine room and the fact that the area of the explosion and the surface of the fuel tank were covered with heavy fuel oil, it was impossible to compare the existing tank with the drawing above. It was impossible to get close enough to the fuel oil service tank to inspect the torn and rough areas of the tank seam and the confined space above the tank.

After the accident, it was reported by the vessel's engine personnel that the alarm system indicating the temperature of the fuel in the fuel tank was found in the project (Image 5). Still, there is currently no alarm system for high temperatures; the temperature is read by means of an analogue thermometer on the tank (Image 8). Still, it was stated that this fuel temperature value was not recorded in the Engine Room Logbook. It was also stated that the only fuel temperature recorded in the Engine Room Logbook was the temperature value taken from the main engine supply pump outlet. However, the Engine room Logbook was requested from the vessel for control during the investigation but could not be reached.

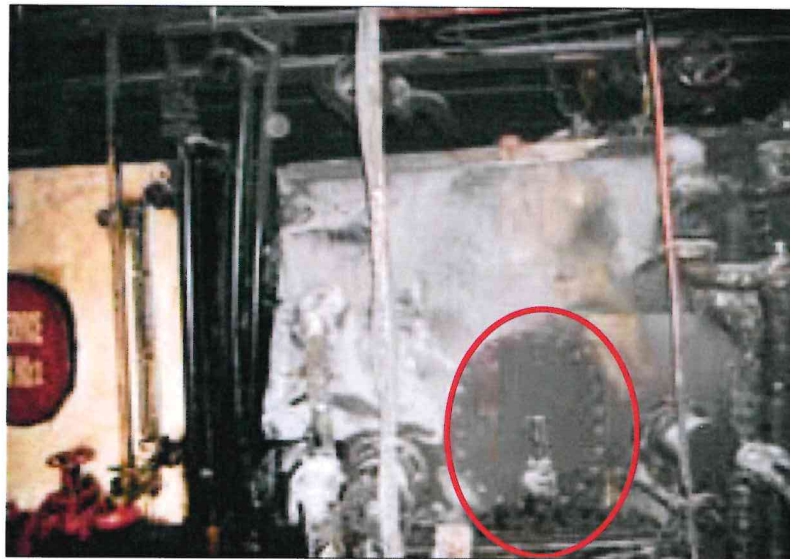
Image 8 Condition of Fuel-Oil Service Tank After the Explosion

In light of the above findings and evaluations, since a sudden pressure may have occurred in the fuel oil fuel tank due to overheating beyond the design parameters, and this pressure may not have been relieved due to blockage of the air-fuel-air vent pipe, etc., tearing occurred in the vertical seams of the fuel tank due to pressure, and 2.9 tons of heavy fuel in the tank into the engine room is considered to have been spilt.

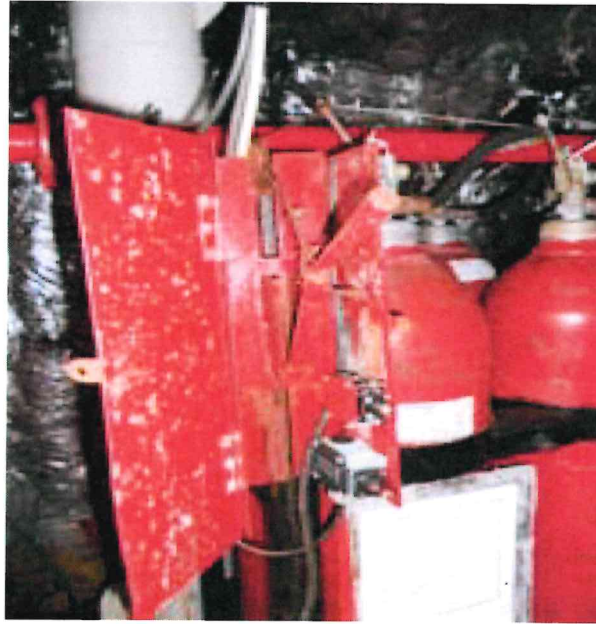
Image 9 CO₂ Detonation Mechanism

Although the vessel's engine personnel stated that the vessel did not have a fixed fire extinguishing system (CO₂), it was determined that there was a CO₂ room. There were 30 CO₂ cylinders in this room, and ten were reserved for the engine room fire and used for fire extinguishing. (Image 9, Image 910)

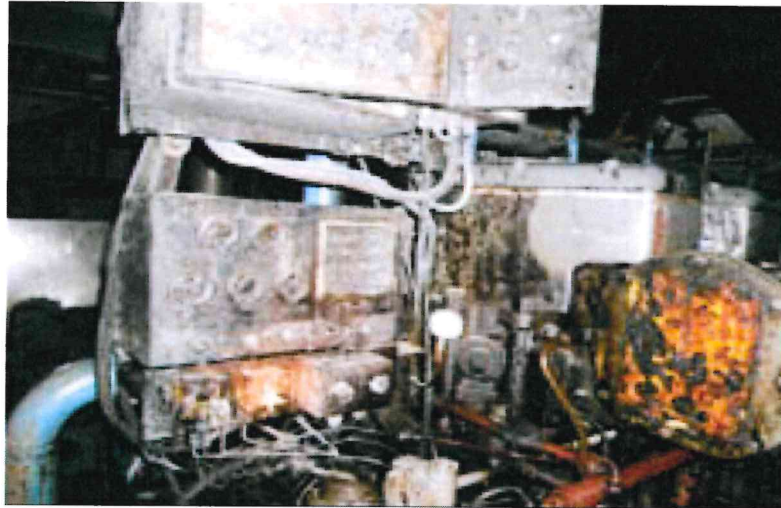
Image 11 Damage to The Main Engine Components

After the heavy fuel tank explosion, 2.9 tons of fuel spilt into the engine room. As a result of the contact of the fuel with the hot surface of the generators, small fires broke out in the engine room. The crew extinguished these fires before they grew too big.

After the fire, generators, electrical cables, electrical cabinets, engine control room, and auxiliary equipment in the engine room were damaged. (Image 11-12-13)
