**REPUBLIC OF TURKEY
MINISTRY OF TRANSPORT, MARITIME AFFAIRS AND COMMUNICATIONS
Accident Investigation Board**

**Marine Accident Investigation Report on the Investigation of
The Capsizing of Dry Cargo Vessel
EROL ŞENKAYA**

**Off Zakynthos Island / Greece
19th May 2012**

Report No: 4/2012

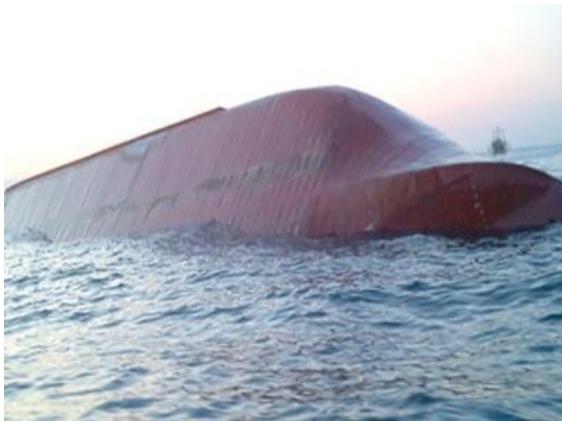
Picture 4: Vessel in Semi-Submerged State (1)

While the vessel was underway at a distance of 8 nautical miles from Zakyntos Island and about 1-1,5 hours after unberthing from the loading port, the vessel started heeling suddenly and quickly towards port side as a result of shifting of the cargo in the hold. The vessel listed totally to its port side in a time shorter than thirty seconds and completely capsized within one or two minutes.

Some time after vessel had reached sea speed, the master switched to automatic pilot and left the bridge after saying to the radio officer that “he would go to his cabin to take a shower and he should immediately be informed in case a change was observed in the clinometers”. After about half an hour (1-1,5 hours after the vessel departed the port and when it was 8 sea miles away from Zakynthos Island), the radio officer noticed a listing of 1-2 degrees to port side on the clinometers and informed the master who came quickly to the bridge. He asked the radio officer to go down to the engine room and transmit the instruction of the master in the direction of discharging some ballast from the ballast tank at the port side. After the radio officer went down to the engine room and transmitted the instruction under consideration and was at the stairs on his return to the bridge, he heard the master bringing the engine order telegraph to “stop” position. At that moment, the vessel suddenly started to list towards port side. Radio officer and other crew at the corridors/halls etc. ran out of the accommodation area through the watertight doors to the poop deck. However, the vessel listed to its side in a time shorter than thirty seconds and completely capsized within 1-2 minutes. Some of the crew fell to the sea, second engineer, radio officer and oiler continued to hold on to the guards at the poop deck at the moment of capsizing and then were able to climb the hull of the completely capsized vessel. By the capsizing of the vessel, a life raft was released from the ship and was inflated by the crew in the sea. First three crew members in the sea, then the other three members waiting on the hull took refuge to the life raft and moved away from the floating vessel in capsized position.

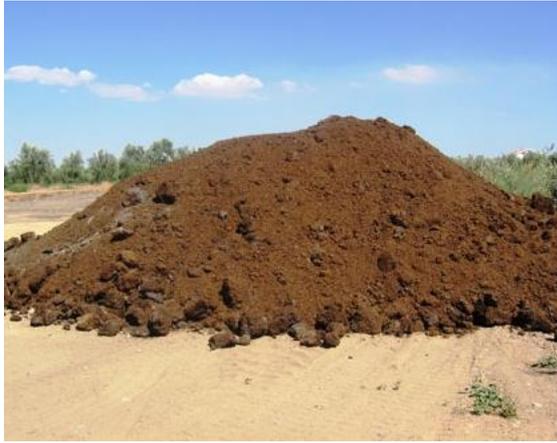
Picture 8: Olive cake (1)

Motion of the cargo in the hold occurs in two ways: due to topping and due to liquefaction. It is understood from the statements of witnesses that there were not cargo topping in the holds after the completion of loading and, in general, the cargo was loaded homogeneously. However, it is possible that the oil within the cargo may not be distributed equally in the whole cargo. While some part of the cargo contains a high level of moisture / liquid, another part may be dry. Even if the surface of cargo is dry, the layer containing more liquid can be formed within the cargo and easily slip to a side. As it has a gummy fluidity, the cargo may flow to one side of the vessel in a heel, but it may not return completely to the other side with the same heel. Therefore, the vessel reaches to a dangerous angle of heel within the passing time and may quickly capsize.

As understood from the statements by the vessel’s crew, the cargo in question contains pretty much liquid (olive oil) in its body and it is in the form of mud. The expression included in the bill of lading that *“more than 3%”* does not clearly indicate the rate of olive oil within the cargo. In the interview made with the relevant personnel of the owner, it is understood that any information directed to the character, properties and stacking of the cargo was not handed over to the vessel by the shipper.

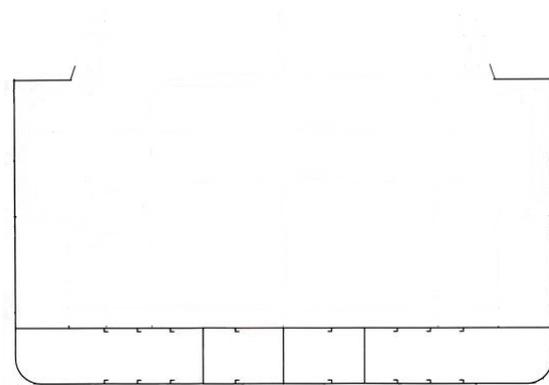
Picture 10: Hold Design of Bulk Carrier 11: Hold Design of General Cargo Vessel

Topside / upper wing tanks at both sides of the hold in bulk carriers has a function to prevent / reduce the movement of cargo. However, the holds of the vessel in question has a straight form as been in a large portion of general cargo vessels of such tonnage and this form causes easy progress of the moving cargoes to the sides during heeling.
