Marine Casualty Investigation Report
Fatal Accident due to the Fall Down of A Seafarer into the Cargo Hold

M/V FİDAN

Rapor No: 11/2015

Port of İskenderun Anchorage Area
20th February 2015
Report No: 11/2015

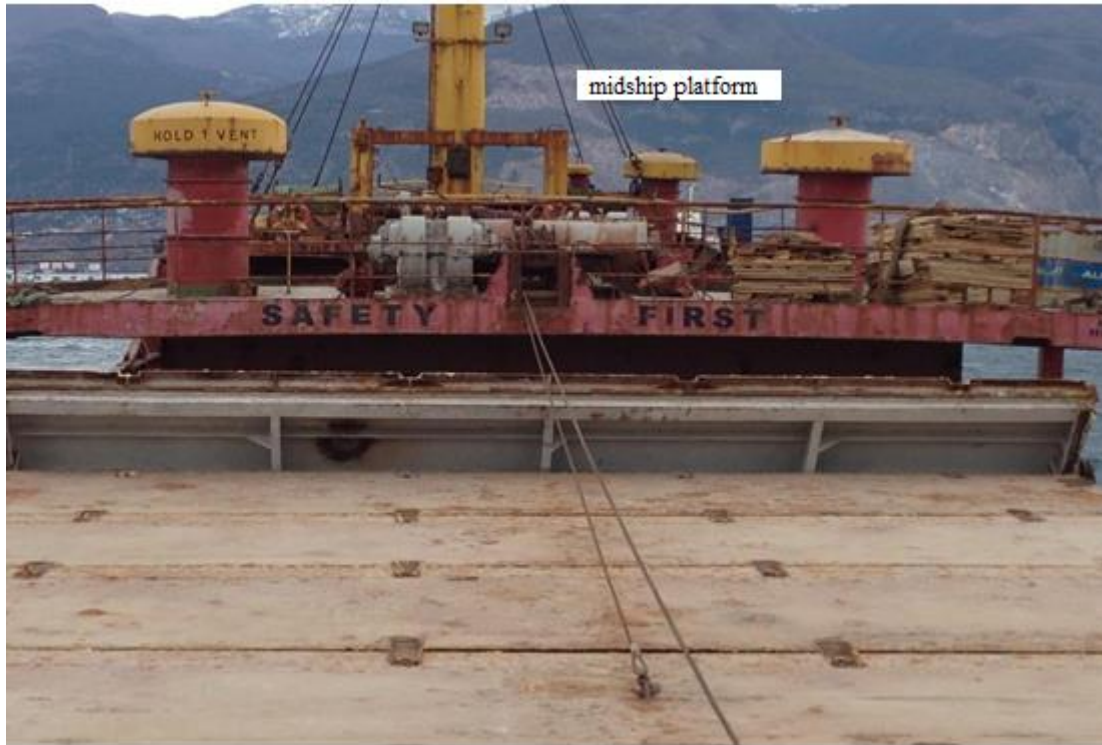
Figure 2. Hatchcovers

The seaman that the Captain had assigned took out the wire from the eyebolt over the hold in order to bring the wire from the position of closing the hatchcover to the opening position. The seaman pulled the wire towards the forward part of the ship and at that time after the wire was wound over the pulley with the help of an A/B, the seaman moved aftwards in order to fix the wire to the eye bolt over the hatchcover and fixed the wire to the eye bolt and brought the hatchcover to opening position. At this time the Captain was at the windlass waiting to open the hatchcover.

Right after this time, around 17:40, the seaman fell down to the bottom of the hold, approximately 8 metres below, how it happened being unidentified. The hatchcover gap was measured as 1,5 metres approximately.

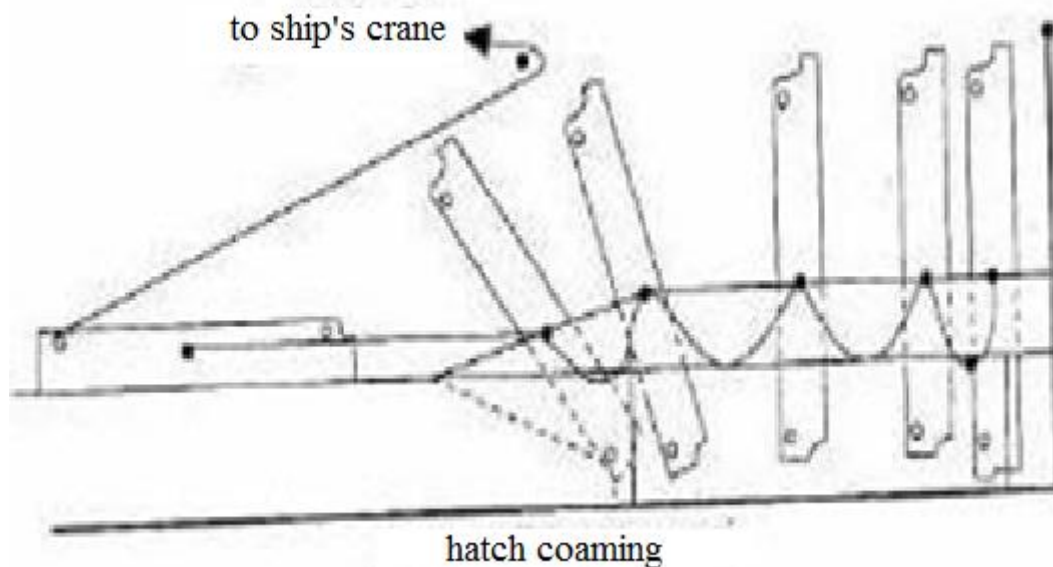
Figure 3. McGregor Single Pull Type Hatchcover

The hatchcovers are closed in a sequence by releasing the wire rope over the windlass drum as appropriate and directly attaching to the eyebolts over the hatchcovers and then enrolling the wire rope over the drum.

And in order to open the hatchcovers, after taking the wire through the tackle on its opposite side, the wire shall be attached to the eyebolt over the hatchcover and the windlass shall start to enroll the wire over the drum.

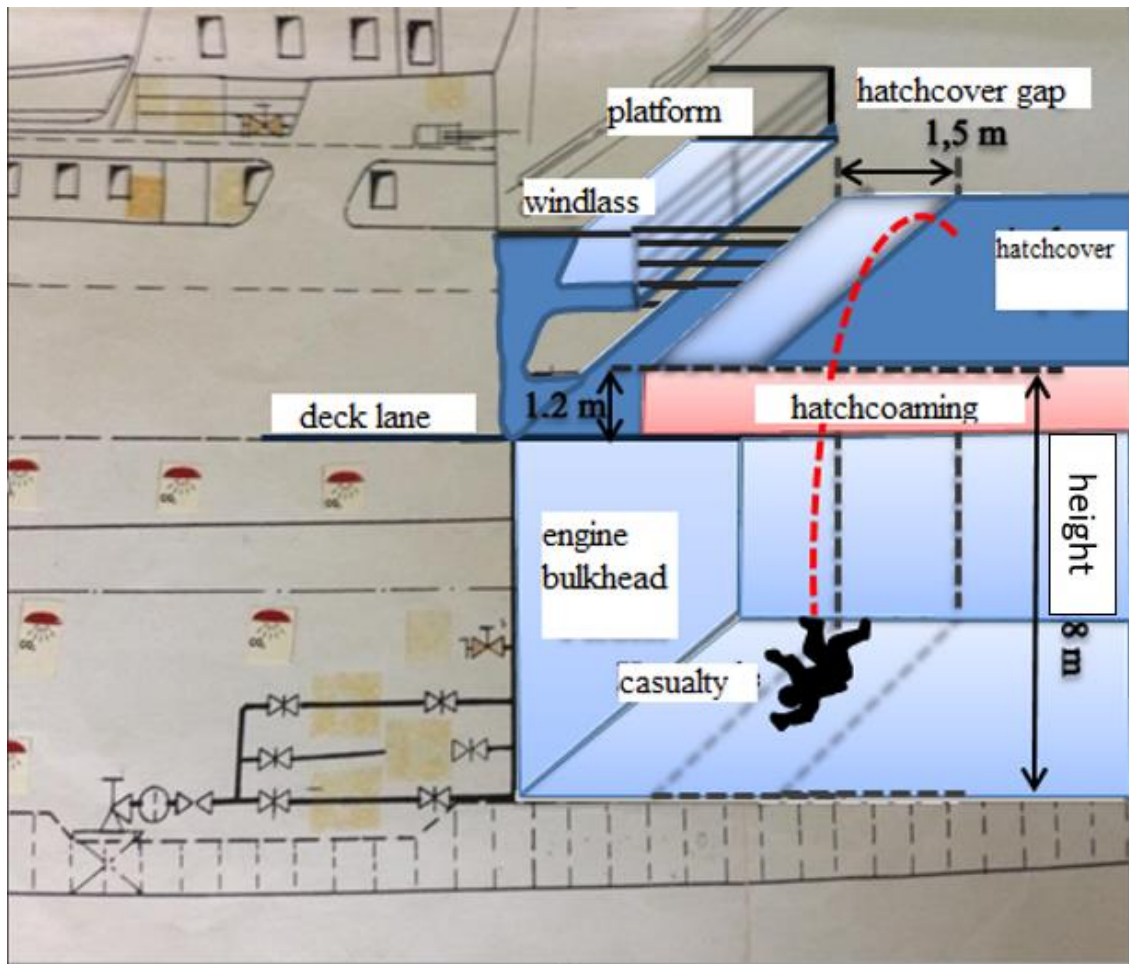
Figure 4. The Sketch of the Accident

According to the autopsy records, there are serious injuries and breaks on his left shoulder and skull and there aren't any breaks on the feet and arms other than small scratches. In addition, after he fell down, the seaman was found face down approximately 1,3 metres from the hatch opening towards the aft of the ship.

In the light of the findings in hand, it is one of the probabilities that, assessing the gap of the hatchcover as a little distance, as he was holding to the handrails and trying to pass to the platform where the windlass was mounted. Another probability is that the seaman might have wanted to climb over to the hatch coaming and at that time might have lost his balance and fallen down into the hold. It is assessed to be among the probabilities that prior to the opening of the hatchcovers, while the seaman was over the hatchcovers and right in front of the platform and as the hatchcovers were being opened, he might have lost his balance and fallen into the hold.

The accident occurred right after the sunset. Therefore it is considered that the shade of the upper structure might have been one of the contributing factors of the accident.

1. Prepare and implement procedures for the opening and closing of hatchcovers and for other shipboard operations which may present risks
2. Train all the ship's crew for the safe conduct of the opening and closing operations of the hatchcovers and ensure that the importance of the matter is totally understood.
