## FINAL REPORT ON VERY SERIOUS MARINE CASUALTY

<b>NAME &amp; IMO No</b>	: ESRA C
<b>FLAG</b>	: Panama
<b>LOCATION OF ACCIDENT</b>	: Diliskelesi / KOCAELİ
<b>DATE OF ACCIDENT</b>	: 9/8/2021 / 14:12 LT
<b>FATALITY/INJURY</b>	: 1/-
<b>DAMAGE&amp;POLLUTION</b>	: - /-

*Board Decision No: 09 / D-03 / 2022*

*Date: 16 / 05 / 2022*

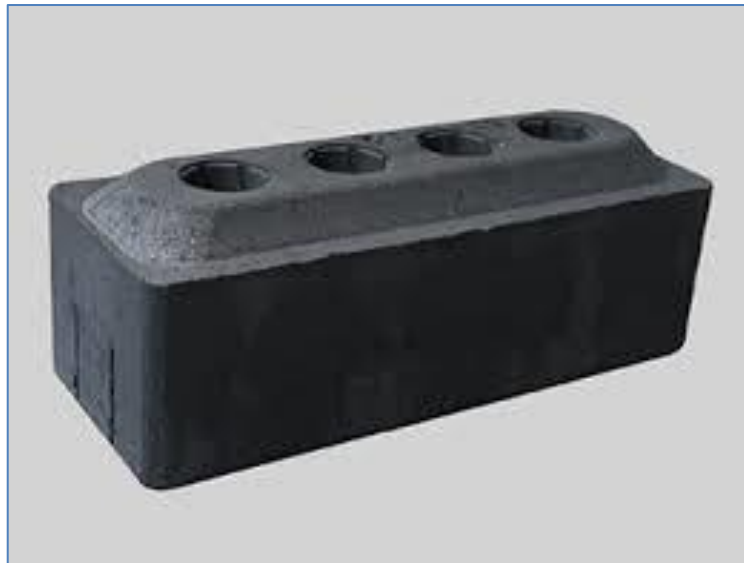
**Image 5:** Block Carbon Anode

The block carbon anode cargo, on the other hand, seems to be a standard type of cargo, but it is clear from *Image 5* that it was not manufactured in a geometrically smooth-edged shape.

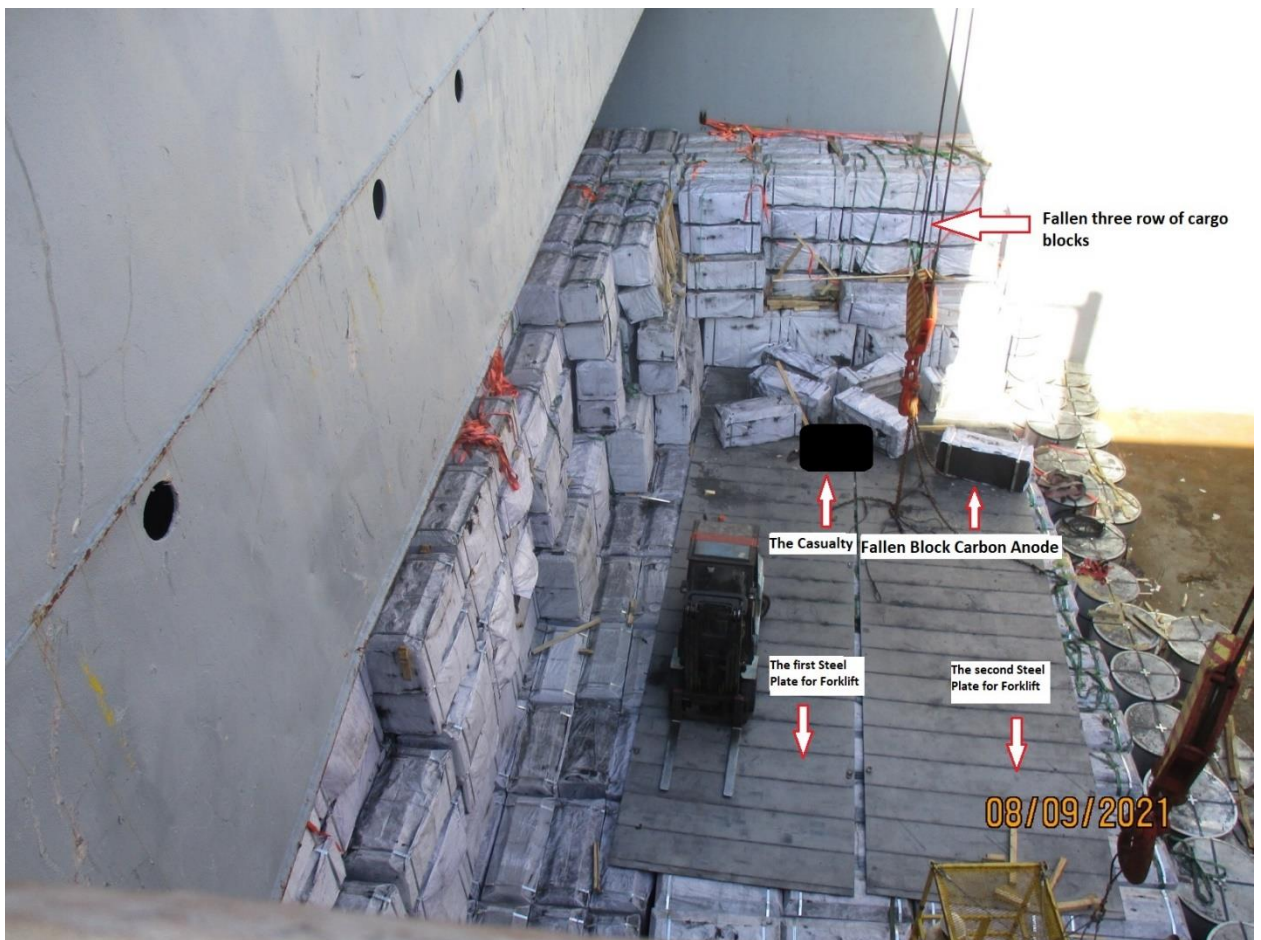
**Image 6:** A View Following the Accident

The images from the accident scene indicate that the steel plates were displaced after five rows of cargo had been unloaded. Considering that the accident took place during the unlashings of the slings after the second steel plate was placed, the question raises of what factors could have contributed to the cargo blocks falling over.

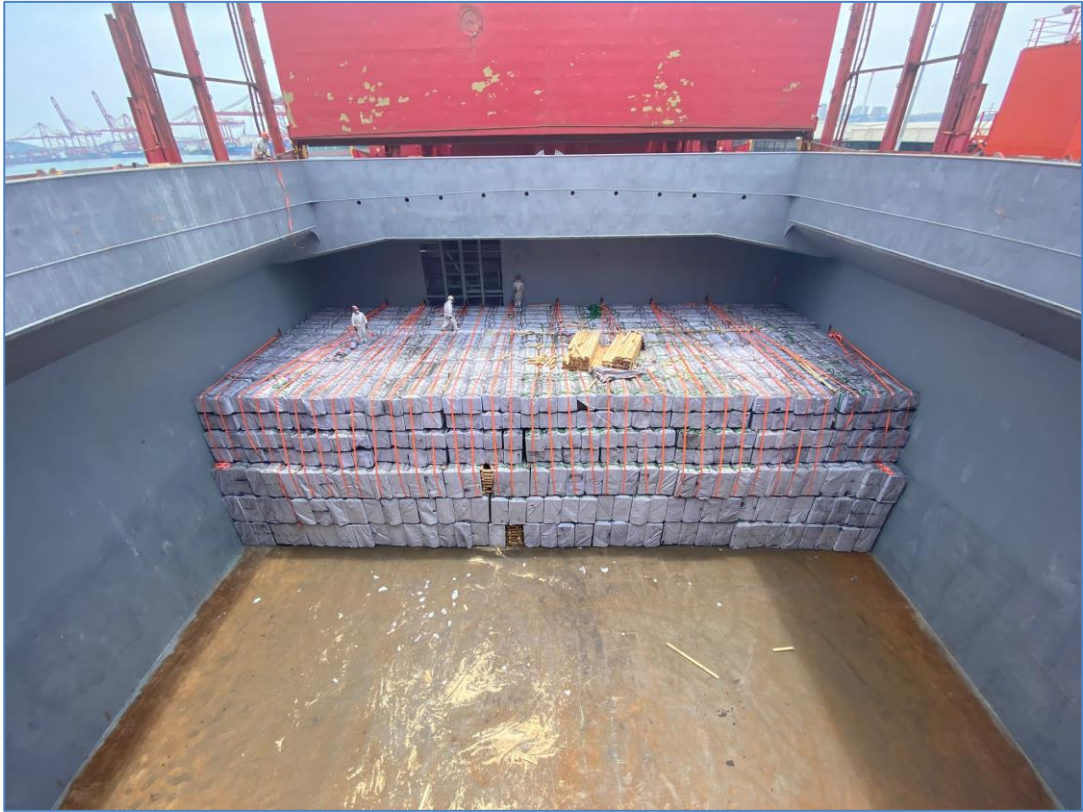
As shown in *Image 7*, the block carbon anodes were stowed such that they laid on the bulkhead between holds 4 and 3. The back of the block carbon anode cargo was then loaded with steel coils, and plywood was stacked on top of it, as shown in *Image 8*. The block carbon anode cargo, which came out after the second row, was shown to be secured inside the vessel with proper lashing equipment in order to prevent longitudinal cargo movement throughout the navigation of the vessel due to the height difference that resulted after the cargo was loaded.

However, taking into consideration the hold design of the vessel, it is a fact that there will be gaps between the cargo blocks during the loading of this kind of cargo. Therefore, it is possible to fill the gaps between the cargo blocks with a process called “chocking”<sup>2</sup> by using “dunnage”<sup>3</sup> and loading the cargo blocks on a smooth surface. Nonetheless, similar procedures were followed throughout the loading of a vessel, as can be seen in *Images 7* and *8*.

**Image 7:** A View from Hold Number 4 While Loading and Lashing Block Carbon Anode

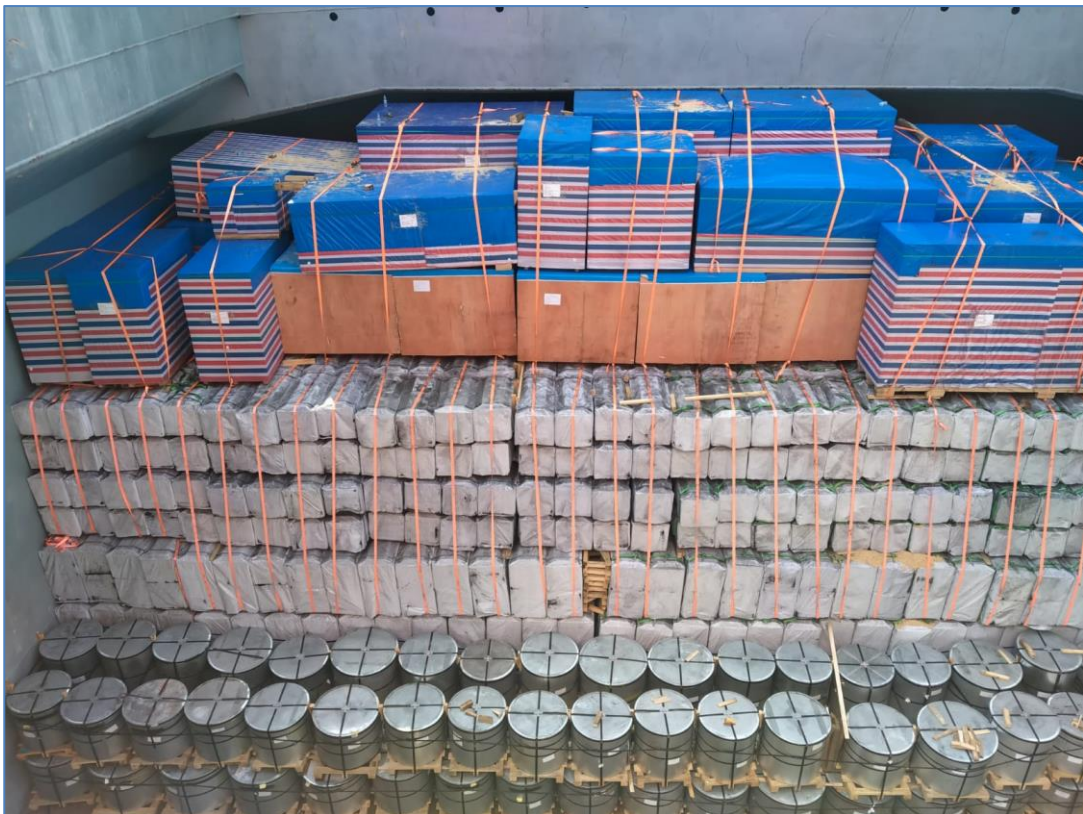
**Image 8:** A View from Hold Number 4 After Loading

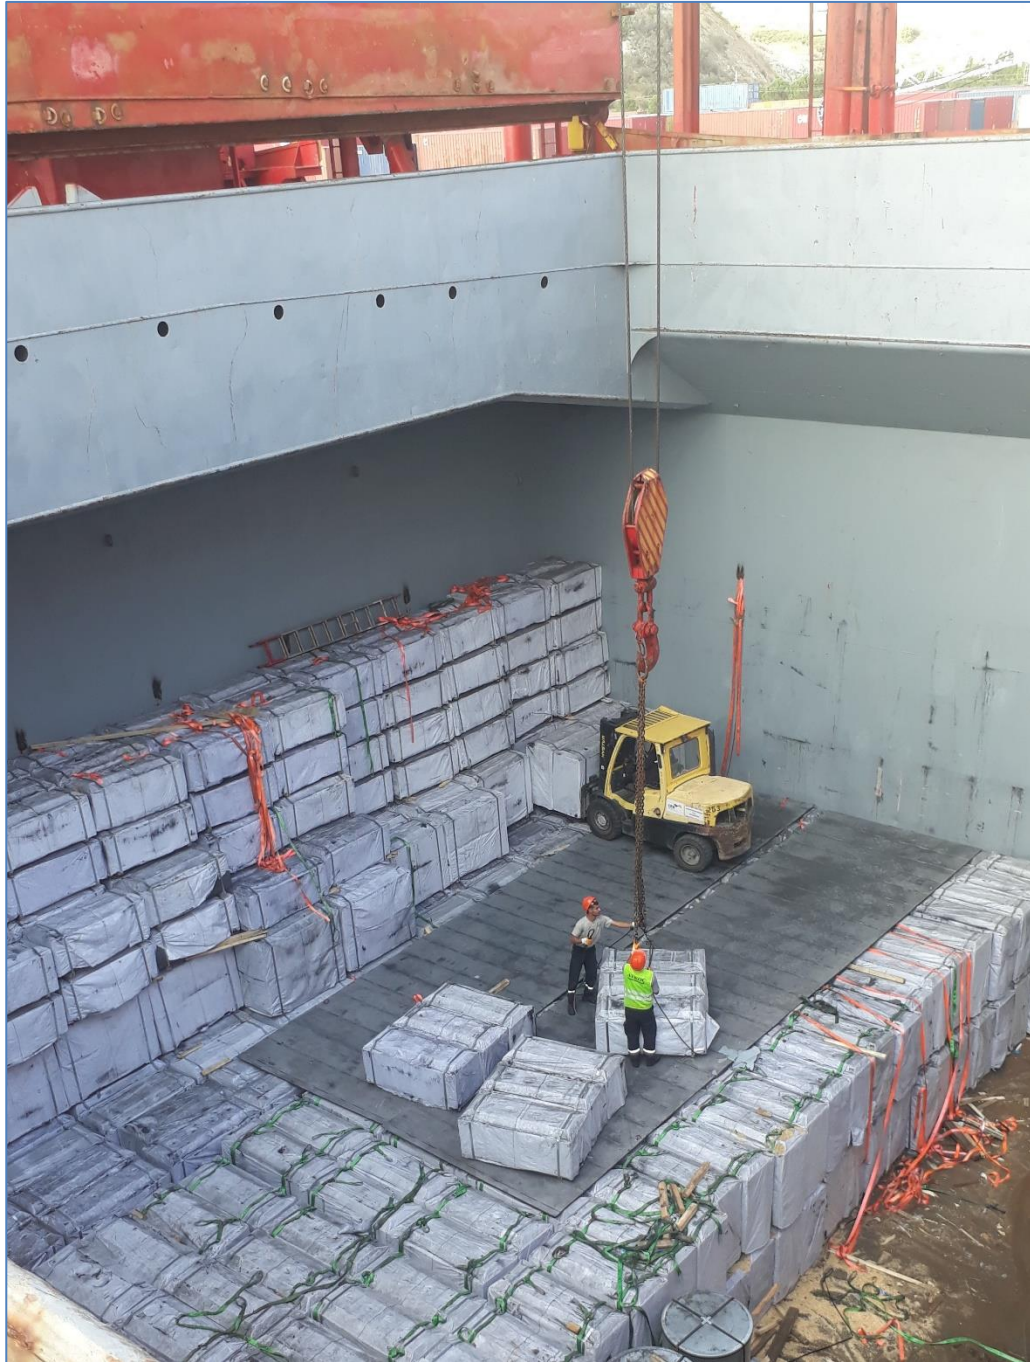
Steel plates that were used to make forklift manoeuvre easier were placed beneath or near the cargo block so that it may be unloaded by crane. The forklift moved on those steel plates and left the cargo units taken from the cargo block onto the steel plates close to the middle section of the hold. The Stevedores slung the cargo units with a chain sling and signalled the Crane operator to unload the cargo units. (*Image 9*)

**Image 9:** A View from the Ongoing Unloading Operation After the Accident

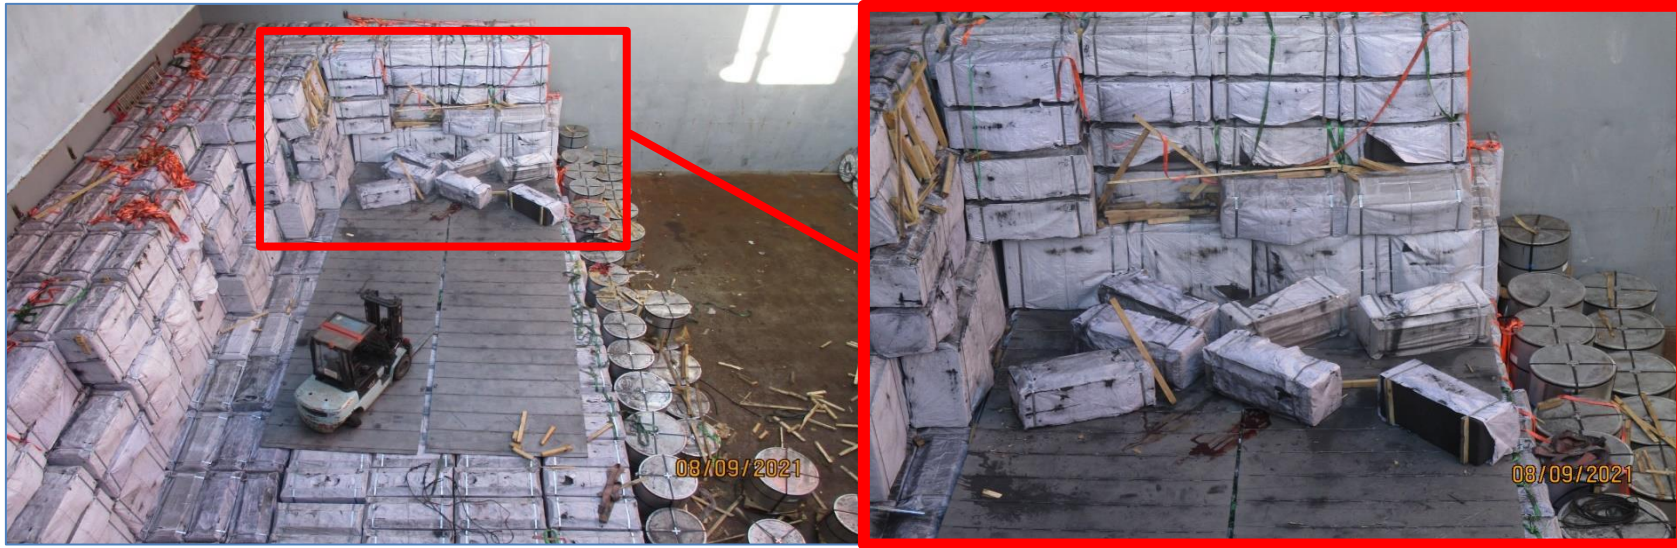
It was learned that these straps were cut by the stevedores while the unloading operation was in progress. Similarly, some units in the cargo block that fell over were also observed to be strapped in *Images 10* and *11*.

The accident was found to have taken place as a consequence of combining some or all of the preceding factors at that time. When each of the above factors is examined separately, a five-units-high cargo block that was close to the wings without being secured inside the vessel at that time, irregular stacking of four-floor units atop the first-floor unit of different size, as seen in *Image 11*, and finally the possible contact of the steel plate that was getting closer to the cargo block with the block have considered having caused the cargo units losing their weight balance and falling over. The casualty, who was close to the cargo block and was detaching the sheet metal from the sling at that time, was unable to escape despite the warnings and perished by being trapped beneath the fallen block. Besides, no evidence of the vessel oscillation was identified in the video footage retrieved from the vessel.

According to these evaluations, the factors that contributed to the accident are considered to be the cargo units being stacked over the permissible level during the unloading operation, as well as the inability to account for non-standard cargo unit sizes that pose balancing risks.

Image 10: Horizontal View of Fallen Cargo Block

**13/03-22** To develop a procedure for enforcing risk-reduction/prevention measures, particularly the cargo height tolerance while identifying the risks associated with the operations to be undertaken with the Vessel Representative before beginning the loading/unloading operations,

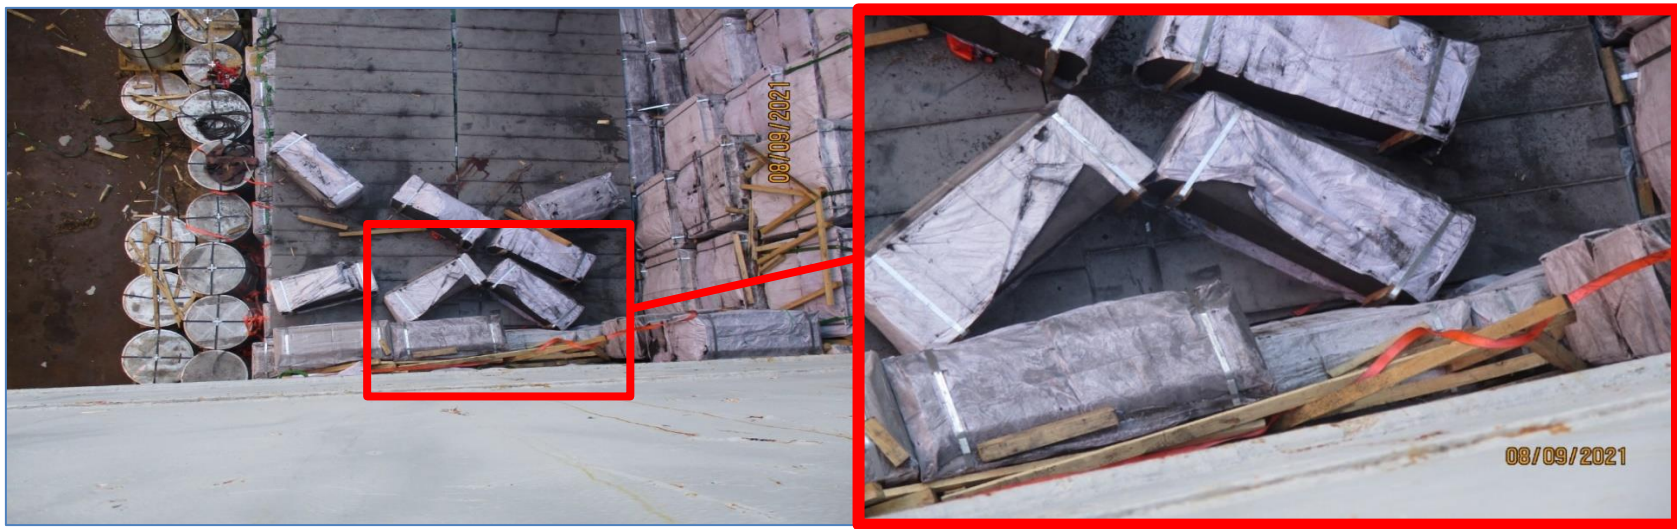
Image 11: Vertical View of Fallen Cargo Block

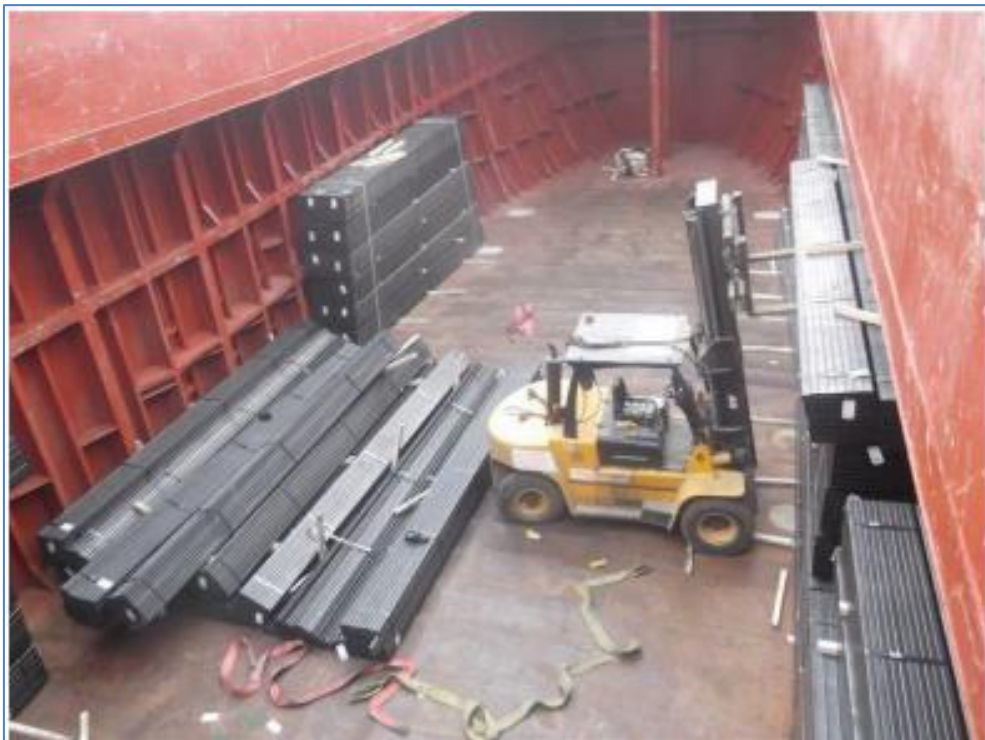
On January 10, 2018, while the loading of profile pipes on the dry cargo vessel ALİ OSMAN-E at the port in Derince district of Kocaeli province, the profile pipes stacked on the port side rolled over and a stevedore who was unlashng the slings at that time trapped under the profile pipes and perished. (*Image 12*)

**Image 12:** A View Following the Accident on ALİ OSMAN E

level on the vessel, ALİ OSMAN E were fastened one another, but the cargo units were rolled over since the swing angle of the vessel due to the forklift manoeuvres were above the tolerable angle of the cargo stacking level. On the other hand, the circumstances that led to the accident were discovered to be the result of a lack of an effective risk assessment between the parties prior to loading. In this regard, despite the fact that the ESRA C accident involved unloading operations, it is deemed significant since the circumstances that caused the accident is similar.

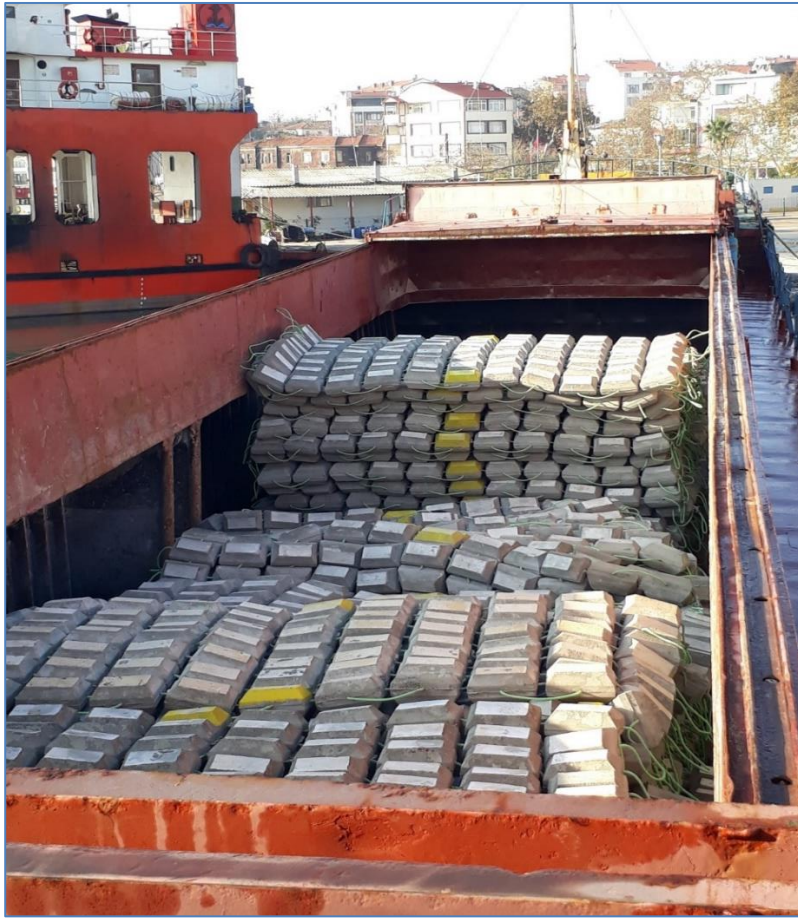
On November 26, 2019, while the M/V CANSEL was loaded concrete blocks for use as bulk material in the area of the natural gas transmission line between Turkey and Greece at Karabiga Municipality Dock, Çanakkale, the cargo block on which the Chief Engineer, who was inside the hold to assist the loading operations, was standing slid and collapsed, and the Chief Engineer fell from a height and died. (*Image 13*)

As a result of the accident investigation, it was evaluated that no occupational safety meeting between the parties was conducted before loading, where the risks would be assessed and the loading plan would be shared, and that the transshipment operation of the vessel RV DERINSU, which was alongside the vessel CANSEL while the loading operations were in progress, caused the cargo blocks aboard the vessel to oscillate, and the cargo blocks that had previously been stacked without being secured to each other or the vessel slid. Against the backdrop, it is considered to be similar to the ESRA C accident with reference to the significance of risk assessment and the comprehension of the factors that affect the stability of the cargo blocks.

**Image 13:** A View Following the Accident On CANSEL
