FINAL MARINE SAFETY INVESTIGATION REPORT ON  
VERY SERIOUS MARINE CASUALTY

<b>VESSELS' NAMES</b>	GLARD 2	DURSUN ALI COSKUN
<b>FLAGS OF THE VESSELS</b>	RUSSIAN	TURKISH
<b>IMO NOs OF THE VESSELS</b>	9687980	8687294
<b>LOCATION OF ACCIDENT</b>	5.87 Nautical Miles North West of Rumeli Feneri/Istanbul BLACK SEA	
<b>DATE OF ACCIDENT</b>	10 January 2020 / 06.06 (LT)	
<b>DEAD/INJURED/MISSING</b>	2/-/1	
<b>DAMAGE DEGREE:</b>	- / Fishing Vessel Sank	
<b>ENVIRONMENTAL POLLUTION</b>	-

Board Decision No: 3 / D- 02 / 2023

Date: 27 / 02 / 2023

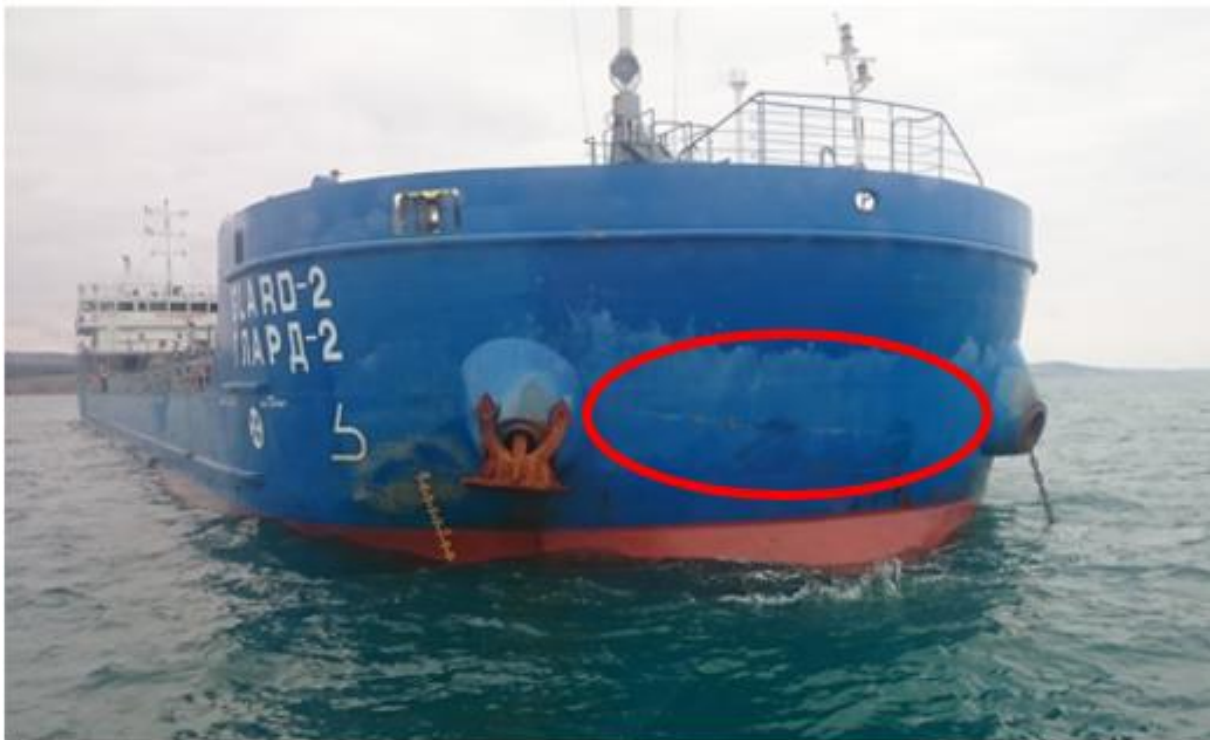
Image 5 Front view of the tanker GLARD 2

During the accident investigation on the tanker GLARD 2, which was at anchor in the anchorage site after the accident, the traces observed in the area between the starboard and port hawsepipes after the accident caught attention (Image 5).

During the damage inspection at the anchorage site, the impact point was determined to be between two hawsepipes.

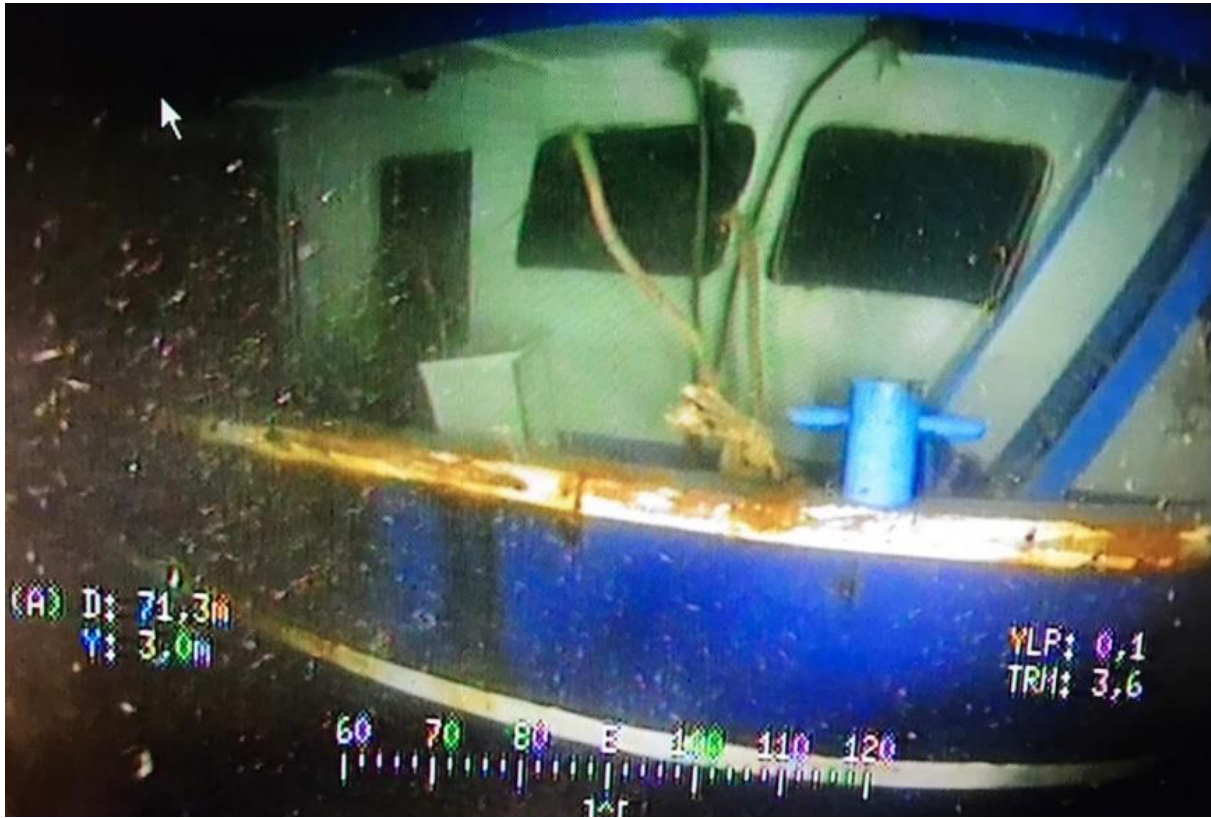
*Image 6 Shipwreck Image of the Fishing Vessel DURSUN ALİ ÇOŞKUN*

The fishing vessel DURSUN ALİ ÇOŞKUN sank after heavy damages that she sustained after the collision. The depth measured in the shipwreck images is 71,3 metres (Figure 6).

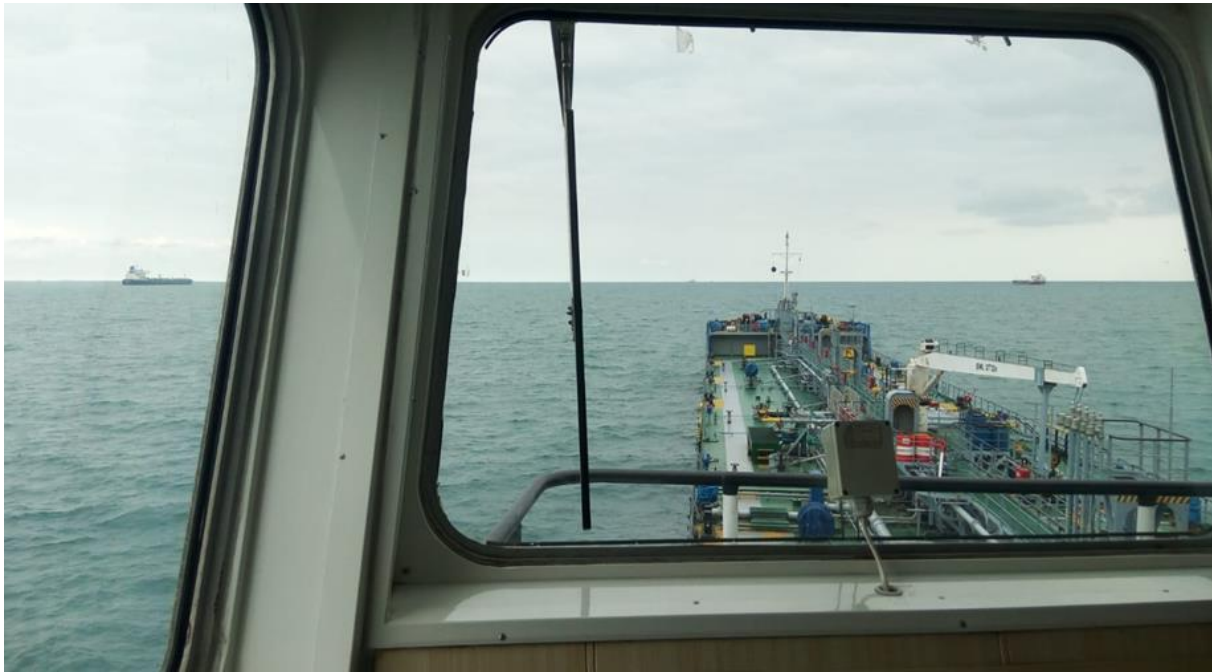
*Image 7 View from the bridge towards the bow*

On the other hand, there are no cranes and similar structures that could potentially create blind spots in the perspective of the tanker from the bridge to the bow, which may adversely affect the lookout (Image 7).

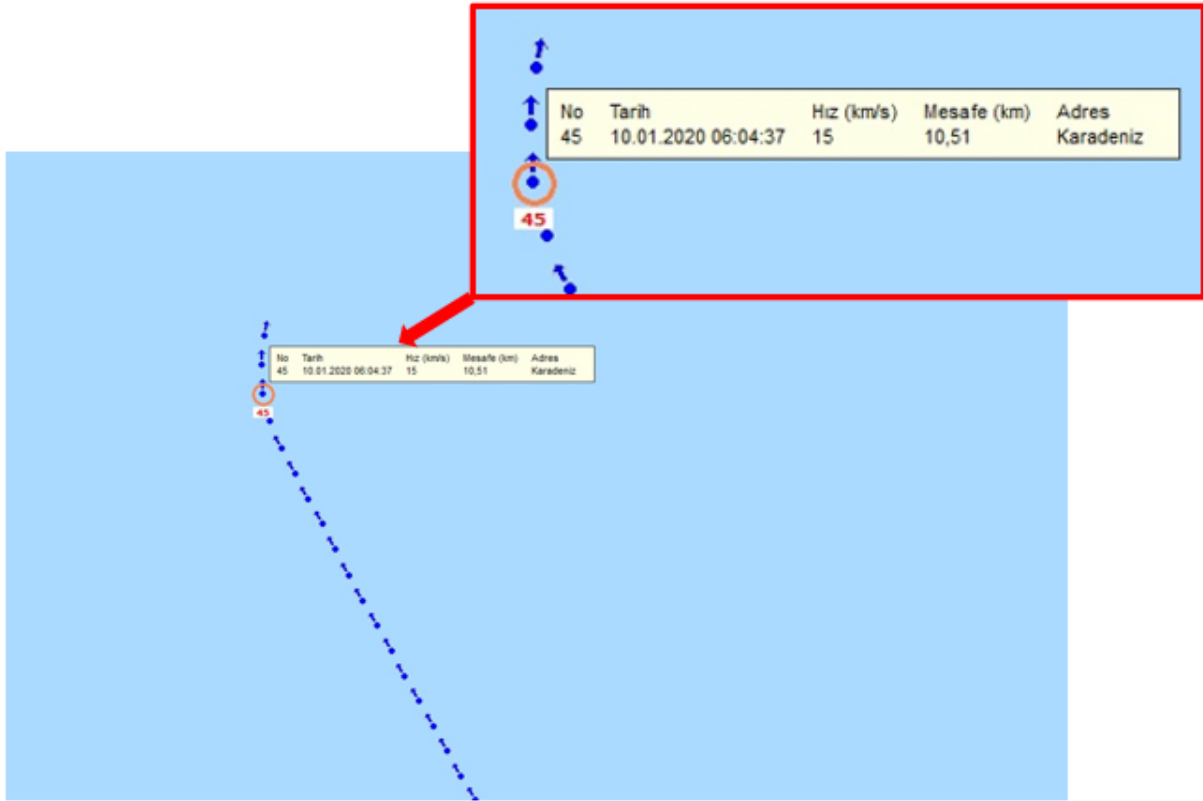
Image 8 Image from Boat Tracking Module Approximately 2.5 Minutes Before the Collision

While the fishing vessel was following Course Over Ground (COG) at 333°, she started to alter her course to starboard at 06:03:37 and her course over ground became 005° at 06:06:06 when the collision took place. This course alteration was not sufficient to avoid the collision and the collision took place. This suggests that the fishing vessel did not notice the tanker in sufficient time, therefore, did not keep an effective lookout with radar and sight for safe navigation according to the COLREG.

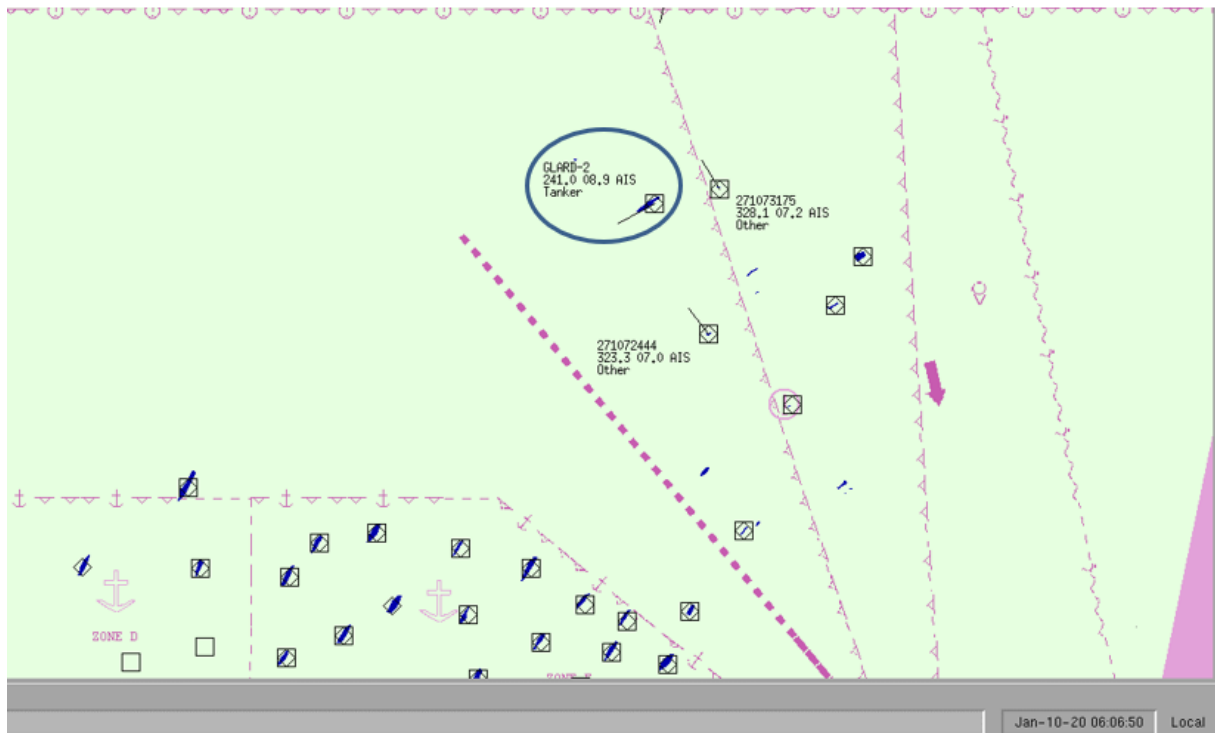
Image 11 The Collision Time and the Course Followed by the Tanker after the Collision from the ECDIS Device

On the other hand, when the course followed by the tanker during and after the collision was analysed from the ECDIS device (Figure 11), it appears that the tanker maintained her course after the collision and then negligibly altered her course due to the effect of the collision.

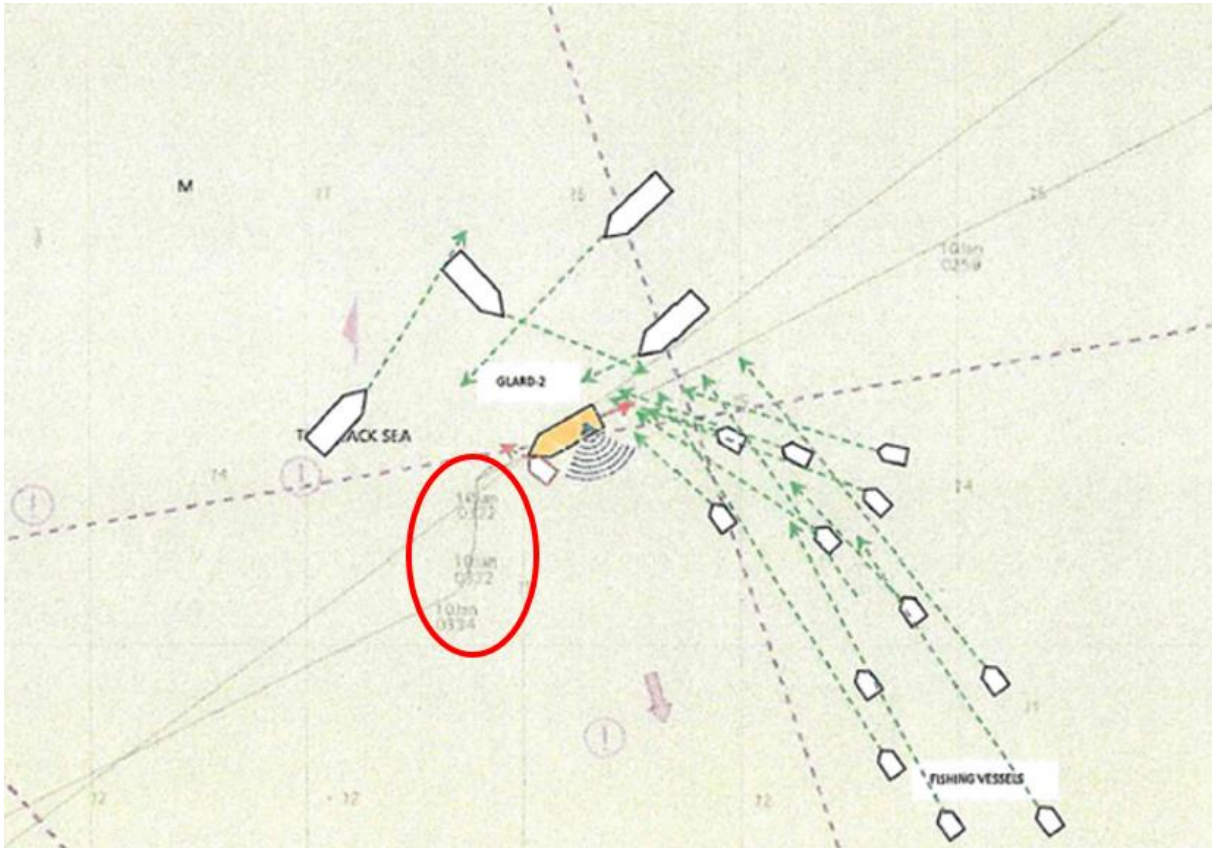
*Image 12 Speed and Course of the Tanker after the Collision*

The tanker bridge crew, contrary to their statements on the occurrence of the accident, did not manoeuvre appropriately to avoid collision and did not slow down their speed since they neither saw the fishing vessel with their eyes nor identified it on the radar. Hence, based on the data obtained, the speed of the tanker started to slow down after the collision. It is considered that the tanker slowed down after the collision due to the fact that the fishing vessel stuck in front of the bulb of the tanker after the collision first, prevented the tanker from sailing ahead; and then, the bridge crew of the tanker noticed the collision and commanded the main engine to full astern propulsion.

Consequently, it was found out based on the data from the VTS of the tanker that there was neither any alteration in the speed nor any alteration in the course of the tanker until the time of the collision. This suggests that the bridge crew of the tanker had no situational awareness of the approaching collision hazard. Also, it is considered that the failure of the tanker to alter course and speed in time to avoid collision led the fishing vessel to drift for about 3 minutes

after the collision, consequently, escalated the severity of the collision and intensified the extent of the damage to the fishing vessel.

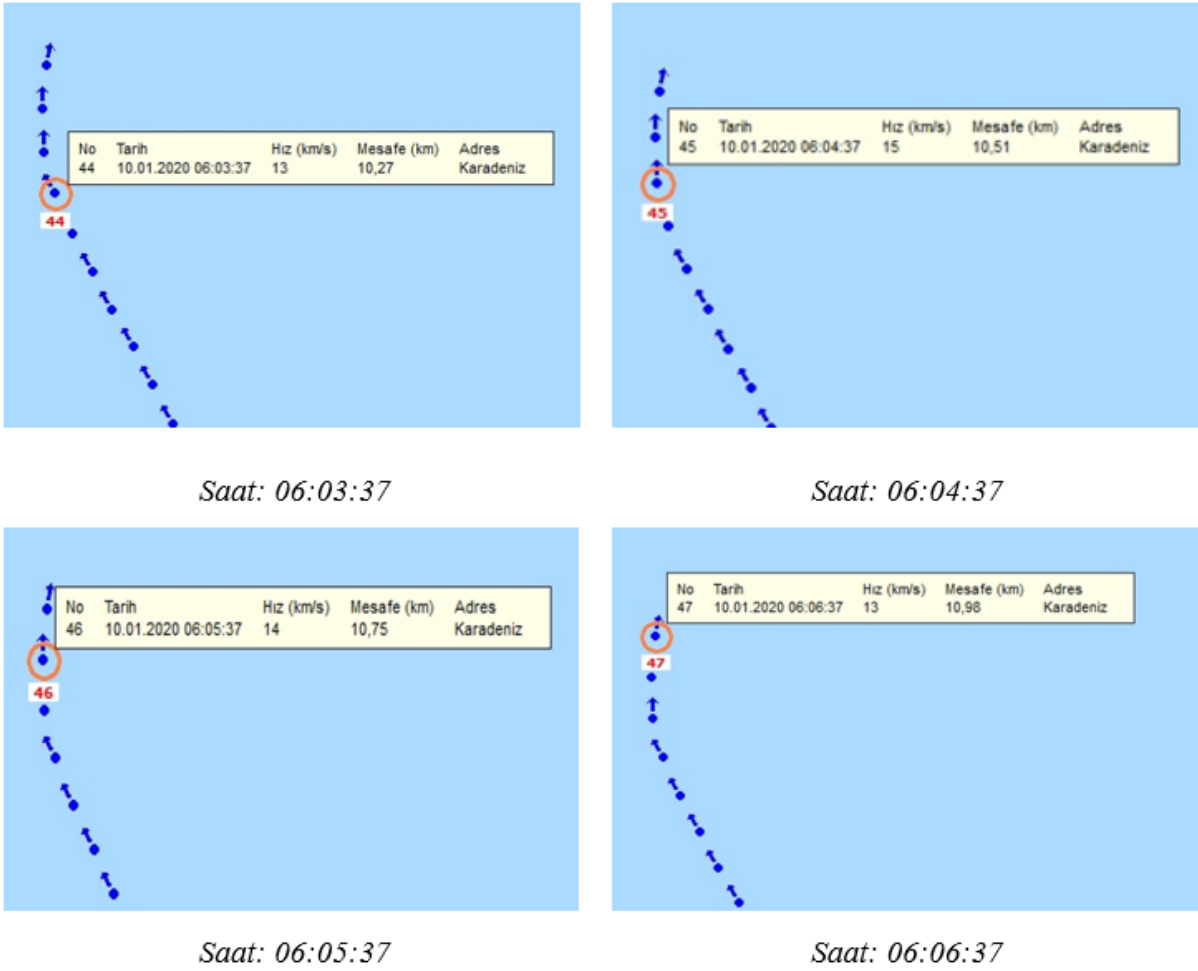
Image 15 Alterations to the Course of the Fishing Vessel

Besides, the data from the Vessel Tracking Module on the course followed by the fishing vessel shows that the fishing vessel was sailing on a 333° course (over the ground) until 06:03:37 after the northern exit of the Istanbul Strait. The alterations in the course of the fishing vessel afterwards are noteworthy. (Image 15)

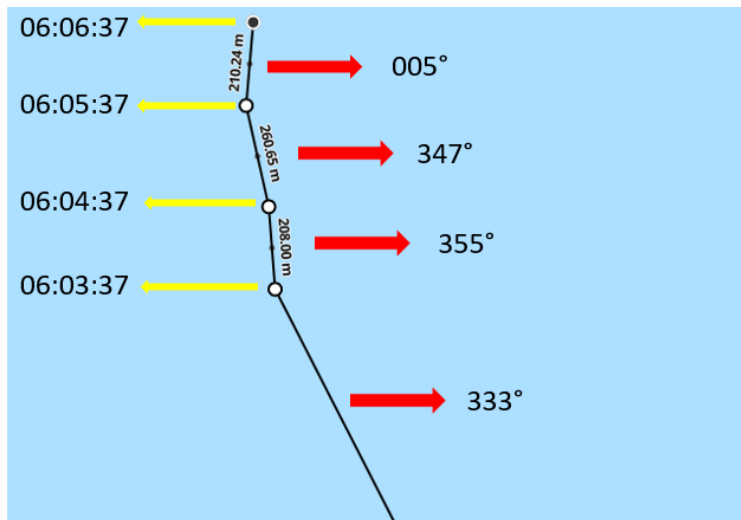
Figure 3 Course the Fishing Vessel Followed Before the Collision

Figure 3 displays the course of the fishing vessel at 06:03:37 and the changes in the course of the fishing vessel for the last 3 minutes when the location data recorded by the Vessel Tracking Module are plotted on the map at each one-minute interval after 06:03:37.

As Figure-3 shows, the fishing vessel altered her course by 22 degrees between 06:03:37 and 06:04:37 and proceeded 208 metres in one minute. Then, the fishing vessel followed a course of 347° and sailed 260,65 metres. According to her last location data obtained from the fishing vessel, she sailed about 210 metres on course 005°. This indicates that the fishing vessel altered her course 32 degrees to her starboard in the last three minutes to avoid a collision, but since she did not alter her course in time, this course alteration was not sufficient to avoid the collision.

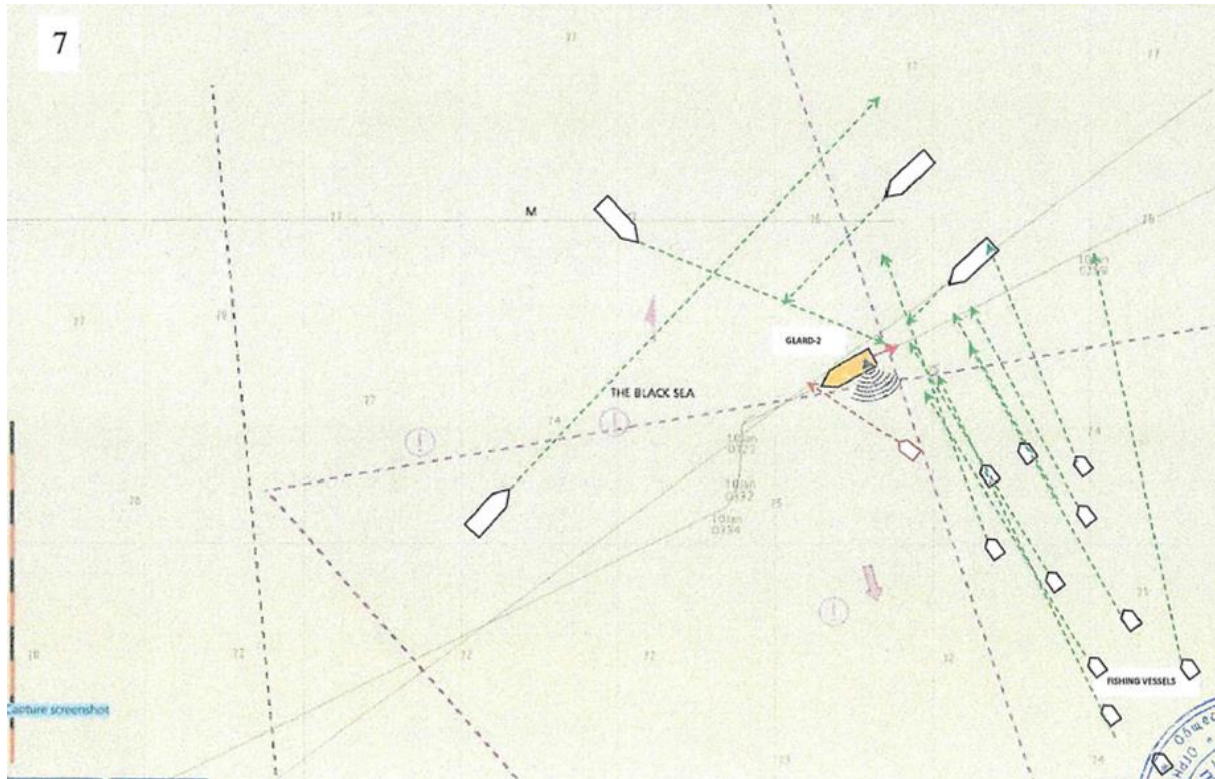
Image 16 ECDIS Image of the Vessel at the Time of the Accident

of the tanker from the ECDIS screen at the time of the accident (Figure 16) draws attention to the heavy traffic of vessels sailing to join or leave the traffic separation lane. This suggests the possibility that the bridge crew of GLARD 2 was concentrating on the manoeuvres of the vessels nearby before the accident and was not aware of the fishing vessel sailing dangerously towards them.

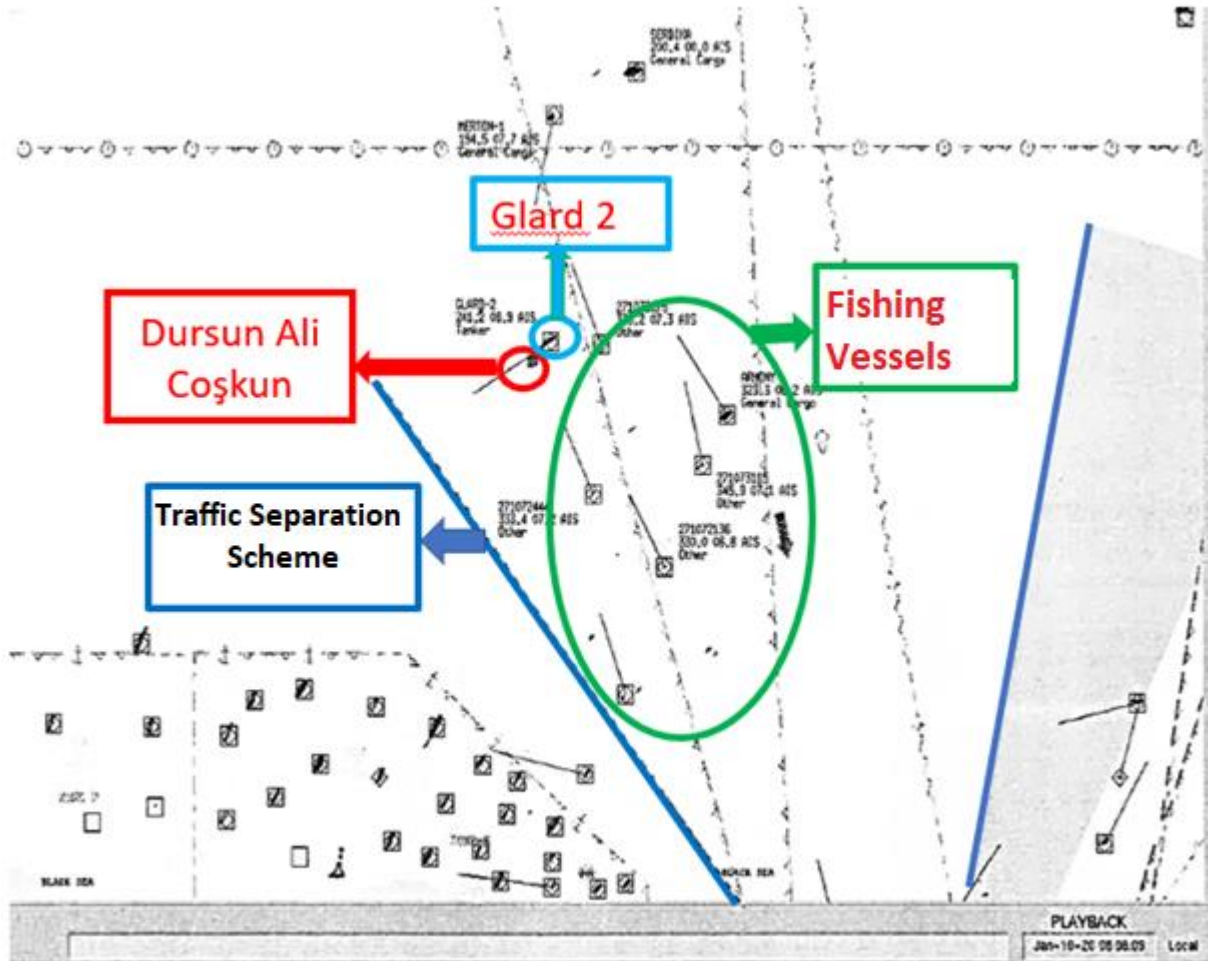
Image 18 Screenshot Captured from The VTS Before the Accident

Additionally, it is remarkable that there are other fishing vessels that violated similar rules in the said traffic lane in the screenshot captured from the VTS before the accident (Figure 18). This indicates that the fishing vessels that engaged in fishing in the area not only routinely violate the rules to reach the fishing grounds by the shortest route, but also ignore the warnings of the VTSC from time to time.
