**REPUBLIC OF TURKEY**  
**MINISTRY OF TRANSPORT, MARITIME AFFAIRS AND**  
**COMMUNICATIONS**  
**Accident Investigation Board**

**Report on the Investigation of**  
**The Collision Between**  
**M/V GÖKBEL and M/V LADY AZIZA**

**ITALY / Off Ravenna Port**

**02/DNZ-02/2016**

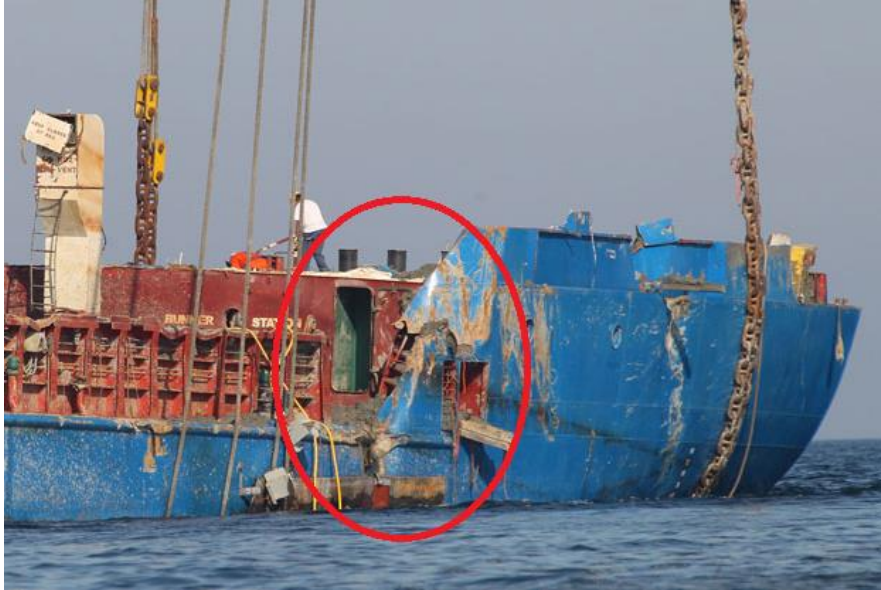
*Picture 21: Wreck Removal of GÖKBEL*

While the deck and accommodation of GÖKBEL had material damage over the water level close the aft quarter of the portside hold number 2, it was damaged in the board at a section near to the engine room bulkhead under the water level at portside hold number 2.

The ship started flooding due to the damages and it sank due to loss of stability. None of the ship personnel was injured during the collision. However, after the abandonment, one of the ship personnel was lost and corpses of four were found in the sea. One of six accident victims who were rescued alive from the accident lost his life after being saved. After the collision, any environmental pollution originating from GÖKBEL was not reported.

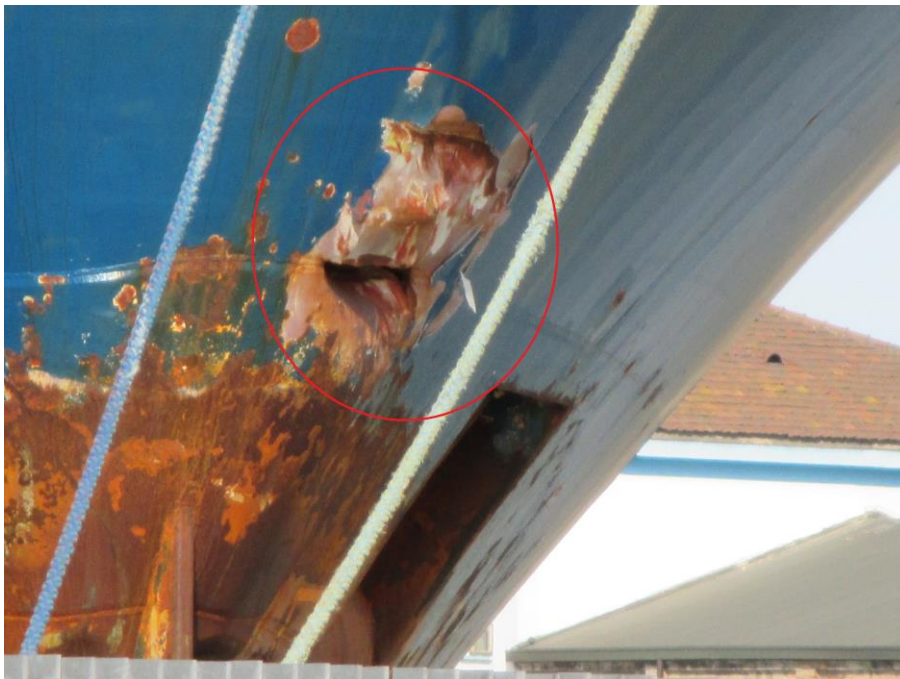
***Picture 23: Damage on LADY AZIZA After Collision***

Two very close breakdowns happened on the forecastle over waterline of LADY AZIZA. None of the personnel of the ship was injured in the collision. After the collision, any environmental pollution originating from LADY AZIZA was not reported.

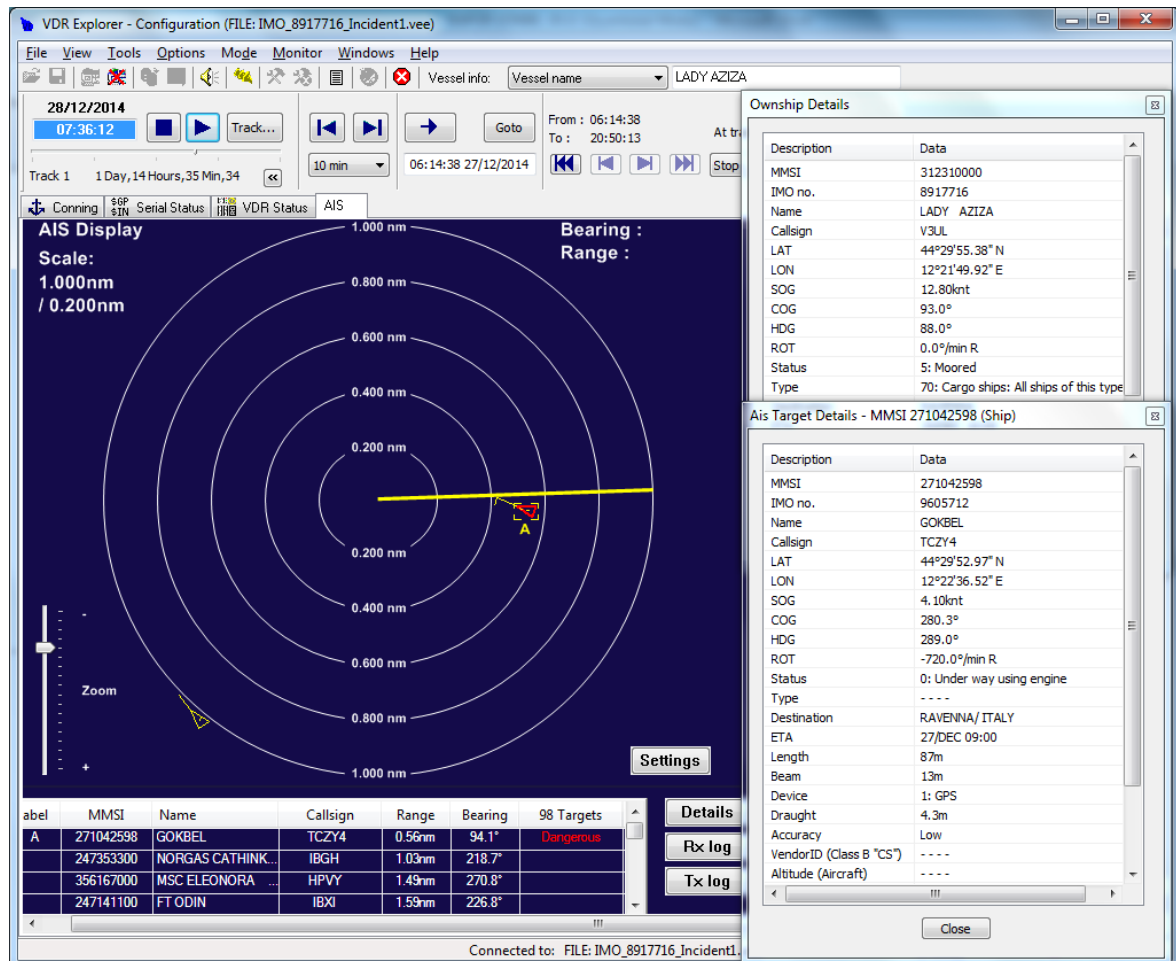
**Figure 15:** Position of Each Ship Opposite to the Other at 08:36:12 (VDR-AIS)

between the ships. This distance has not become sufficient for GÖKBEL to conduct the manoeuvre of avoiding collision. As a matter of fact, the collision has occurred in 1 minute 46 seconds following the start of manoeuvre of avoiding collision.

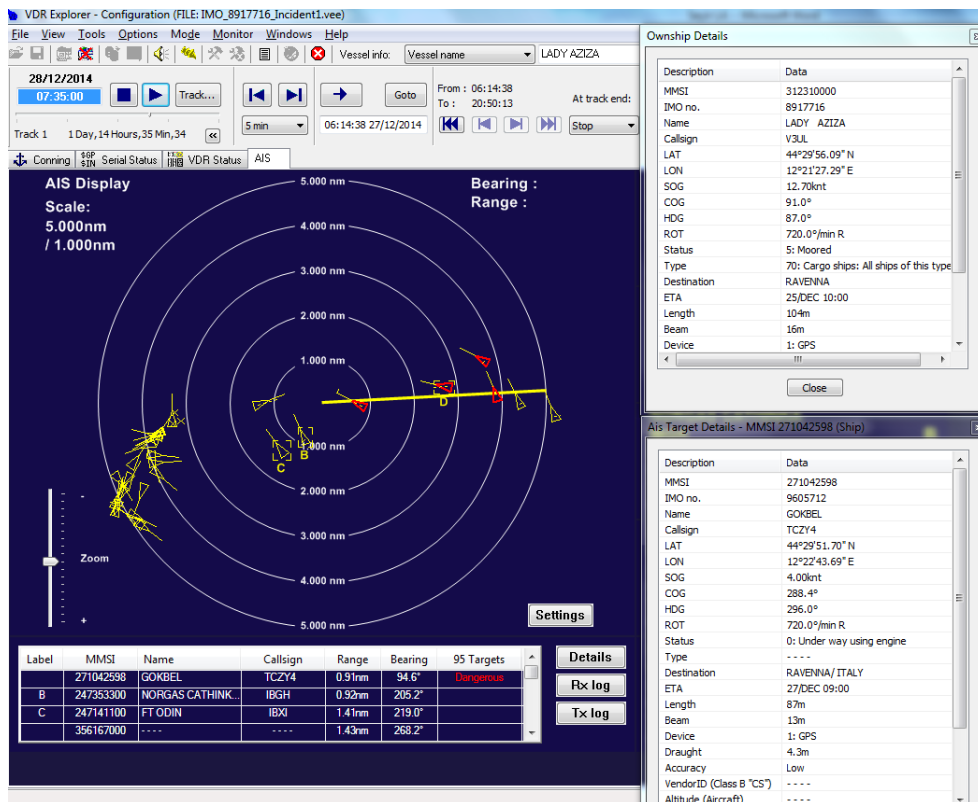
**Figure 17: Position of Each Ship Opposite to the Other at 08:35 (VDR-AIS)**

According to the deck logbook records of LADY AZIZA, it is stated that the chief officer positioned on the forecastle informed the bridge at 08:35 about a ship in front of them and the master turned the rudder hard to starboard to avoid collision. There is a distance of 0,91 miles between two ships which progress on the collision course at 08:35. It is clear that the collision can be avoided in case LADY AZIZA turns its rudder hard to starboard. However, there was no change in the speed and navigating course of LADY AZIZA from 08:35 to the moment of collision. This situation clearly puts forth that LADY AZIZA hasn't made hard-a-starboard to avoid collision as indicated in the logbook.

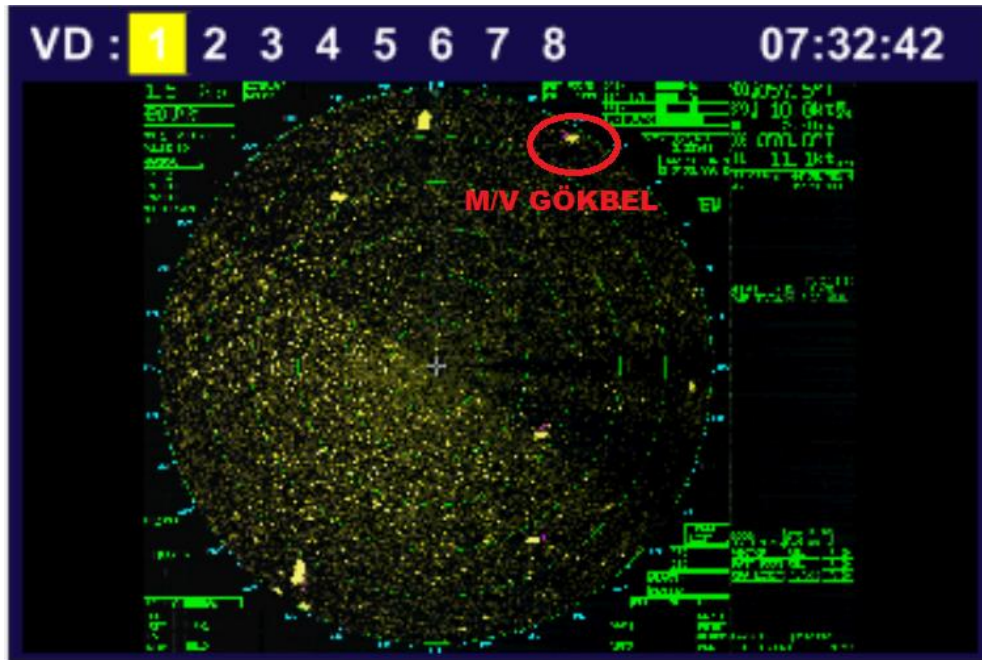
**Figure 18:** *GÖKBEL's Image on Radar Screen of LADY AZIZA (VDR-AIS)*

This situation shows that electronic navigation aids (radar or AIS) were not used and an effective look out was not made as there were not a sufficient number of personnel on the bridge of LADY AZIZA.

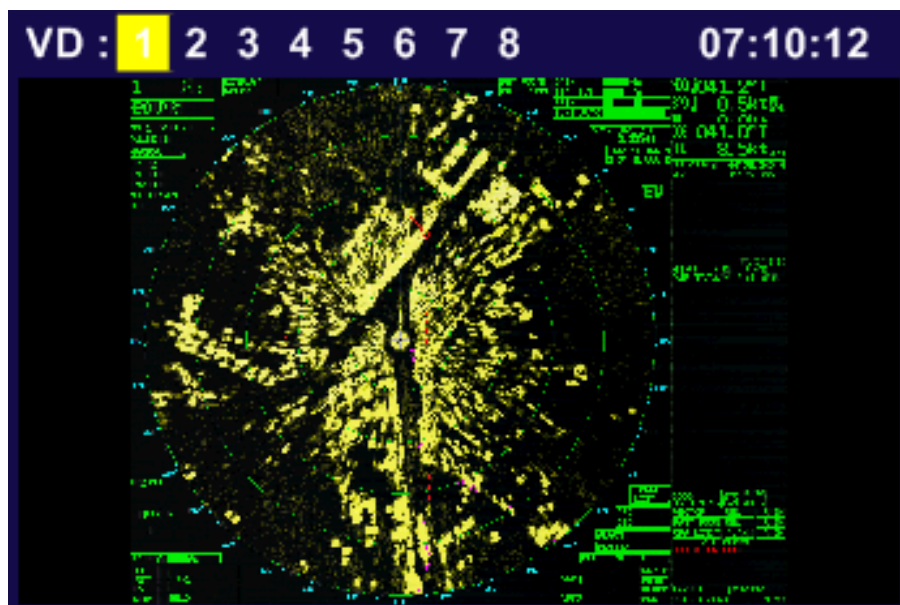
**Figure 27:** *Radar Image of LADY AZIZA (VDR)*

The time at which the pilot who guided LADY AZIZA left the ship was recorded as 08:10 to deck logbook records. But, it is seen according to VDR records of LADY AZIZA that LADY AZIZA didn't complete the channel pass of Ravenna port yet at the indicated time. It is observed in the continuation of VDR records that the navigation speed of the ship decreased from 8 knots to 7,2 knots and immediately after that, it was 9,50 at 08:25:31 and the speed of ship continued to increase. In this case, it is assessed that the pilot disembarked when the speed of ship was low and when the ship was in the breakwater. Therefore, it is thought that the disembarkation time of the pilot was incorrectly written in the logbook- records.

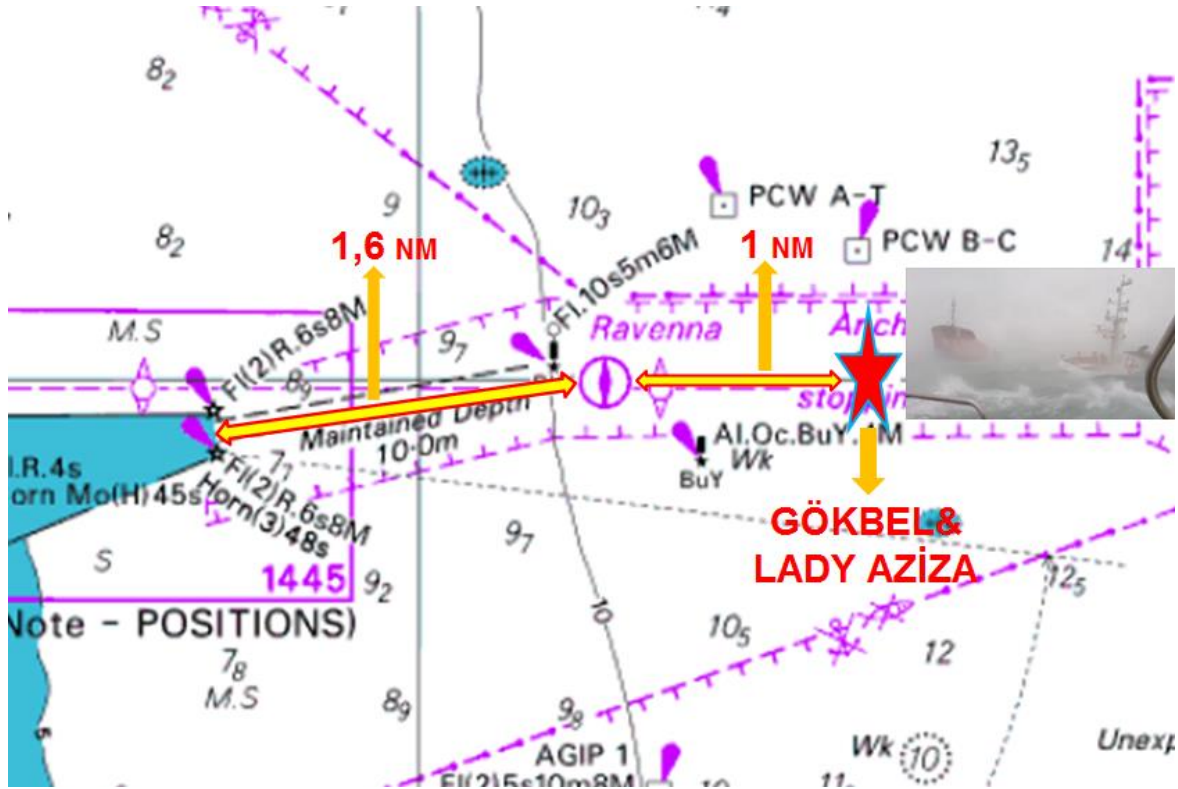
**Figure 28:** Demonstration of the Accident Scene and the Location Where the harbor pilot would embarked/disembarked the Ship on chart no BA 1467

transfer of pilot to the ships. It is assessed that disembarkation of the harbor pilot 1 mile before the disembarkation location determined on the chart doesn't comply with the piloting application obliged to ensure the safe navigation of the ships which enter and exit to and from Ravenna port.
