Accident Investigation Report On
Fire Onboard of M/T HABAŞ

Habaş Platform / İzmit /Turkey
29 April 2017

DNZ-04/2018

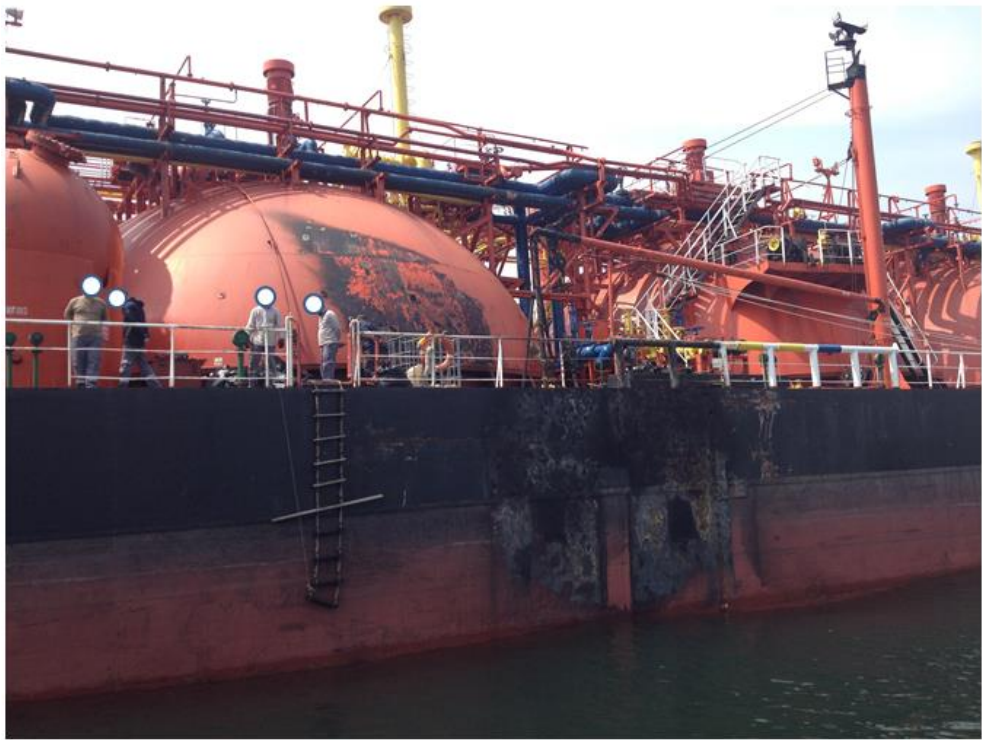
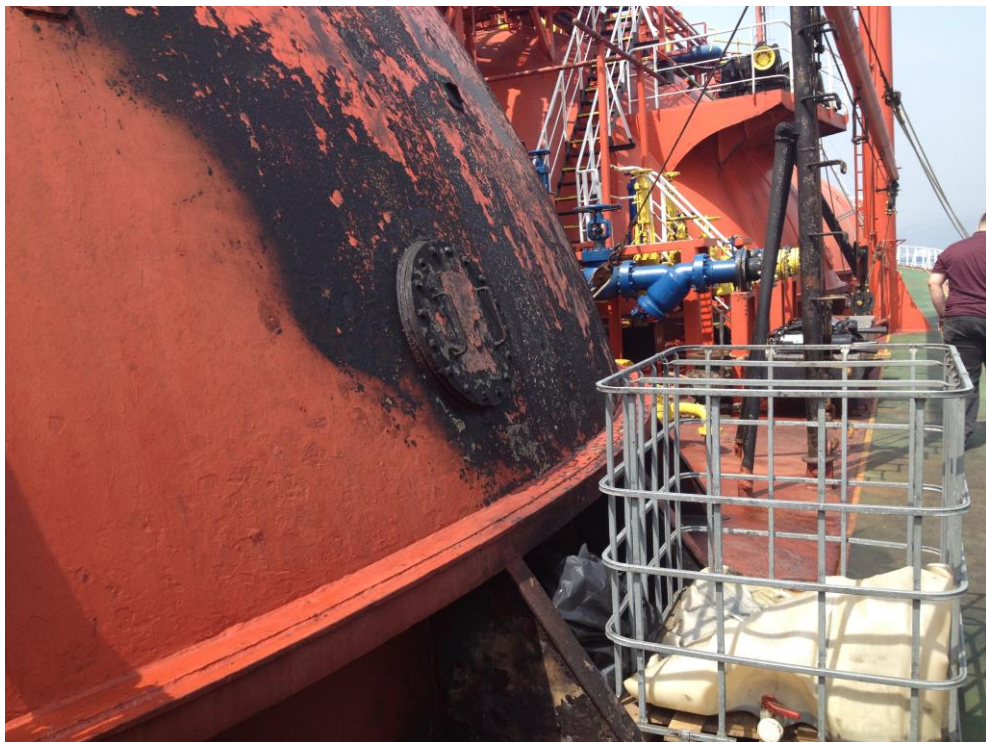
Fire on the vessel was a paint fire in general. As a result of the fire, a paint damage occurred on the vessel's starboard freeboard deck, handrails and the starboard side of the tank No. 4 (Figure 4, 5).

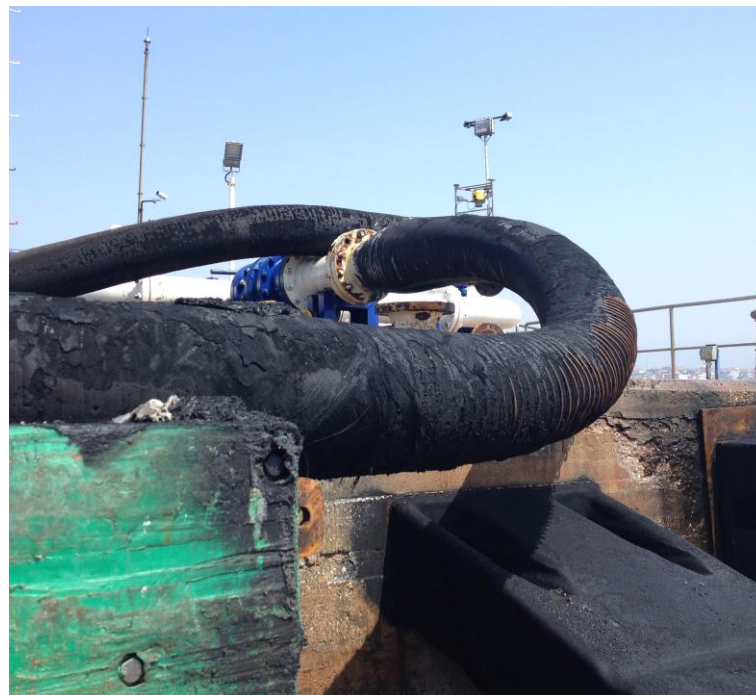
Figure 7: Black Hose Damaged by the Fire

The gray hose, which is used to especially releasing the remaining gas in the vessel's tanks into the sea and which was attached to the vessel's manifold at the time of the fire, was completely burned (Figure 6). The black rubber hose used in unloading the vessel's cargo and the platform fenders was partially burnt (Figure 7).

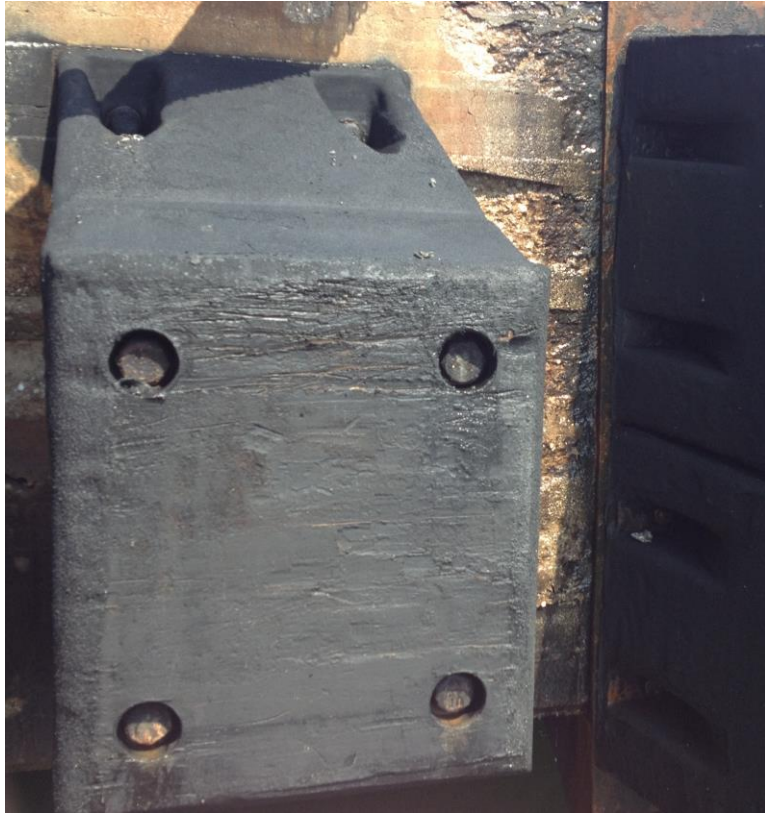
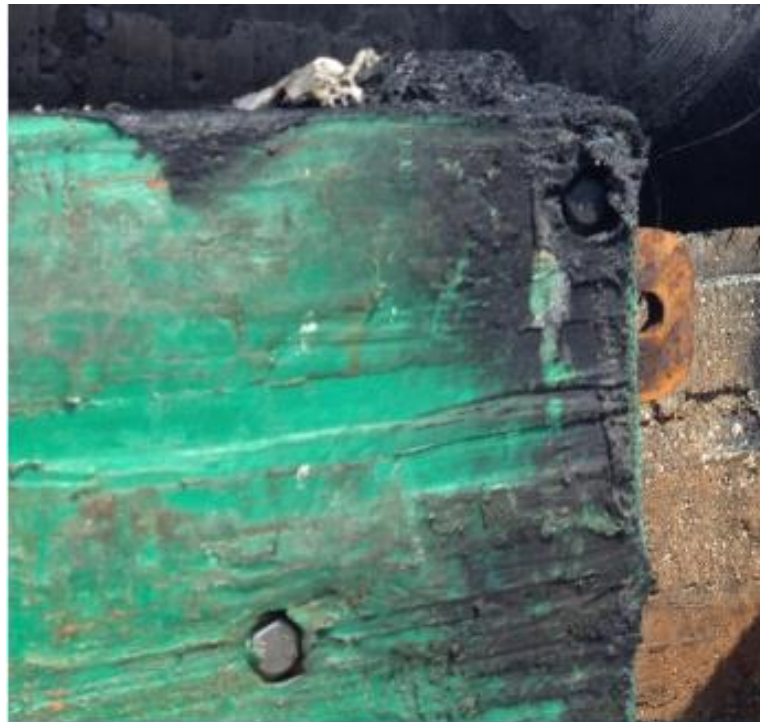
The rubber and plastic fenders of the Habaş Platform were also damaged by the fire (*Figure 8,9*).

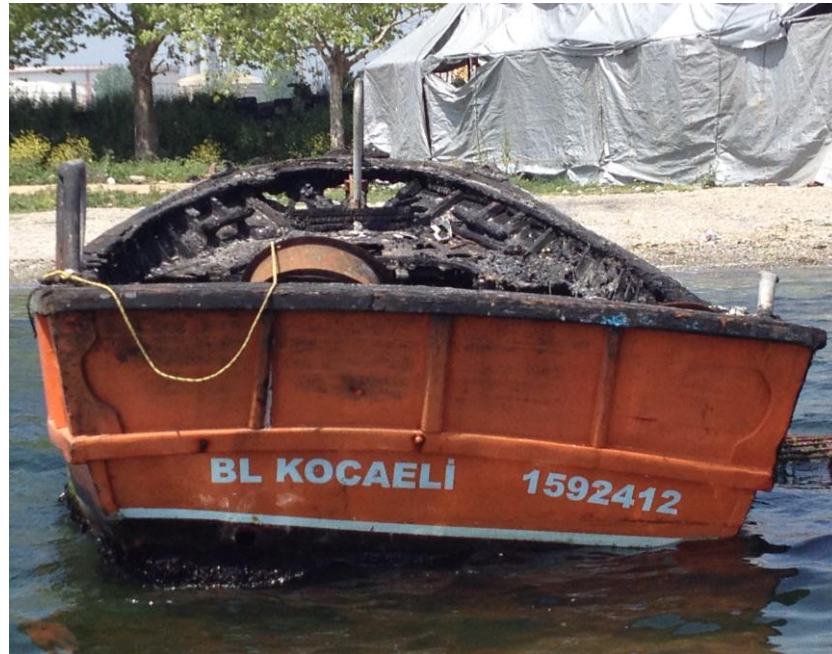
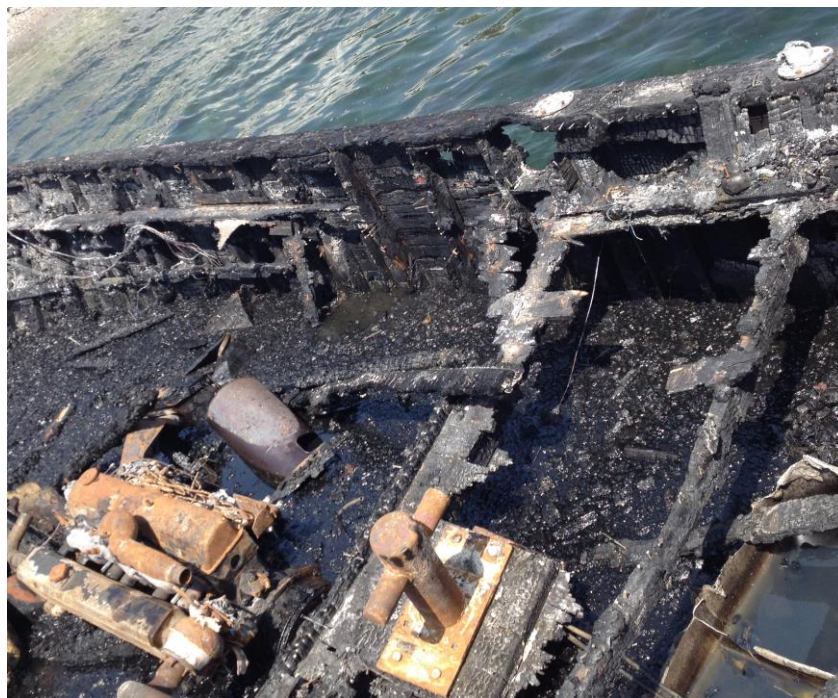
While the boat superstructure of the agent boat SERDAR 2 was completely burned, port and starboard of the shell were partially burned, the fuel tank were broken to pieces after the explosion and the boat became unusable (Figure 10, 11).

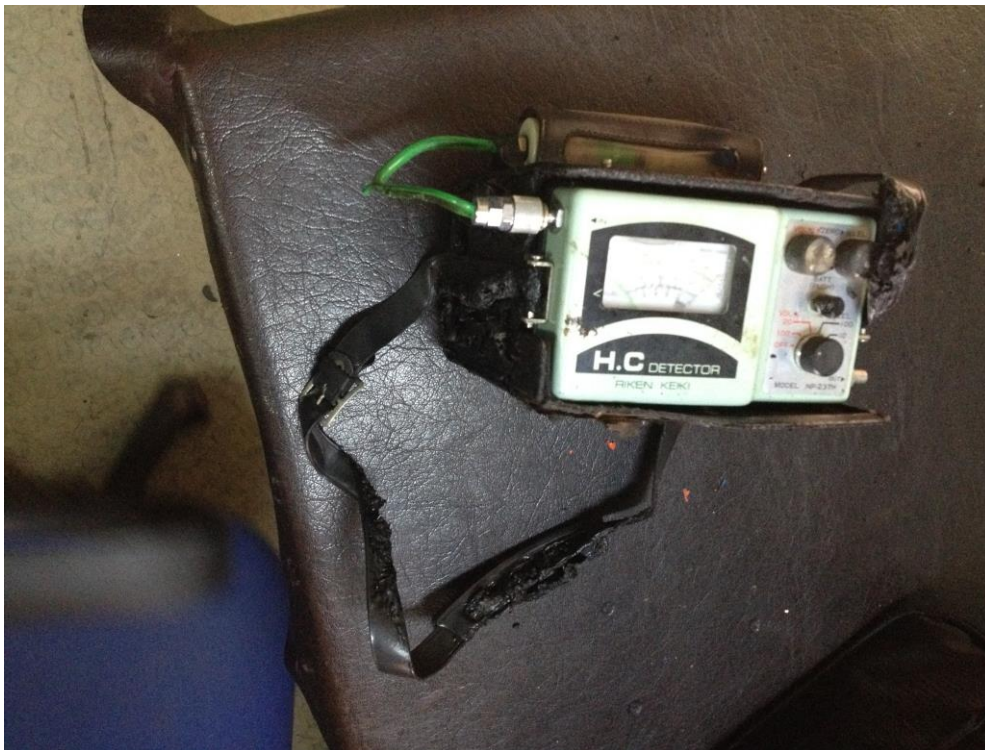
Figure 12: Gas Detector Damaged by the Fire

1st Officer stated that there was a fixed gasometer on the platform and a portable gasometer which belongs to the vessel on the vessel, measurements were carried out continuously with the portable gasometer during the unloading and no alarm heard during the unloading on the day of the incident. As a matter of fact, the portable gas detector used by the ship personnel during the unloading of the cargo was severely damaged by the fire (Figure 12).

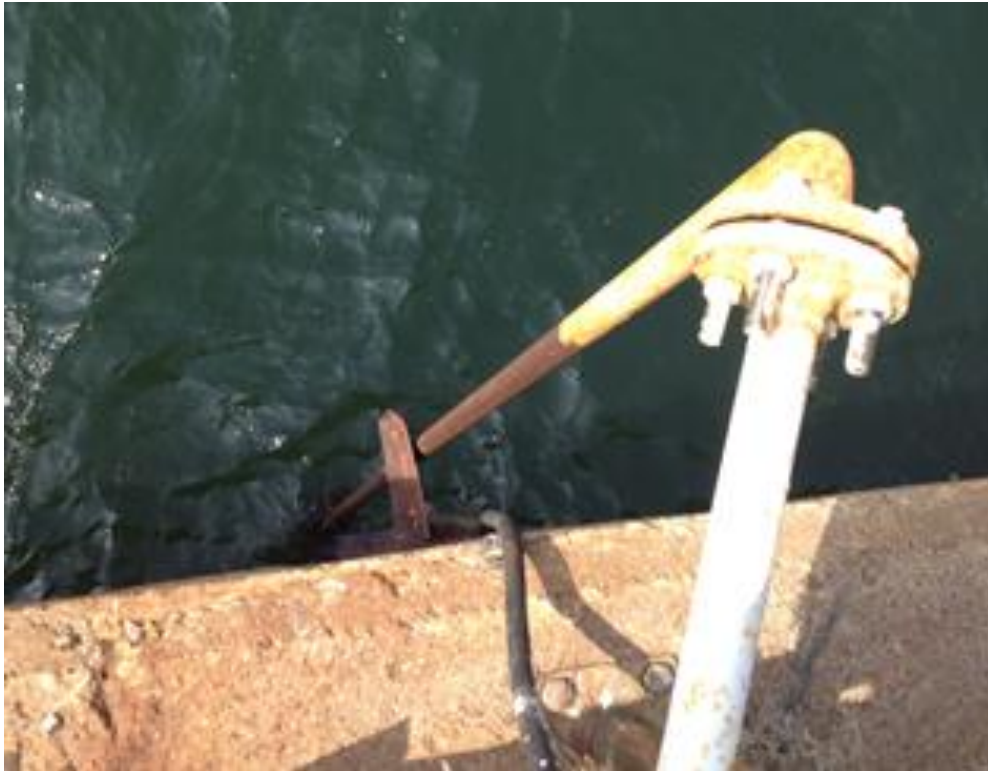
Figure 13: Gas Draining Line at the Platform

- 1. The unloading of the cargo in the gas phase was started on the date of 28.04.2017 at 10:15 and ended on the date of 29.04.2017 at 14:30.*
- 2. After completion of the unloading, the manifold valve was closed and the drain valve at the platform was opened for draining of the remaining gas in the cargo hose (Figure 13).*

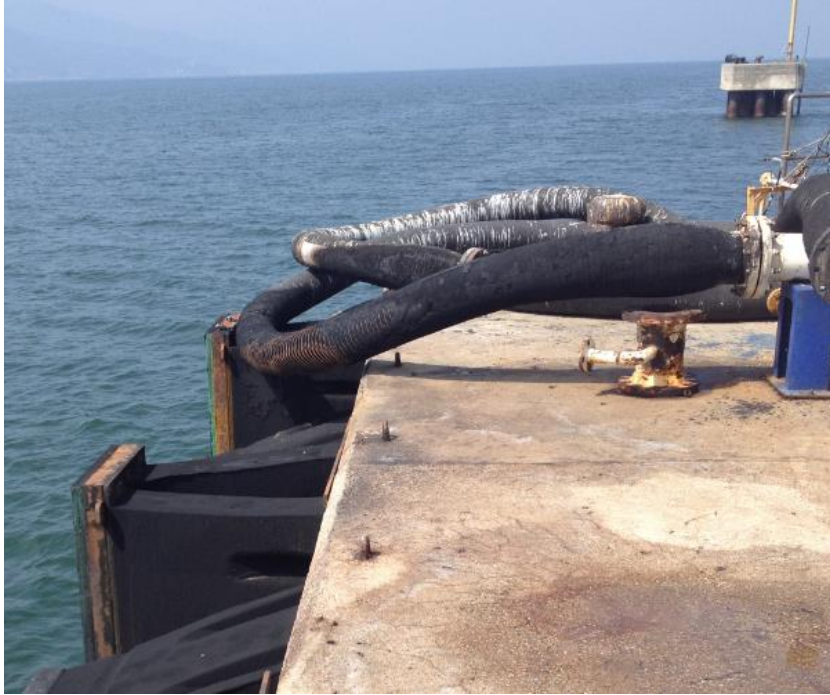
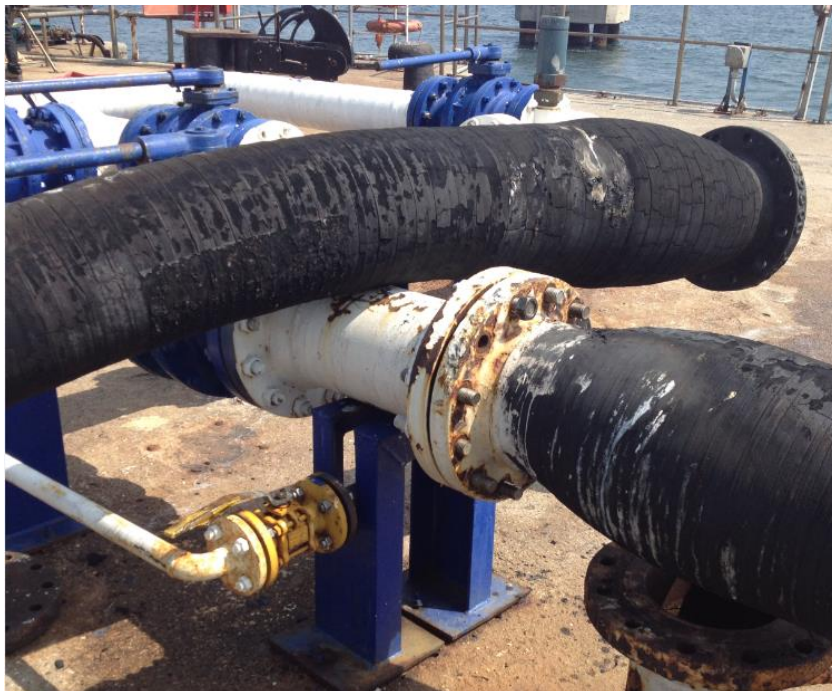
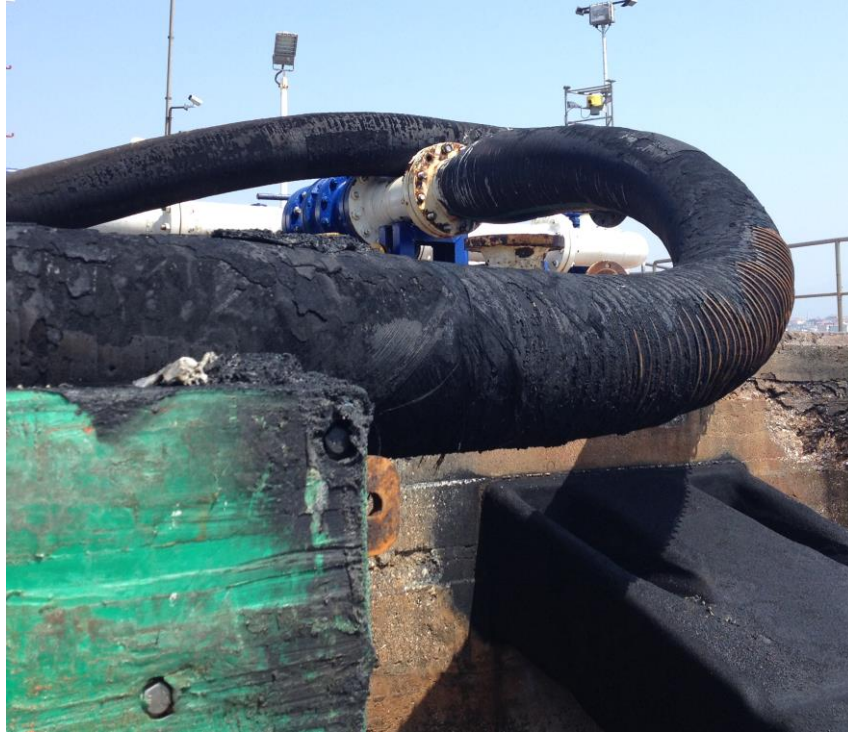
After the accident, when the pictures taken at the scene of the accident are examined, the cargo hose, which was used in the unloading of the vessel's cargo and taken to the platform after the unloading of the cargo was completed, was partially burned (Figure 14, 15, 16).

As it can be understood from the pictures taken after the accident, the black cargo hose was partially affected by the fire, while the other spiral hose of gray color was completely burned.

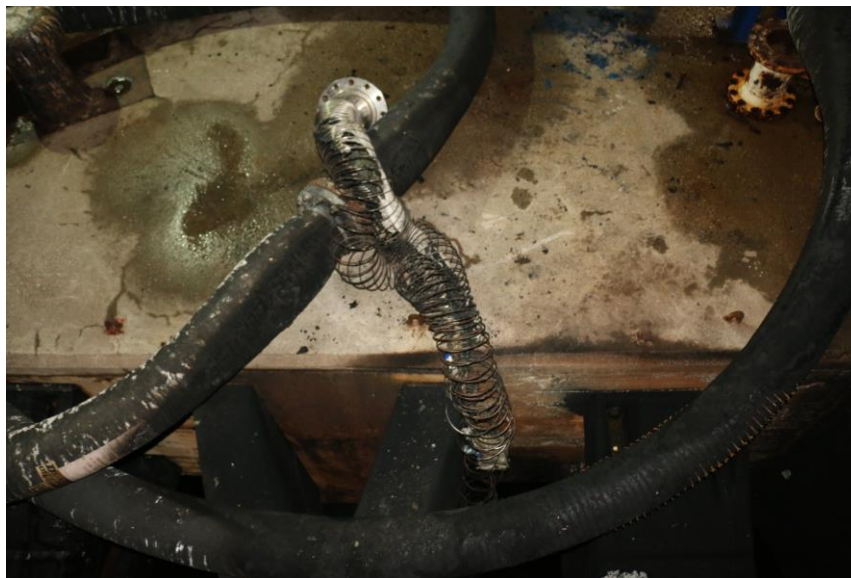
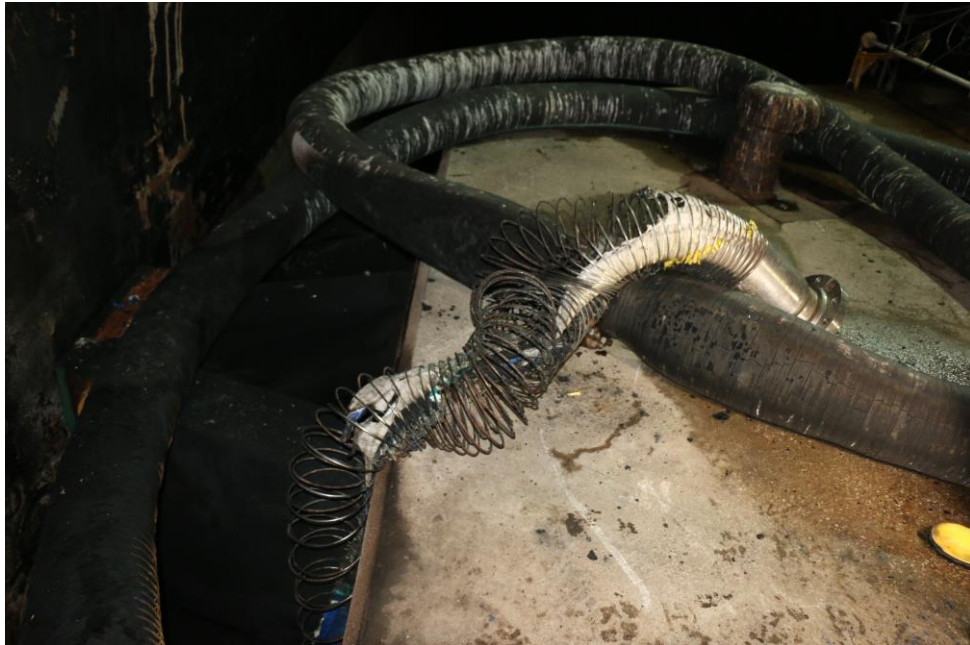
The gray colored spiral hose, which was stated by the casualty personnel and used for releasing the cargo/gas remaining in the tanks into the sea, was completely burned (Figure 17, 18).

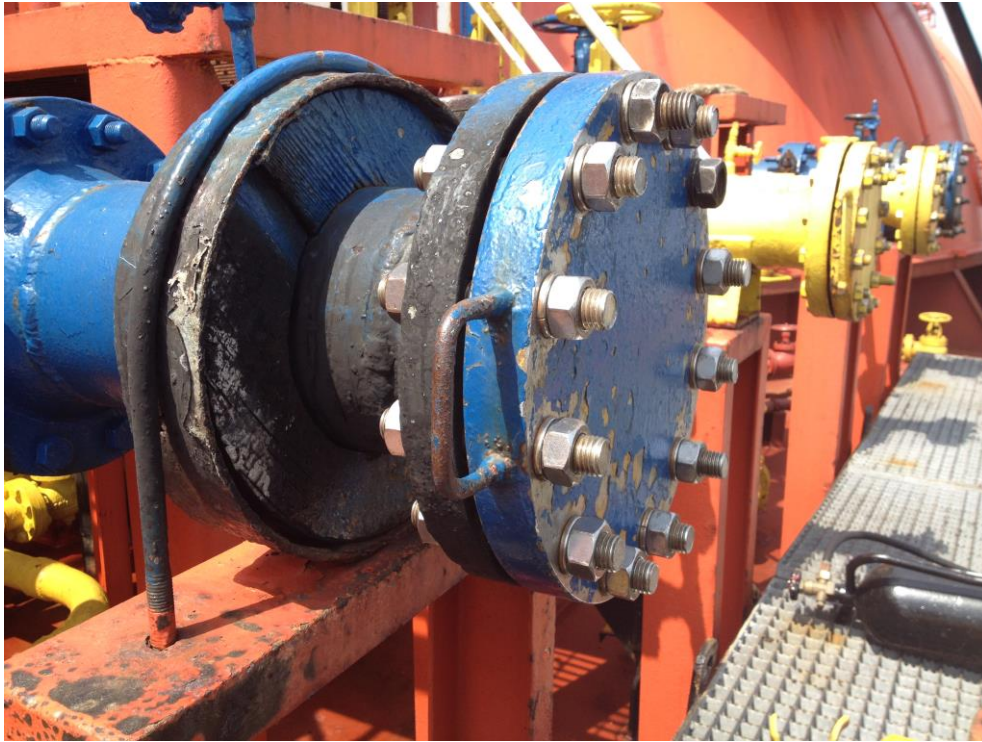
Figure 19: The Vessel's Manifold

2. The burn marks was observed on the vessel's manifold on the starboard side of the vessel where the fire took place, while there were no signs found regarding the fire on the blind flange of the manifold (Figure 19). This supports the statements of the casualties about that the gray flexible hose, which was connected to the vessel's manifold at the time of fire and that the manifold was not closed with a blind flange, contrary to the submitted documents and some of casualty's statements.

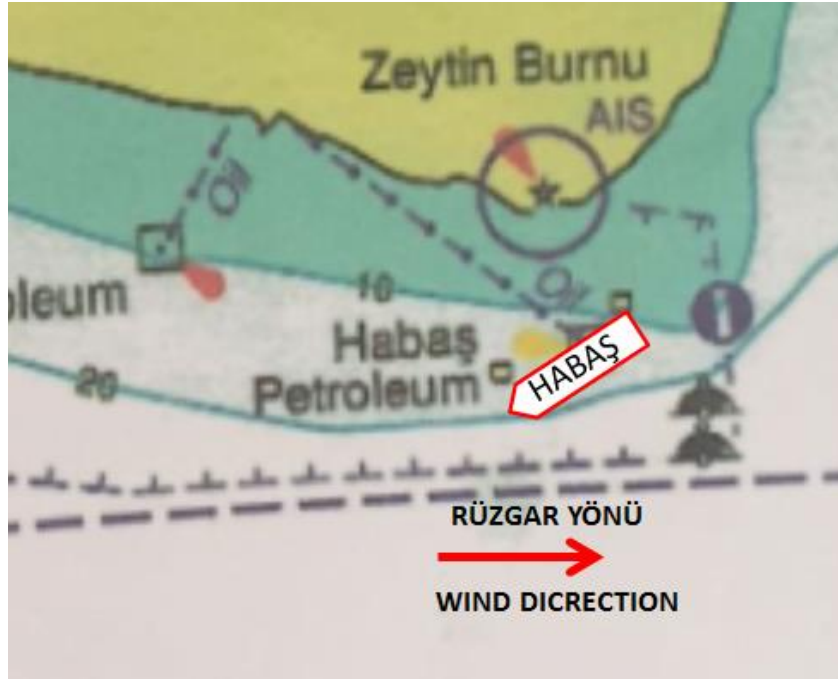
Figure 3: Wind Direction on the Day of the Accident

It is considered that when the wind speed is lower than 9 km/h (5 miles/hr), and when it is considered that the wind is not able to take away the flammable/toxic gases, the present meteorological conditions allowed the LPG cloud to stay above the water and close to the vessel (*Figure 3*).

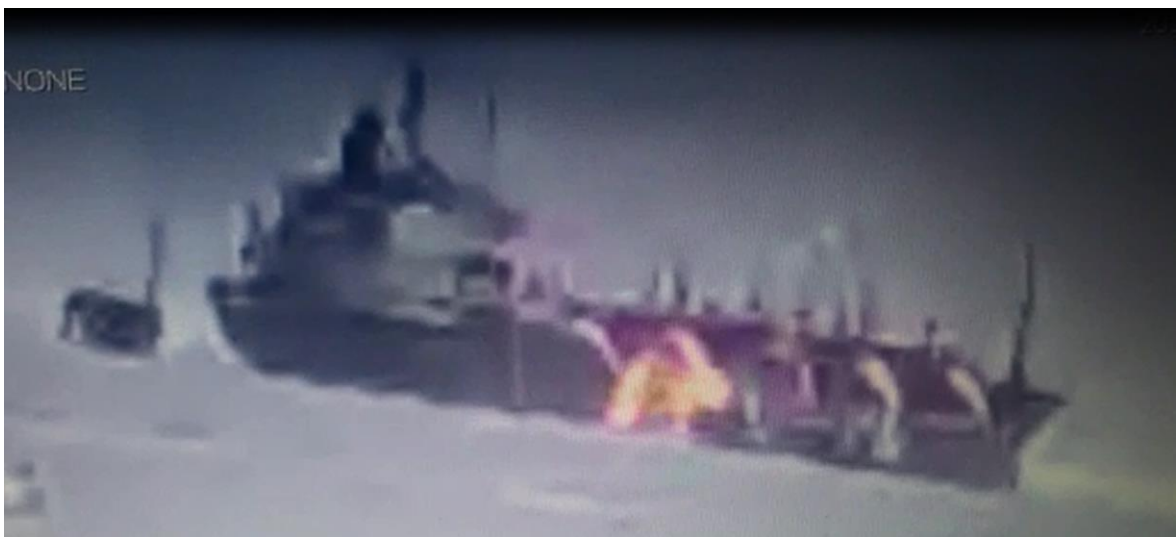
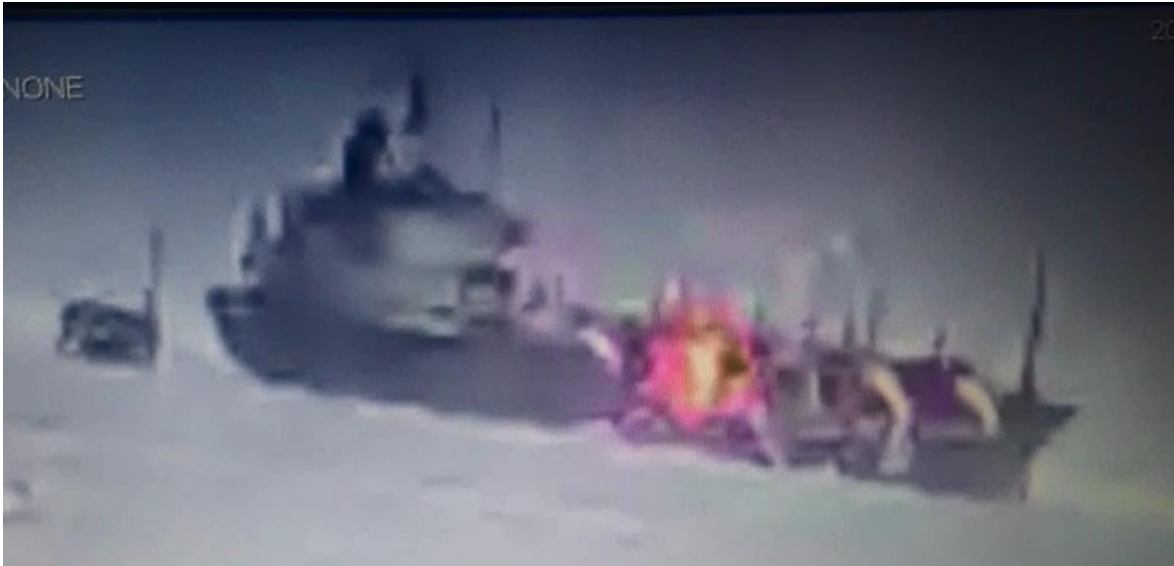
Immediately after the explosion, a fireball arose from the sea surface towards the vessel's deck (*Figure 20, 21*).

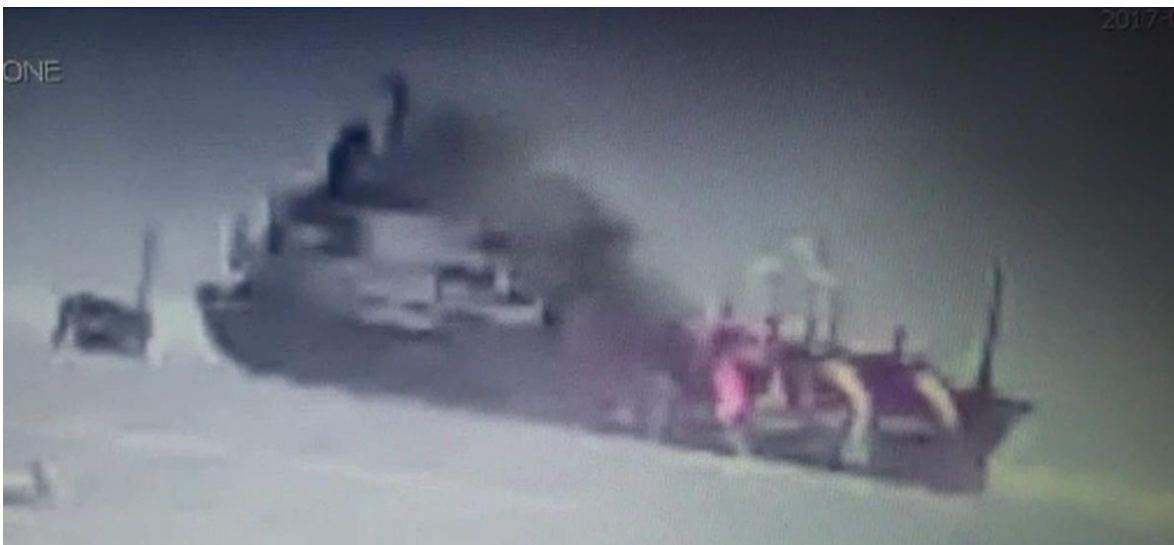
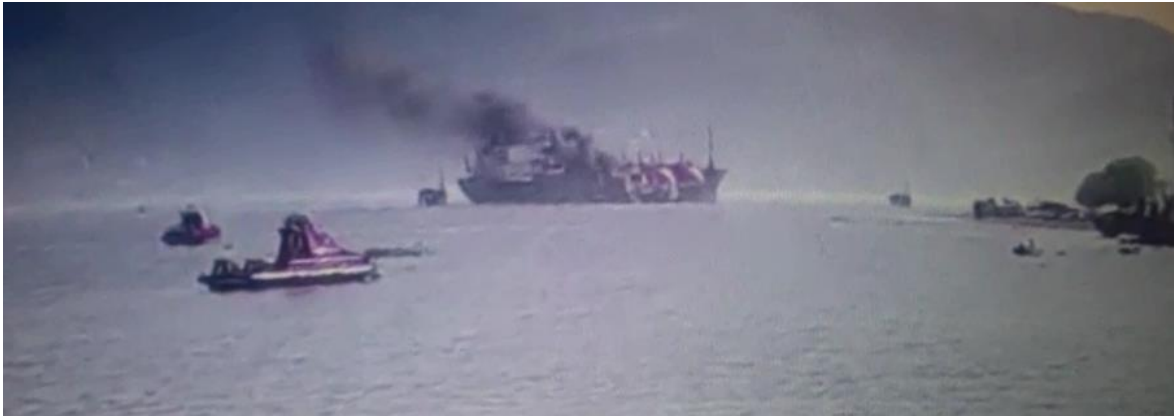
As the gas in the environment run out, flames which could be seen from far away reduced after seconds. The fire that started on the vessel's side caused the vessel's paint, the gray-colored spiral hose attached to the vessel and the rubber platform fenders to catch fire. After a short time, the fire grew and the bare flames began to be accompanied by a dark black smoke (*Figure 22, 23*).

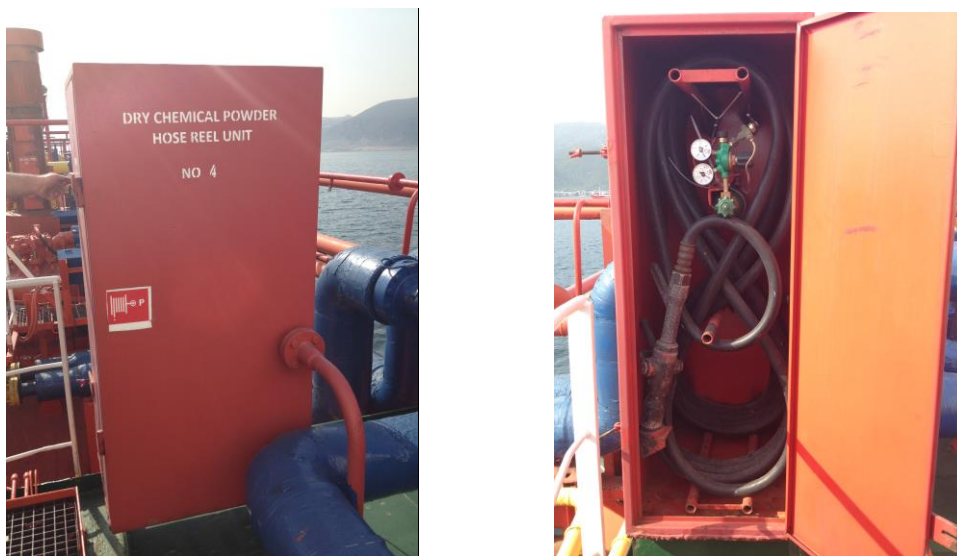
Figure 24,25: Fixed Dry Chemical Powder Firefighting System

fire extinguishing system, emergency fire line and portable fire extinguishers. All systems are shown in the Fire Control Plan (Annex-2). With the fixed dry chemical powder fire extinguishing system on the deck (Figure 24, 25), it is possible to carry out an effective firefighting. However, since fire extinguishing operations lacked a good planning, this system was not used in fire extinguishing operations and some of the ship's crew could not participate in fire extinguishing operations.

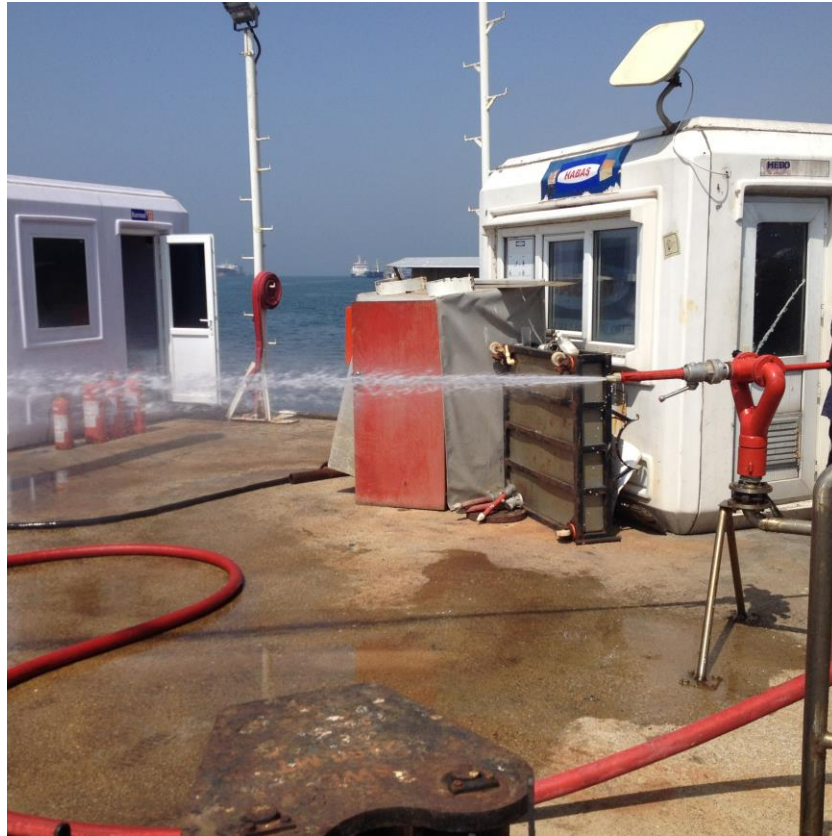
Figure 26 : Water Cannon Used in Firefighting Operations

The platform attendant, who got out from the cabin in the platform with the sound of the explosion, operated the fire pump on the platform. The platform officer first tried to support the firefighting operations by spraying water with the help of the water cannon (Figure 26) first towards the place which the smoke was coming from and then to the burning agent boat. Upon seeing that the burning agent boat moving away from the vessel, he tried to extinguish the ongoing fire on the platform fenders and the cargo unloading hose.

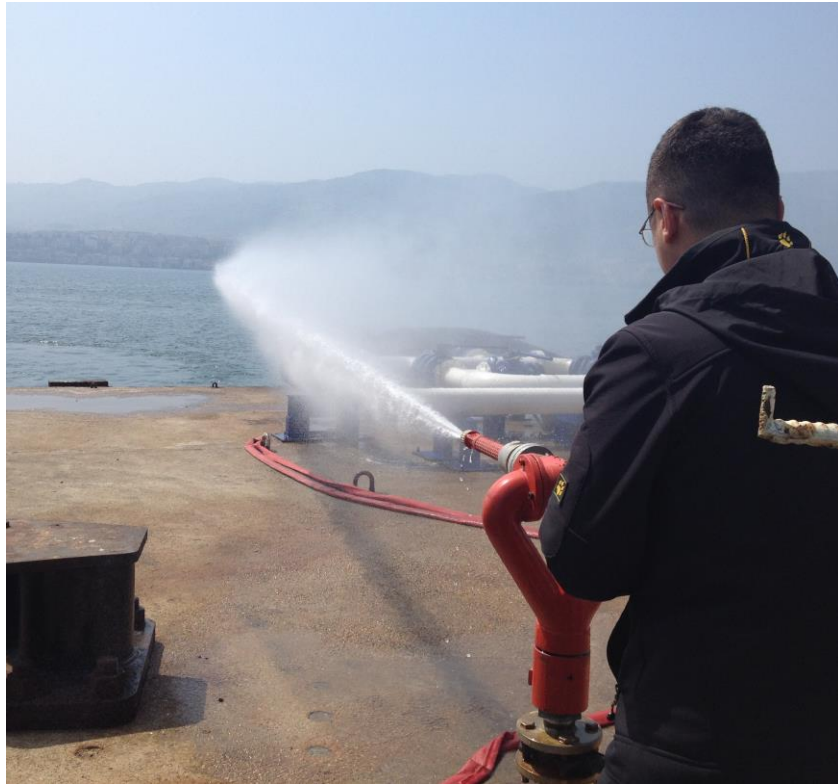
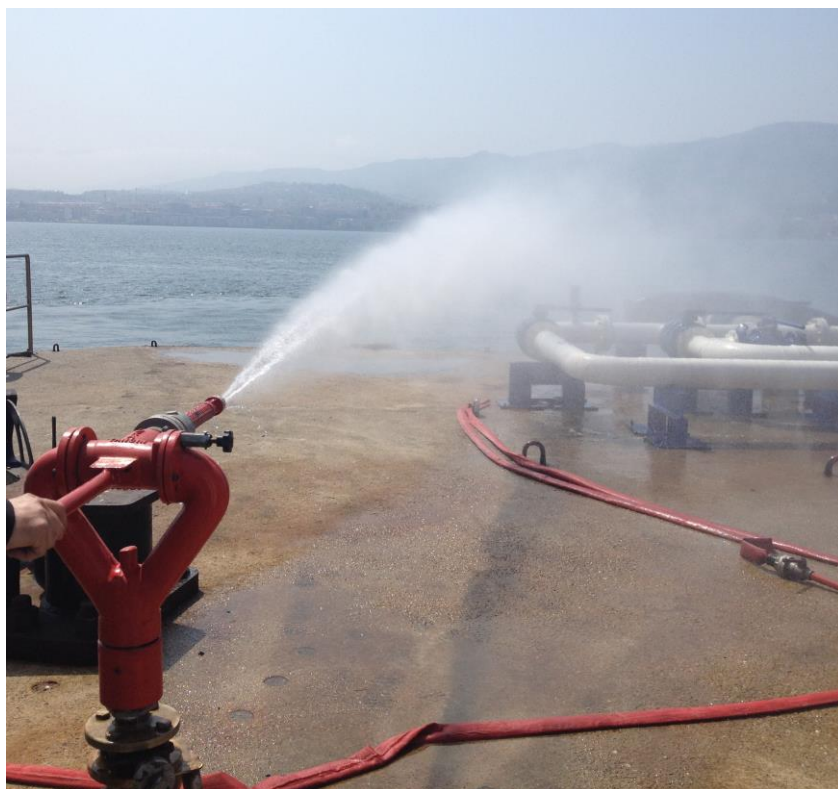
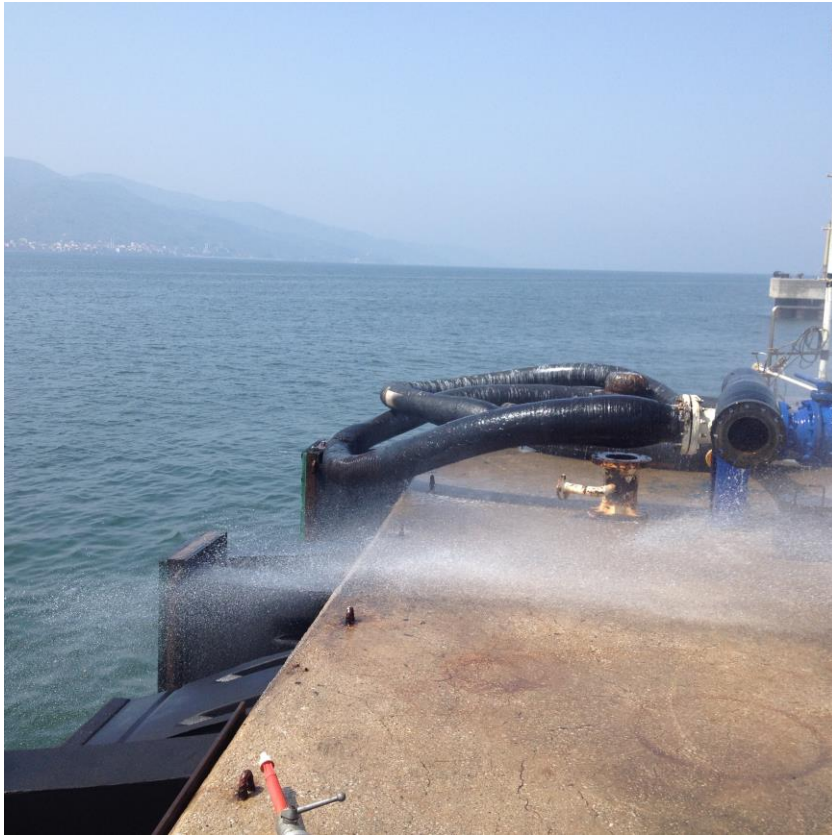
Within the scope of the examinations at the scene of the accident after the accident, the platform was also examined. In these examinations, the fire pump was operated to see the range of spraying water of the water cannon on the platform (Figure 27, 28, 29). The water coming out of the fire extinguishing cannon can reach from its place to the edge of the platform where the vessels approach. It is designed not only to respond to the fires on platform, but also to fires that break out onboard vessels. It is considered that the water cannon was insufficient in firefighting operations with both its range and its low pressure.
