## FINAL MARINE SAFETY INVESTIGATION REPORT

**NAME OF THE SHIP** : HC JETTE MARIT  
**IMO NUMBER** : 9509255  
**FLAG** : ANTIGUA AND BARBUDA  
**LOCATION OF ACCIDENT** : TEKİRDAĞ PORT  
**DATE OF ACCIDENT** : 30.12.2018 / 15:20 (GMT +3)  
**FATALITY/INJURY** : 1 / -  
**DAMAGE** : -  
**POLLUTION** : -

*Committee Decision No: 18/DNZ - 5/2021*

*Date: 16/08/2021*

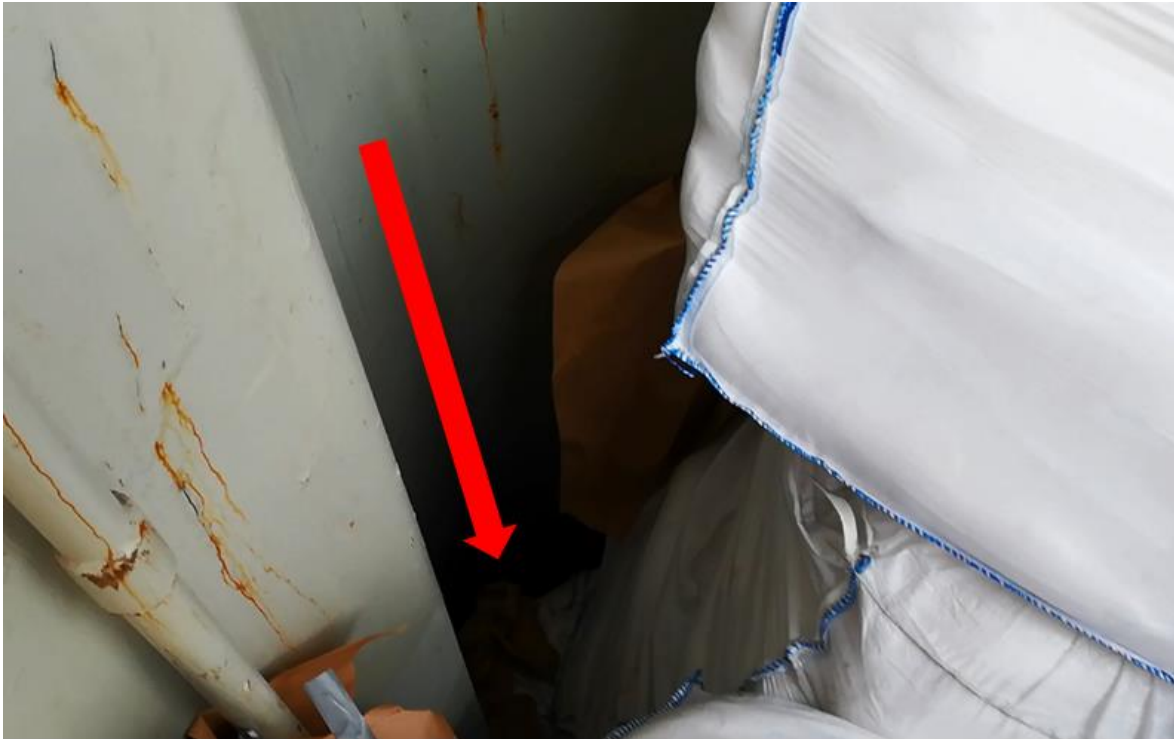
The gap where the casualty had fallen down was 5 big bag height, approximately 6 meters (one big bag height is 1.2 meters). The crane operator of the vessel went down by about 3.6 meters into the gap where the stevedore had fallen and checked whether he could pull the stevedore out there (Photo 5). When the crane operator realized that it was not possible to pull the stevedore out of the gap where he had fallen only by himself, he climbed up and sought help from other stevedores. Other stevedores and workers who had been attaching the cargo to the slings on the trucks on the shore subsequently went down the hold.

Photo 5: The Gap Where the Casualty Fell

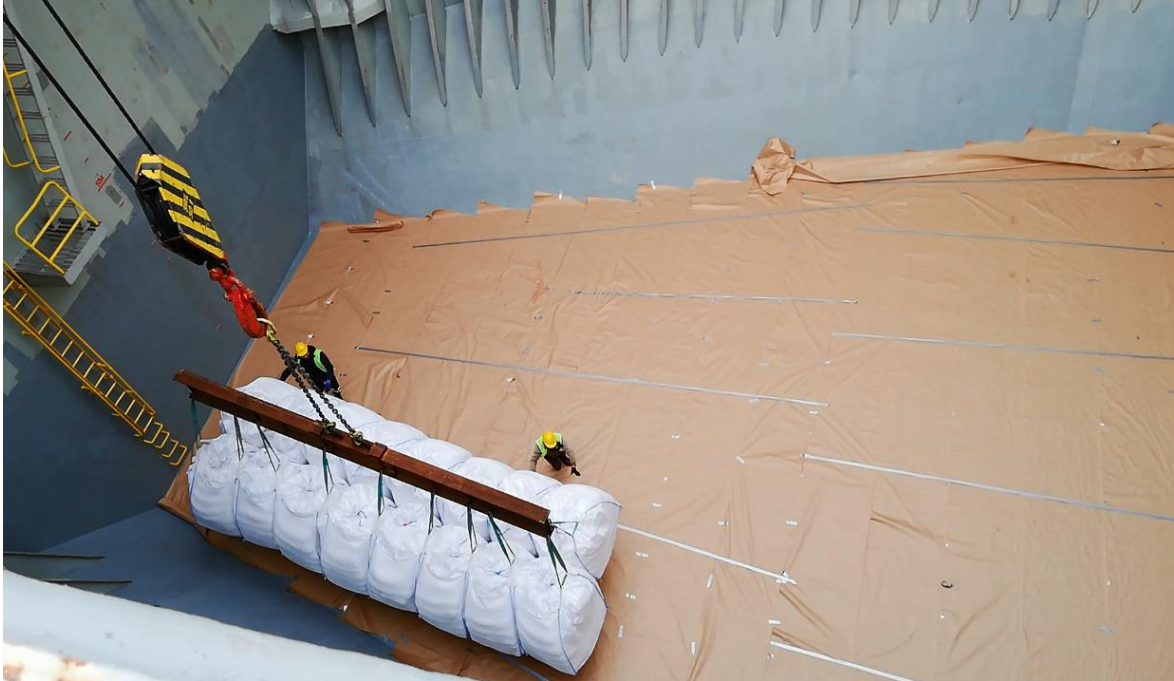
Brown papers are attached to the wings of hold, fore and aft bulkheads and the bottom of the hold to avoid moisture within the hold and the resultant dampness from spoiling the wheat flour during navigation (Figures 8, 9, 10).

Photo 8: Photo of the Lowering Down of the Cargo Inside the Cargo Hold and Paper Attached to the Bottom of the Hold

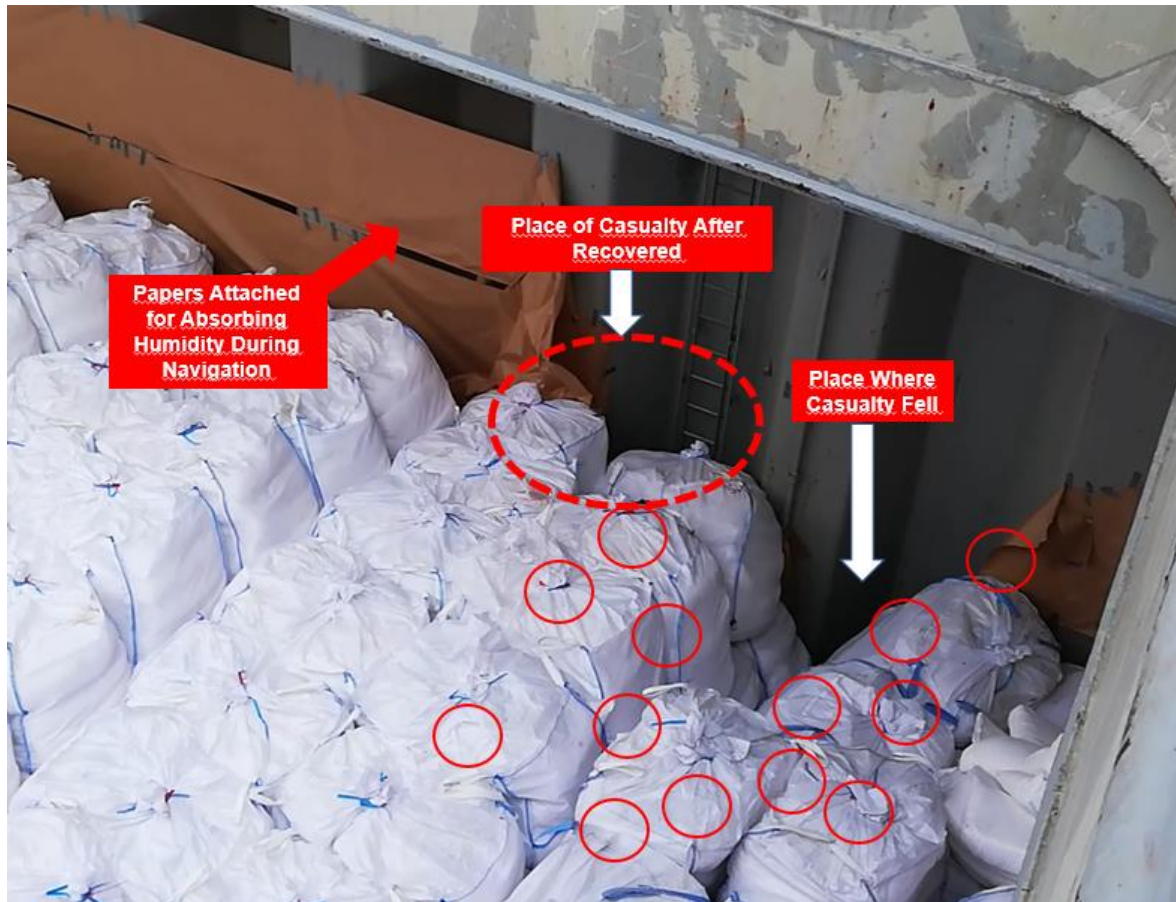
When hold #3 was entered for accident investigation, it was found that the big bags to be loaded and the blue/white coloured grips that are used to attach the bags to the cargo slinger frequently caused the problems of tripping when moving inside the hold. This was considered to be the main cause for the stevedore to fall into the gap inside the hold (Photo 9).

Photo 9: Blue/White Coloured Grips that are Considered to be the Probable Cause for the Fall of the Casualty

**4.4** Although the exact cause of falling down of the casualty into the gap between the big bags and bulkhead was not clearly known, it was most likely that he fell down by being tripped to the grips of big bags or by the holding reflex to the papers that were attached on the aft bulkhead.

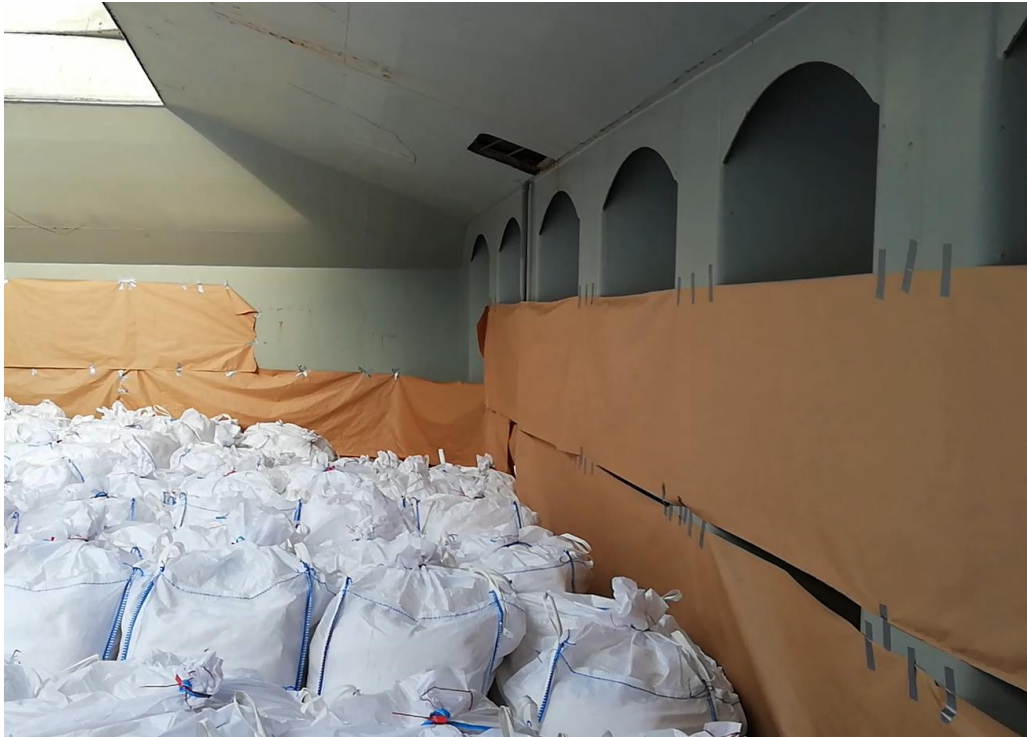
On the other hand, it was reported during the accident investigation that the stevedore fell down with the paper that was attached to absorb moisture from the cargo. The gap in which the casualty fell down was covered with paper, attached on the aft bulkhead to absorb moisture from the cargo (Photo 9, 10). This suggested that the casualty might have tried to hold on to paper with reflex or might have leaned on paper, assuming that there was support behind the paper, while he was falling by being tripped to the grips of big bags. As such, failure to attach the paper without leaving any space on the bulkhead of the hold was considered to be another factor contributing to the accident.

Photo 10: Papers Attached for Absorbing the Humidity of the Cargo

**4.2** The paper that was attached on the wings and aft/fore bulkheads of the hold to absorb moisture from the cargo that may form during navigation was attached by leaving spaces due to the indented form of the aft bulkhead.

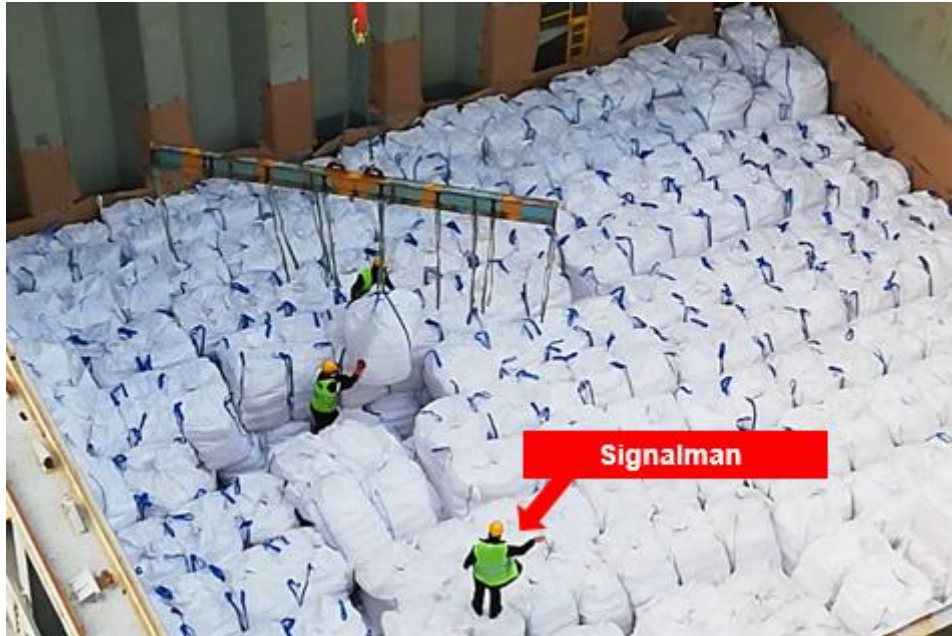
During loading, the two stevedores at hold # 3 are assigned for the proper stacking of cargo in the ship's cargo hold and for removing the grips of the loaded cargo that are attached to the slings. A crane operator is also responsible for taking the cargo that is brought to the shore by the ship's crane and lowering them down the ship's hold properly. The loading operations were monitored and two stevedores and a signalman in contact with the crane operator were noted to be inside the hold during the on board accident investigations on 4

January 2019 following the accident (Photo 11). During the accident, however, no signalman was present for communication and coordination between the stevedores who were working inside the hold and the ship's crane operator.

Photo 11: Signalman who Guides stevedores and Enables the Coordination with the Crane Operator

**4.9** There was no signalman present to enable communication and coordination between the stevedores and the crane operator at the time of the accident.

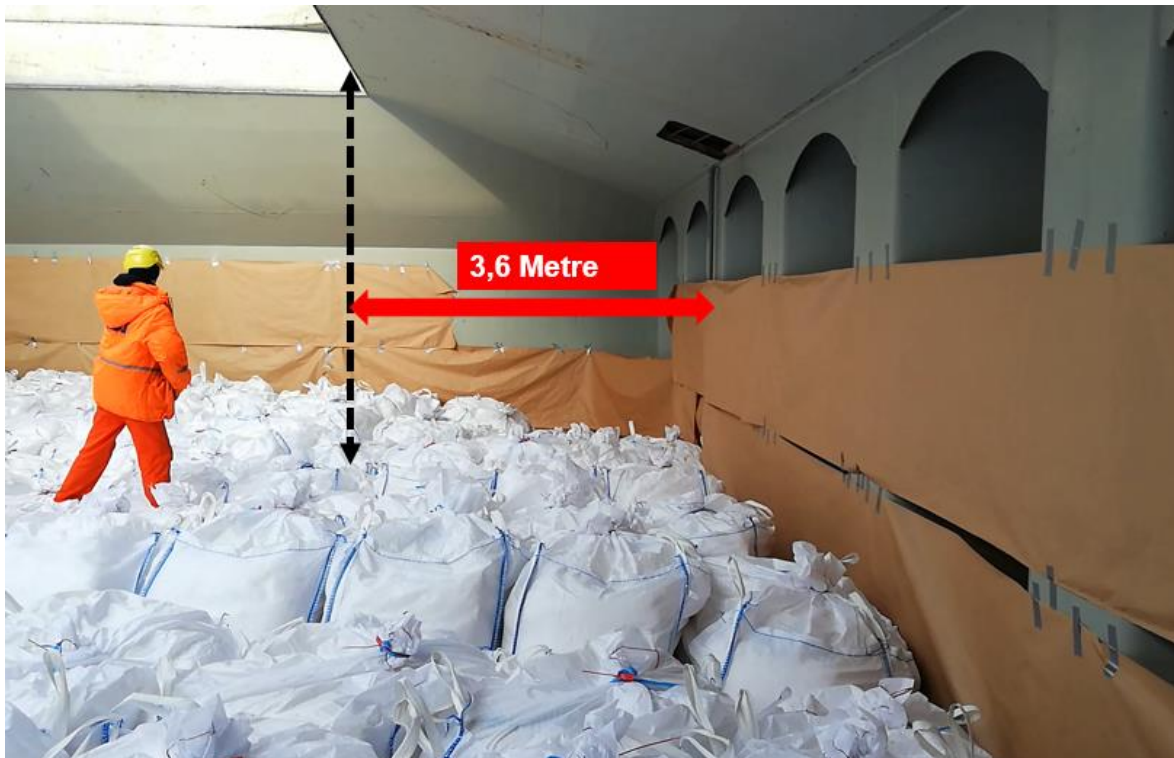
The accident took place while the stevedores were loading the section underneath the hold coaming (Photo 12). Under normal circumstances, it is necessary to establish healthy communication between the stevedores inside the hold and the crane operator during such loading and to keep a signalman available for the communication between the stevedore and the crane operator. Since there was no signalman at the time of the accident, the stevedores inside the hold tried to communicate with the crane operator while loading on the other hand. This was considered to be another factor that distracted the essential concentration of the stevedores on loading at the time and thus, contributed to the accident.

Photo 12: Distance between the Hatch Coaming and the Aft Bulkhead of the Hold

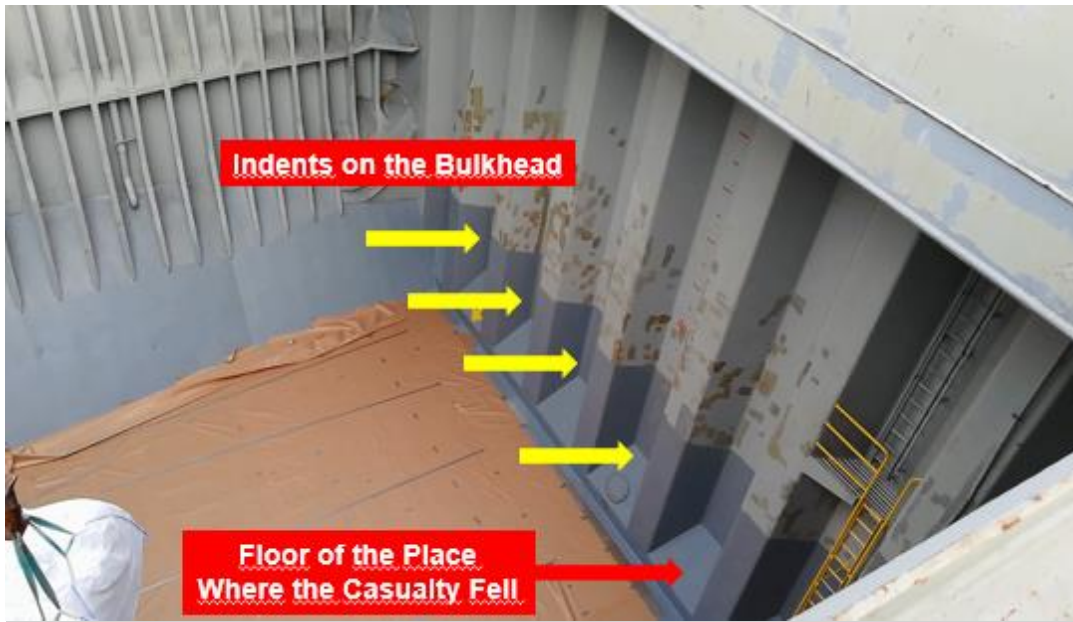
Pictures 13 and 14 show the brown papers said to be attached to absorb the moisture of the flour bags loaded inside the hold. Since the hold bulkheads are indented (Photo 13), some part of the bulkheads were in full contact with the paper, and on some part there were spaces behind, such as the gap where the casualty had fallen. Since this paper did not fully touch the entire aft bulkhead, it was considered to give an impression of imaginary support behind it, even if the back of the paper did not contact the bulkhead and normally there was a gap. This illusion suggested that it might be a factor contributing to the falling of the casualty together with the paper when he was falling down into a gap probably caused by being tripped over the grips of big bags. This illusion suggested that it might be a factor contributing to the falling of the casualty together with the paper when falling down into a gap probably caused by being tripped over the grips of big bags. In this context, it is considered that papers, attached with the aim of absorbing the humidity of the cargo, should have been attached to the bulkhead, so that there would be no gaps between.

Photo 13: Indents at the Bulkhead and Bottom of the Hold Where the Casualty Fell

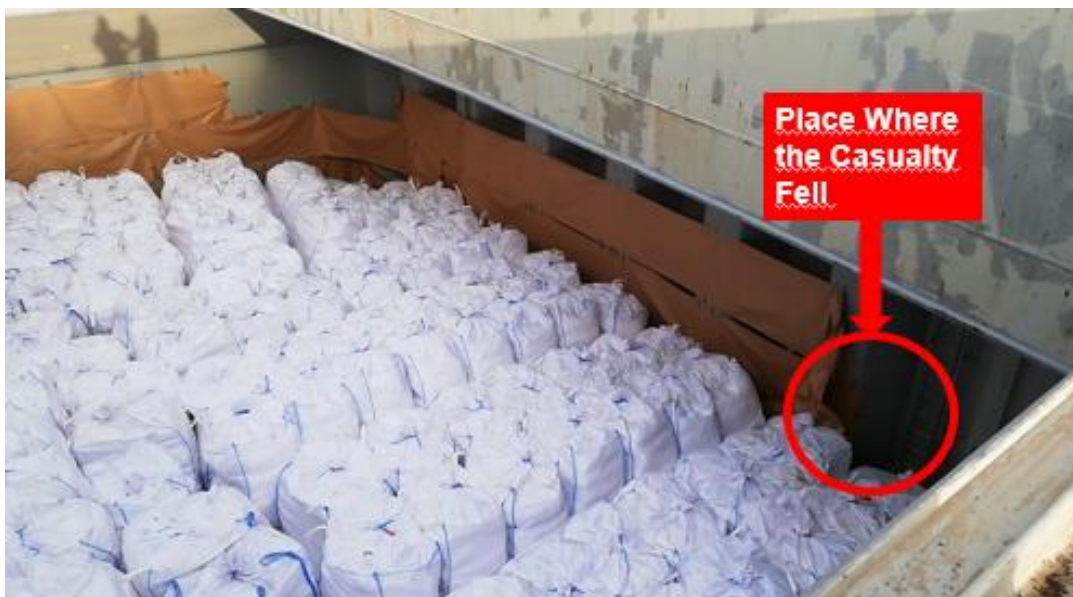
Photo 14: View of the Place from the Hatch Coaming Where the Casualty Fell

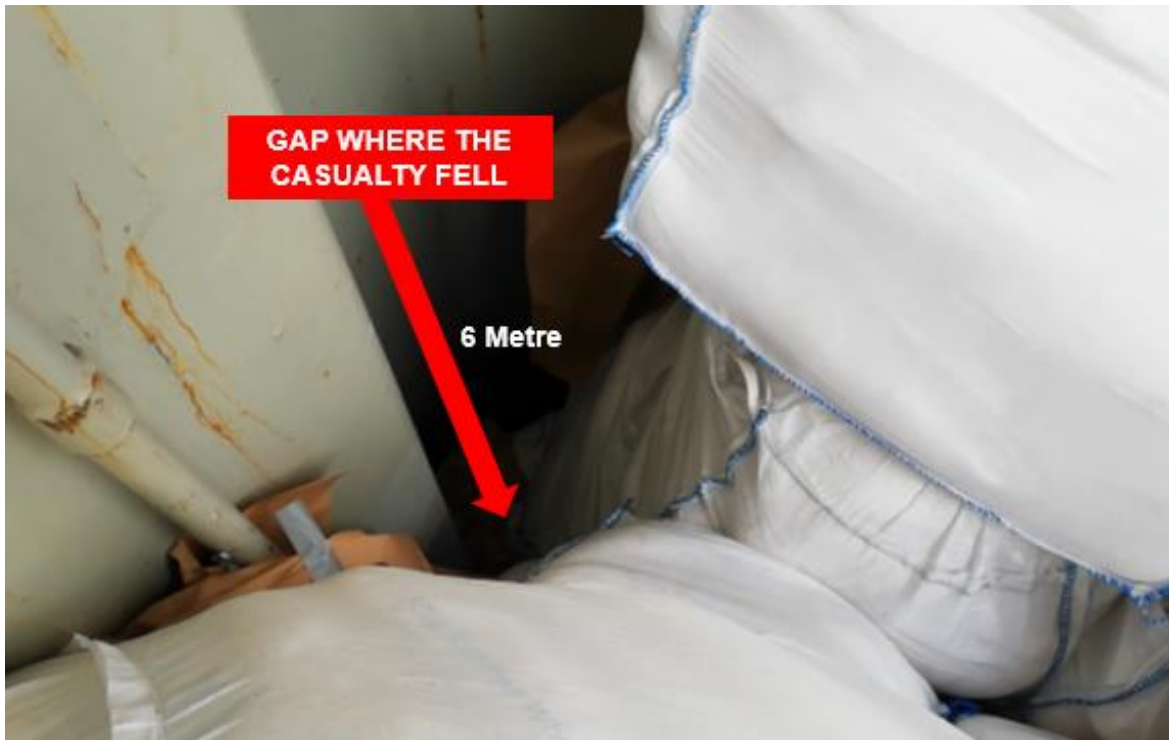
Photo 15: The Place Where the Casualty Fell

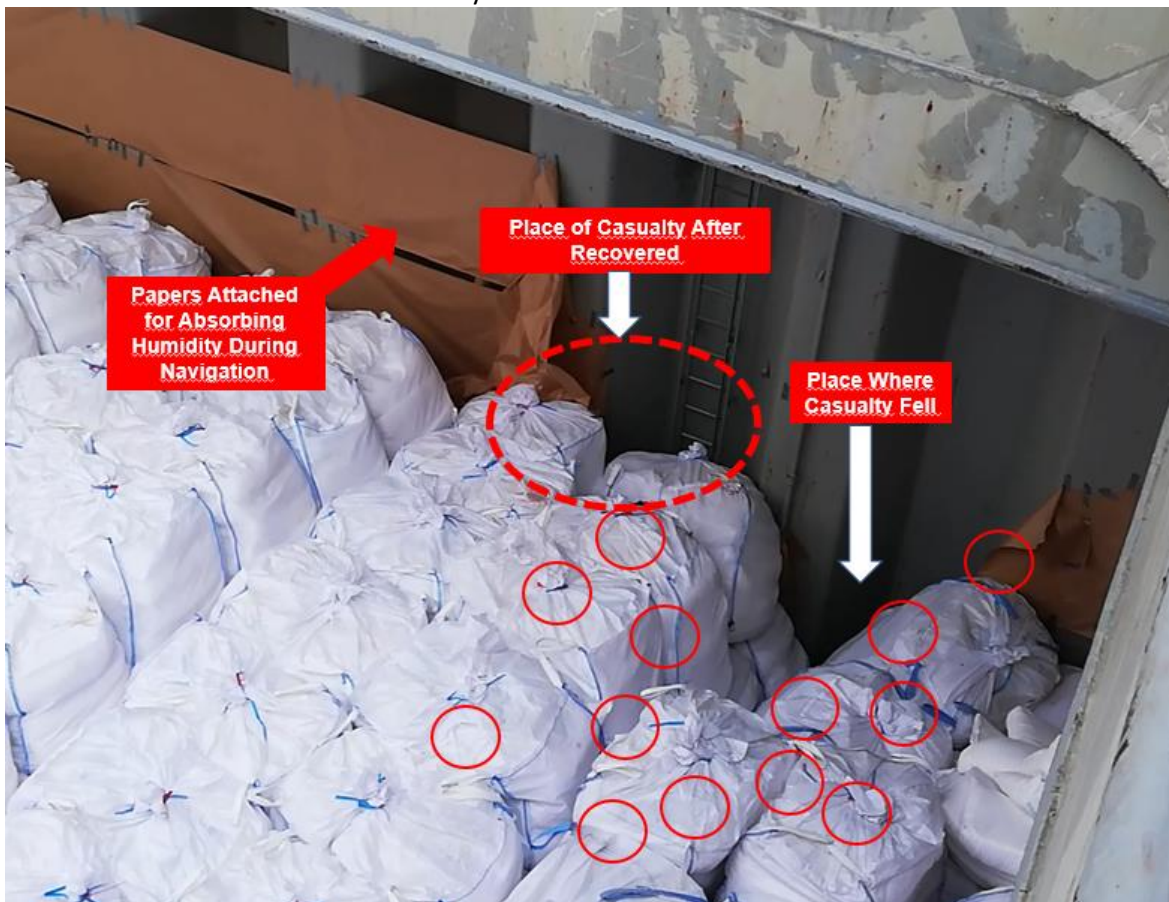
Photo 16: The Gap Where the Casualty Fell and the Grips of the Big Bags
