MARINE SAFETY INVESTIGATION REPORT

OWNER/IMO NO : İLHAN YILMAZ 5/ 9892638

LOCATION OF ACCIDENT: Nouadhibou/MORİTANYA

DATE OF ACCIDENT : 26.11.2019/13:00 Lt

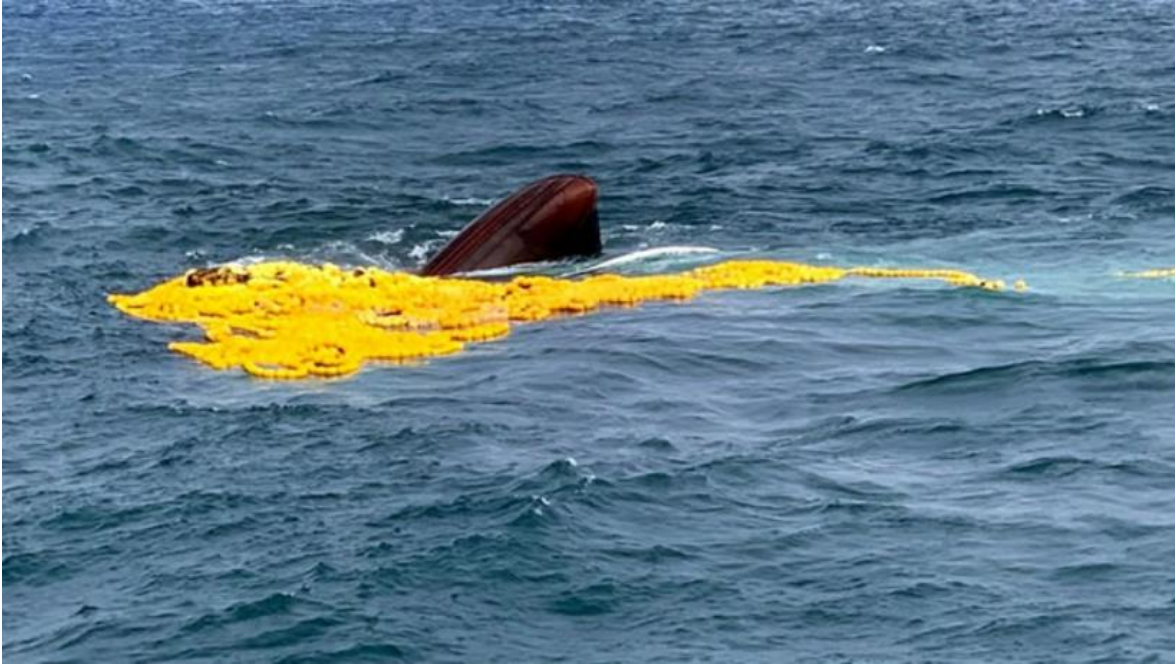
Image 3: Sinking of İlhan YILMAZ-5

As a result of the investigations, the vessel lost stability and sank as the water flooded into the fish hold and the accommodation whose hatches were open at the bad weather and sea conditions.

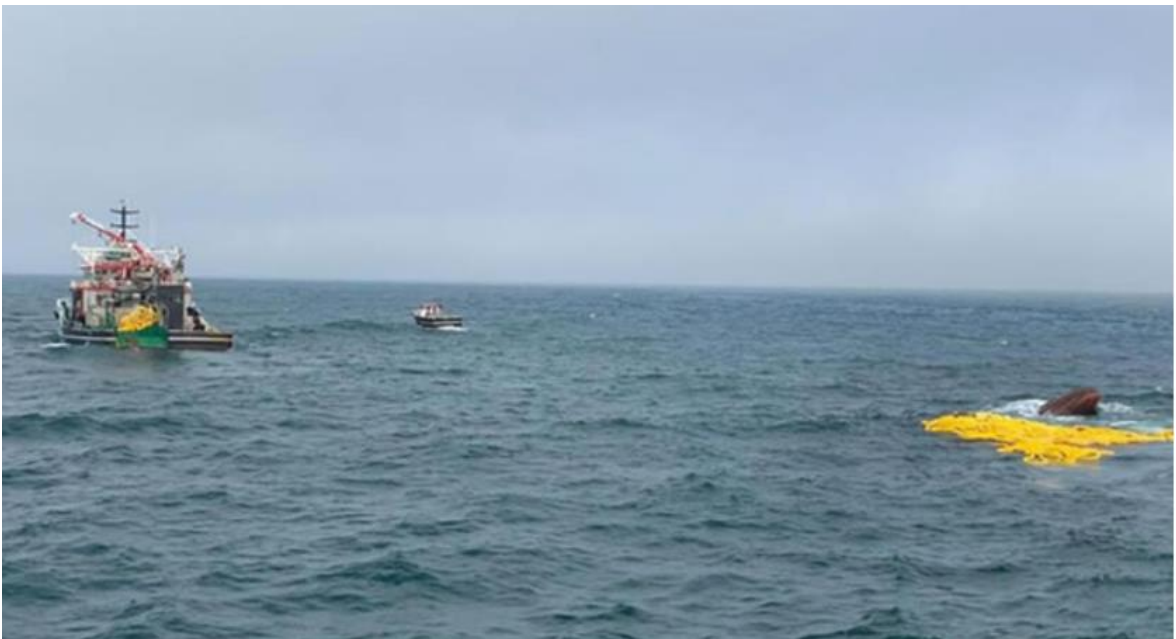
Image 4: View of The Vessel at The Time of Sinking

As the stem of the vessel submerged, the water heavily intruded through the open hatches on the stem, respectively, fish holds, accommodation and the engine room.

The crew tried to drain out the heavy seawater that was accumulated inside the fish holds through the portable and fixed pumps, but the amount of seawater that intruded into the holds was over the capacity of the pumps to drain the seawater out, they failed to do so and they also couldn't prevent the subsequent water intrusions due to the lost trimming of the vessel. Rapid water intrusion into the vessel led the crew towards the rescue boat on the aft. Launching the rescue boat that was located at the endpoint of the sternpost caused the vessel, trimmed by the head, to be trimmed further by the head and made it easy for the vessel to take water in through the foreside and to sink. Besides, setting the engine full speed ahead also expedited the vessel, trimmed by the head, to sink.

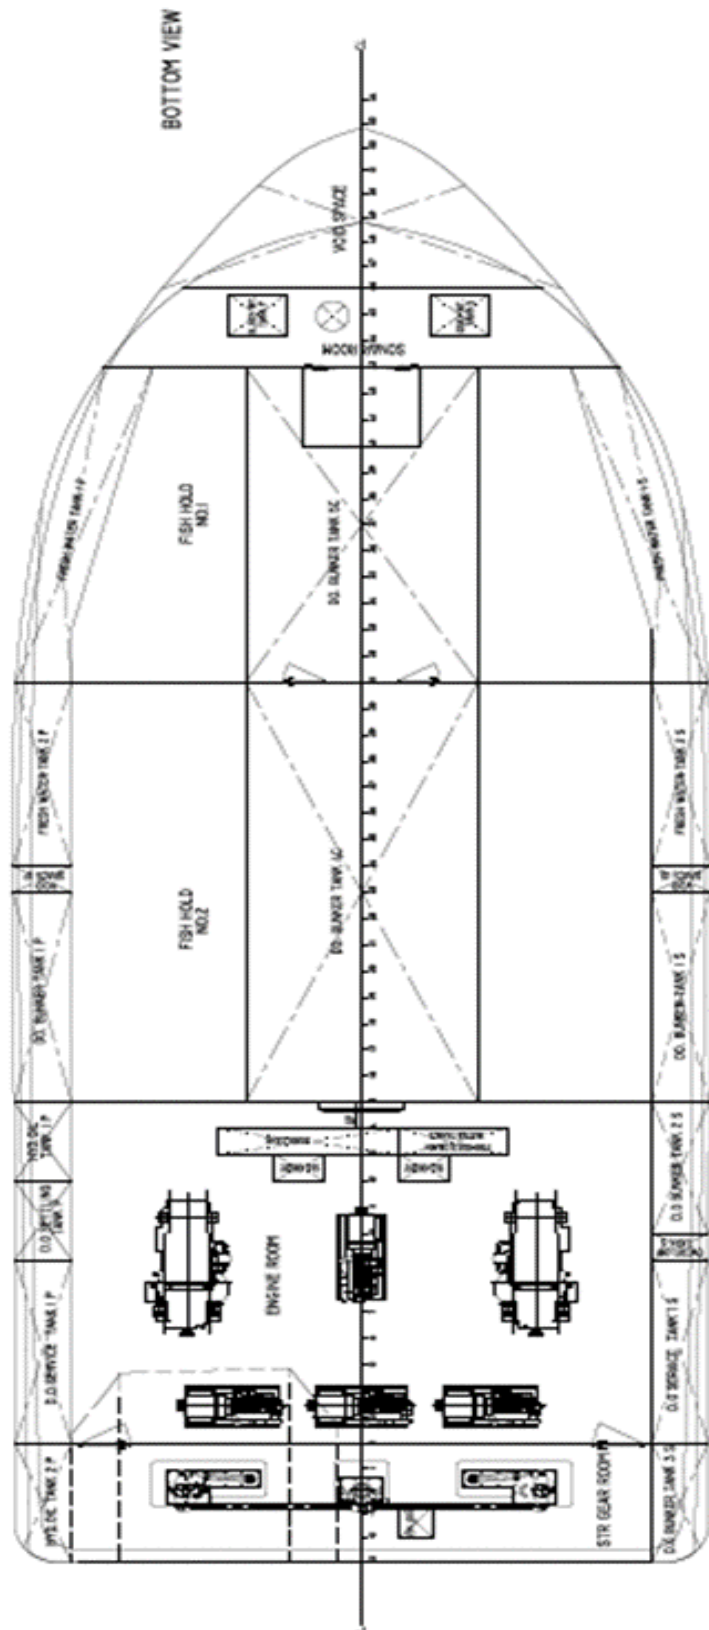
Image 5: Bottom Tank Plan of the Vessel

The hull of the vessel was built under the Accredited Class Rules. There are two fish holds of 70 tons on the stem and two fish holds of 30 tons from the midship towards the stern. The total capacity of the fish holds on the stem is 140 tons and about half of these holds were filled with 60 tons of fish and the other half was empty. The vessel sailed as the hatch covers of the fish holds on the stem, accommodation doors and the engine room hatches open due to high temperature in the navigation zone and exposed to high waves.

9. The cargo was loaded in the largest tank no. 1, which has the greatest Free Surface Moment, instead of tank no. 2, which is the most eligible for stability and has the lowest Free Surface Moment. The increased trim by the head through the water intrusion into the Tank no.1 and the loss of stability due to FSM raised the risk of a vessel sinking.

To prevent the stability loss in consequence of endangering the buoyancy of the vessel and the trim of the vessel by the head in case of any damage to or filling water into the large fish holds, it's safer to locate large fish holds on the aft side instead of the foreside.

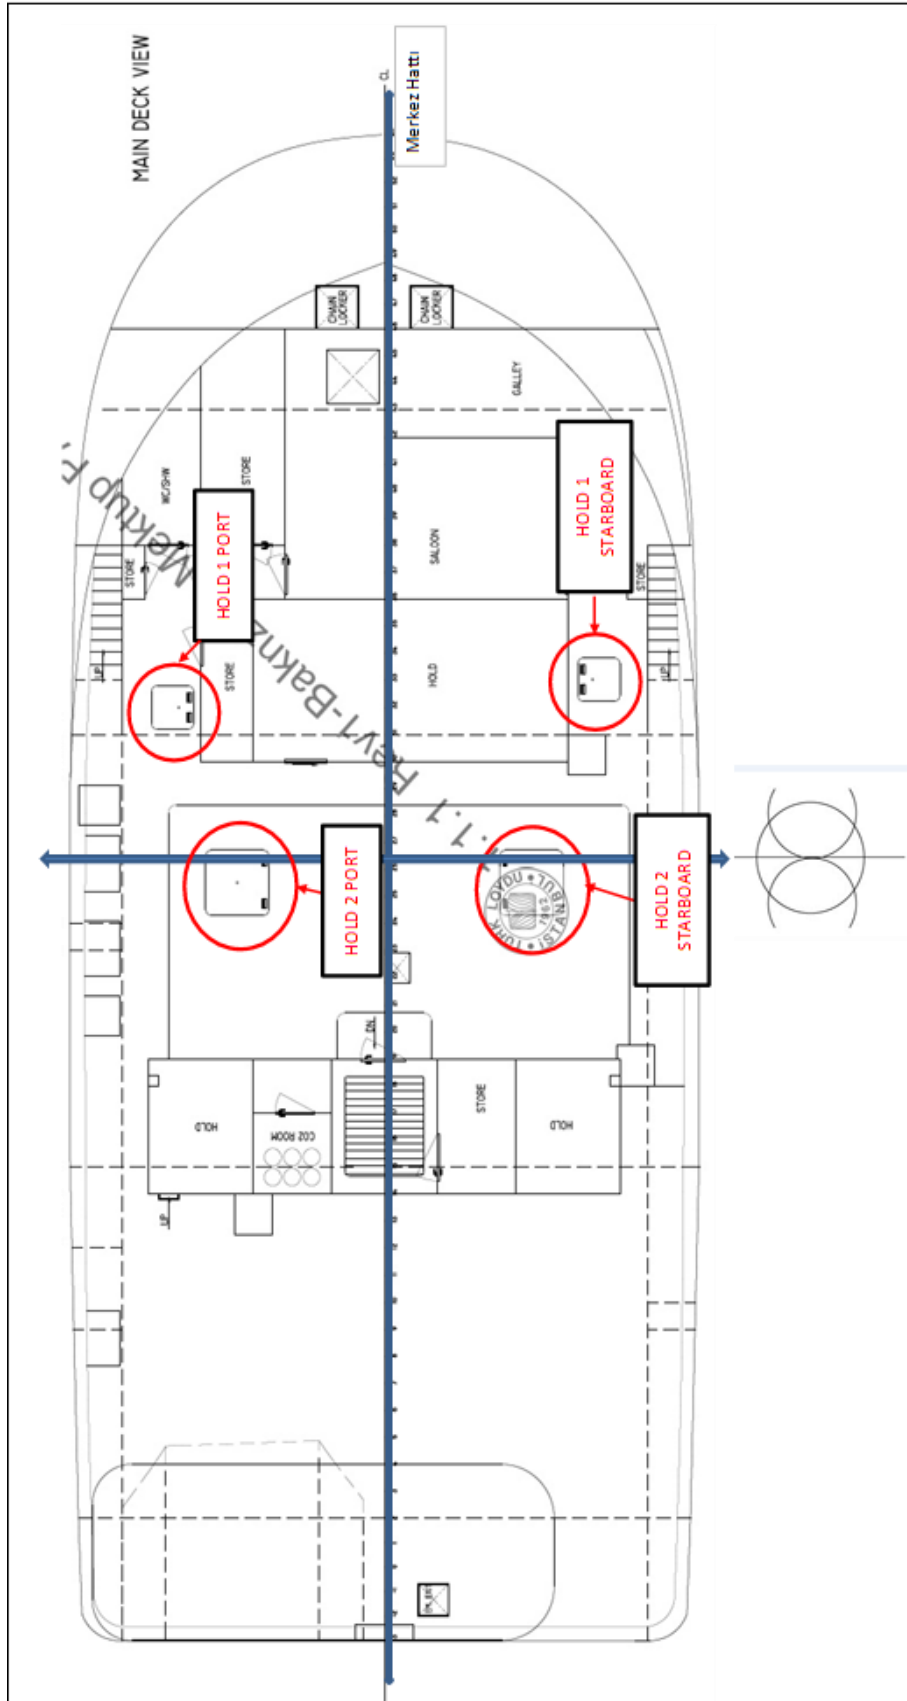
Image 6: Main Deck Plan of the Vessel

2. It appeared that the hatches and holes on the stem and the ports close to the side increased the risk of water intrusion and weakened the ability of the vessel's stability due to the exposure of the vessel's stem to heavy waves.

Locating the hatches and the holes on the aft side and close to the centreline due to the exposure of the vessel's stem to heavy waves is a safer condition for its seaworthiness to prevent the vessel from taking in water.
