**Accident Investigation Report On**  
**The Foundering of KURT C**

**Off Kaleiçi Port / Antalya**

**03 September 2016**

**36/DNZ-05/2017**

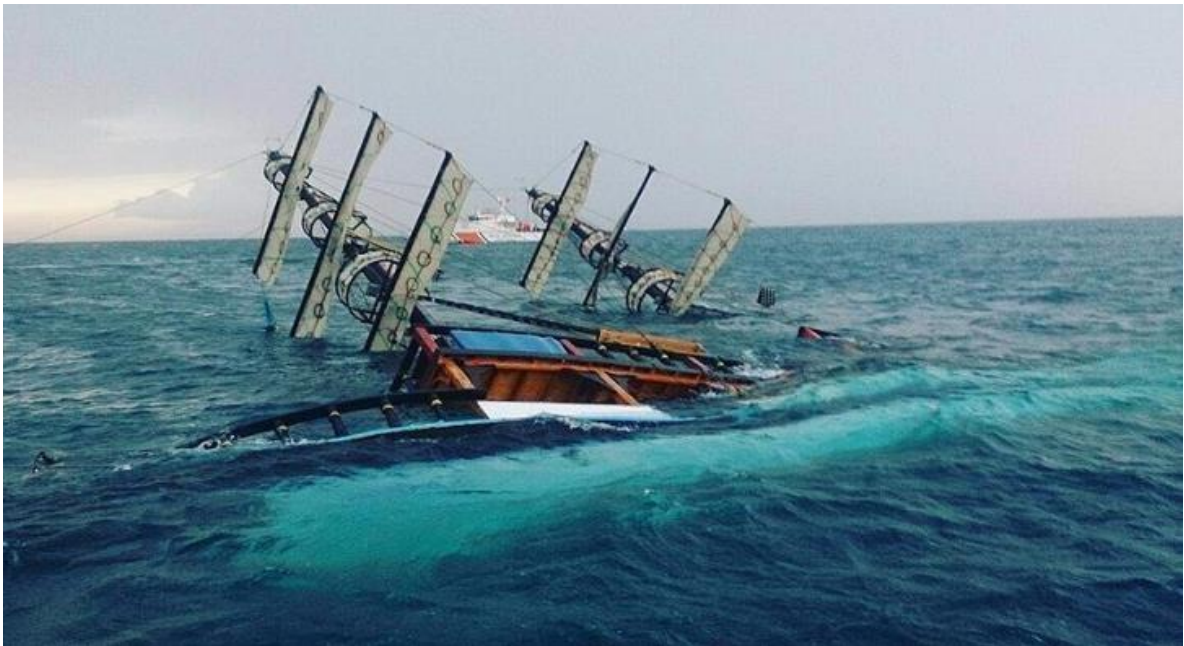
Figure 8: KURT C, in her toppled position.

In this accident, KURT C toppled to her starboard side at such an angle that was too big for her to be able to become upright again and due to the magnitude of the leaning angle, fell into an unstable equilibrium, and as a result could not become upright again and sank.

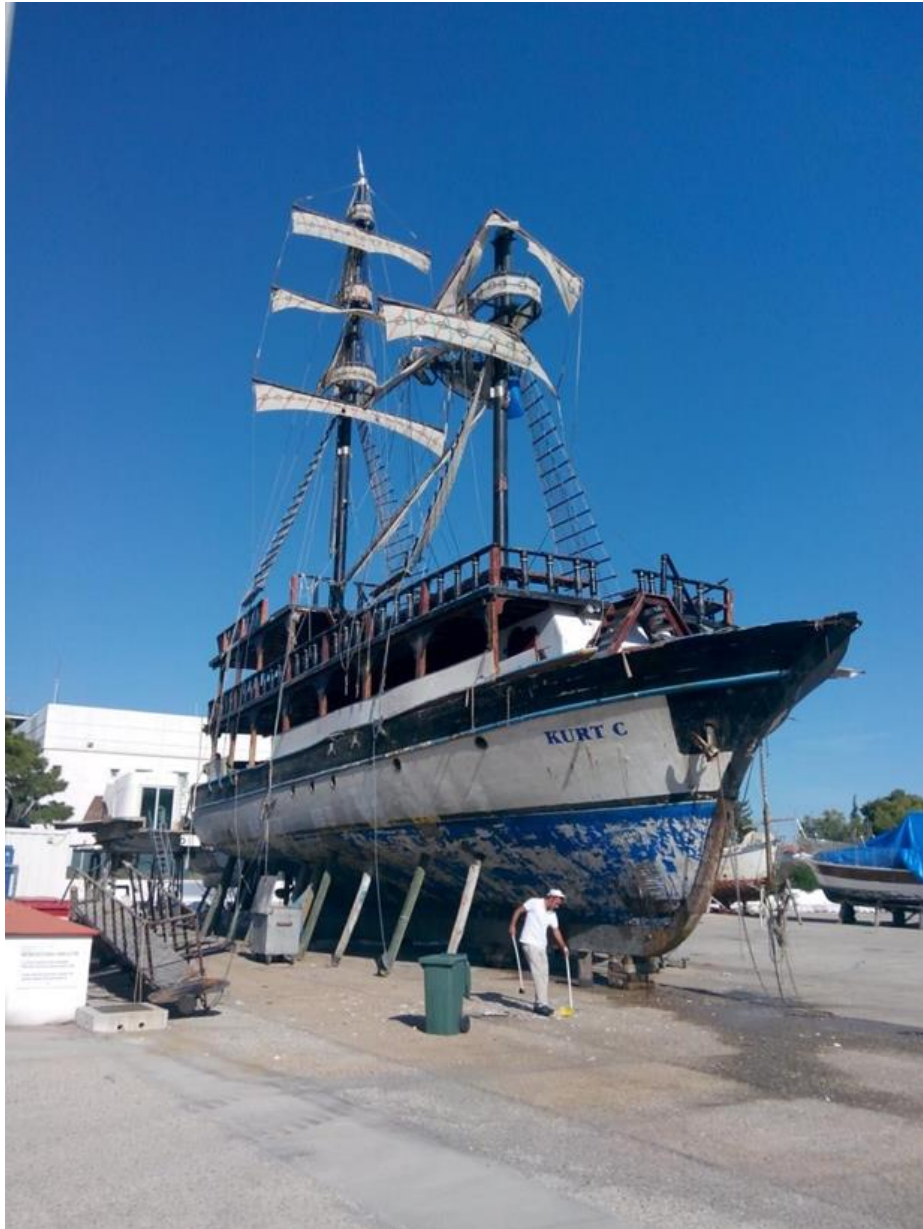
Figure 14: KURT C, SETUR Marina

The superstructure, masts and sails of KURT C are the factors that make the wind more effective and make the boat topple. With this strong effect of the wind, the boat leaned to such an extent that she could not become upright again and sank.

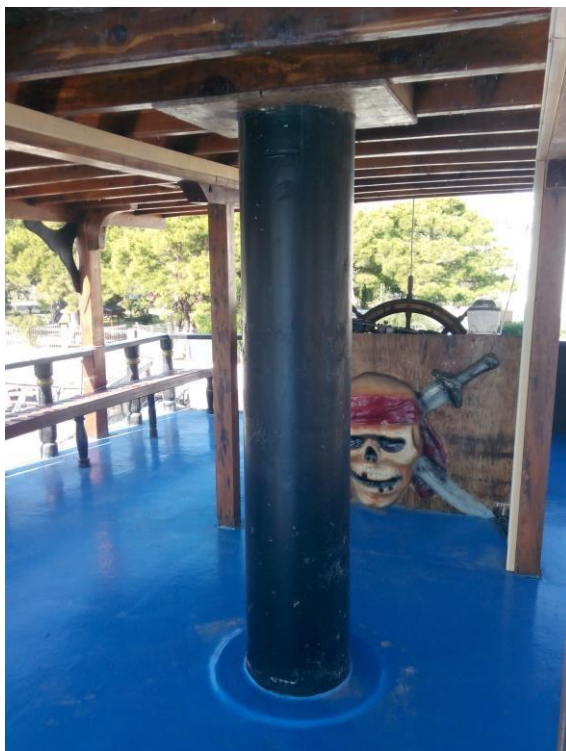
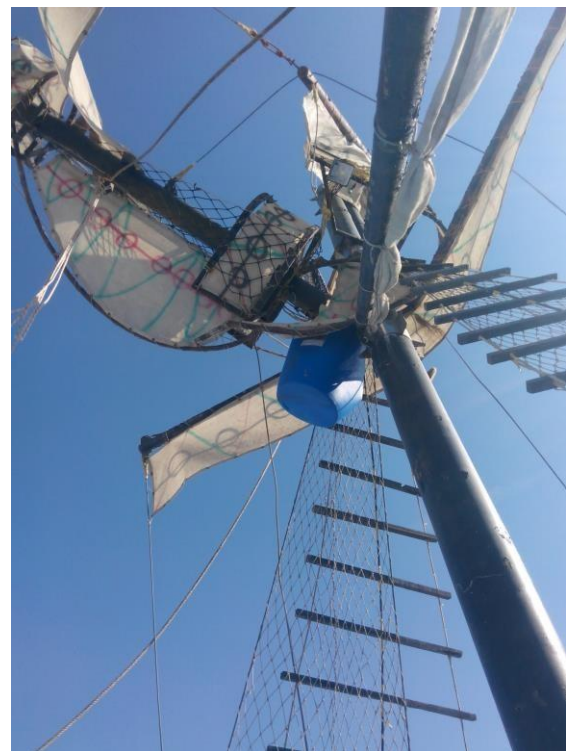
Figure 15: The Masts of KURT C

A boat which rolls due to an effect like wind, will roll at a higher degree, as the weight of the mast increases, with comparison to a boat with a lighter mast. However, when the effect of wind disappears, the rolling of a boat with heavier masts will stop more quickly than a boat's rolling with lighter masts.

As removing a boat's mast will increase the stability of the boat, on the other hand it will cause the boat's rolls to be more harsh and the boat will fall into sudden and hard rolls at the same time. Hence, although most of the gulets do not use sails, the reason for having a mast is that the boat becomes more stable particularly in high waves thanks to the mast and cross wires. The rigging and tension of the crosswires render the boat more stable.

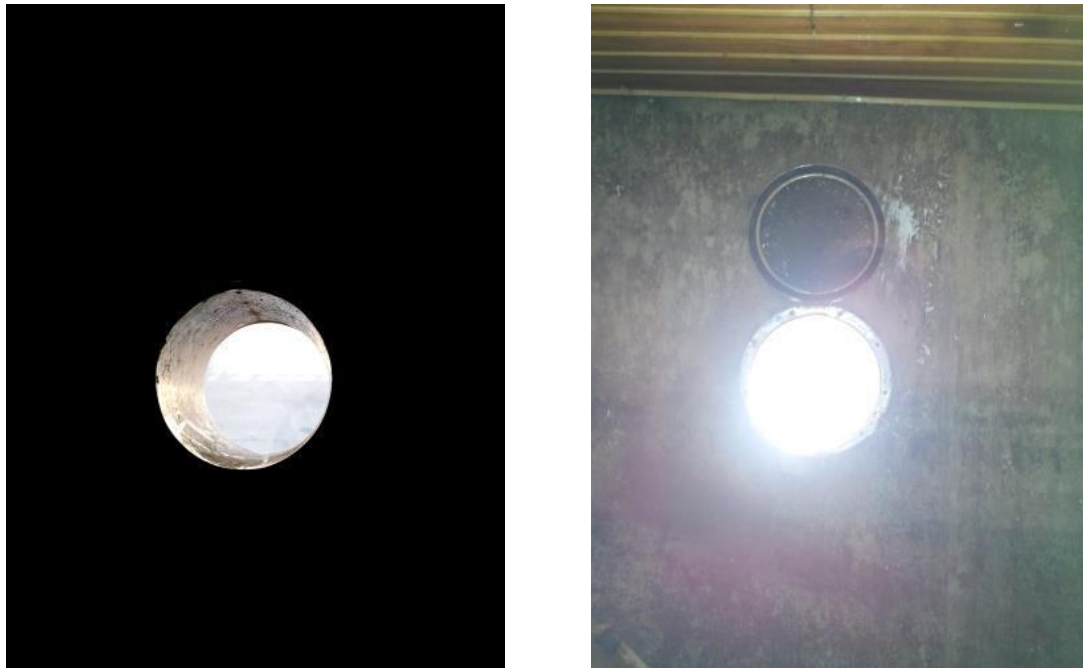
Figure 16: Portholes of KURT C from inside

As the height of the portholes is measured to be 1100 mm from the loaded water line, this height value is in line with the Article 24 of the Ships' Technical By-law, which states that "The lower bottom of the portholes shall be at least 500 mm above the water line".

The portholes at the freeboard of the boat have been equipped with watertight covers. The purpose of these covers is to be closed at high waves when there is the possibility of water ingress from the freeboards and thus to prevent the boat from being flooded. The pictures taken while the boat was under the water show that the portholes were open. This can be interpreted as the Captain and the crew members had not remembered to close the portholes or they didn't have time to do it.

As a result of the boat' tilting, water penetration from the open portholes caused the boat to lean on its side further more and caused the weights that sank the boat to increase, thus constituting one of the factors in the sinking of the boat or accelerating this process.

- 3.3 The boat's upperstructure, masts and sails increased the effect of the wind and contributed to the toppling of the boat.
- 3.4 The portholes of the boat being open caused the waters to fill rapidly into the toppled boat and were a factor for the boat's further leaning to her side and not being able to upright again.

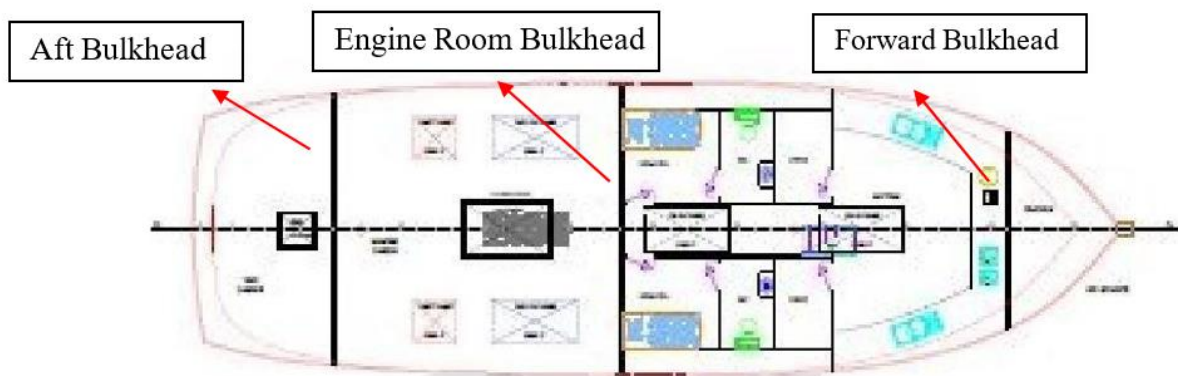
Figure 18: Bulkheads of KURT C

According to the aforementioned By-law, KURT C is obliged to have only the forward collision bulkhead. Since the boat was over 24 meters before the modifications, she was obliged to have an aft bulkhead and additionally another bulkhead forward of the engine room space. KURT C had all these bulkheads.

- 3.5 Since the bulkheads that should normally be waterproof were not in proper condition, the waters which filled through the portholes progressed rapidly to the engine room and were effective in the boat's losing of stability and as a result toppling to her side.

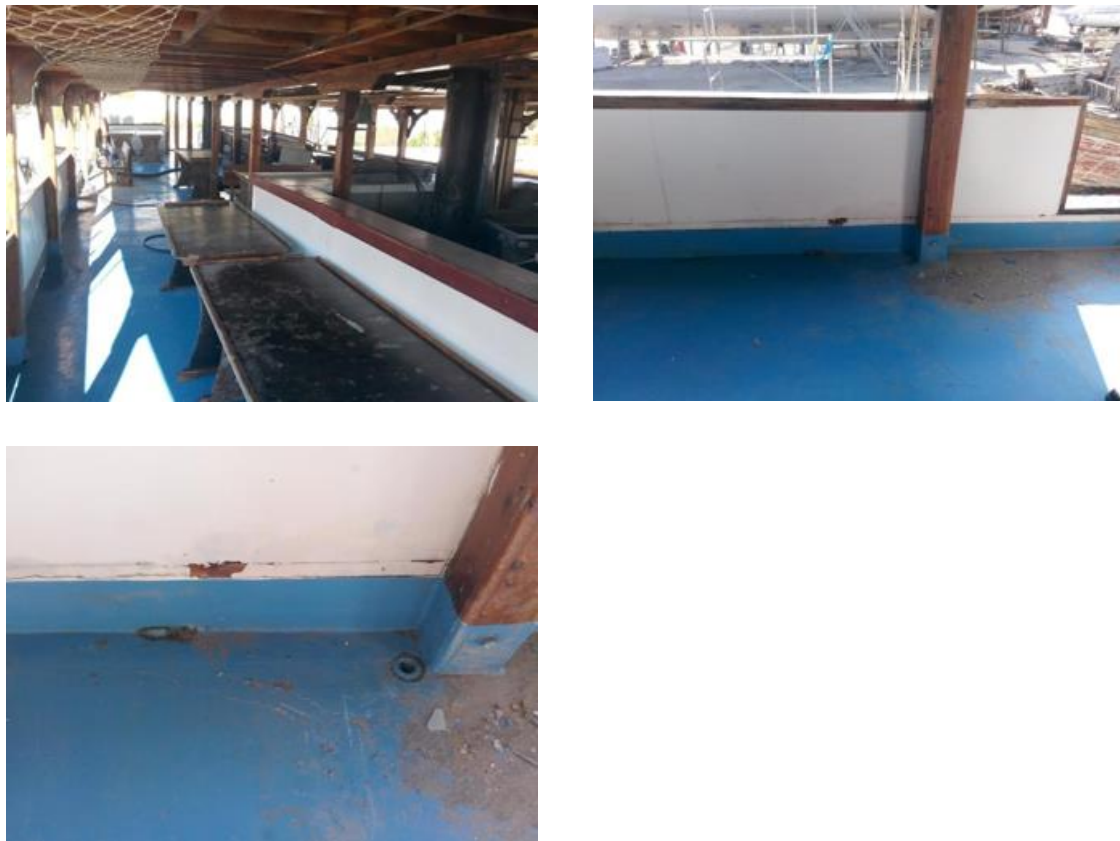
Figure 19: Passenger hall, bulwarks and the water drainage hole in front of the bulwarks

Water drainage holes are good enough for draining only a small amount of water on the deck (such as deck washing water or rainwater) whereas they are not sufficient for the rapid discharge of large amounts of water.

It is considered that the waters coming to deck have accumulated at the bulwarks and have contributed largely to the forces that laid the boat to her starboard.

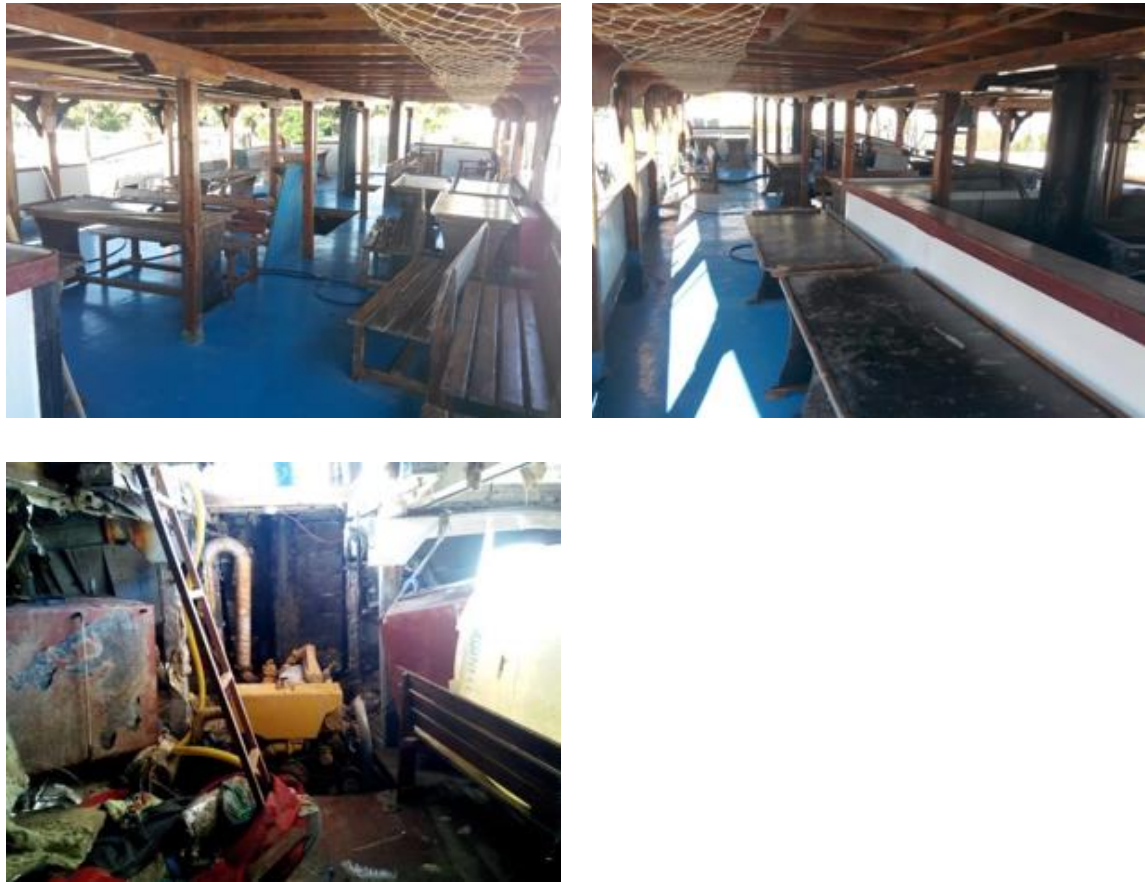
Figure 20: The Unfixed Items on the Boat

It is also considered that as the ship lay to her starboard side, the tables in the passenger hall as well as the tanks (fuel, clean water, dirty water, etc.) in the engine room which were not fixed by a strong lashing hindered the uprighting of the boat.
