MARINE SAFETY INVESTIGATION REPORT

OWNER	: SAREIA SHIPPING INC.
MANAGER	: OTONIO SHIP MANAGEMENT COMPANY INC.
NAME OF SHIP / CALL SIGN	: KYME / XUPY9
FLAG	: KING OF CAMBODIA
SCENE OF ACCIDENT	: İstanbul - Zeytinburnu Anchorage Area / TURKEY
DATE OF ACCIDENT / TIME	: 03.06.2014 / 15:15 LT
FATALITY / INJURY	: 1/-
DAMAGE / POLLUTION	: -/-

Board Resolution No: 18/DNZ-06/2019

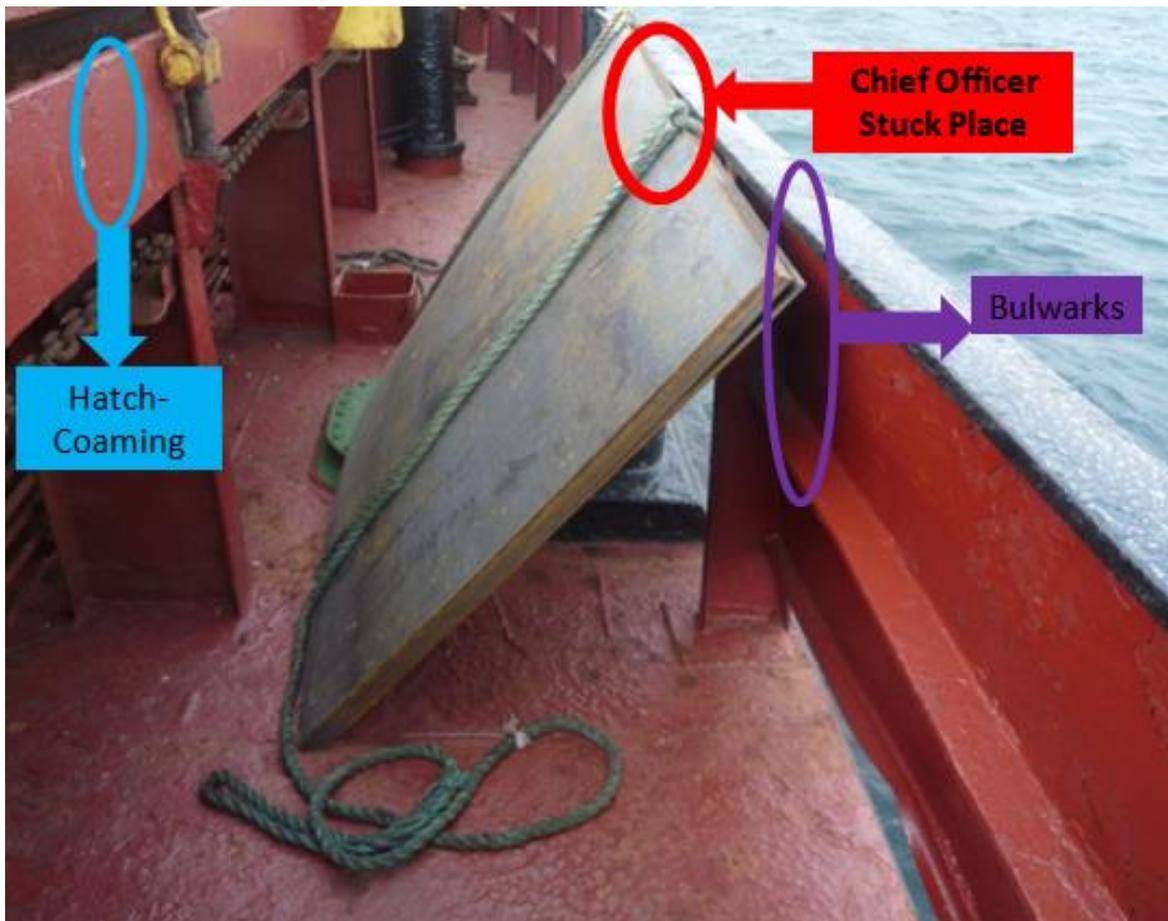
Figure 8: The position where the chief officer was stuck between the metal plates and the ship's bulwark

At this instance, the side of the metal plates which were leaning towards the hatch-coaming moved towards the bulwarks and the chief officer who was standing between the bulwarks and the metal plates was stuck at 15:15 (Figure 8)

- 4.6** The Chief Officer was stuck between the metal plates and the ship's bulwark while he was shortening the slings which were over the metal plates at the starboard side of No. 1 hold and lost his life in the aftermath.

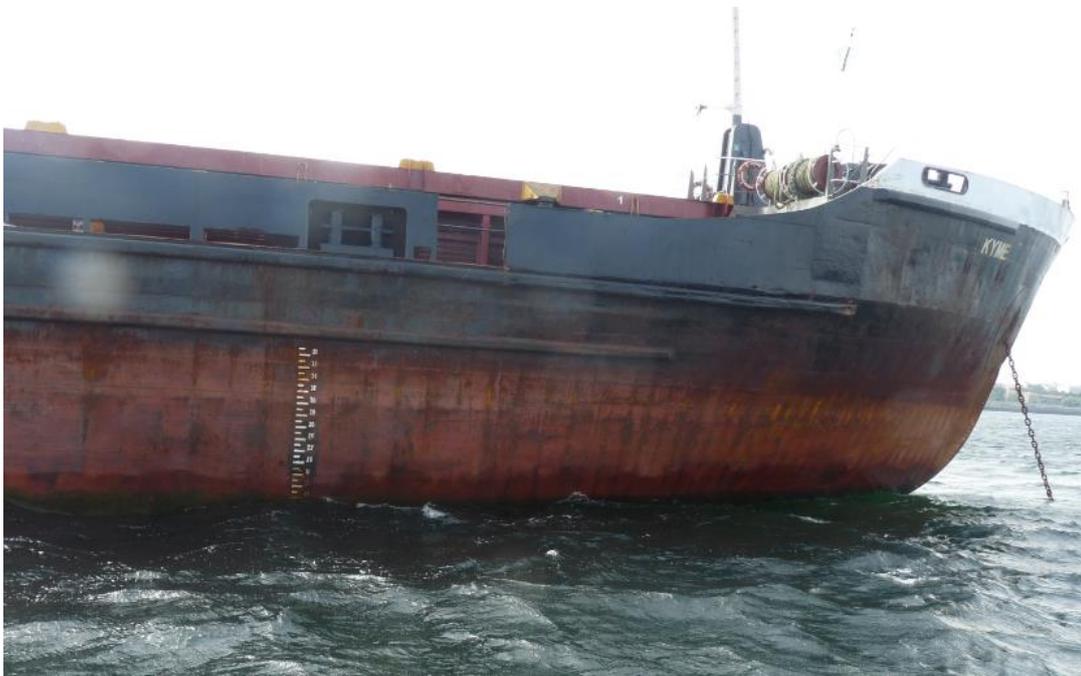
Figure 9: The side where YILDIRAY I came alongside M/V KYME

KYME's moulded depth registered in the International Tonnage Certificate is 5.5 metres. The ship's draught at the position where the metal plates would be transferred to the ship was 1.2 metres (Figure 9)

Calculating the current draught and the moulded depth, the ship's bulwark's height from the sea level is approximately 7 metres. Deducting the boat's freeboard from this distance, the distance between the boat's deck and the place where the metal plates were given to the ship is approximately 6 metres.

As the place where the metal plates would be loaded was very high and as the length of the slings which would be used to lift the metal plates to the ship was very long, the crane boom's length was not sufficient to place the metal plates over the hold.

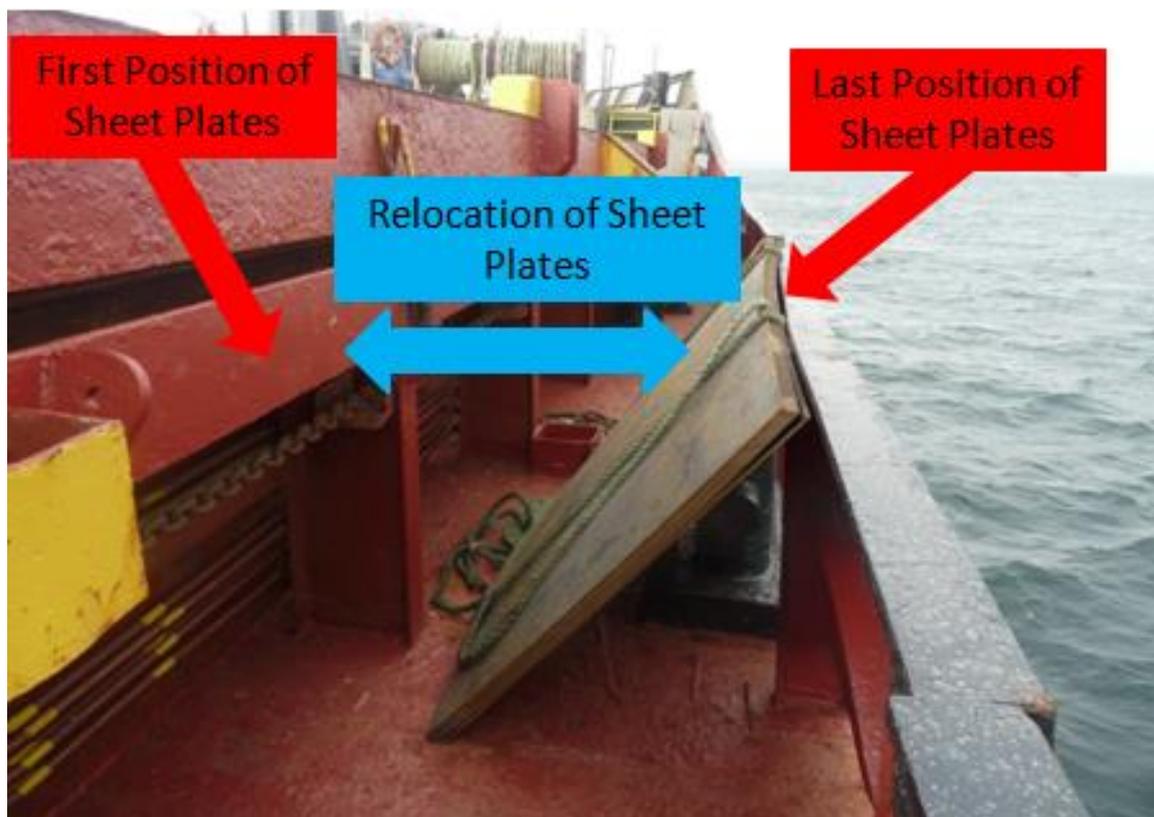
Figure 10: The metal plates which were placed on deck

Thereupon, the boat captain was able to place the long side of the steel plate on the starboard deck and the other long side on the ship's deck by resting to the ship's hatch coaming (Figure 10).

Each metal plate weighed 1 ton. As there were 10 pieces of these metal plates at the slings, total weight reached 10 tonnes. On the other hand, for the metal plates not to slide over the deck, they needed to be placed leaning to the hatch-coaming. It is not possible for the metal plates to slide towards the Chief Officer while he was trying to take the slings. This could be possible only when the ship rolls strongly towards starboard and port sides due to strong waves when there is a storm in the region or which may be caused by seacrafts passing close to the ship.

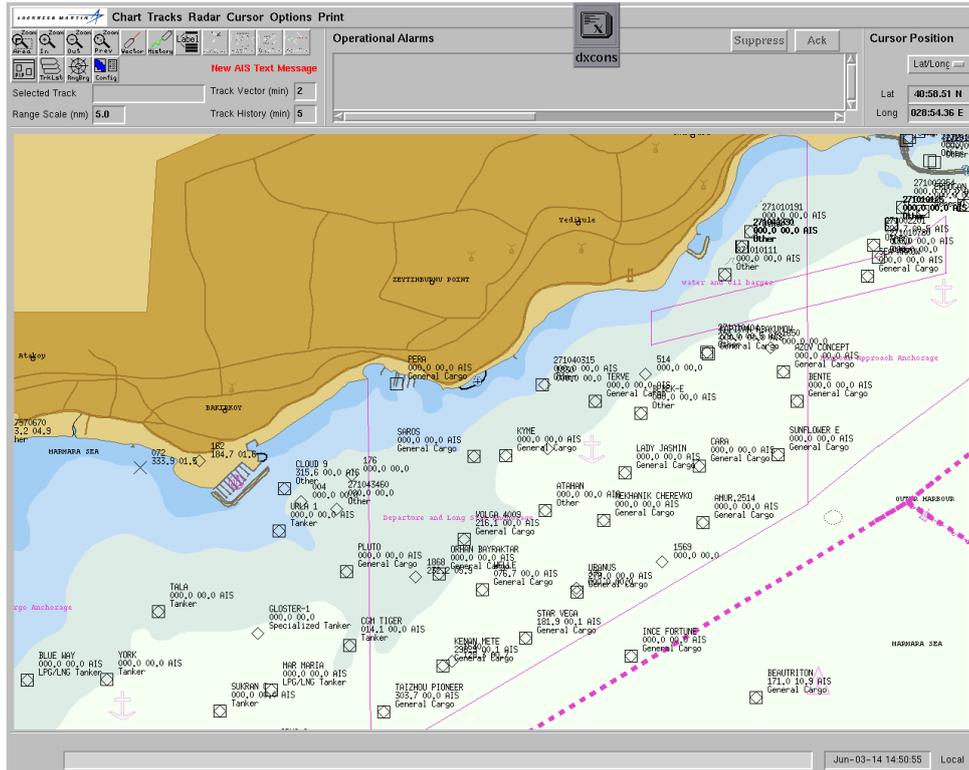
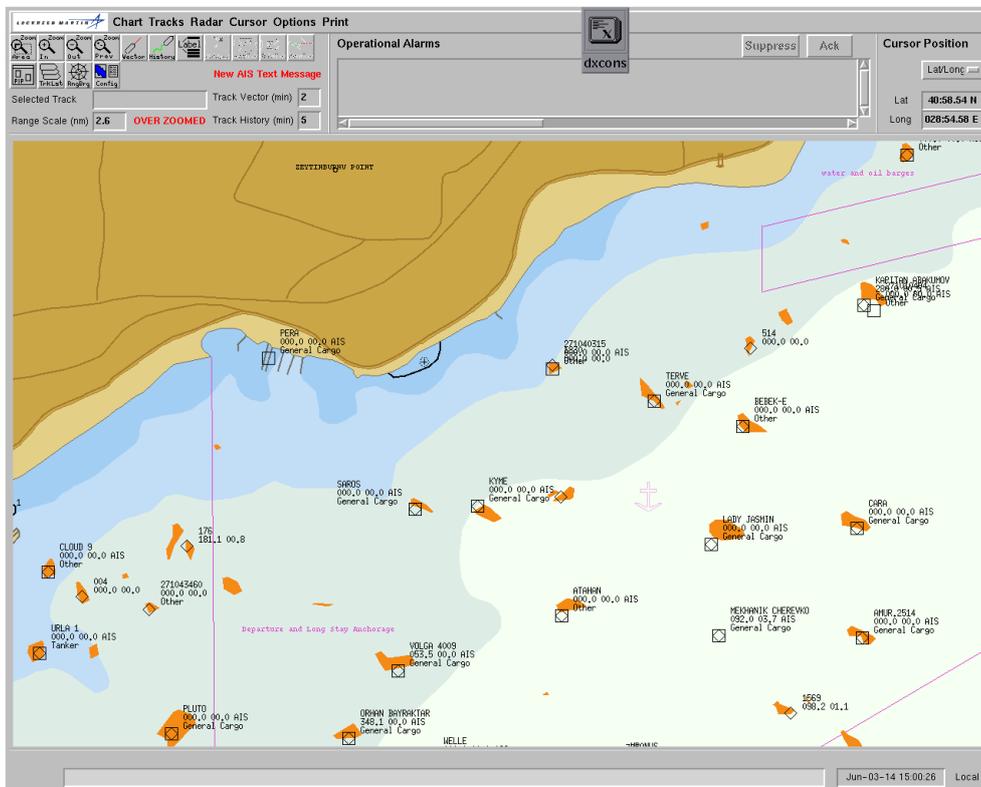
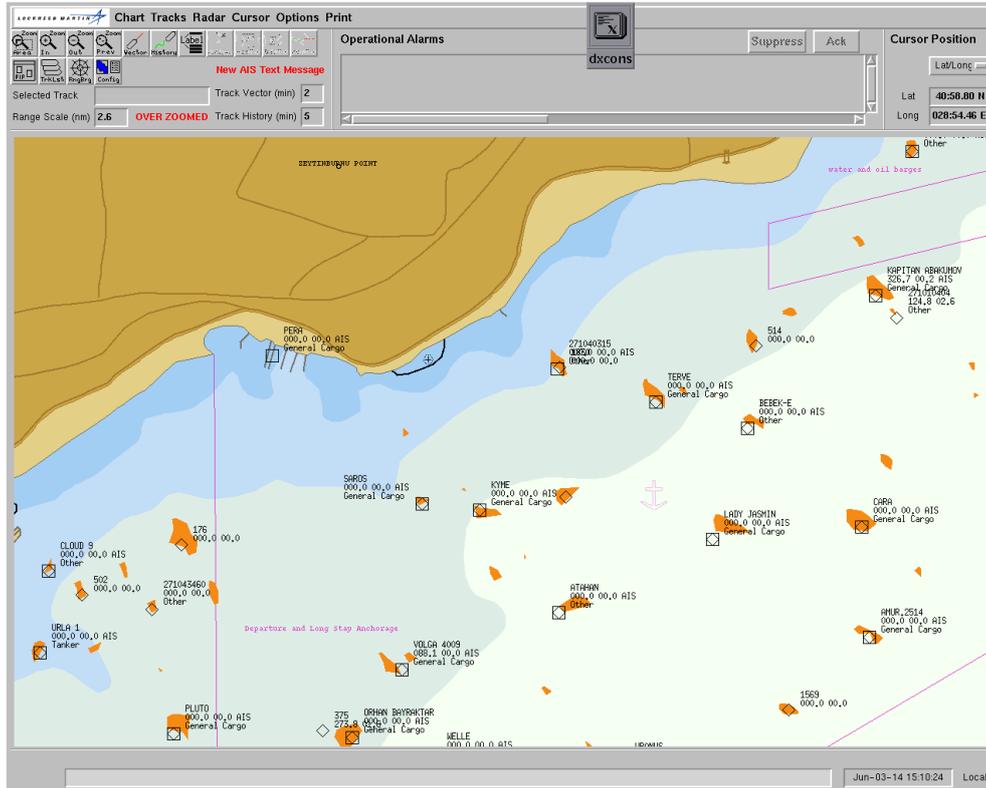
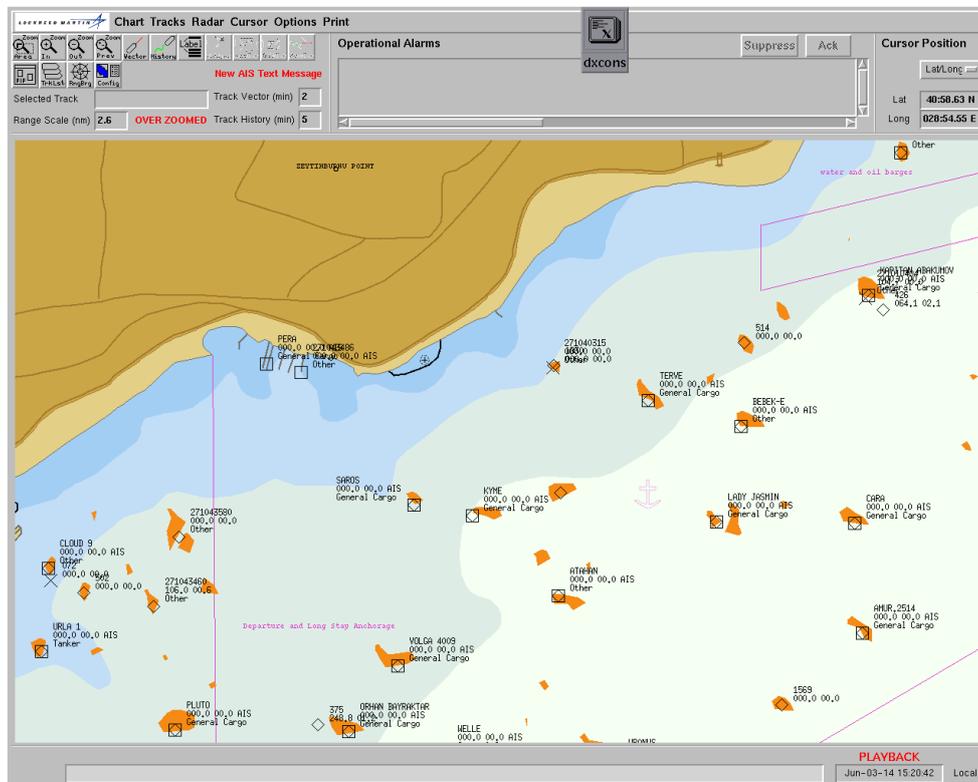
Additionally, VTS screen shots were taken regarding the ship's anchorage area at 10-minute intervals (Figures 11,12,13,14). In the light of these pictures, it is concluded that no seacraft had passed very close to KYME, which could have affected the vessel. With regard to the information about the weather conditions and the views acquired from the VTS, it is seen that there weren't any waves that would cause the ship to roll strongly to her starboard and port sides. While this situation reduces the probability of the accident to occur in line with the boat captain's and boat seaman's statements, it increases the probability of the accident to occur in the way as the ship crew had given their testimonies.

- 4.2** A vessel traffic that could affect the ship before and at the time of the accident was not detected from the images obtained from the VTS.
- 4.3** According to the meteorological data for the day of the accident, it can be seen that the weather conditions did not affect the oscillation of the ship.

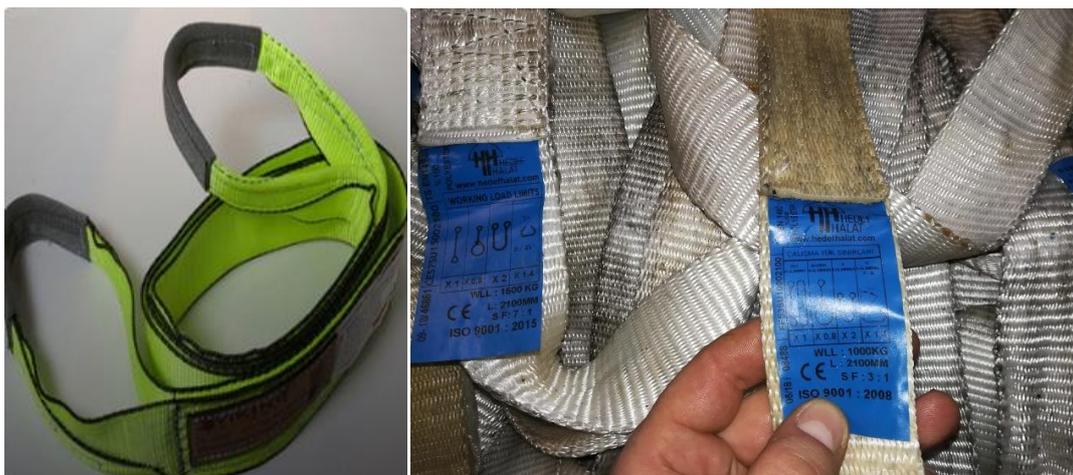
Figure 15: Polyester Slings Used for Ship Loading and Unloading Operations

The crane and its rigging should be suitable for the work being performed and the rigging should be checked in advance so as not to cause any troubles. The last periodical maintenance of the subject crane was carried out on 30.04.2012 (Annex-1).before the metal plates were lifted to the ship, the provision basket was lifted to the ship without any troubles. Thus, it is seen that the crane and its rigging was appropriate for the provision. However, during the lifting of the metal plates, rope slings were used. Although when the rope slings are examined externally, it is observed that they are not the usual type of polyester slings (Figure 15) used for loading operations on ships and that the safe working weight required on these ropes are not provided on the rope, any splitting to yarns or deformation that would prevent the sling from performing adequately were not observed.

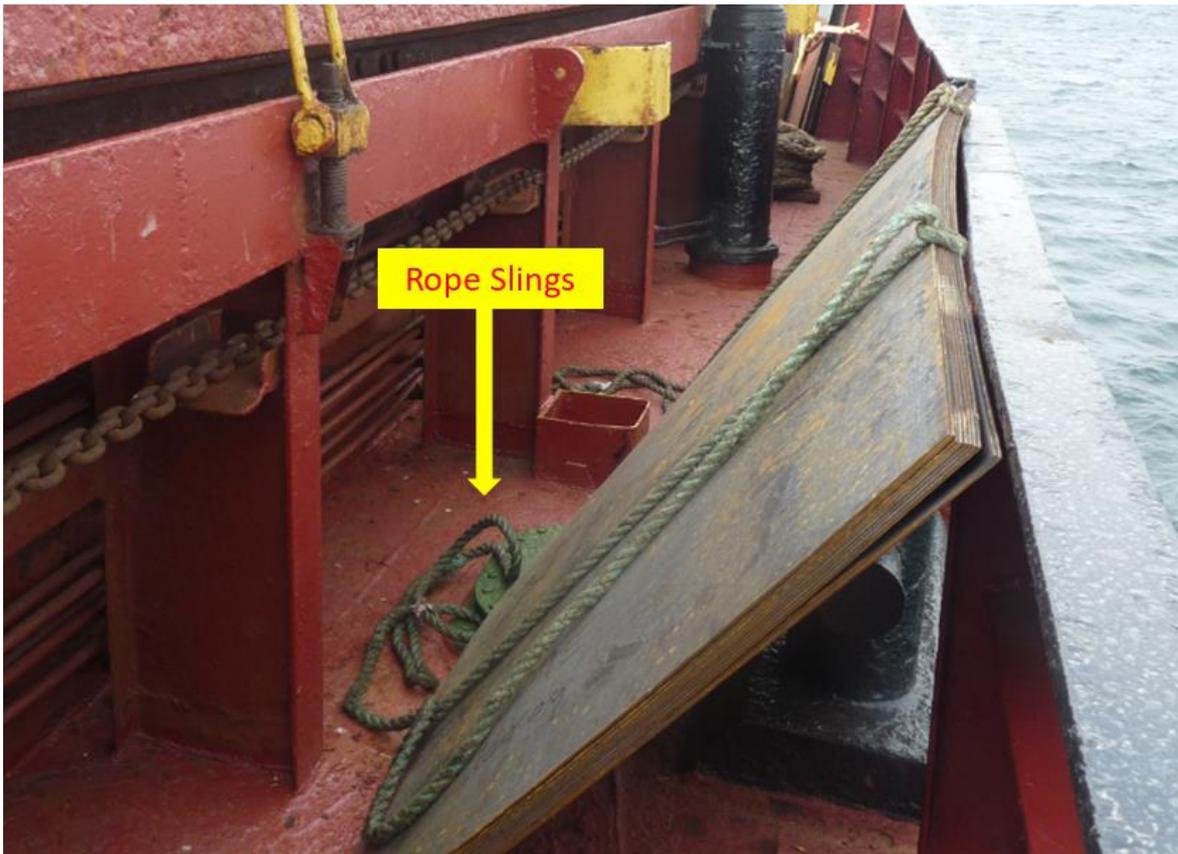
Figure 16: Rope Slings Used for the Loading of Metal Plates to the Vessel

However, the rope slings used in the operation (Figure 16) had to be shortened, owing to remaining long for the work done.

- 4.4** There are no labels indicating the suitability of the rope slings used to lift the metal plates from the agent boat to the ship at the time of the accident, for the job performed.

- 4.5** It is highly probable that, during the accident, the rope slings used to lift the metal plates from the agent boat to the ship were attached to the crane's hook.
