REPUBLIC OF TURKEY
MINISTRY OF TRANSPORT, MARITIME AFFAIRS AND
COMMUNICATIONS
Accident Investigation Board

Marine Accident Investigation Report
On the Injury of a Person
As a Result of Breaking of Towing Line of
M/V KRISTIN-C

Port of Gllk
21st August 2013

Report No: 10/2015

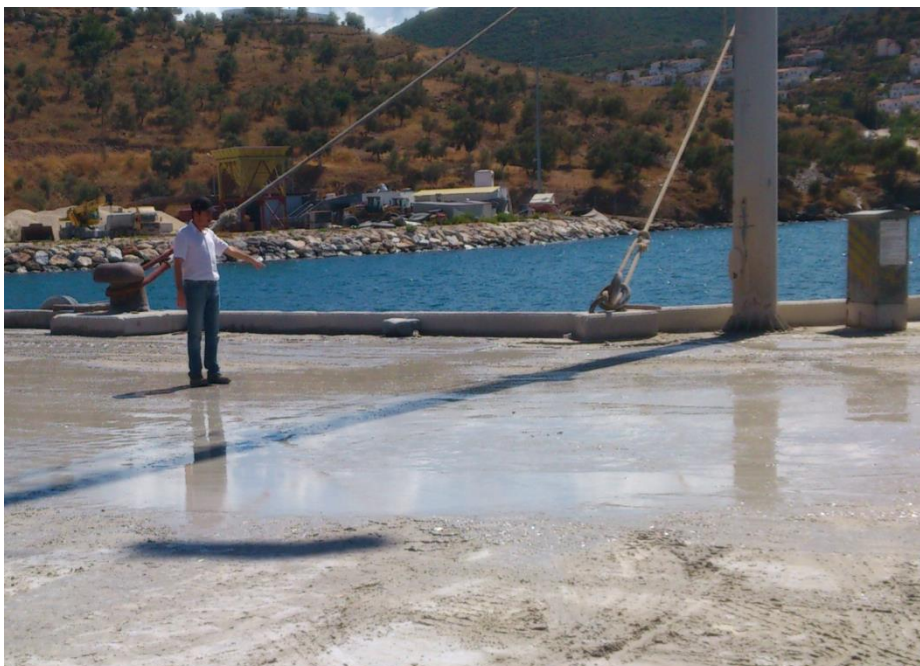
Picture 8: Location of the accident victim during the maneuver

While the aft of ship edged away only 2-3 meters (*Figure 1*) and the tugboat was continuing the towing process by increasing its pulling force from slow to half speed gradually (1000-1100 rpm), the rope given by the ship to the tugboat and used in the towing process suddenly broke into two from the middle (a portion of 17,3 m being left on board of the tugboat) at 11:15 and hit Önal KARADUMAN, one of the two mooring personnel who were standing side by side at the snapback area of the rope (*Picture 8*) and caused grave injury to him , ..

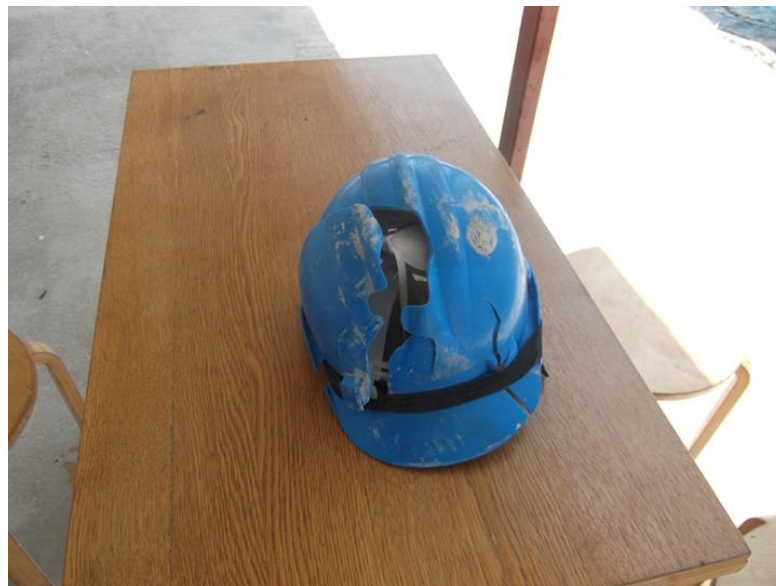
Picture 9: Helmet of the accident victim to whom the rope hit

Önal KARADUMAN skid and fell down as a result of the hitting of the rope on his helmet (*Picture 9*) and shoulder (*Picture 10*). The first response was by the other hawser personnel who had first aid knowledge and who witnessed the incident. The other hawser personnel turned Önal KARADUMAN to his side against the risk of asphyxia and provided to keep his trachea open. Meanwhile, the security personnel of the port called 112 emergency ambulance service at 11:17. The ambulance attendants who burst into the scene of accident at 11:24 hospitalized the wounded at 11:34 after the first response to the accident victim.

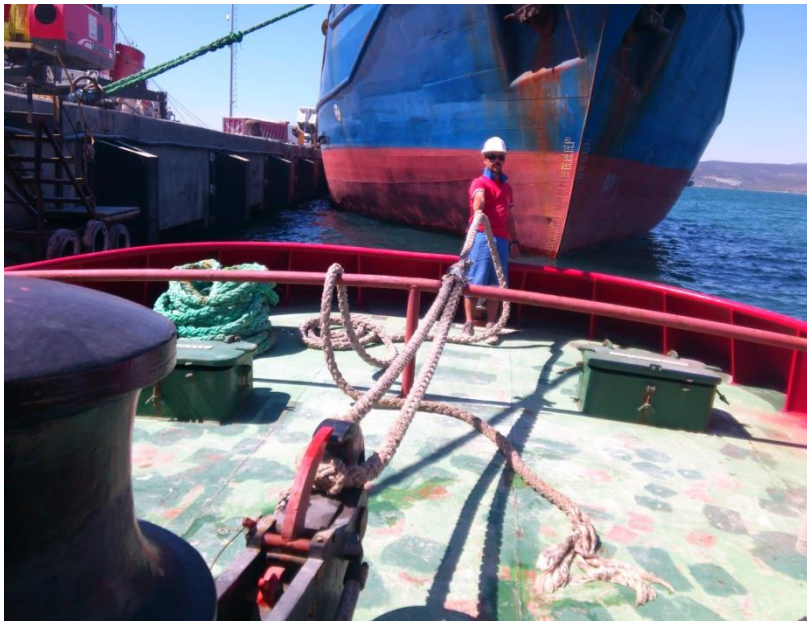
Picture 11: Portion of the rope used in the maneuver left on the tugboat

In addition, in the report issued after the accident by the ship's captain, it is stated that the rope which was used in the towing process was not a new rope, but it was checked every month and the condition of the rope was good pursuant to the last check made on 05/08/2013 and the rope was believed to be robust.

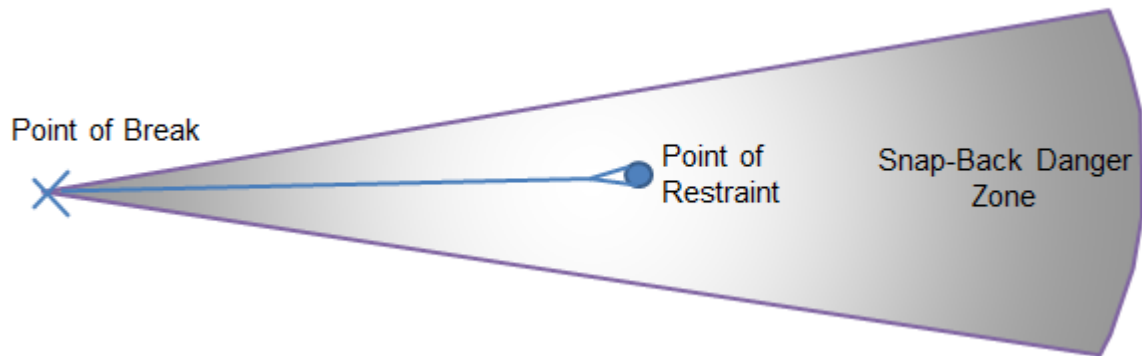
Figure 2: Return Area of The Rope

While resilience rates of the polypropylene ropes are about %8-11 under normal working load, their elongation rates are about %25-40 under forces close to breaking forces.⁴ Since polypropylene ropes yield more because they have an elastic structure, the back skidding force of the rope becomes more. As polypropylene ropes may suddenly break without giving any notice, the persons who handle the ropes should not stay within the return area of the rope which is shown in Figure-2 which is a very dangerous area.

Within normal maneuver order, the hawser personnel should leave the port area after they cast off the ropes of KRISTIN C ship or wait for the instructions of the pilot away from the snapback area of the ropes. But, the hawser personnel (the one not being the accident victim) who cast off the aft ropes of the ship is positioned on the dock and at a point close to the aft of KRISTIN C to check the distance between KRISTIN C and another ship moored just at the aft side of KRISTIN C (at dock no 2) and to inform the pilot who was managing the maneuver about the distance between the two ships, as required. On the other hand, Önal KARADUMAN who cast off the stern ropes of the ship took a rubber fender against the probability of damage to KRISTIN C during the maneuver by hitting the section of the dock which did not contain any fenders and went beside the other hawser personnel. Despite the working and occupational safety rules determined by the port, this action by Önal KARADUMAN without the instruction and request of anybody shows the existence of a wrong practice at the port concerning similar cases. On the other hand, in the interviews made with the port employees, it is evaluated that the employees have adopted the business place and are inclined to act in the direction of their initiatives without taking instructions from anybody to prevent any damage to the berths and ships.

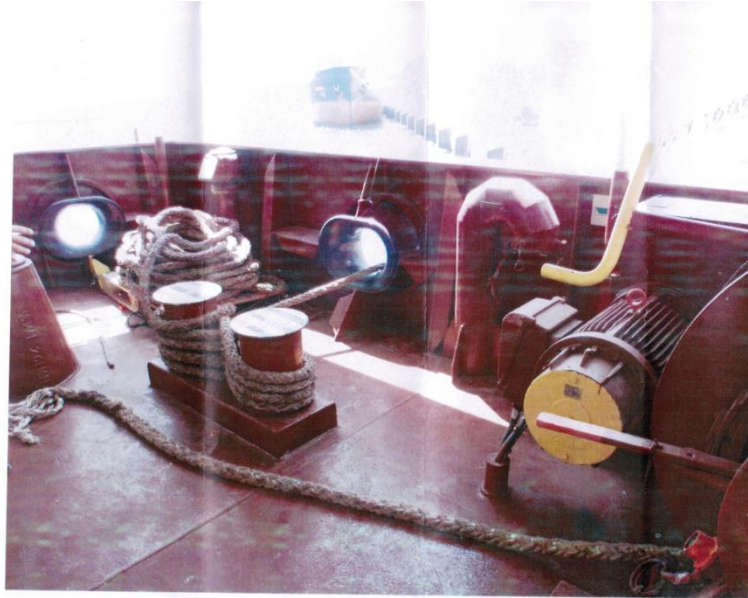
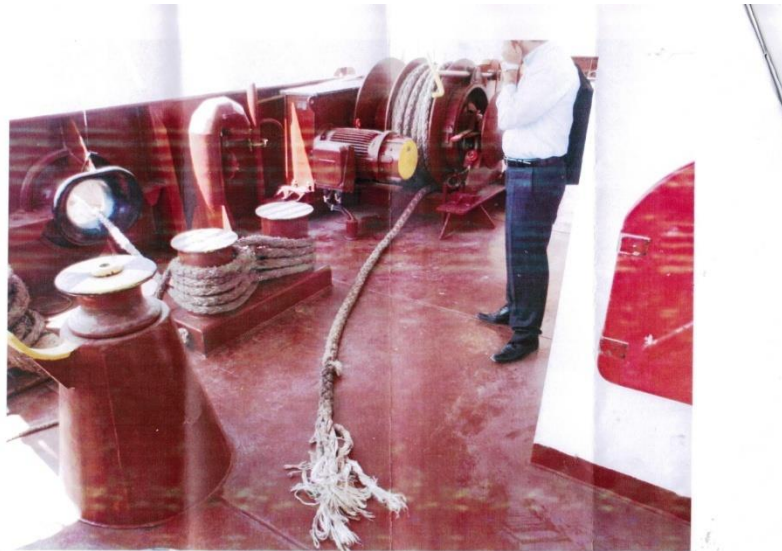
On the other hand, although the ship's captain stated that the broken rope was made fast to the starboard aft bollard, it is seen that the rope in question was on the port

aft drum of the ship in the pictures (*Picture 13-14*) taken from the aft side of the ship concerning the rope following the accident. This situation suggests the probability that the rope was made fast on the rope drum instead of the bollard.

As the rope drum's brake mechanism did not step in automatically, as the captain states, it is evaluated that the rope was either enlaid on the aft bollard or the rope was broken before the rope drum automatically stepped in since the rope was not robust.

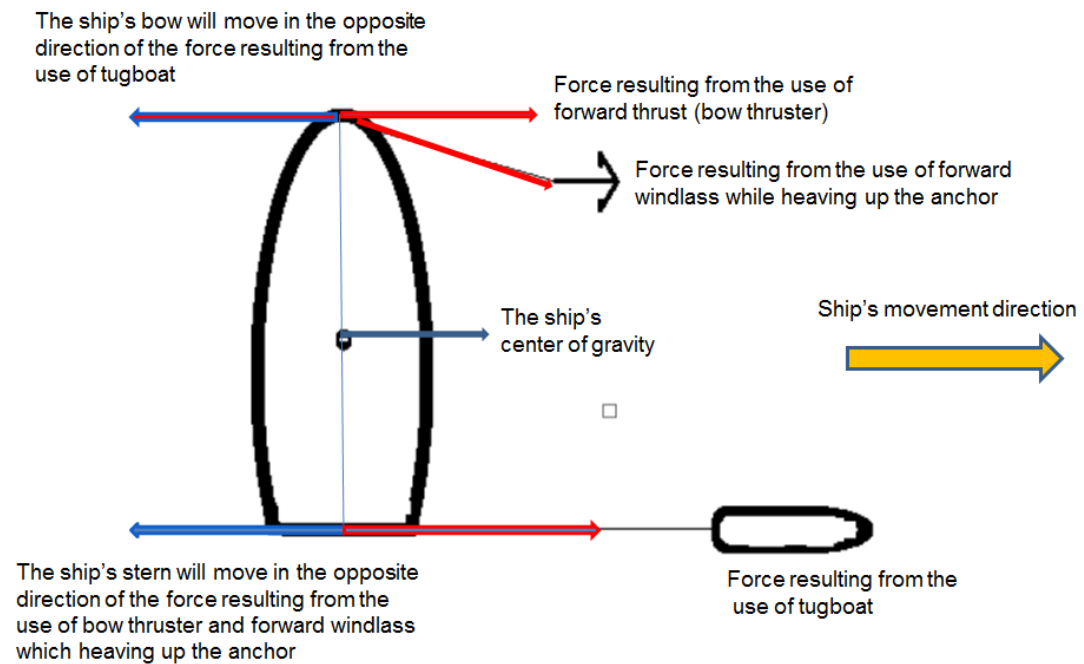
Figure-3 Forces influencing the rope

A towing process can be realized with long connection method from 0 degree to 150 degrees angle with regard to the keel of the ship and the trail rope has made an angle of 90 degrees with regard to the hull at the moment of breaking of the rope. According to the force which is applied to the towing rope through long connection method by the tugboat, the highest turning effect on the ship emerges as regards to the center of gravity of the ship when the towing angle between the towing rope and the keel becomes 90 degrees.⁷ Depending on the angle between the rope and the hull, the stern side of the ship tried to skid in a direction opposite to the towing direction. But, the skidding force applied to the stern side was overcome by heaving of the starboard anchor of the ship and using the bow thruster of the ship in the direction of edging the ship away simultaneously with towing and the stern side of the ship started to edge away. In the same way, using the bow thruster of the ship in the direction of edging the ship away and heaving of the starboard anchor of the ship formed a skidding force at the aft side of the ship towards the dock. This skidding force was overcome by the tugboat towing the ship and the ship started to edge away towards the towing direction of the tugboat. (Figure-3)

Body of the rope which is used in the process of towing the ship is basically under 3 forces. First of these forces is the force which is formed by the tugboat towing the trail rope. The other two forces are the indirect resultant forces (skidding force) formed by heaving the ship's anchor and running the bow thruster of the ship in the direction of edging away. It is evaluated that the rope which was influenced by the resultant influence of the forces expressed above was broken after a certain time passed.

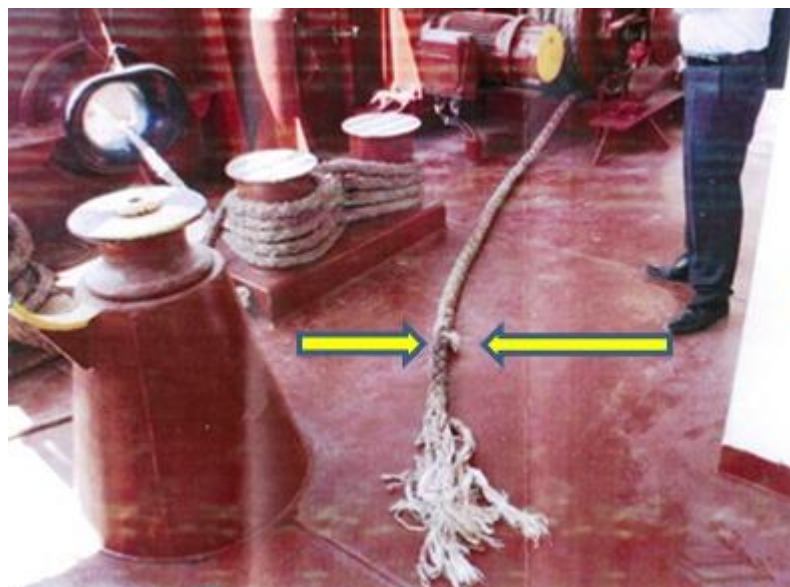
Picture 16: *Portion of the rope left on the ship*

Although reports are prepared that the condition of the rope was good following the checks made in the ship concerning the rope, as observed in the photos taken on the ship just after the rope was broken, the rope is seen on the ship's drum and a burst strand is observed just beyond the breaking point. (*Picture 16*)

- 4.1.1 Not employ worn ropes in ship maneuvers and replace them with new ones,
- 4.1.2 Keeping the ropes away from the chemicals such as paint which shall destroy their properties,
- 4.1.3 Making the checks for the evaluation of usability of the ropes on board of the ships more sensitively / carefully,

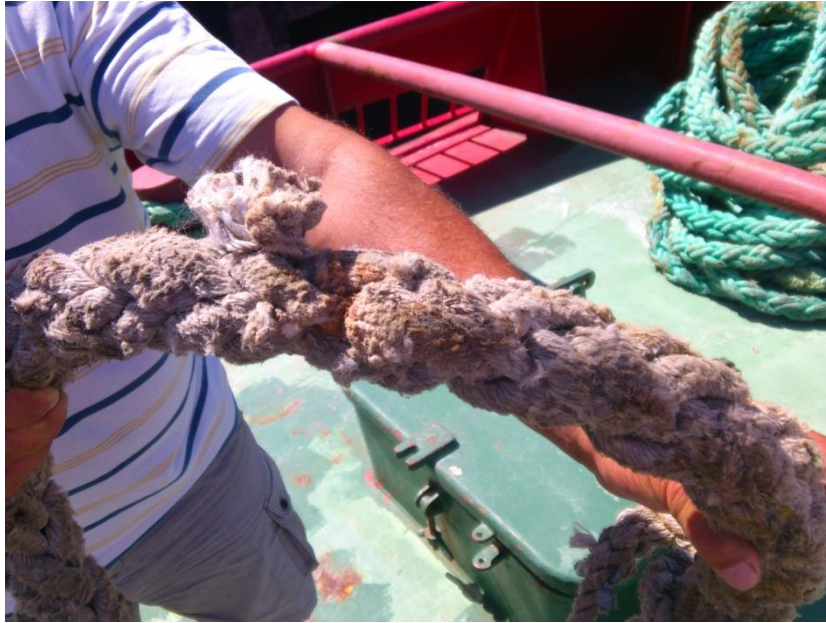
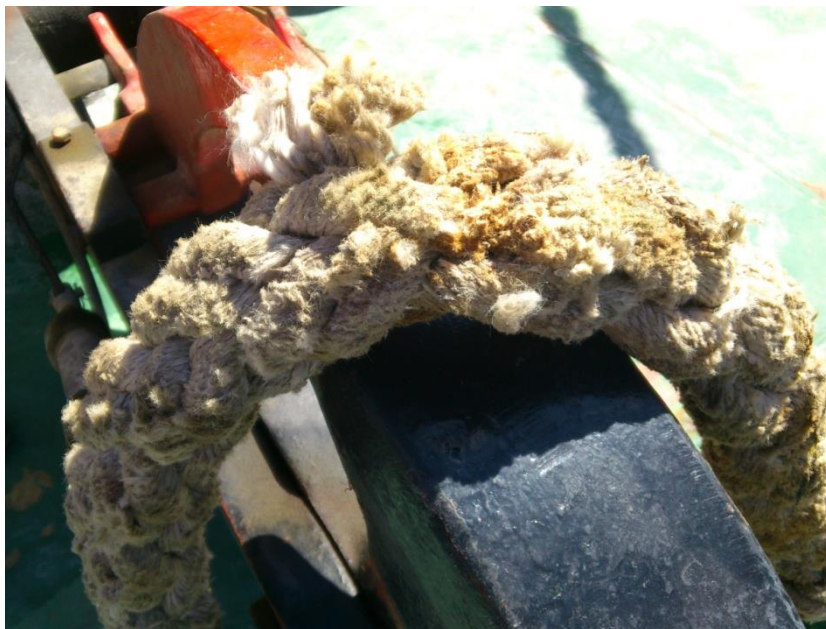
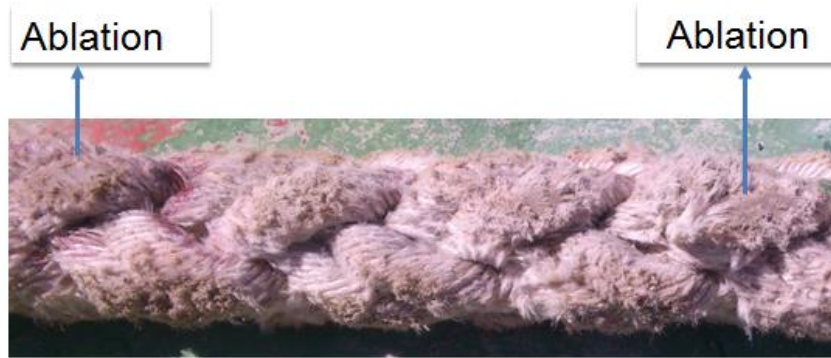
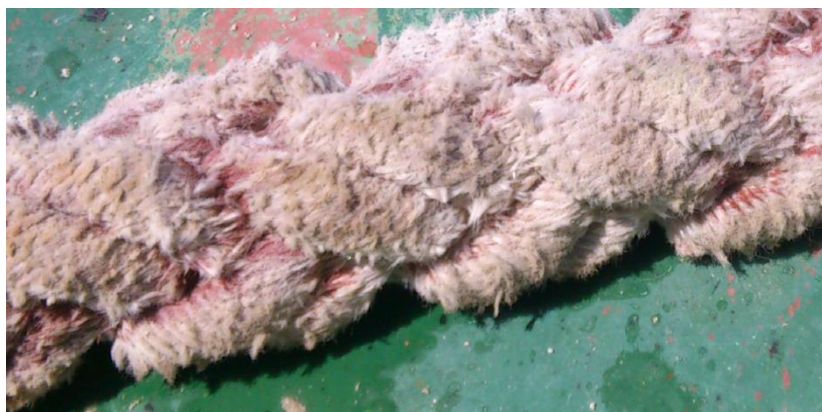
In the further external physical examination of the portion of the rope left on board of the tugboat; it is observed that a strand was burst at the eye section of the rope (Picture 17, 18), there were local melting on the body surface of the rope due to the heat originating from friction (Picture 19), the fibers on the surface of yarns were ruptured depending on wear and paint residues within the strands of the rope (Picture 20). It is evaluated that the breaking strength of the rope was significantly

reduced and, due to this, the rope was broken because that the burst strands were present both at the eye and body of the rope, the body of rope exhibited in general a worn appearance and paint residuals were present in the body of the rope.

- 4.3.1 When a rope is given from the ship to the tugboat, not to accept such ropes for the towing operation, which are worn out such as to reduce breaking strength, with strands burst out, melted as a result of heating originating from excessive friction and which are contaminated with chemicals,
