**Accident Investigation Report On**  
**The Fire Onboard RETAJ**

**Denbirport Port / Iskenderun / Turkey**

**14<sup>th</sup> of January 2015**

**Report Number: 08/2015**

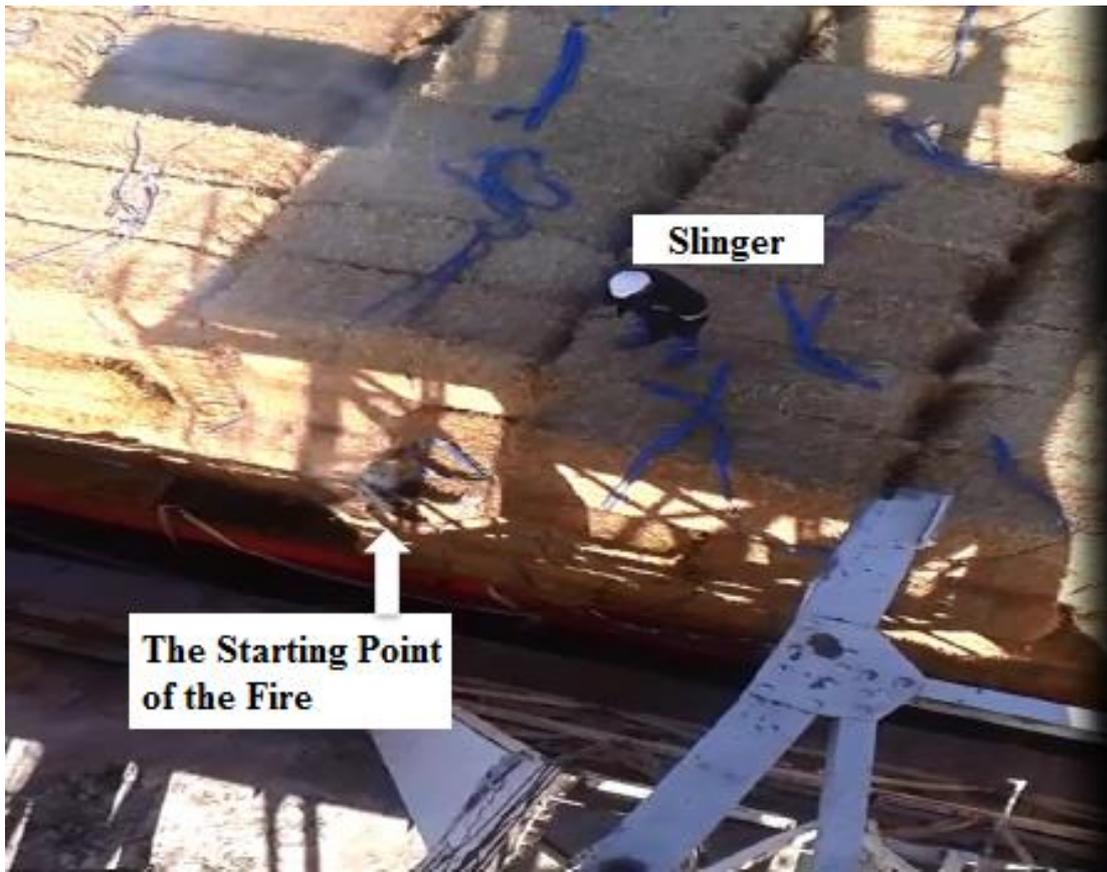
At around 9:40, the loading to the starboard bow of the vessel was in progress and the person, the so-called slinger, was working on the bales of hay onboard. In the meantime, the slinger saw that smoke was coming from the 1<sup>st</sup> or 2<sup>nd</sup> bottom tiers of bales loaded on the hatch covers near portside midship. Thereupon, the crane operator was warned about the fire by this person and a fire alarm on the portside was sounded. In the meantime, a fire call was made by calling the Iskenderun Fire Company at around 09:43.

Figure 2. The moment that the fire was noticed

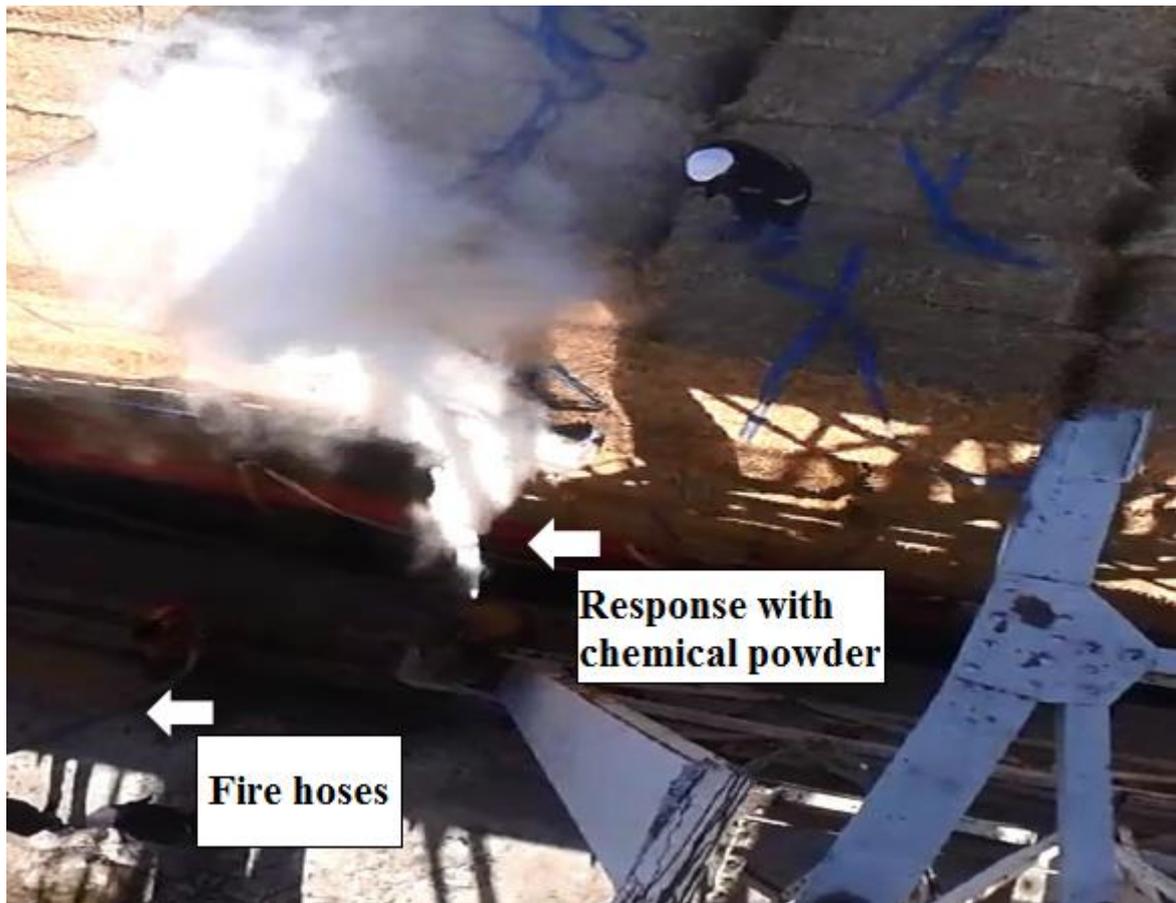
**Response from Shore:** After the fire alarm sounded, the people at the pier started to respond to the fire immediately. First of all, fire hoses were started to be pulled from the fire line located at the port to the point where smoke from the vessel was arising in order to respond with water. On the other hand, while the fire hoses were being pulled, a worker at the pier responded with dry chemical powder tubes.

Figure 3. Initial response to the fire

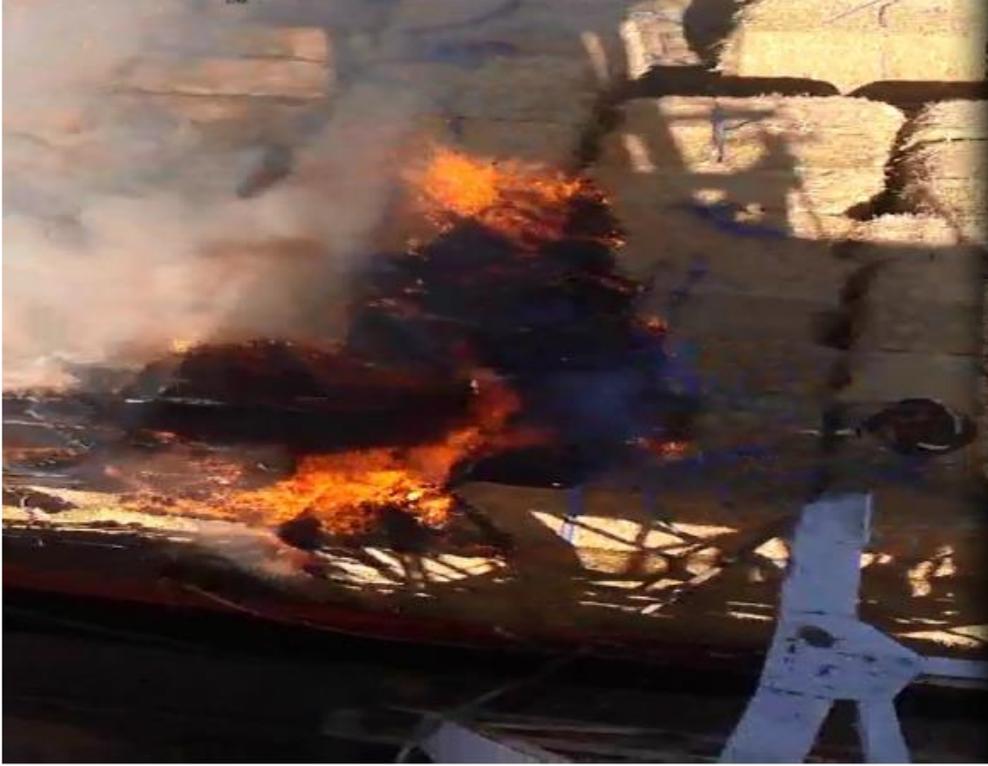
However, the response made with chemical powder did not make a visible contribution to the extinguishing activities with the effect of the wind. Since it was understood that the responses to the fire from the pier would be insufficient due to the effect of the wind, it was considered as appropriate that the fire hose be extended to reach the vessel by crane and that the response be made by the slinger on the bales of hay. Meanwhile, second response made with chemical powder from the pier. In this very moment, the flames appeared at the point where the smoke was arising and in a very short time, the flames reached the bales at the top. With the effect of the wind blowing strongly, the flames started to spread rapidly towards the portside bow and starboard of the vessel by igniting the parts of the bales exposed to open air. Meanwhile, the fire hose and nozzle were delivered to the slinger on the bales of hay within 2-3 minutes. However, as the water pressure was insufficient and the nozzle and hose connection could not be made completely, the response made by the aforementioned person for 4-5 minutes was insufficient and the person left the vessel due to the excessive increase of the smoke and went to the pier.

Figure 4. Spread of fire

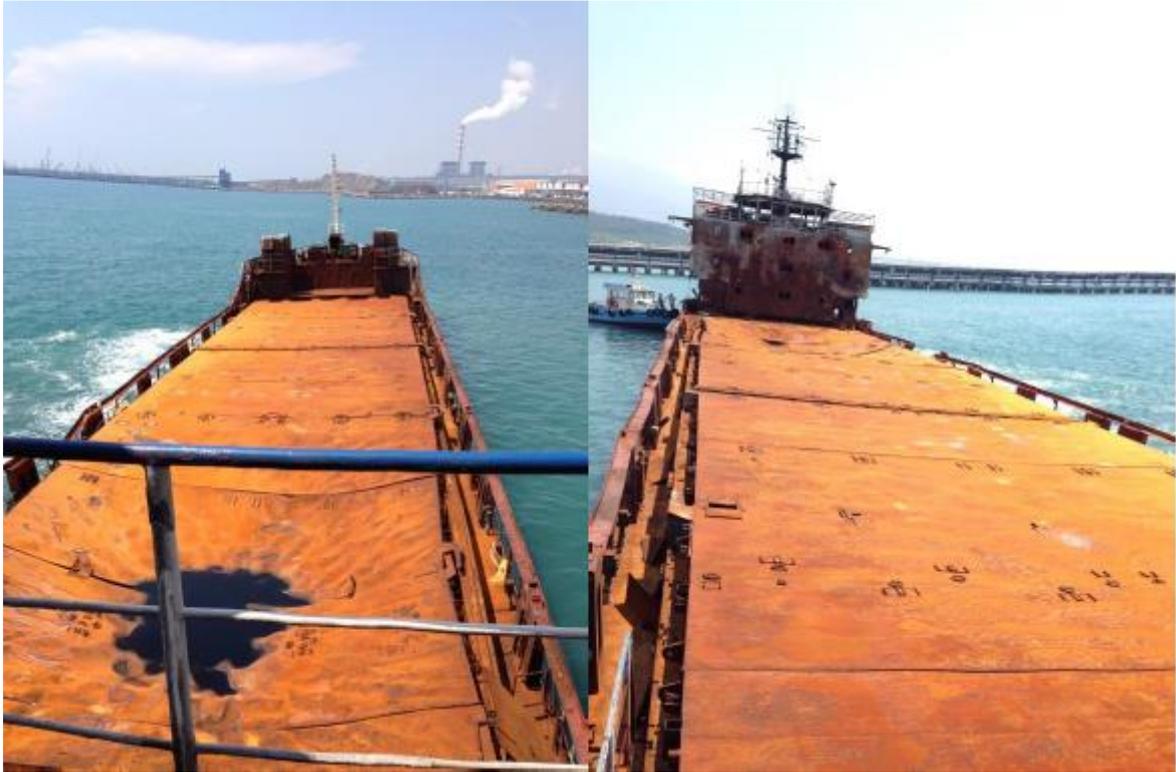
In the investigation carried out on the vessel, it was observed that the fire was effective throughout almost all over vessel including the fore peak. The hold covers on the stern on the deck have collapsed in a wide and deep way and deformation occurred on the other hold covers. The fire also spread into the hold, the superstructure, including holds and the bridge, was almost completely burned and the vessel became unusable.

Figure 5. Vessel's deck and superstructure after fire

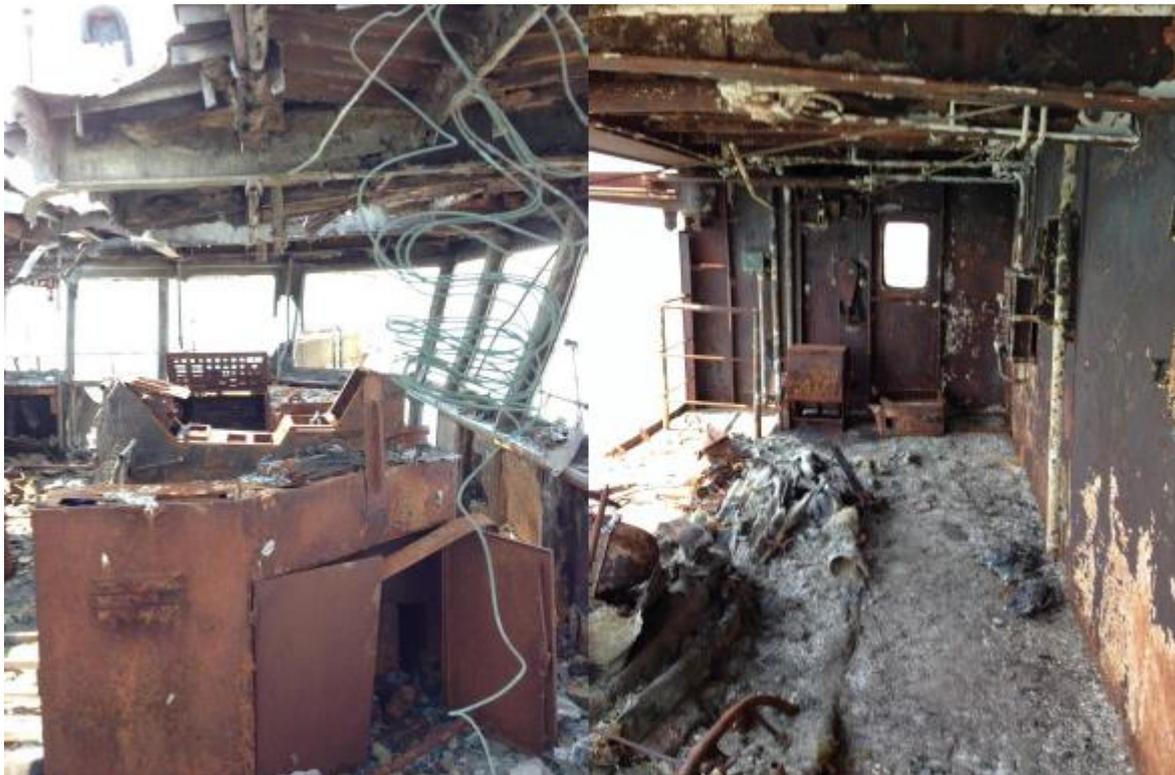
Figure 6. Bridge and accommodation space after fire
