REPUBLIC OF TURKEY
MINISTRY OF TRANSPORT, MARITIME AFFAIRS
AND
COMMUNICATION
Accident Investigation Board

**Marine Safety Investigation Report on the Maritime Accident
Caused by the Collision of Vessels**

LILIAN Z
and
MURADIYE

Izmit Bay/Off the Coast of Eskihisar
14TH JANUARY 2015

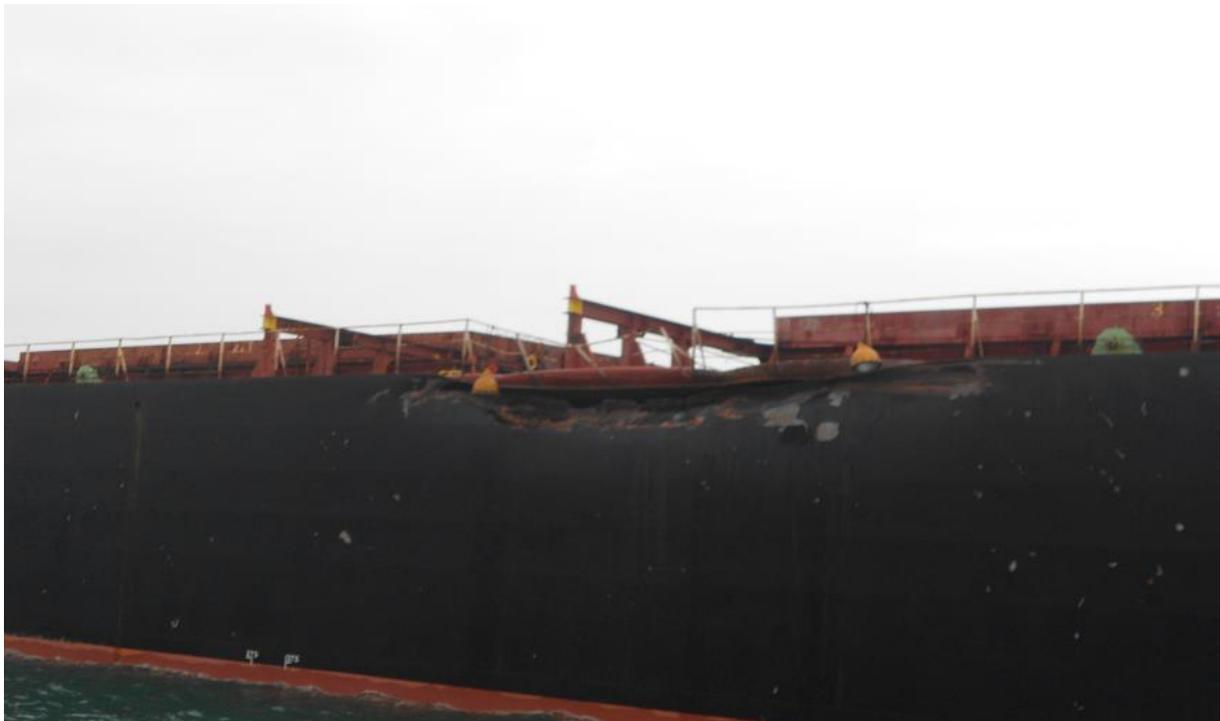
Image 6: Damage on the Side of the Bulk Carrier LILIAN Z

After the collision, there was a rupture on the side shell plating of the bulk carrier LILIAN Z, which is in line with the port side topside tank number 3, and deformation sustained by guard rails. Additionally, there are a few minor deformations on the deck shell plating.

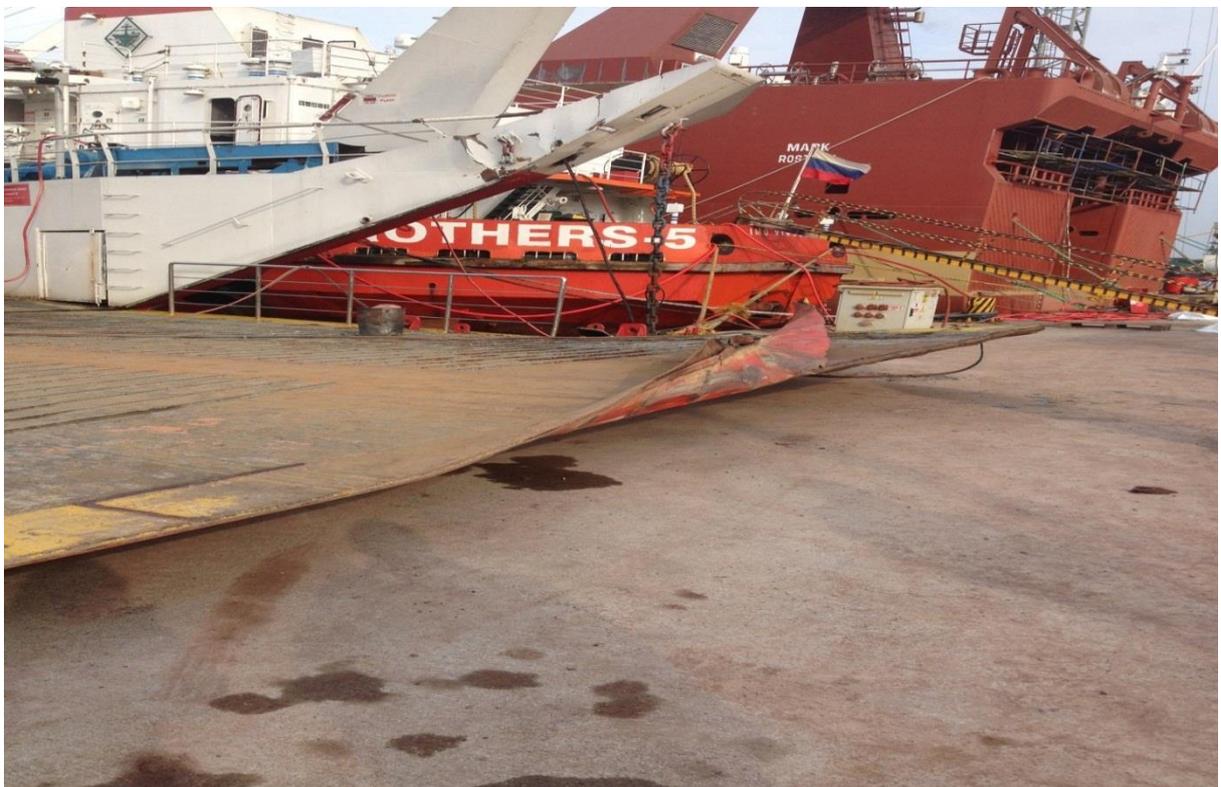
Image 8: Damage on the Ramp of the Ferry MURADIYE

After the collision, the very end of the ramp of the ferry MURADIYE had a minor deformation on the port side.
