FINAL MARINE SAFETY INVESTIGATION REPORT

NAME AND TYPE	: MEDSUN - Primitive Wooden Vessel
FLAG	: Turkey
LOCATION OF ACCIDENT	: Killebükü – Göcek / MUĞLA
DATE OF INCIDENT	: 16.09.2019 / 05:00
CASUALTIES	: 1 Dead, 4 Injured
DAMAGE AND POLLUTION	: Fire and Sinking / No Pollution

Committee Decision No: 29 / DNZ-04 / 2020

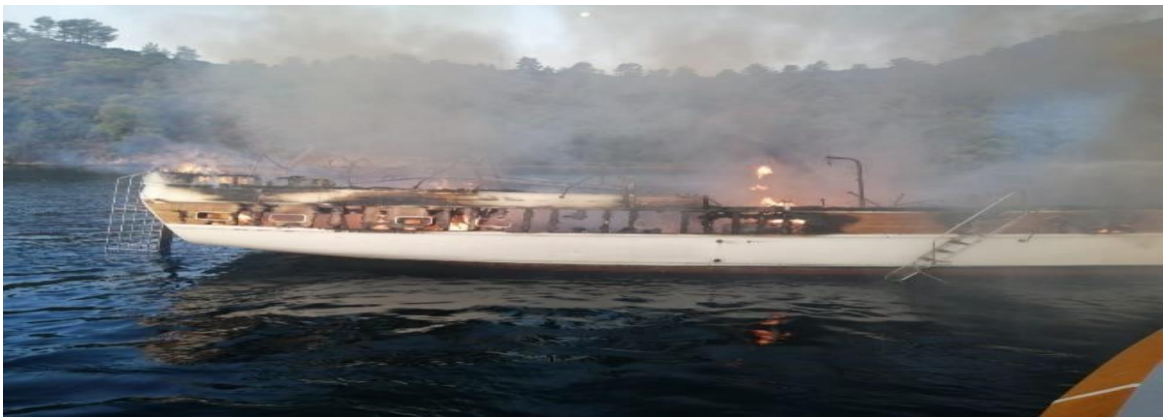
Picture 4: The Moment of Burning of the Vessel

The fire was first noticed by the passengers on KUZHEY UYGUN named tour vessel in the same bay outside the vessel and the Coast Guard Command was first notified. The burning vessel and other vessels around it were alerted by the captain and crew of the same vessel by horn and radio. The first rescue operation was carried out by the captain of the vessel and crew with the vessel's service boat to rescue the survivors.

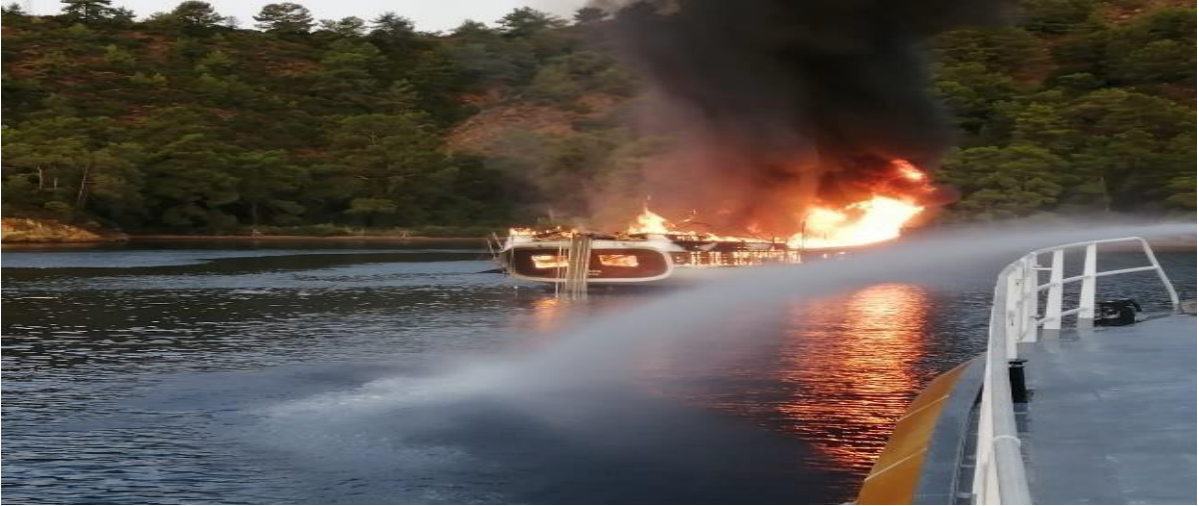
Picture 7: Fire extinguishing works of the burning MEDSUN

The first response to the fire was carried out by KIYEM-5 Vessel belonging to the General Directorate of Coast Guard around 06:50. The fire was extinguished at 07:50, but the vessel sank at 08:30.

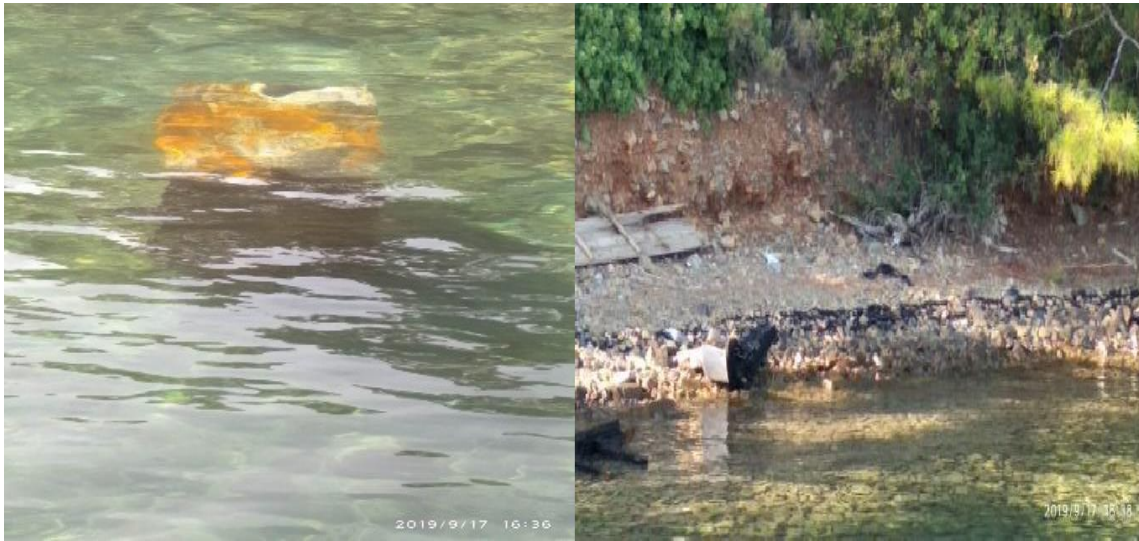
The vessel sank in the area where the accident occurred. Diesel and oil pollution occurred on the surface and bottom of the sea where the vessel sank. At the request of Göcek Port Authority, the vessel was taken out of the sea on 22.11.2019, but it was decided that it had become unusable and its registration was cancelled.

Pictures 8-9: Coastal and marine pollution caused by the burning of the vessel

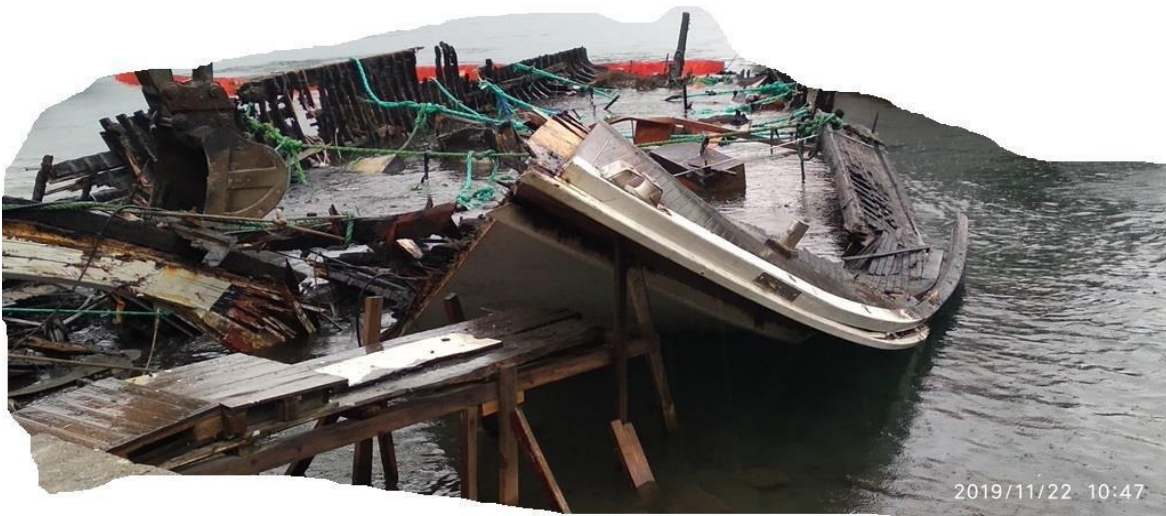
Picture 14: Images of The MEDSUN after it is pulled out of the water

MEDSUN Vessel is a primitive wooden Vessel. The materials used are easily combustible materials such as wood, paint and glue. Most of the vessel was burned and eventually sunk in the accident. Despite being pulled out of the sea after the vessel sank, the damage was too great for it to be floated again. Therefore, the evidence necessary to understand the exact cause of the accident could not be reached since the vessel was completely burned and sunk.

There are five refrigerators in total, three in the kitchen section, one in the bar and one in the wheelhouse, as the equipment that will cause fire onboard. One cabinet in the kitchen has a deep freeze feature. There is also an electric water heater in the kitchen. However, there are three tubes in the kitchen, one gas cooker operated by tube, two of which are full and one of which is empty.

However, according to witnesses, the fact that the fire was initially seen as black smoke in the kitchen suggests that the fire may have originated from the electrical equipment in the kitchen. Only refrigerators operate during the hours of the fire and they are supplied from the batteries onboard.

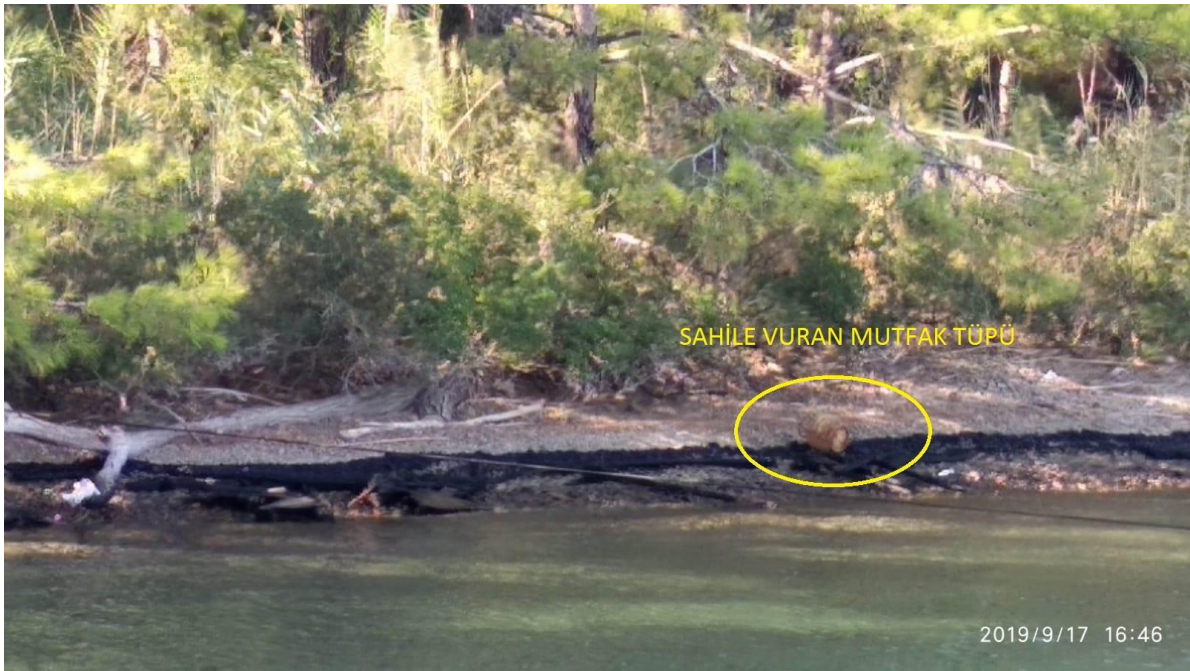
Picture 15: A kitchen tube that washes ashore from the MEDSUN

Again, the occurrence of explosions in the future suggests that it may have been caused by the tube in the kitchen. Considering that the kitchen onboard is in front of the captain's cabin, the captain waking up with the sound of an explosion reinforces this claim. It has been evaluated that the explosions occurred in the later period may have been caused by the spare tubes stored under the wheel.

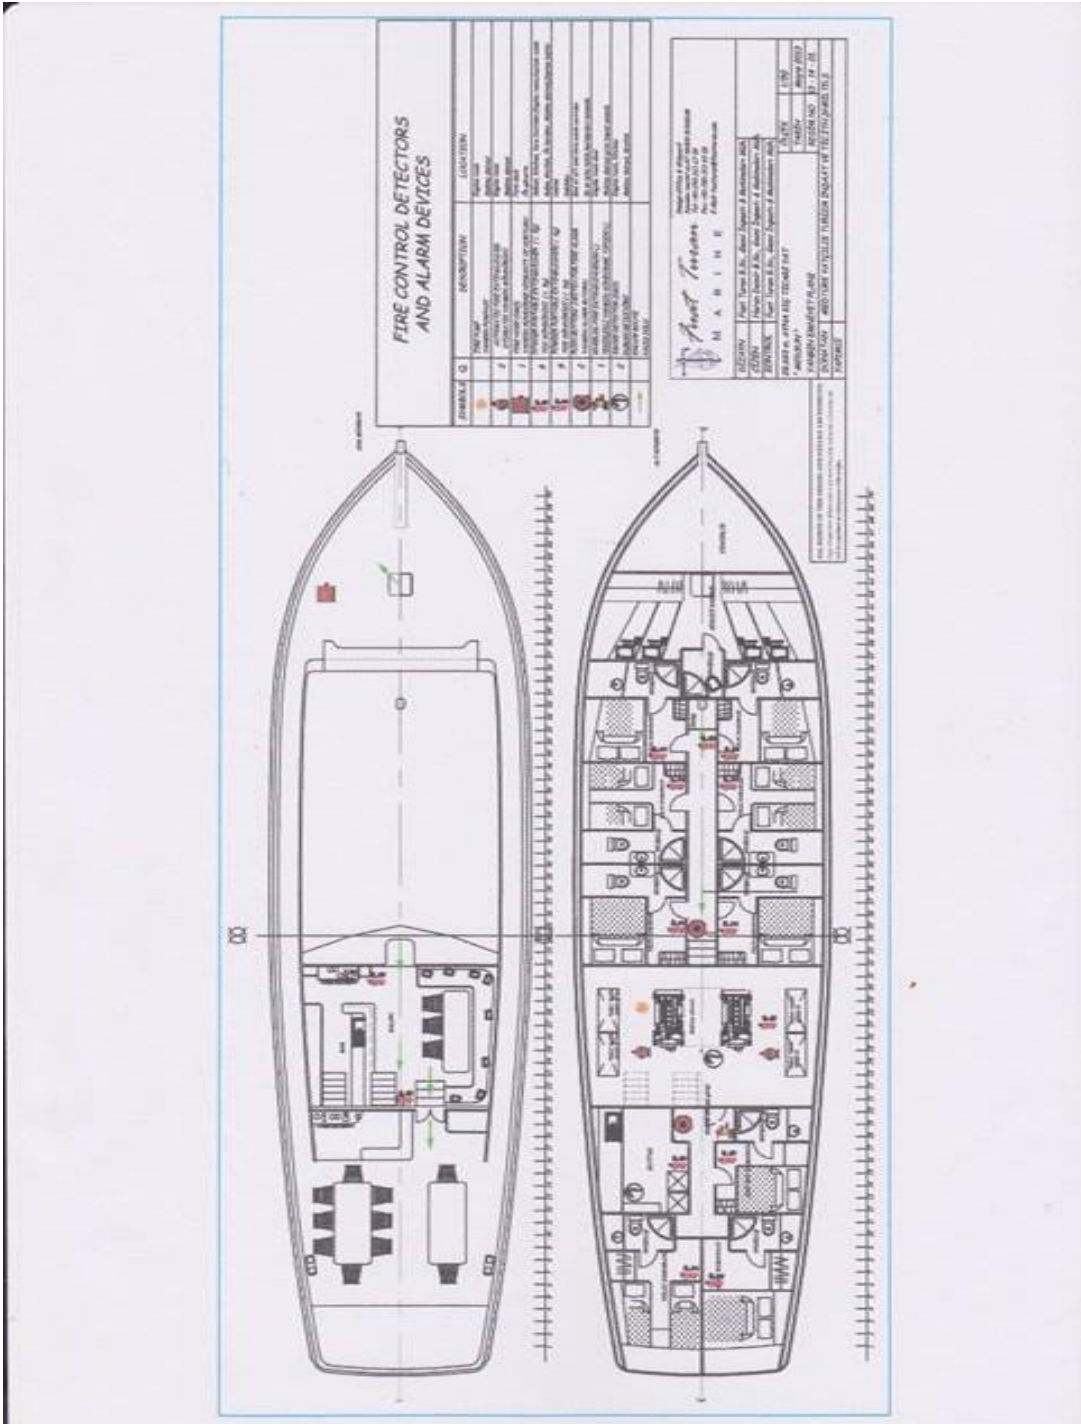
Picture 16: Fire Layout Plan of MEDSUN

However, there are two fire alarm buttons onboard. These are located at the end of the front and rear cabin corridors. Since the fire covered the corridor, these buttons could not be reached. Therefore, the Captain, who was the first to notice the fire, was unable to activate the alarm and had to use other methods to warn crew and passengers.

According to the fire plan, the smoke detectors are available in the kitchen and engine room, but they did not work in the fire. According to the Captain's statement, the batteries of the smoke detectors were checked and even some of them were changed during the marine survey performed while the Certificate of Seaworthiness was issued. The fact that the smoke detectors onboard do not work during the fire suggests that the fuses on the electric panel may have been switched off beforehand.

However, during the examination of this situation, sufficient evidence could not be reached. However, the failure of fire alarm systems caused the fire not to be noticed by the crew at an early stage and it grew. This is thought to be one of the factors causing the accident that resulted in death.

- 13/04-20** To develop a procedure for effective inspection of the seaworthiness and adequacy of portable electrical devices and electrical equipment used in vessels without class society's approval,
- 14/04-20** To take effective measures in order to check the periodic emergency drills are carried out and recorded, including informing passengers about emergencies, throughout the certification of such vessels, in particular.
- 15/04-20** To make a regulation in order to operate fixed fire pumps remotely, in such vessels.

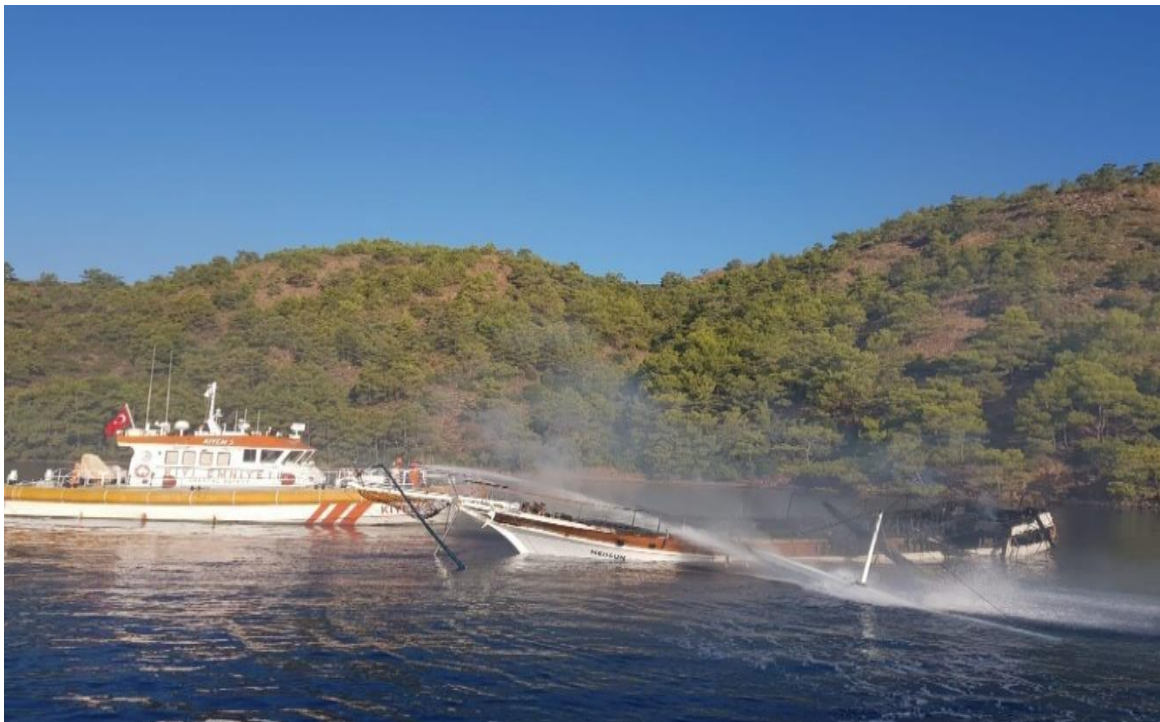
Picture 18: Appearance of MEDSUN after extinguishing

Considering the fire on the MEDSUN, the very rapid progress of the fire was since the construction material of the vessel was very fast burning material.
