**Accident Investigation Report On**  
**The Flooding and Foundering of**  
**MURAT HACİBEKİROĞLU II**

**ANTALYA, off the Coast of Alanya Port**  
**19th of September 2016**

**06/DNZ-01/2017**

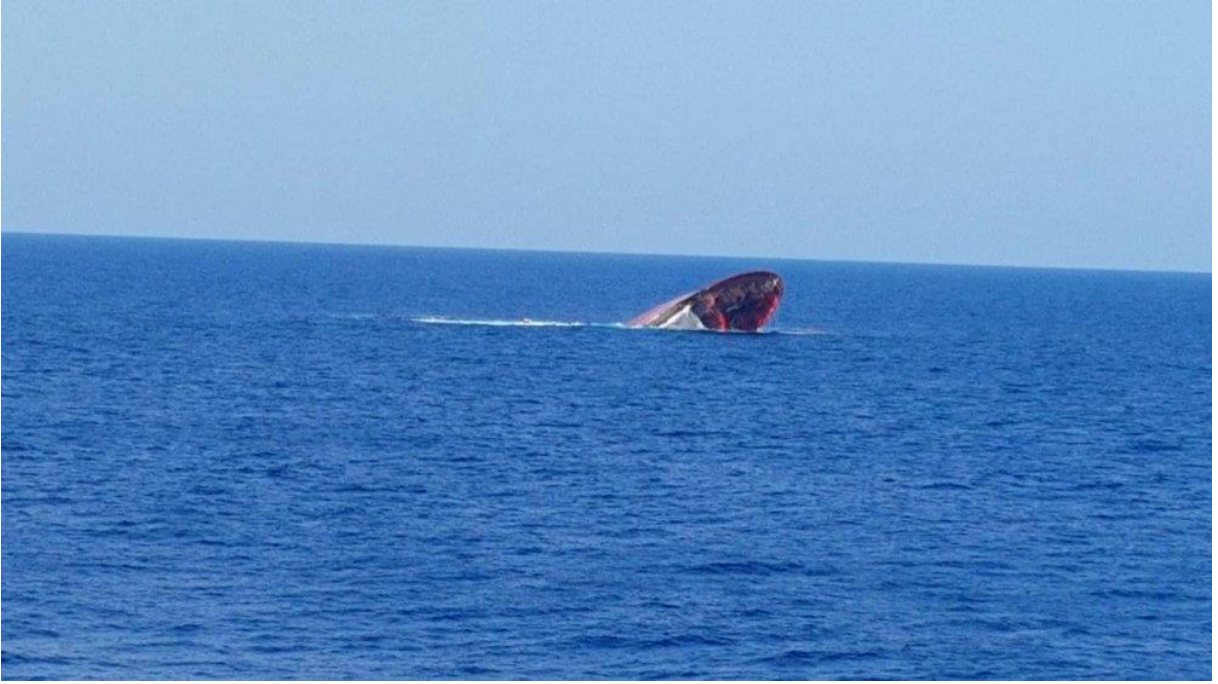
**Figure 5:** Sinking moment of MURAT HACIBEKİROĞLU II

Meanwhile MURAT HACIBEKİROĞLU II sank completely at 15:36.

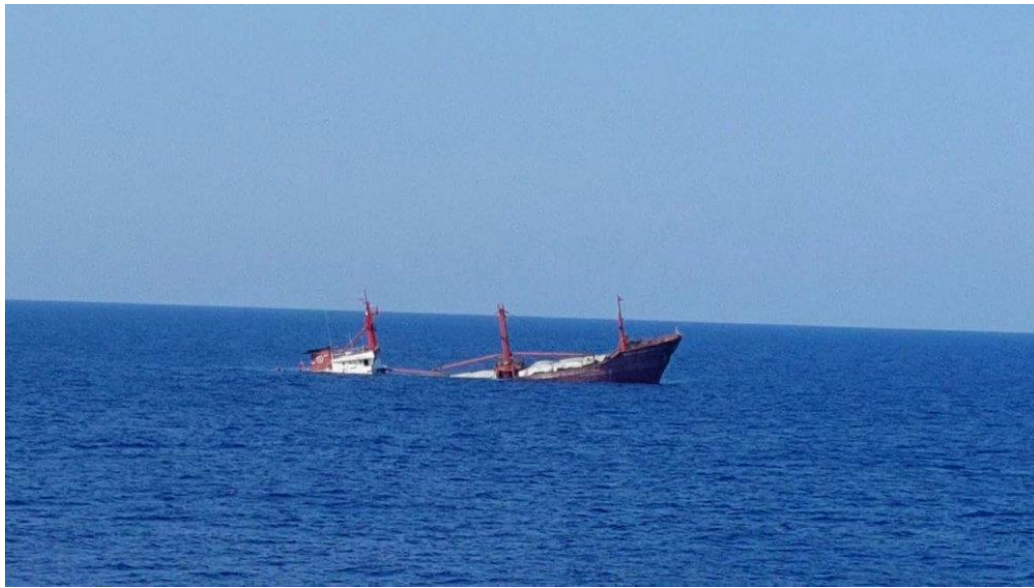
**Figure 7:** Snapshot of the sinking

was sinking, showing sinking of the ship from the aft side without making heel to starboard or port side, clear away the possibility of flooding of the holds (Figure 7).

- 2.** It is assessed that, the reason for flooding of the ship was because of a failure occurred in the engine room seawater lines or originated from failure of keel bottom plate of the engine room.

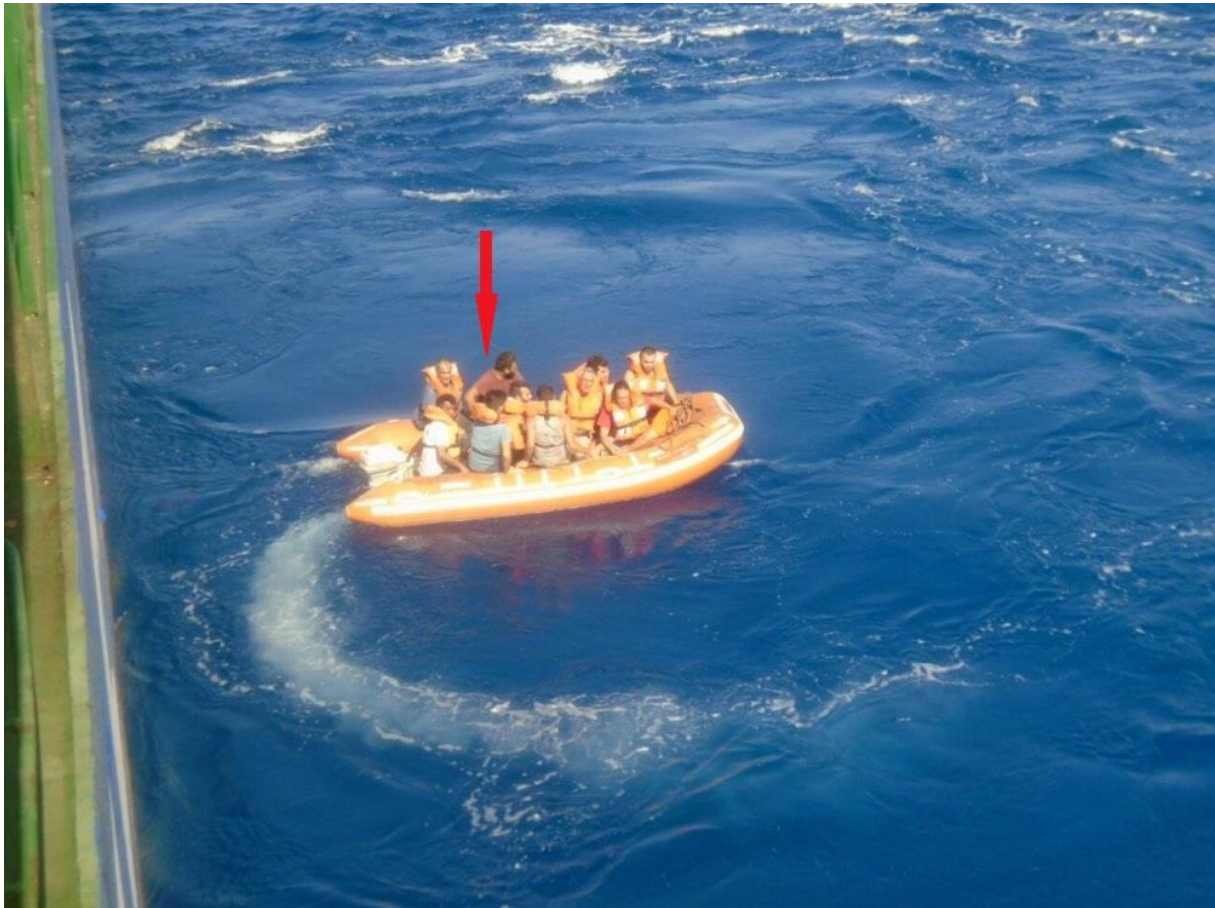
**Figure 8:** Casualty crew members on the rescue boat

It attracts the attention that and it is an another observation that the capacity of the rescue boat, which was used instead of liferaft, was 6 persons while the crew comprised of 10 persons. In addition, it was observed that one personnel was not wearing a life jacket as can be seen from Figure 8.

- 7.** It was observed that one of the crew who abandoned the ship was not wearing a lifejacket.

- 1.** Ensure that emergency drills are being carried out periodically and effectively on the ships under its' fleet or management,
- 2.** Ensure that effective watchkeeping in the engine room is being carried out on the ships under its' fleet or management and periodic controls are being carried out that are required in the engine room.
