**MARINE SAFETY INVESTIGATION REPORT ON
VERY SERIOUS MARINE CASUALTY**

VESSEL NAME : M/V OLMA
IMO NO : 8004806
FLAG OF THE VESSEL : Honduras
LOCATION OF ACCIDENT : Port of Mersin Anchorage Area No. 2
DATE and TIME OF ACCIDENT : 09 February 2022 / 09:17 (UTC+3)
FATALITY/INJURY : 1/-
DAMAGE CONDITION: : None
ENVIRONMENTAL POLLUTION : None

Board Decision No: 01 / D-01 / 2023

Date: 16/01/2023

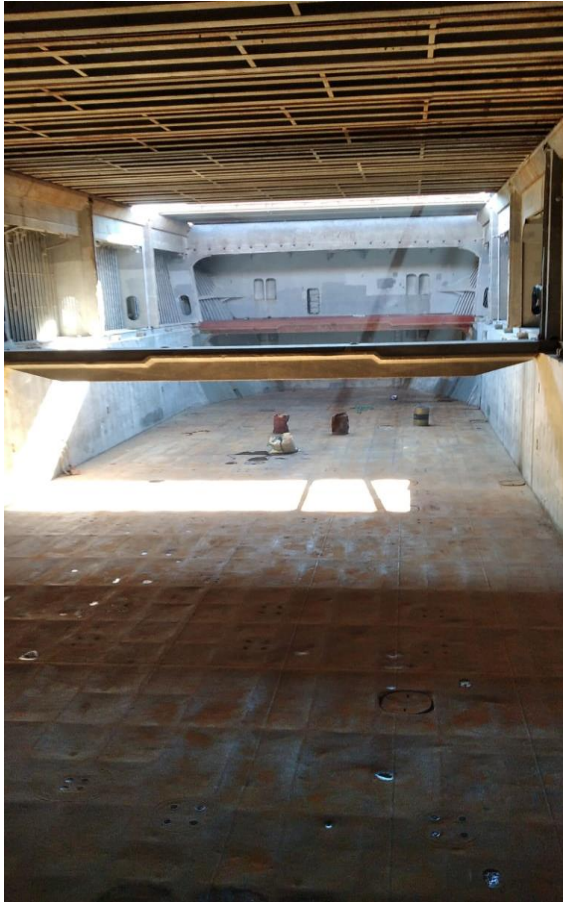
Image 5 General View of the Vessel's Hold

At around 09.00, the Second Engineer called the Master on VHF channel 77, who was waiting for the weather conditions to get better while traverse sailing on the bridge, and reported that the Chief Officer had fallen from a height of about 4 metres (tween deck) to the hold floor (**Image 5**) and sustained a broken leg and a head injury.

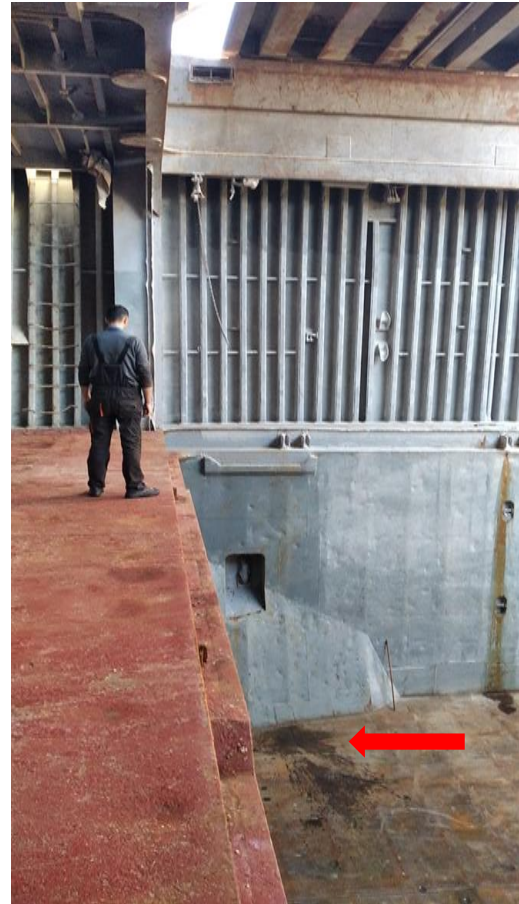
Image 6 Illustration of the Casualty at the Scene of the Fall

The cause of why the casualty, Chief Officer fell onto the hold floor from the tween deck of the hold was not entirely identified and probabilities were evaluated based on the information and documents obtained from the accident investigation.

On the other hand, it would be usual for the vessel in ballast condition to heel towards the starboard/port side of the vessel with serious angles in very short periods due to the effect of the wind blowing suddenly and the high seas. Considering that the casualty was walking on a path with a width of about 1.5 metres, it is clear that he could have lost his balance and fallen into the hold due to the heeling of the ship on both her starboard and port sides at serious angles.

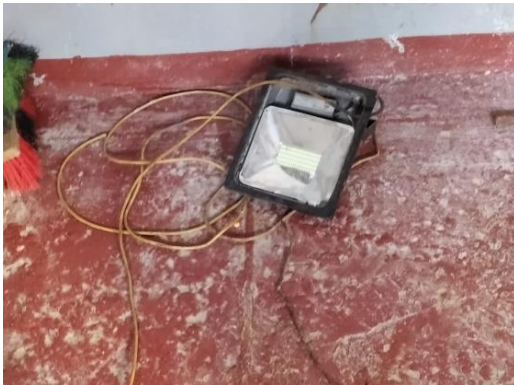
Image 8 Portable Light

The sun rose at 07.29 on the day of the accident. The hatch covers of said vessel, which was waiting in ballast condition, were closed. However, the portable lights (Image 7) in the hold into which the casualty went were inadequate and given that the flashlight he was carrying (Image 8) was inadequate, it is considered that the Chief Officer, who was walking through the tween deck with a walking width of approximately 1.5 metres, could not fully see the footing due to the inadequate lighting and may have fallen down.

3. There was not sufficient light in the hold where the Chief Officer went down. The flashlight that he used for lighting was unable to provide enough visibility since the hatch cover was closed.

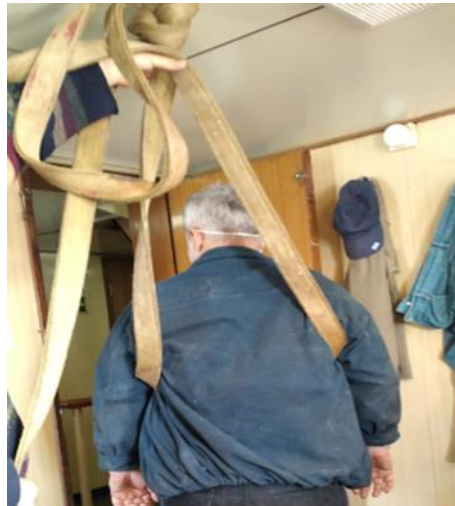
Image 10 Illustrated Recovery of the Casualty

In case of a fall from height, the casualty must be recovered by professional teams and with adequate and certified equipment. Even though the casualty is considered to sustain a head injury, other unseen vital organs may have been injured due to falling from a height. These life-threatening injuries include a neck fracture (if not recovered properly, even if the patient survives, he may still have to live a life dependent on the bed due to spinal cord injury), injury/bleeding in the internal organs due to a fall, the swallow of bleeding from head/neck area into lungs with respiration when the patient is positioned facing down, and complete cessation of difficult but ongoing respiration of the patient, as well as the leak of gastric stuff into the lungs as the stomach becomes empty when the patient is placed facing down. In such cases, the patient's state of consciousness should be monitored until professional teams arrive at the scene. If the casualty can be accessed, he must be observed, first by trying to communicate, then with gentle touches to the shoulder/body whether to respond or not, and if he cannot be reached, it must be observed whether he reacts to the voice. If the airway can be checked, his breathing must be maintained; if there is visible bleeding, the bleeding must be tried to be controlled by proper precautions. Even if the casualty is taken out from the place where he has fallen, since the medical teams are unable to respond under appropriate conditions, taking the casualty out unconsciously or without the proper equipment before the medical teams arrive may cause secondary injury and stroke.

Therefore, the International Medical Guide for Ships clearly states the correct course of action to be taken under the heading “Response to a Fall from a Height”. After the casualty was found by the Second Engineer, his colleagues made efforts in good faith to recover the casualty from the scene. Within this context, the ship’s crew tied the casualty with the suspender attachment (Image 10) in order to take the Chief Officer on deck and then, carried him to his cabin. It is clear that the practices by the ship’s crew both during the recovery of the casualty from the hold and during the transfer to his cabin were not in accordance with the procedures stated in the International Medical Guide for Ships under “Response to Fall from a Height”. Based on the above remarks, it is considered that the recovery of the casualty out of the hold from which he had fallen was not duly executed.

4. The helmet of the casualty was not on his head at the time of the accident.
5. The process of recovering the casualty from the place where he fell to carrying him to his cabin was not in compliance with the procedures described in the International Medical Guide under "Response to Falling from Height".
