## FINAL MARINE SAFETY INVESTIGATION REPORT

**VESSEL NAME** : M/V SERVET ANA  
**IMO NO** : 9443774  
**FLAG OF THE VESSEL** : Turkish  
**LOCATION OF ACCIDENT** : 11.6 miles southwest of the coast of Liberia  
**DATE and TIME OF ACCIDENT** : 3<sup>rd</sup> of October 2020 - 24:00  
**FATALITY/INJURY** : 1/1  
**DAMAGE CONDITION:** : A Rescue Boat has been missing  
**ENVIRONMENT POLLUTION** : None

*Board Decision No: 13 / D-05 / 2022*

*Date: 20 / 07 / 2022*

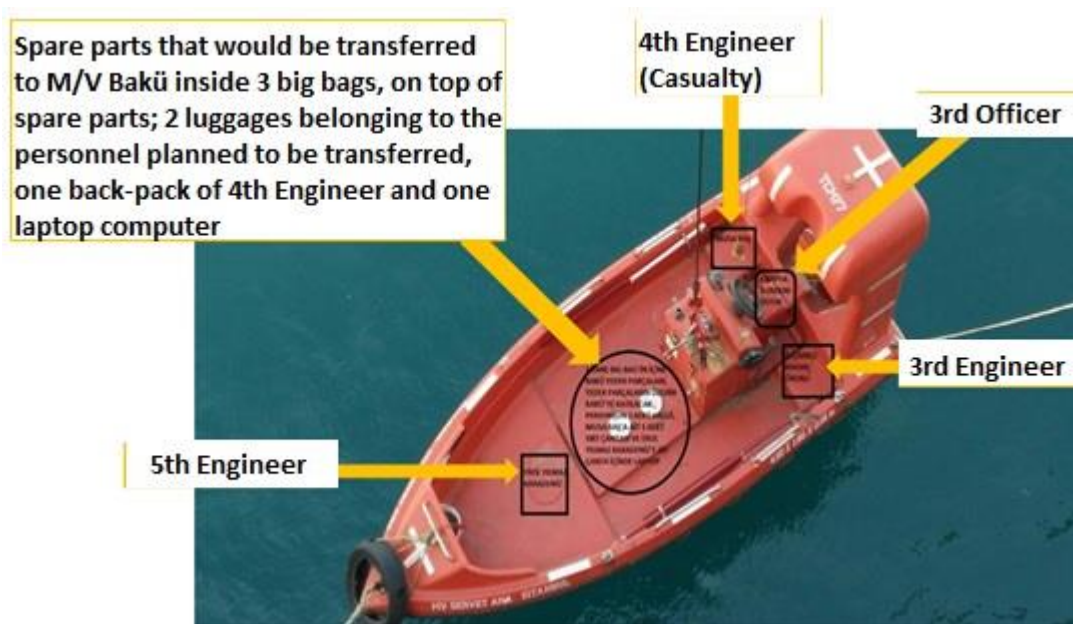
*Image 4 Layout of the Crew and Supplies Aboard the Rescue Boat*

On 3<sup>rd</sup> of October 2020, at around 24.00 hours, it was waited for the weather to lower, and the rescue boat located on the starboard quarter deck began to be launched using the davit of the rescue boat directed by the Chief Engineer. The seating and layout aboard the rescue boat appear in the image (Image 4).

The rescue boat capsized immediately after being launched into the water, and the four people were over board. When the master and other crew members saw the accident on the aft deck, they released the side ladder and throw the life buoys along with the heaving lines to catch the crew members who had been over-board. At first, the casualty, IV. Engineer and V. Engineer appeared to be holding on to the side ladder, but soon after, both of them started to move away from the side ladder. The other two crew members climbed up the side ladder with their own efforts. The master decided to release the enclosed lifeboat to rescue the two casualties who were unable to hold on to the side ladder and began to drift into open water.

3. Although it is considered that a reverse wave was the cause of the boat turning over immediately after it was launched into the water, the actual weight of the loads and materials that were brought into the boat is unknown. Furthermore, it was not secured to the boat so that it would not slide off.

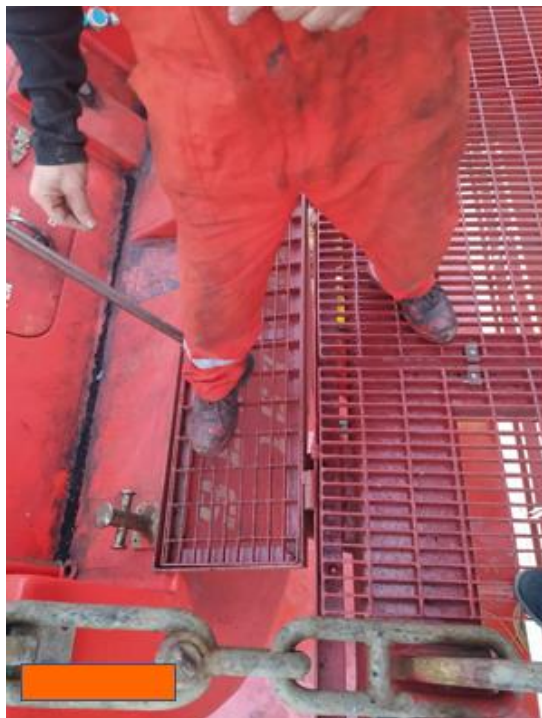
*Image 5 Representative Location of the Casualty, the Oiler Before the Accident*

Although he was not given an assignment during the launch of the enclosed lifeboat according to the muster list, he was critically injured after falling on the quarter deck from the deck where the lifeboat was located while removing the safety pin of the enclosed lifeboat. Following the accident, he was handed over to the medical staff at the port of Monrovia for being hospitalized. Following his first treatment in Liberia, he was

The Image 5 represents the location where the Oiler stood before falling and getting injured afterwards, during the launch of the enclosed lifeboat from the vessel M/V Servet Ana.

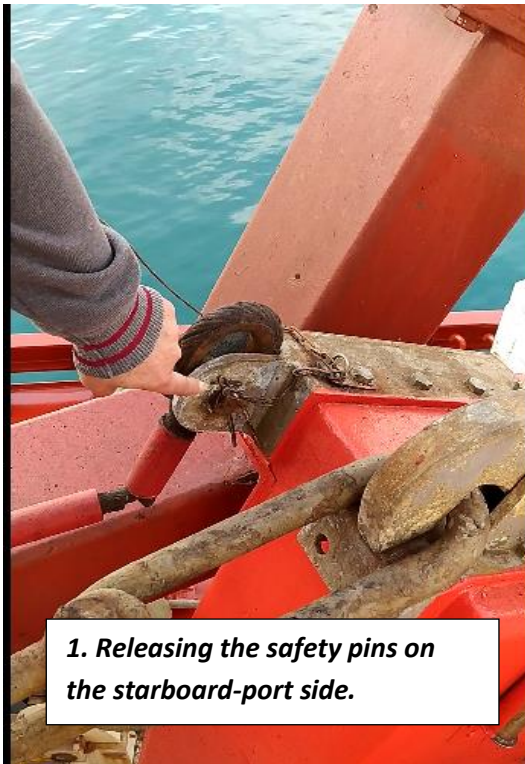
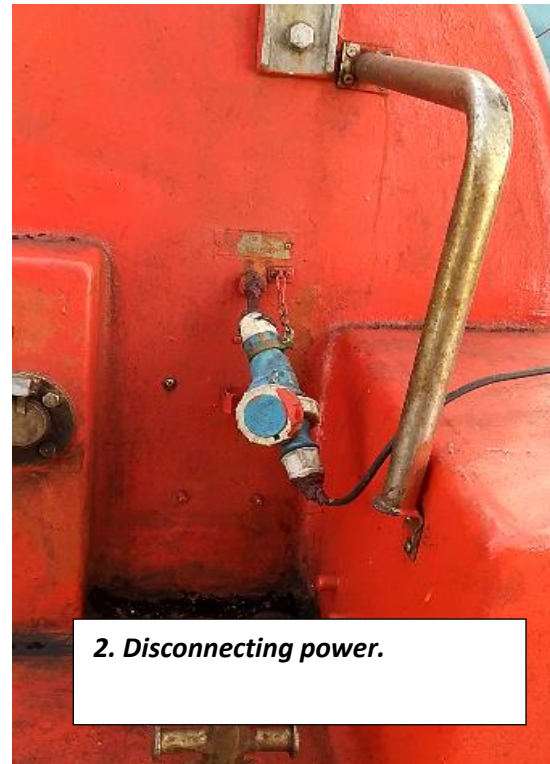
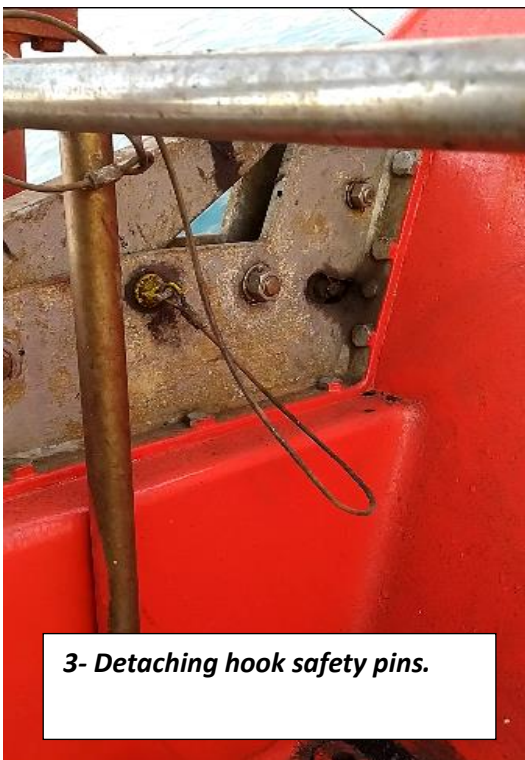
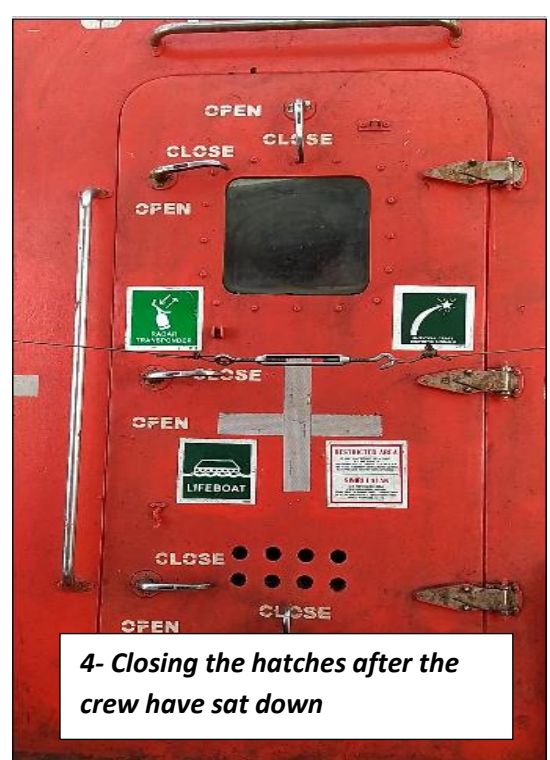
*Image 6 Launching Steps of the Enclosed Lifeboat*

The procedures to be followed for the operation of launching the enclosed lifeboat, the titles of the crew members who will carry out this operation, and the steps to be taken are all clearly stated in the company Safety Management System (SMS/ISM) manual. Image 6 provides the order of these steps.

5. The sequence and procedures described in the ISM guideline were not followed during the lowering of the enclosed lifeboat of the vessel M/V Servet Ana. The oiler sustained injuries while lowering the enclosed lifeboat, and the crew members who participated in the operation did not conform to the muster list.

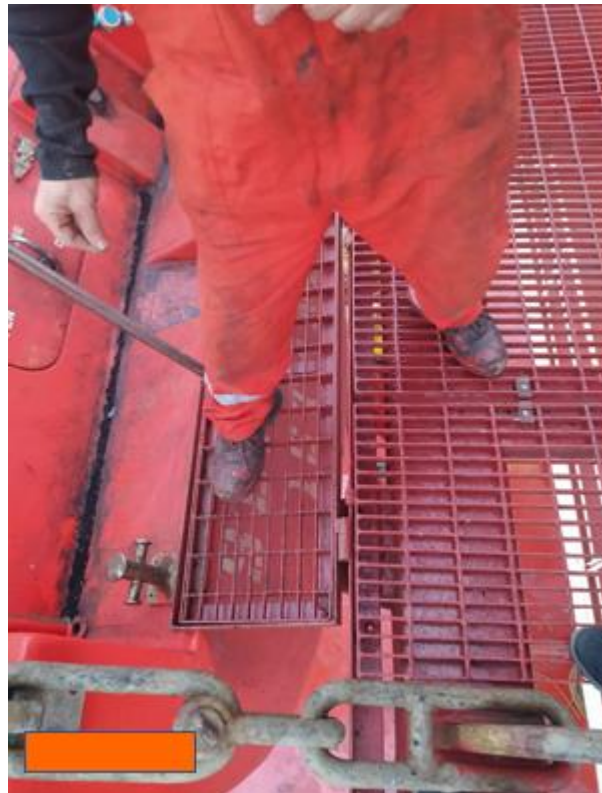
*Image 7 Representative Visualization of the Location Where the Casualty, the Oiler, Stood on the Platform*

The master decided to release the enclosed lifeboat in order to rescue the casualties at sea as quickly as possible. Concordantly, the master was the first to get in the lifeboat, followed by the II. Engineer and the III. Officer. The safety pin was stuck during the operations to release the enclosed lifeboat as quickly as possible since the safety pin of the release hook of the boat could not be unlash in the order indicated above. The oiler, in an effort to be of assistance in freeing the stuck pin, tried to dislodge it by hammering. The oiler, meantime, had one foot on the vessel and the other foot on the moveable platform, which allows him to move between the life raft and the vessel (Image 7). During this process, the lifeboat rapidly fell into the water as a result of the sudden dislocation of the pin, while the oiler was severely injured by falling onto the aft deck, which was roughly 5 meters below the floor, as the platform folded.
