MARINE SAFETY INVESTIGATION REPORT

VESSEL NAME : PALLADA
IMO NO : 8866931
FLAG OF THE VESSEL : Cameron
PLACE OF ACCIDENT : Port of Karadeniz Ereğli
DATE and TIME of ACCIDENT : 19 November 2023 - 09:51 (GMT+3)
FATALITY/INJURY : -/-
DAMAGE DEGREE: : The vessel broke into two pieces and grounded
ENVIRONMENT POLLUTION : None

Board Decision No: 17/D-05/2024

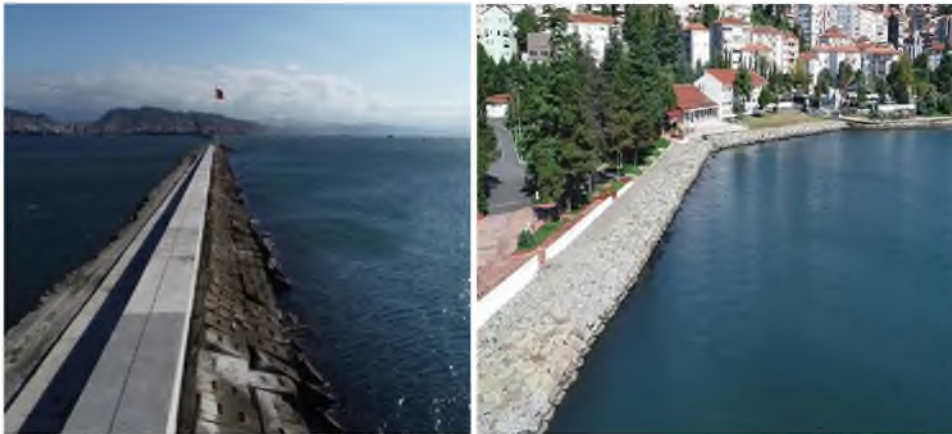
Image 4 Images of the North Breakwater after Renovation

As a result of the investigations on wave overtopping and losses in the cross-section of the inner layout on the North Breakwater of the Port, repair works started on 15 December 2017. A 380 m crown wall was constructed, the main breakwater was repaired, 390 m of rubble mound fortifications were built, and the breakwater was repaired and renovated and completed on 30 November 2019.

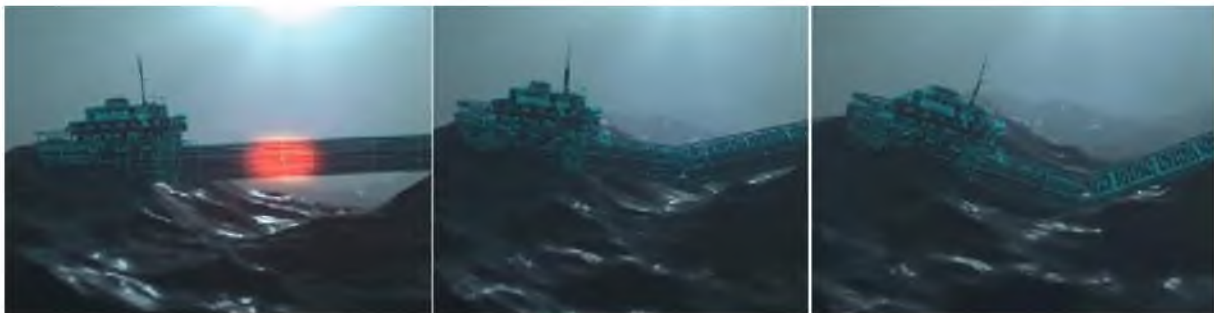
Image 8 Illustration of the Breakage of PALLADA

While the vessel PALLADA was on the starboard anchor in Anchorage Site No. 4 of the Port of Ereğli Bozhane, she was informed about the meteorological forecast that the weather and sea conditions getting worse as of 17 November 2023. Immediately after the last meteorological report received on 19 November 2023 at 08:30 on the date of the accident, sea and weather conditions worsened. Although the main engines and generator were operational, the vessel could not hold at anchor, and the anchor began to dredge. According to the Beaufort Scale¹⁰, the wind speed increased to a full gale between 09:45 and 09:50. Subsequently, upon the breaking noise heard from the vessel, it was understood that the vessel broke at 09:51.

The vessel PALLADA is equipped with four cargo holds, and due to the structure of the holds of the vessel, it has large hatch covers, and therefore, large hatch apertures. Due to this structural feature, considering the metal fatigue caused by the advanced age of the vessel, it is inevitable that the hatch apertures will be subjected to major diagonal deformations and impact stresses under complex torsional moments in waves. Since the torsional strength of the vessel PALLADA should be measured at the structural design stage, the extent to which the structure of the vessel affected its breakage was not evaluated. However, it was evaluated that the breakage took place in the midship part of the vessel, where the stress was relatively higher than in the other parts of the vessel, and this was the main factor in the breakage of the vessel exposed to the waves caused by worst weather conditions.

- 5.4 The bridge crew of PALLADA selected an inappropriate anchorage site considering the meteorological conditions.
- 5.5 The vessel broke into two pieces due to the worn-out river-type old hull structure (metal fatigue) under unfavourable weather-sea conditions and the presence of an unsuitable anchorage site.

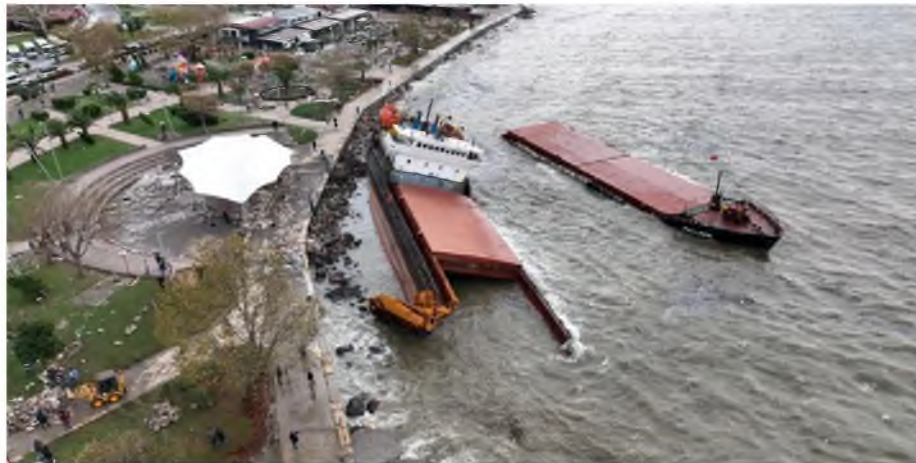
Image 9 Condition of Broken Parts of PALLADA

The broken vessel drifted and leaned against the coastline in two separate pieces. At around 10:00, the vessel's crew asked for rescue help from the Port Authority and the pilotage organisation via VHF¹¹. Meanwhile, the Turkish Search and Rescue Centre (AAKKM) received an EPIRB signal from the vessel PALLADA via the COSPAS-SARSAT¹² system at 10:11 on 19 November 2023 and notified Turkish Radio for a search. All 13 crew members on board were safely evacuated from the vessel with the cableway¹³ system established by the local fire brigade and AFAD teams.

The vessel was encircled with a sorbent barrier against the possibility of environmental pollution on 21 November 2023 at 12:00, and pollutants (10,000 kg), including oil, fuel, and bilge wastes, were removed from the vessel at 15:00.

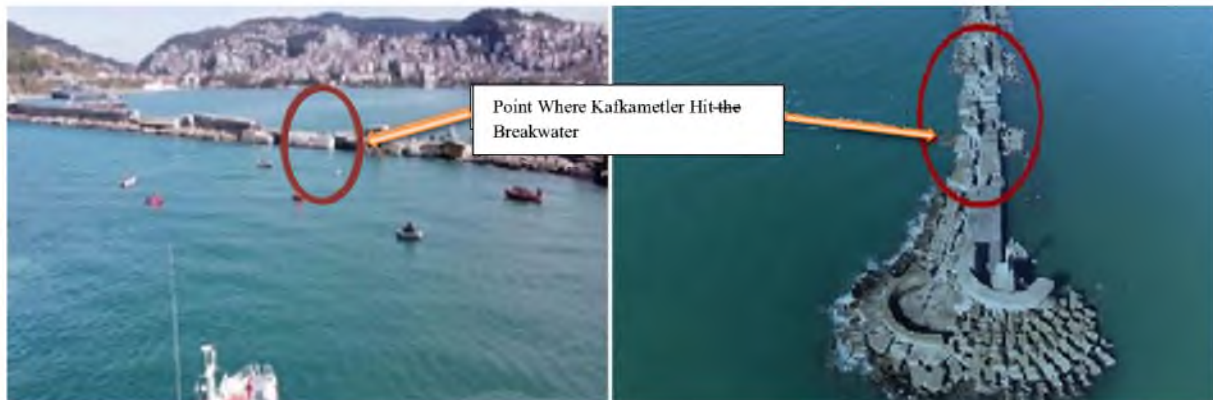
Image 10 Condition of the North Breakwater after Damage

Due to the persistence of wave overtopping problems, the main breakwater crown wall was damaged again and the interior layout ripraps were also deformed.

tonnes. Finally, the outer protective layer of the breakwater between Km:0+200- Km:0+795 meters was also furnished with concrete blocks of 40 tons. **The said breakwater was designed by allowing the wave to top over the breakwater at certain ratios since the formation of a quay on the main breakwater was not considered.**

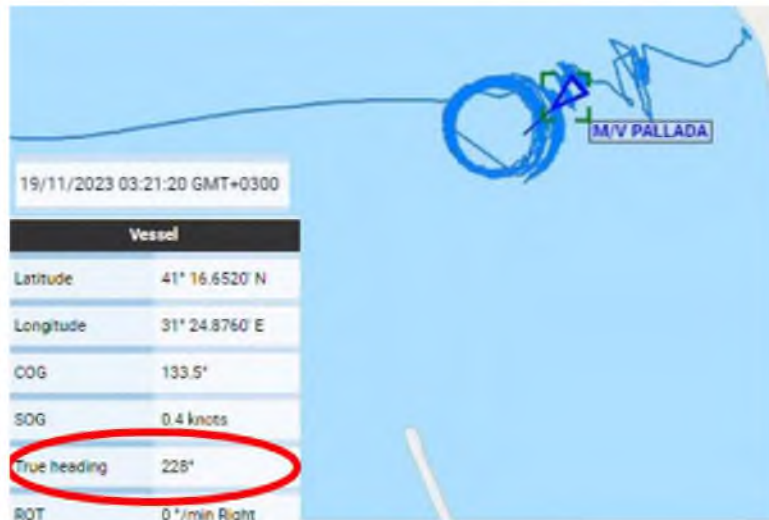
Image 14 Exposure of the Vessel PALLADA to High Seas and Gale

PALLADA, which had been waiting on the starboard anchor in the anchorage site inside the harbour breakwater until the date of the accident, started to be exposed to the south and south-west wind and sea conditions that became effective from the first hours of 19 November. (Image 14)

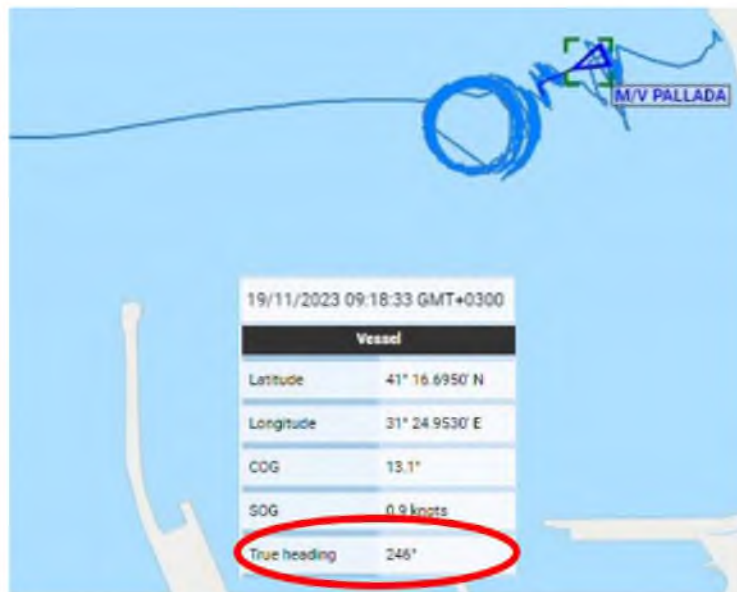
Image 15 Dredging Anchor of the Vessel PALLADA due to Storm

The AIS logs of the vessel indicated that the vessel, which was affected by the storm that aggravated, especially as of 08:00 on 19/11/2023, started to dredge her anchor and consequently moved in zigzags where it was stationed. (Image 15)

Considering that the vessel PALLADA slacked away 1.5 shackles, it is understood that the vessel did not slack away the appropriate length of the anchor chain for safe anchoring under normal conditions. In fact, considering the fact that the vessel is ballasted and the impact of weather conditions on the anchorage site, she should have slacked away more for safe

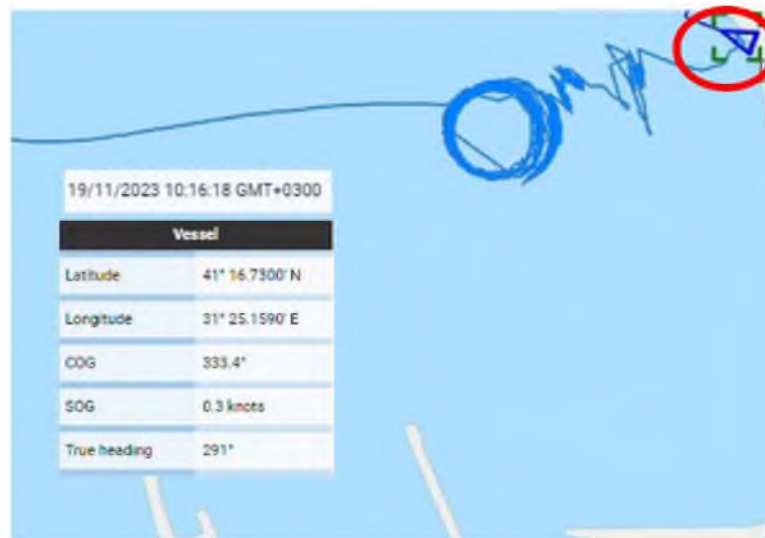
Image 16 Location Where the Vessel PALLADA Was Dragged Ashore

Due to the ongoing exposure to severe sea and weather conditions, the vessel PALLADA (Image 16) first broke into two pieces at its location and then grounded at around 10:16.

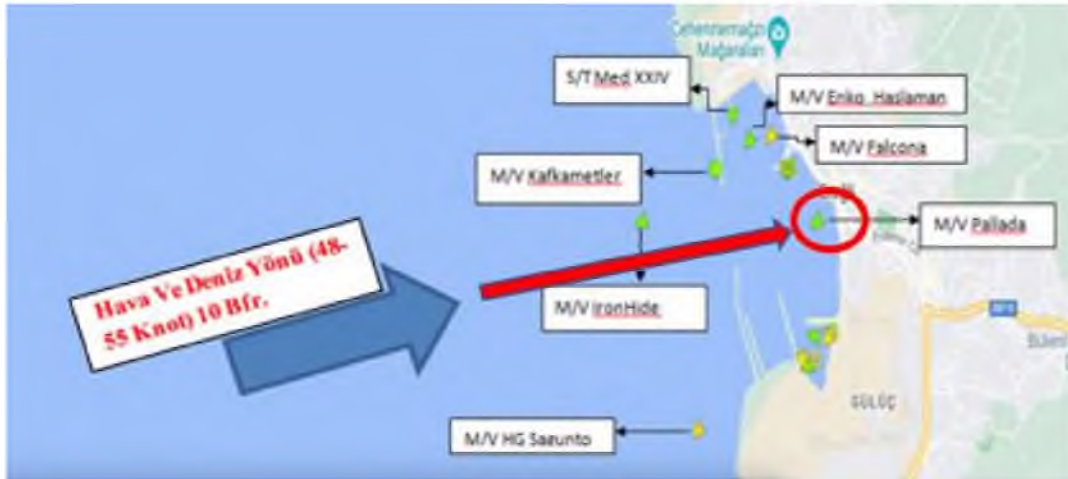
Figure 5 Location of the Vessel PALLADA Exposed to Adverse Weather Conditions Inside the Breakwater

When the accident was analysed holistically, it was clear that the north and south breakwaters that protected the berths inside the breakwaters of the Ereğli Port against the effects of heavy weather and seas could not protect the offshores of Bozhane, where the vessel PALLADA was anchored, against the storm that blew from the west-southwest (Figure 5).

Nevertheless, although the anchorage site inside the breakwater where the bridge crew of the vessel sheltered to protect the vessel from the approaching storm **saved the vessel from heavy weather conditions at first, the vessel began to be exposed to heavy weather and sea conditions as the storm shifted to the southwest. This** suggests that the bridge crew of PALLADA did not properly analyse the weather reports.

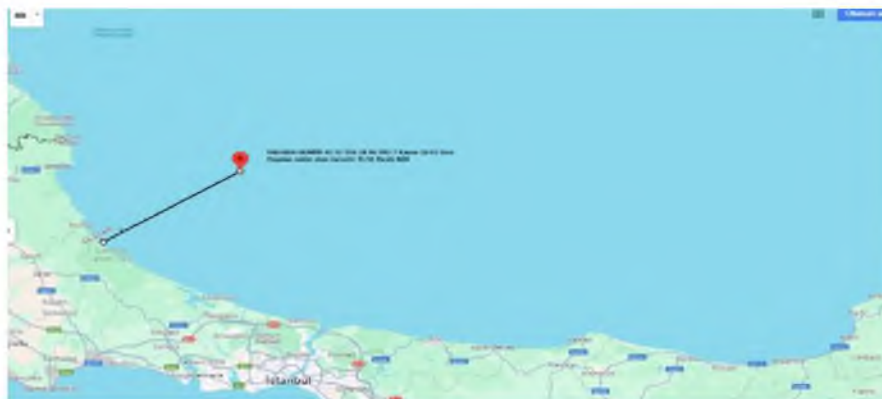
Image 23 Nearest Distance of PALLADA to the Shore

The certificates of the vessel **clearly restrict that she can navigate at a maximum distance of 20 nautical miles offshore in the Black Sea and in meteorological conditions with a maximum wave height of 3.5 meters. Besides, it is obvious that the vessel PALLADA, involved in the accident, could pose many dangers, especially metal fatigue in the vessel's hull and equipment, given her river-type design and her age of 55 years.**

Analysing the course of the vessel before the accident showed that the vessel was navigating at 31.51 nautical miles offshore on 7 November 2023 (Image 23). This suggests that the vessel PALLADA failed to comply with the navigational restrictions despite the prevailing harsh meteorological conditions.

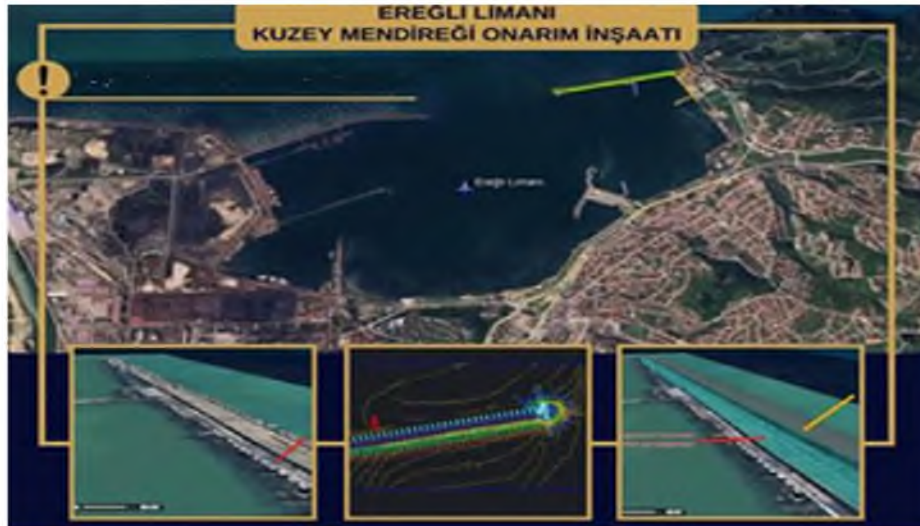
Image 25 Breakwater Repairs and Renovations

It was determined that the crown walls collapsed along a 255-meter-long roundhead of the North Breakwater at Karadeniz Ereğli North Breakwater, that the internal layout along the entire breakwater was scattered, that the energy facilities on the breakwater were damaged, and that the floors of the facilities were displaced. In accordance with the improvements and repairs to be made therein, the existing crown wall was removed, and a new crown was designed with a width of 15 meters, with an inner side at an elevation of +4 meters and the wall side at an elevation of +7.35 meters. The project is designed with a crest height of 7.35 meters, and a crest width of 11.30 meters and 43-ton antifer blocks will be used.

Following the accident, the works carried out to prevent the recurrence of such an accident in the northern breakwater and to take corrective and remedial measures by identifying the existing damages are listed.
