**MINISTRY OF TRANSPORT
MARITIME AFFAIRS
AND COMMUNICATIONS
Accident Investigation Board**

**Safety Investigation Report
Loss Of A Car Overboard From the Ferryboat**

**Marmara Sea / İstanbul Sirkeci Pier
15 March 2014**

Report No: 06/2016

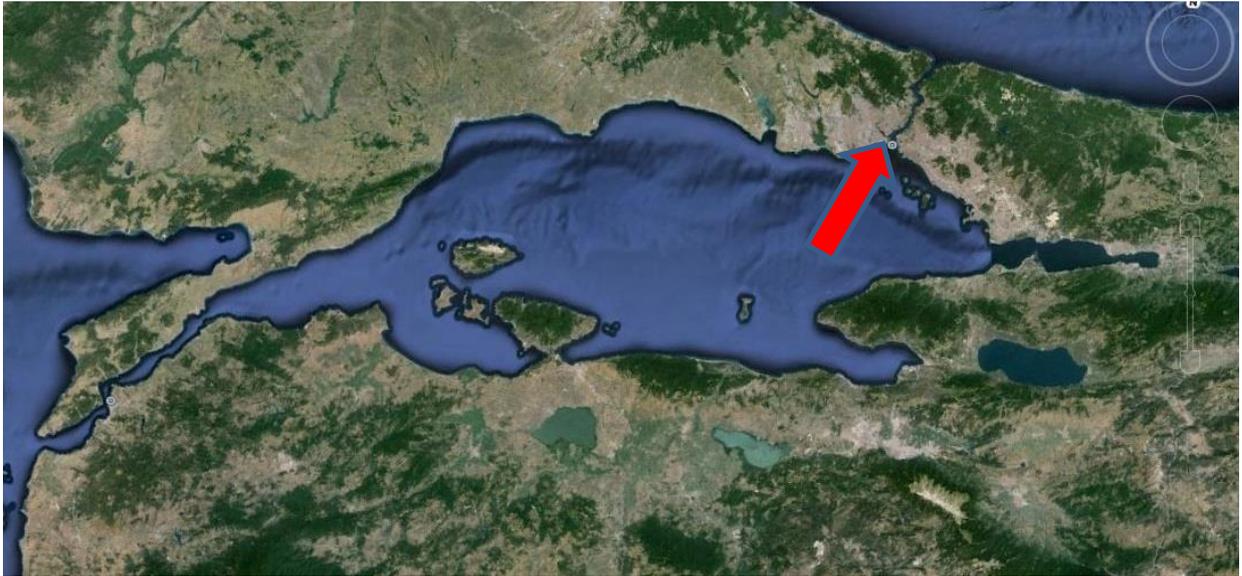
Picture 1 : Scene of the Accident

The ferryboat SADABAT which made Harem – Sirkeci voyage on 15.03.2014 and started to load the vehicles and passengers at 15:10 hours at İDO Sirkeci Pier no. 2 for Sirkeci – Harem voyage. Thinking the audio warning siren by the ferryboat called SULTANAHMET at the adjacent pier while opening its ramp for the purpose of loading the vehicles and passengers belonged to his ship, the master moved to the other console to depart the ship during the loading of the last vehicle. He saw the closed ramp at the stern side (sea side) at the monitor of the closed circuit camera system above the console and supposed that this was the bow side ramp (loading side), got the idea at that moment that he had heard the report “ramp clear” from the seaman’s portable vhf who was coordinating the loading at the bow side and departed the ship ahead before the ramp was closed. Since the ramp through which loading was performed was open at that time, the driver couldn’t understand that the ship departed as the loading ramp was open loaded the vessel with his automobile just at the moment the bow ramp of the ship cleared from the ramp, but couldn’t stay on the ramp due to the reason that the ramp cleared from the ramp and sloped downwards and slid back and the car fell to the sea at 15:15 hours.

Two of 4 persons in the automobile which fell to the sea got out from the automobile by their own means, and the other 2 persons, a girl aged 5 and an elder woman, lost their lives by drowning.

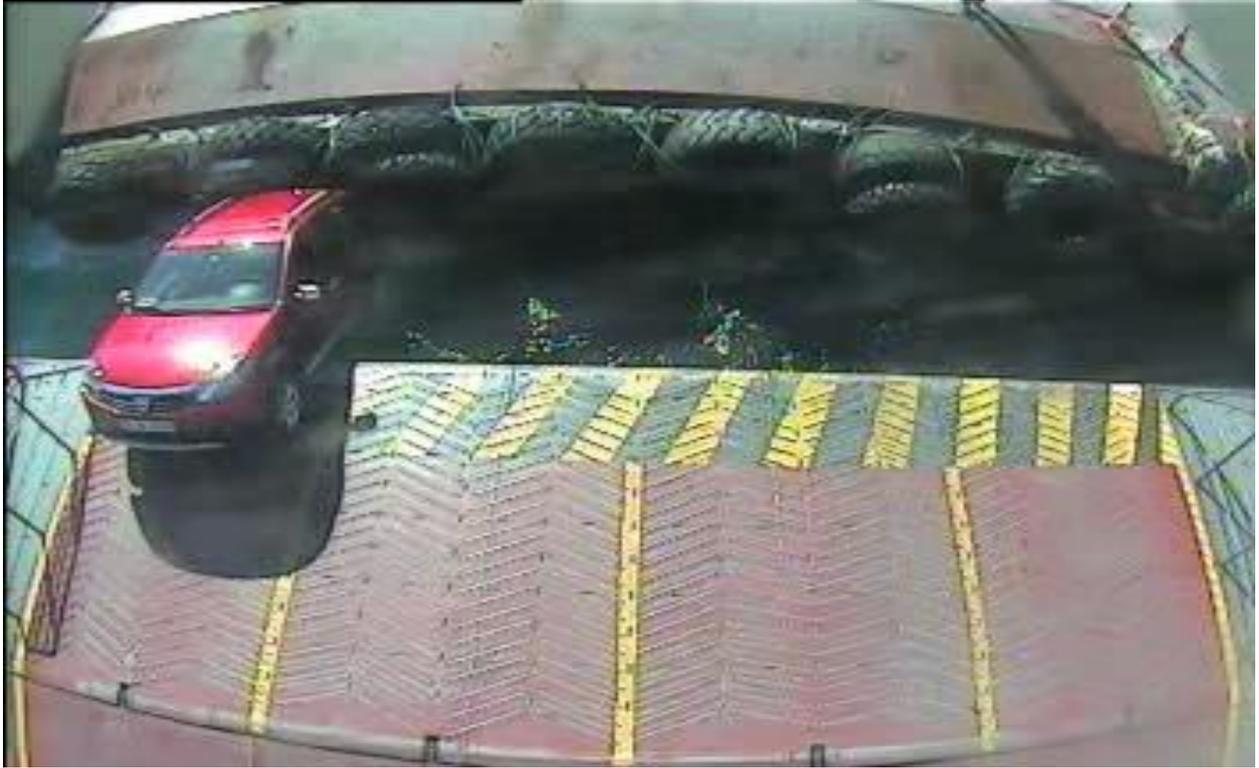
Picture 4 : Overboarding Moment of the Car

The seaman standing on the ramp at 15:14:36 referred with his hand to the last vehicle’s driver to approach to opened ramp. After a while, the seaman saw the ramp was moving and he retreated from ramp to the deck at 15:14:38. Meanwhile the driver couldn’t recognize that the vessel was unberthed and drove to the ramp at 15:14:41 during the clearing of the ship’s ramp from the shore. However, the vehicle couldn’t stay on the ramp due to the sloped ramp downwards and started to slide back. Meanwhile, the master saw vehicle from the monitor at the console and immediately gave the way astern to prevent the fall of the vehicle. However, he supposed to the vehicle was squeezed between ramp and shore, and accordingly gave the way ahead again. Meanwhile the vehicle slid from the ramp and fell to the sea at 15:15:01.

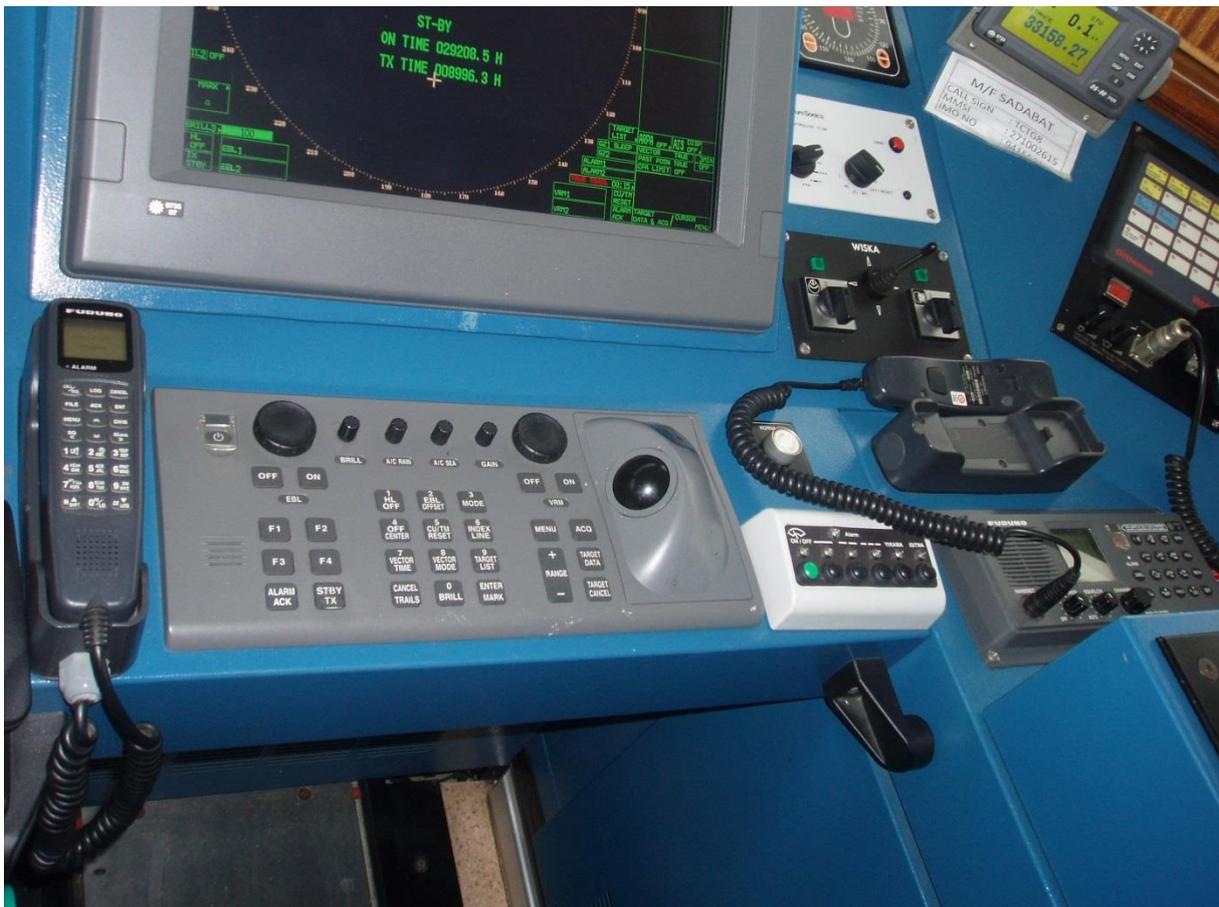
Picture 7 : Fixed VHF's on Bridge Control Console

There exist a total of 4 fixed VHF devices on the bridge, on both consoles. In addition, a portable VHF is used to provide communication between the master and the seaman who coordinates on the ramp the loading and unloading of vehicles. In addition, internal communication system is used from time to time to provide communication between the ramp and bridge. One VHF is in dualwatch² position and 16th channel is listened in addition to 13th channel which is the VTS³ channel.

The other fixed VHF is set to 9th channel to communicate and listen to the local sea traffic. The mentioned VHF's are located on the console just before the seat which the master uses when steering.

Taking account the high decibel sounds from the vessels of local traffic and international traffic in İstanbul Strait, the sounds from the land vehicles loading on the ship and the sounds from the communication devices on the bridge, it is assessed that a great sound pollution is formed. It is proved with scientific data that sound pollution or noise causes negative impacts on humans. It is indicated that sound pollution affects the humans physically, physiologically, and psychologically, as well as, has negative impacts on their performance.

3.1.8 In conclusion the sounds in the bridge and surroundings caused tiredness, attention deficit and concentration impairment of the master.

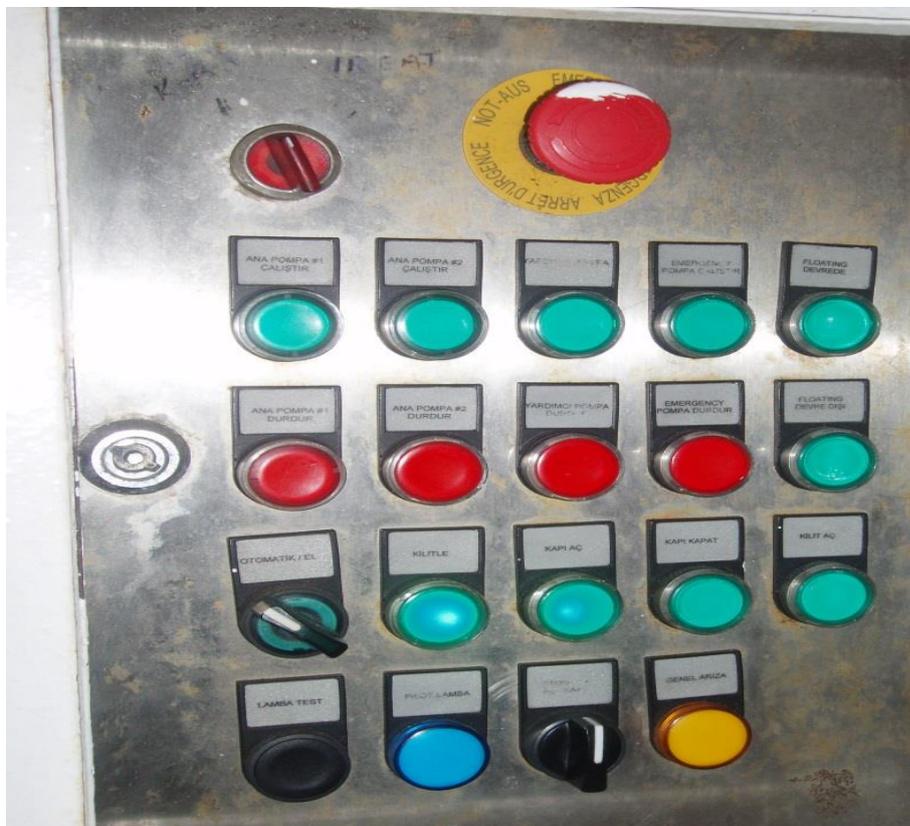
Picture 8 : Ramp Control Panel (Vehicle Deck)

There are two ramps on the ship at the bow and stern with dimensions 12,50x3,60 m operating with hydraulic system. 2 of the ramps control panels are located on the deck at starboard bow and starboard quarter and the other one is on the bridge. The ramps have 3 functions.

The ramp is operated in floating mode in loading and unloading vehicles and passengers to and from the ship. The function of floating system is to prevent excessive loading of the cylinders, therefore the ramps in the elevation differences formed due to the waves and weight differences.

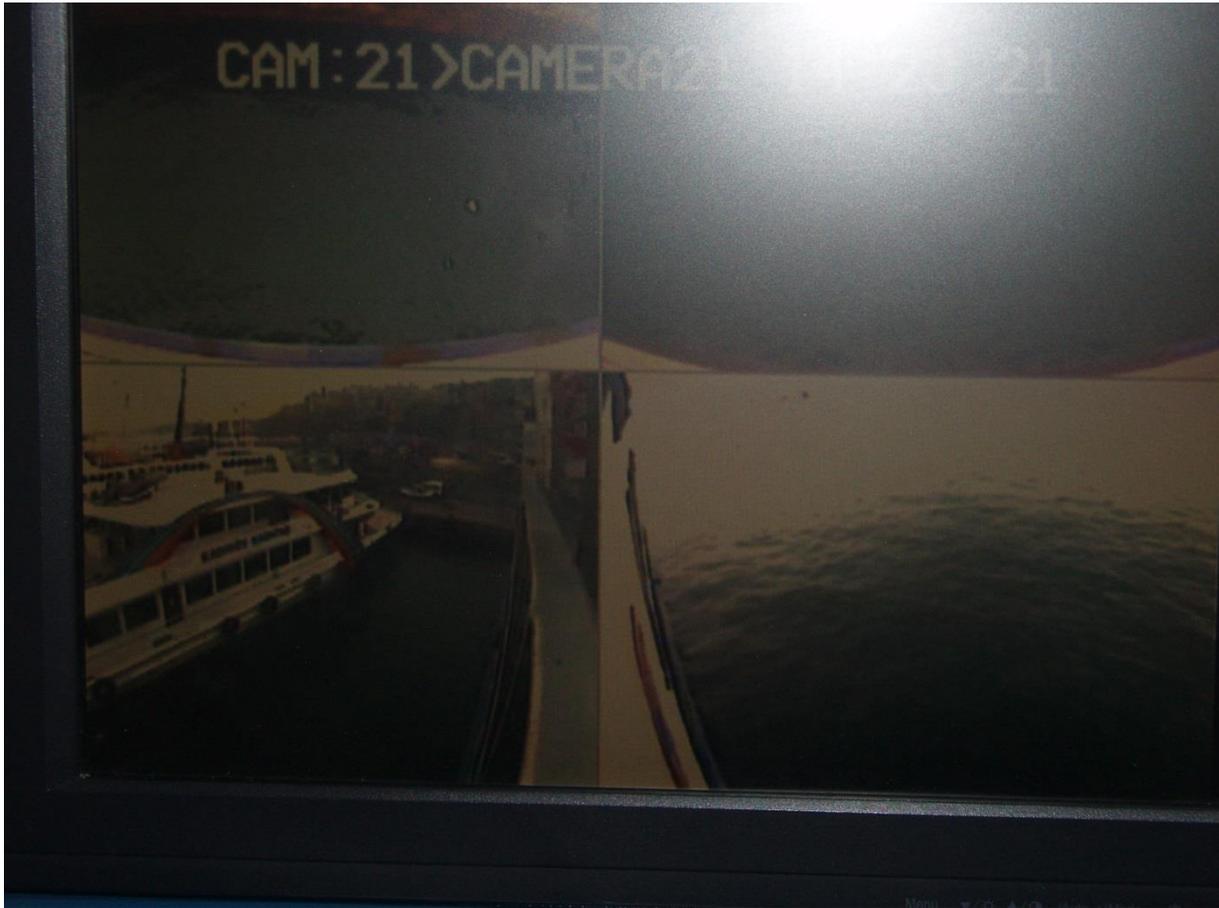
Picture 10 : Closed Circuit Camera System Monitor at Bridge

19 recording cameras exist on board and two are fixed for to watch both ramps. In addition, there exist four more fixed cameras in a position to watch both sides of the ship used during manoeuvres. 6 cameras expressed above are intensely used during the navigation and manoeuvre. The other cameras are fixed in various positions to monitor the passenger halls etc. living locations. It is detected by the technical team who have arrived to get the camera records after the accident that the camera which records the bridge (image and sound) didn't can since 25.02.2014. It couldn't be detected until the accident day.

Desired display may be viewed from the monitor located at the starboard bridge control console by selecting the numbers of cameras present on board. In the interview with the masters of both watches on duty, it is expressed that the mentioned monitor was viewed by dividing it into 4 parts and those were the displays by the cameras which see the bow and stern ramps and 2 cameras which see the side of berthing.

In addition, soon the master understood unberthed without closing the ramp after he saw the car on the ramp from the monitor and tried to prevent overboarding the car by moving the ship astern at first. Then, he gave the way ahead in order for not to squeeze the car between the ship and pier due to its pending position on the ramp. Meanwhile the car overboarded. Although it isn't definitely determined that the movement of the ship forwards and backwards may unbalance the pending car and cause its overboard.
