## MARINE SAFETY INVESTIGATION REPORT

**JOELLE / POLAT 1**  
**Marine Safety Investigation Report**  
**Foundering of F/V POLAT-1 Due to the Collision**

**Bay of Mersin / East Mediterranean Sea**

**22 March 2018**

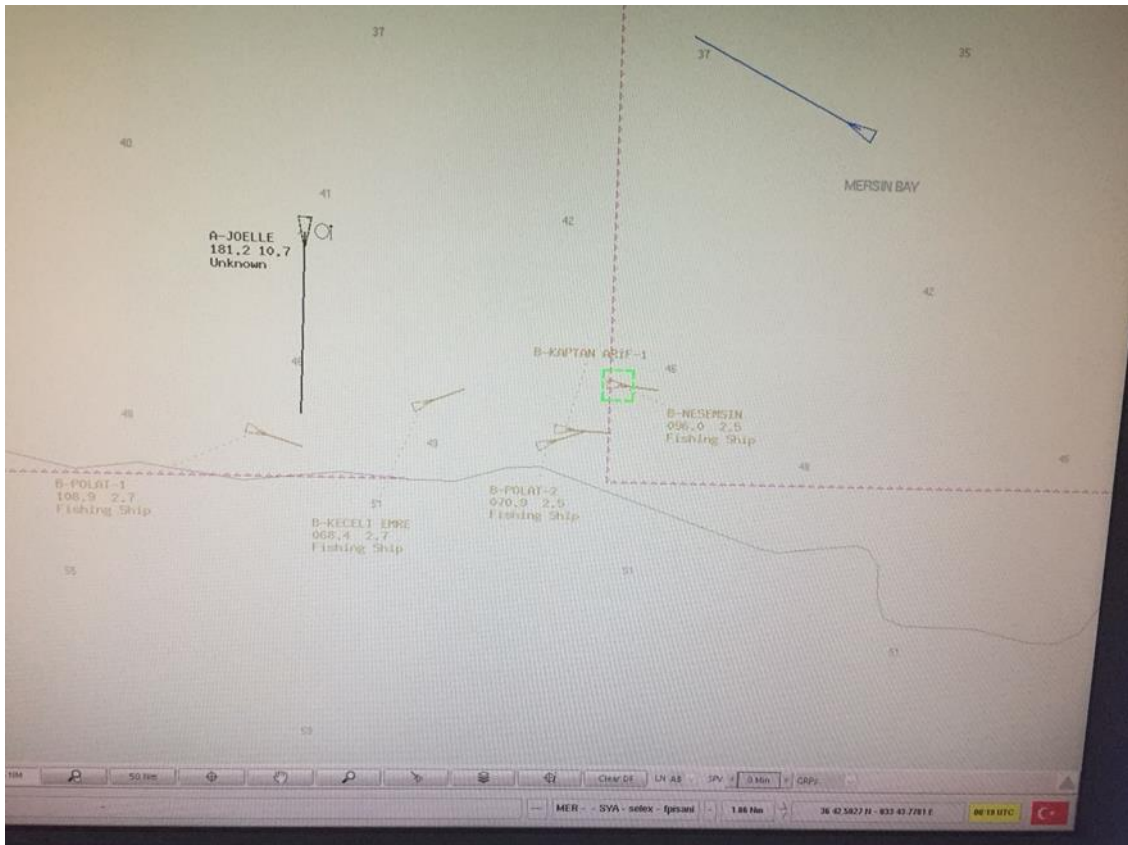
Figure 6: Data obtained from Mersin VTS (03.19)

Data obtained from Mersin VTS regarding the moment of collision confirm the situation.

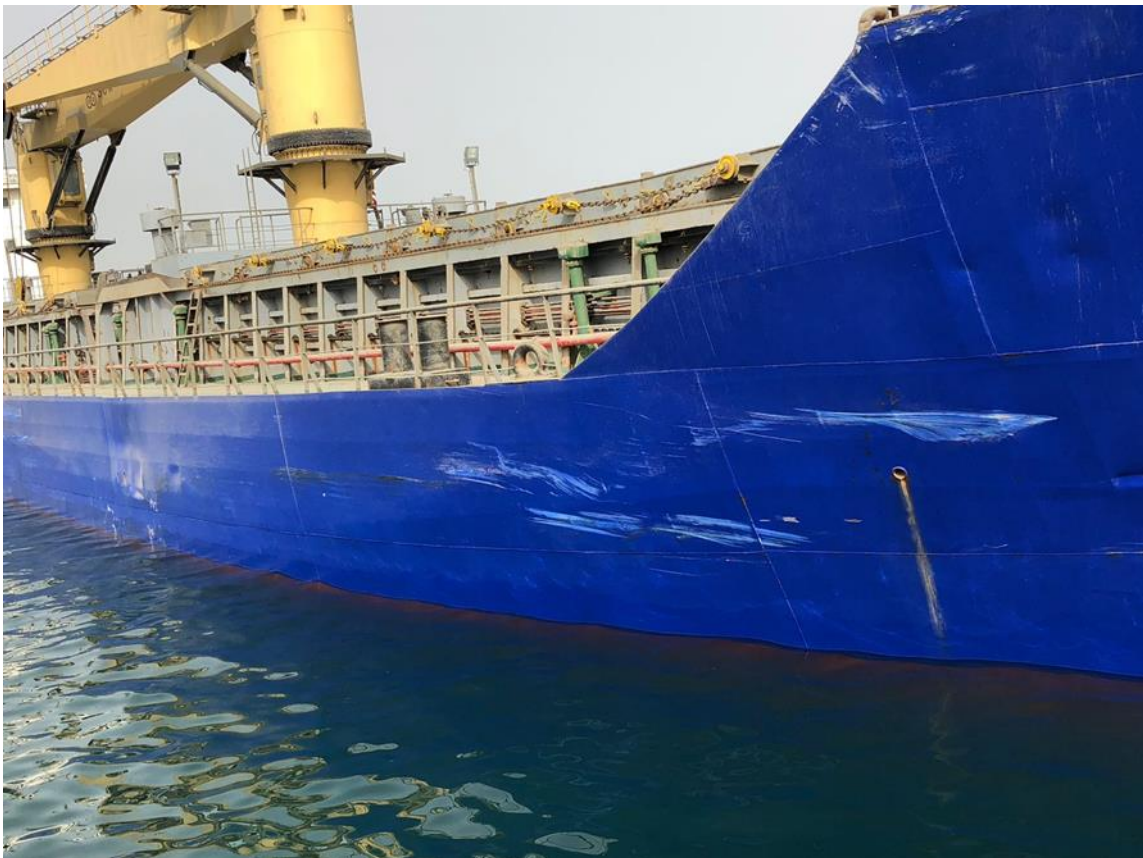
After the accident, M/V JOELLE returned to the Mersin port, during the investigation carried out where the vessel dropped anchor, the damage to the paint at the starboard bow, and on the waterline at the starboard broadside drew attention. [\(Figure 10\)](#) It was stated in the interviews with the ship's crew that the aforementioned paint damage had occurred before.

Figure 10: Image from JOELLE after the accident

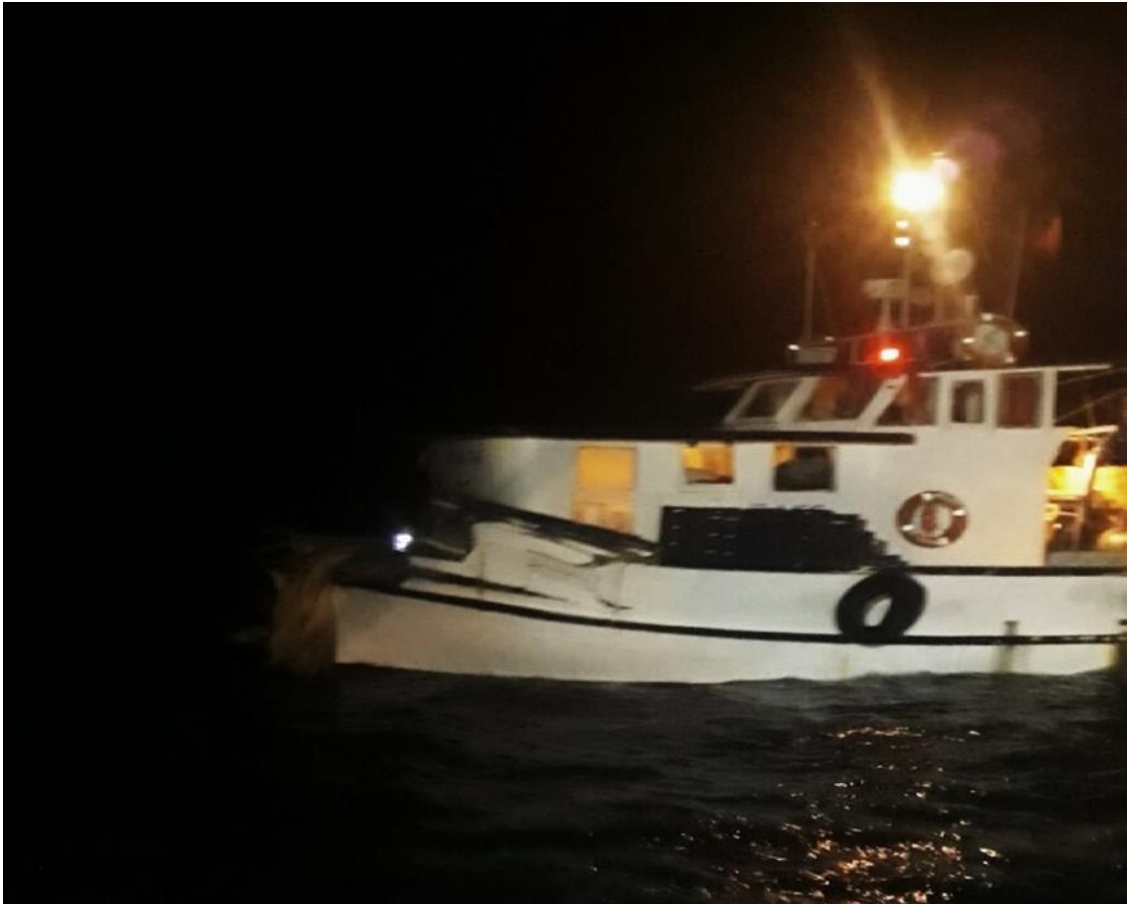
The head/stem of the F/V POLAT-1 was completely damaged due to the collision. [\(Figure 11\)](#) The boat, which was tried to be towed into the port by other boats after the accident, sank due to the inability to discharge the water taken in from the head side. POLAT-1 was removed from the wreck place one year after the accident date and a report indicating that the vessel was unusable and unregistered respectively.

Figure 11: Image from POLAT-1 after the accident

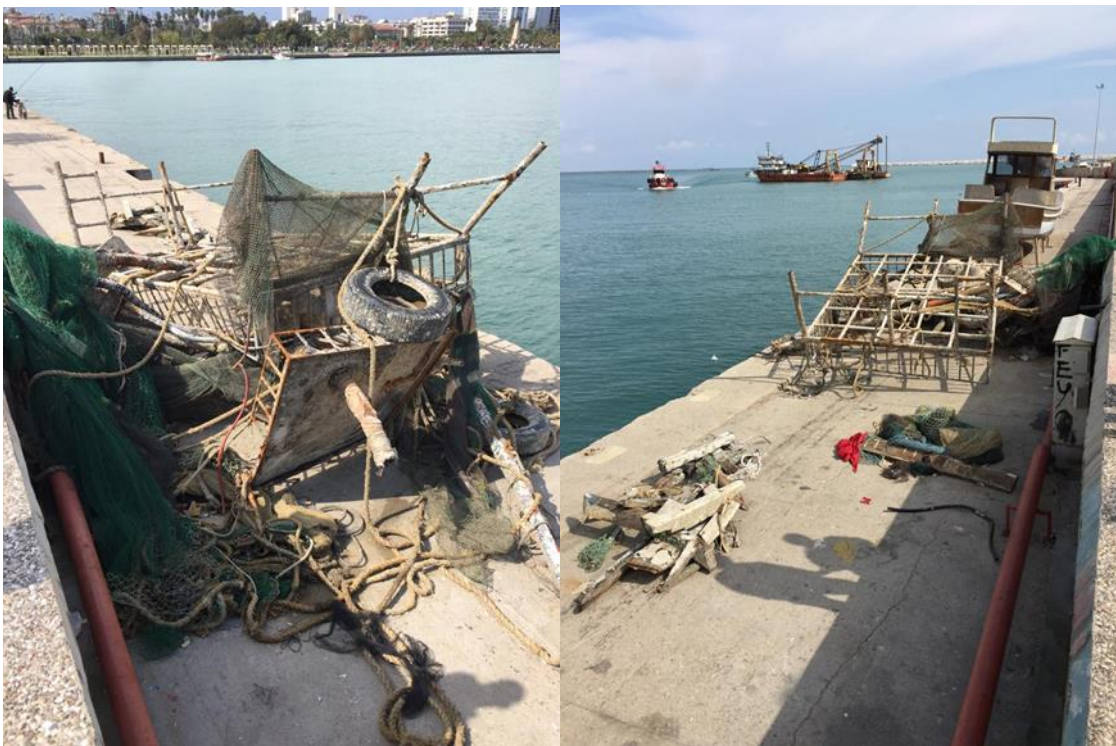
Figure 12: Image of the boat POLAT-1 that was removed from the shipwreck
