**SAFETY INVESTIGATION REPORT
OCCUPATIONAL ACCIDENT ON RO-RO VESSEL UND ATILIM**

VESSEL NAME and IMO No : UND ATILIM - 9242388
FLAG OF THE VESSEL : Turkey
LOCATION OF ACCIDENT : Port of Mersin/MERSİN
DATE OF ACCIDENT : 10.03.2020/16:35 LT
CASUALTIES : 1/-
DAMAGE and POLLUTION : -/-

Board Decision No: 14/DNZ- 04/2021

Date: 12/07/2021

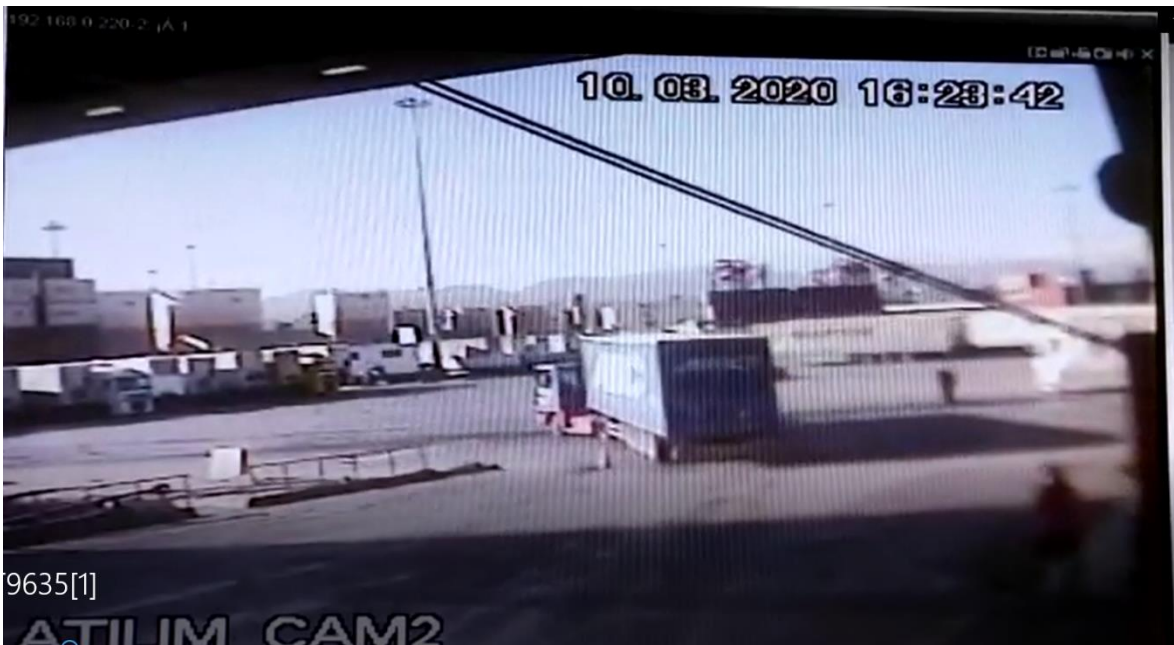
Picture 4: The Moment When the MAFI and the Tracked Trailer That Caused the Accident Approach the Ship

Meanwhile, the mobile scaffold was being displaced and the sprinkler nozzles were being replaced and circuits were being maintained on the main deck. Around 16:35, the trailer that was tracked by the loading MAFI and boarded the main deck from the ship's ramp touched the mobile scaffold, , and caused one of the two workers on the mobile scaffold to lose his balance and fall from a height of 5 meters onto the ground. The other worker was hanged by holding the pipe at the moment and narrowly escaped from falling (*Photo 3 – 4 – 5 - 6*).

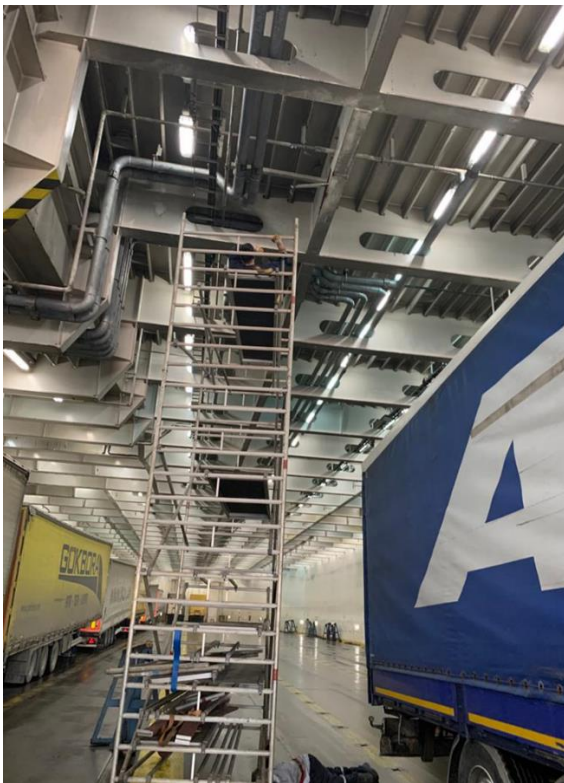
Picture 7: A post-accident photo

The port operation unit immediately called for the workers who fell on the ground and requested an ambulance. The ambulance stationed in the port arrived at the scene in a short time around 4:40 PM and transported the casualty to the hospital following the first intervention. (*Photo 7 - 8*)

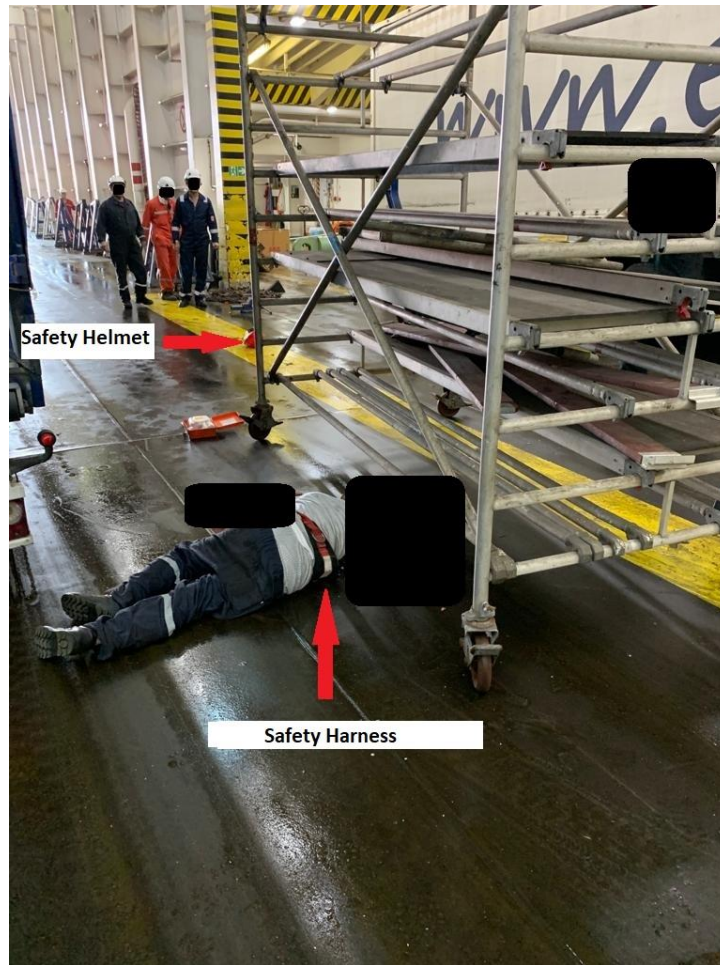
It was found that the casualty wore "*Work Positioning Harness*" and the scaffold was not anchored as it was displaced during the accident. A work positioning harness is required for the employee to work within a specific site and is designed to work safely on that site. (*Photo 9 - 10*)

Picture 9: Safety Harness and Helmet on the Casualty

The statements and photographs also show that the helmet came off the casualty's head after the fall and was broken. The chin straps of such helmets keep them balanced and prevent them from coming off easily in cases, such as trips, overturns, and falls. Although there is no evidence of how the casualty utilized his helmet throughout the operation, the discovery of a broken helmet indicates that it did not come off during the fall.

Failure to deploy the parachute type safety harnesses along with fall arrest systems is considered to be one of the factors that contributed to the accident.

- 4.6** The casualty was working with a “*Work Positioning Harness*” provided to him however, it was not hooked to a fixed point at that moment.
- 4.7** The helmet of the worker was on his head while he was falling and damaged by the fall.

19/04-21 To support workers with the appropriate PPE for the working at heights and taking measures to raise awareness of your employees for potential risks by considering this accident report,

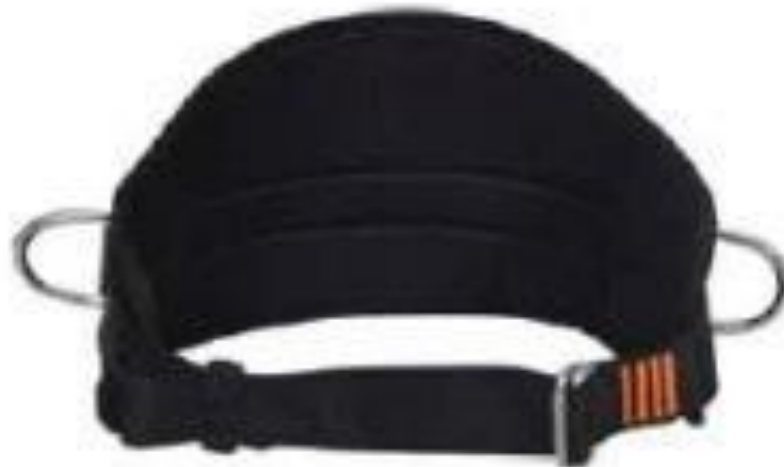
However, when it is considered that such types of harnesses should be continuously unhooked from the anchor points in dynamic work sites, it is obvious that they are unable to provide highly efficient works and prevent fatal injuries when the risk of falling escalates. On the contrary, statements indicate that the worker's safety harnesses were not hooked to a fixed point since the scaffold was displaced during the accident. The risk will be minimized if the parachute type safety harnesses are used along with fall arrest systems, especially in the site where the operations are dynamic or constant change is necessary. (*Photo - 11*)

Picture 10: Work Positioning Harness

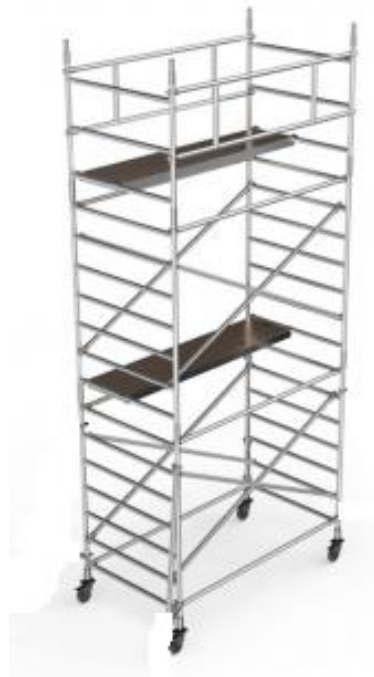
Picture 13: Mobile Scaffold (Figurative Photo)

However, when the site where workers work on the mobile scaffold in **Photo -14** was examined, the front and rear guardrails, shown in **Photo -13** were seen to be missing. It was found that although the workers who appeared to be unavoidable to work on the top had the chance to place the mobile braces and guardrails in the lower parts according to the worksite, they didn’t do so, and they were not warned on such issue.

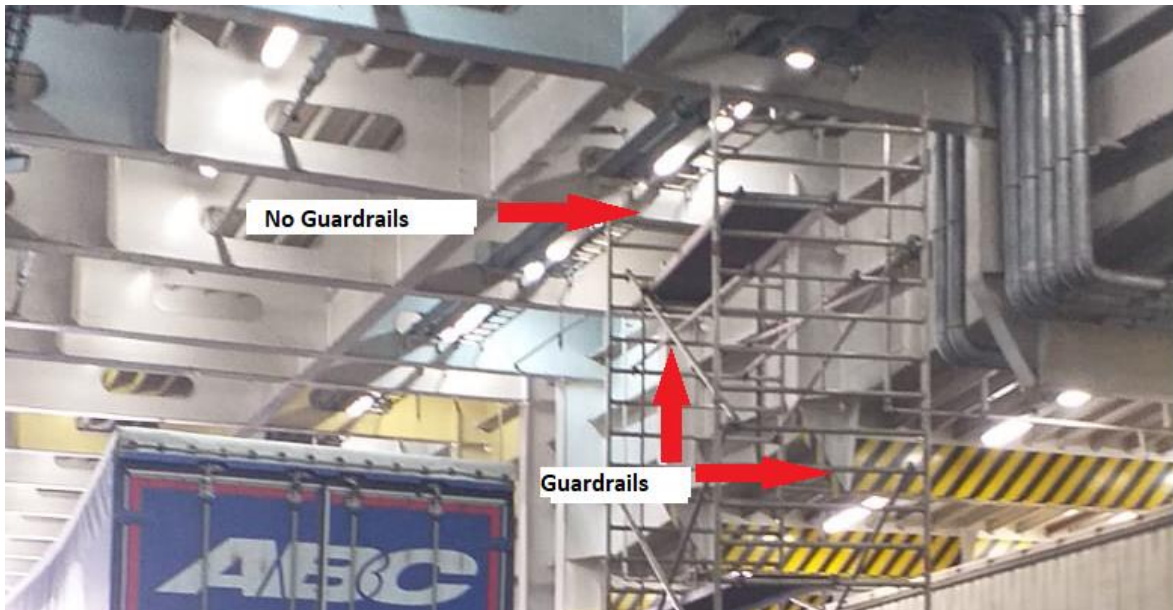
Improper use of the mobile scaffold delivered for work is considered to be one of the factors that contributed to the accident.

Picture 14: Top of Mobile Scaffold where Workers Work

- 4.8** Mobile scaffold equipment delivered for the work was not properly used.
- 4.9** There is no data on the proper performance of the work even if how and who would supervise/control the operations was stated while planning the “*Work aloft*”
