**REPUBLIC OF TURKEY**  
**MINISTRY OF TRANSPORT, MARITIME AFFAIRS AND**  
**COMMUNICATIONS**  
**Accident Investigation Board**

**Accident Investigation Report On**  
**The Collision Between TANAIS DREAM & SULTANAHMET**

**Istanbul Strait / Sarayburnu**  
**18<sup>th</sup> of December 2014**

**Report Number: 04/2015**

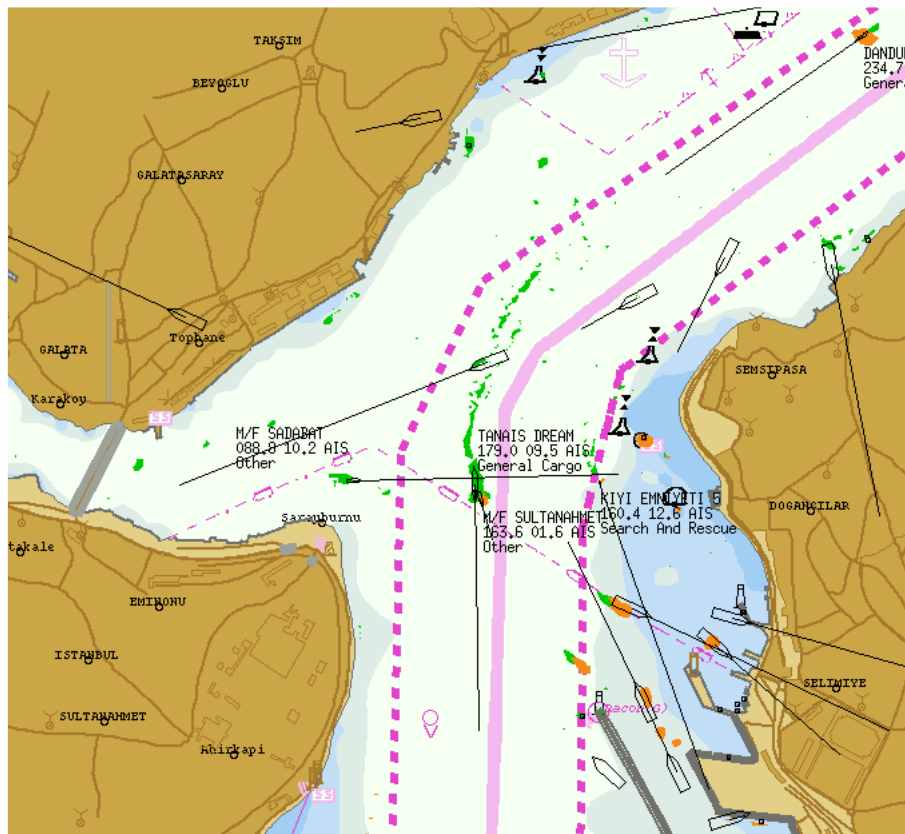
**Figure 8:** AIS snapshot at 19:39:50

The master of SULTANAHMET operated the engines in the direction to starboard and started to turn towards the Maiden's Tower to starboard to keep clear from the bow of TANAIS DREAM, however, this maneuver was not sufficient, the stem of TANAIS DREAM touched the port board side of SULTANAHMET and they collided at 19:39:50. Just before the contact, the master of SULTANAHMET set the engine control arms towards the port in order to reduce the severity of the crash.

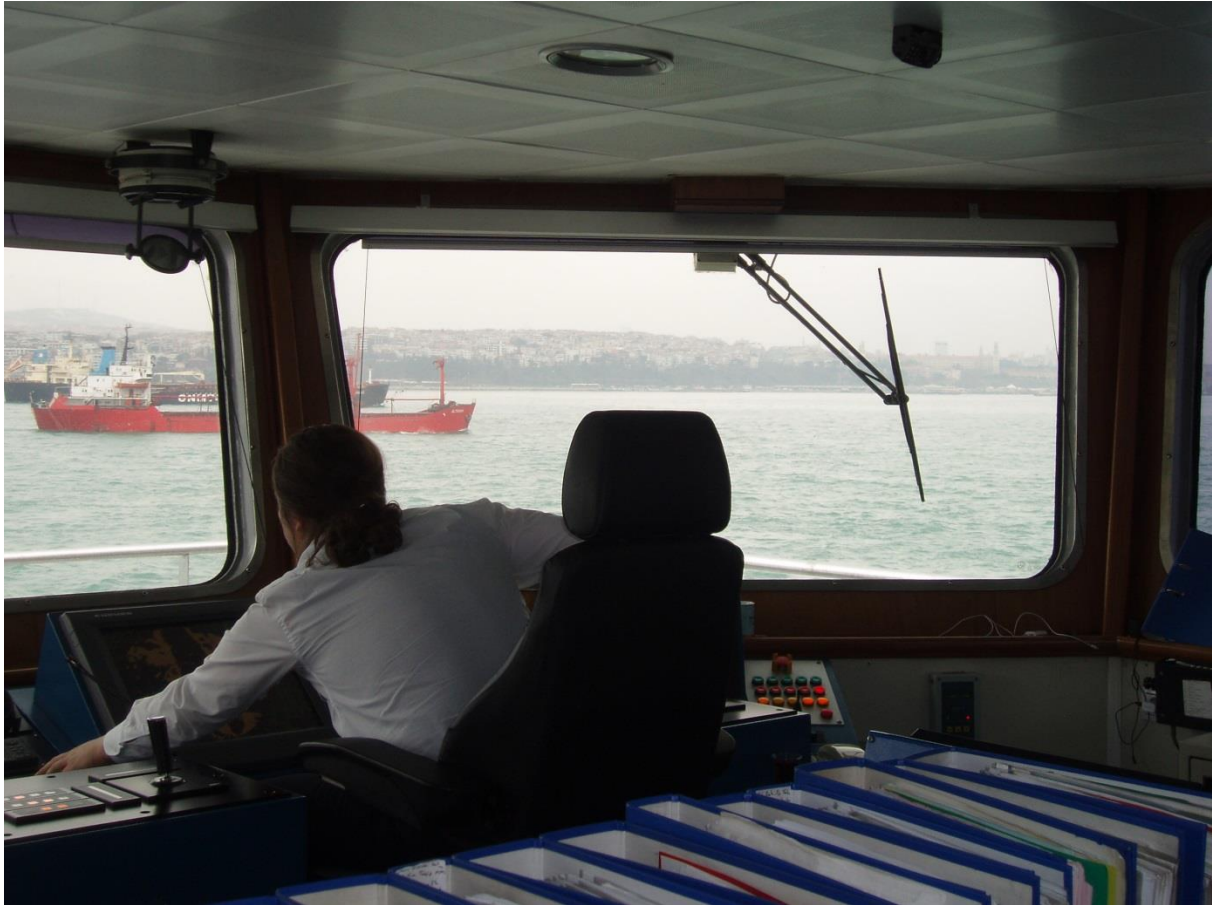
The vessel has 2 control consoles on the bridge in head-stern direction. During navigation, the master controls the engines and use navigation devices such as radar etc. by sitting on the seat mounted just in front of these consoles. It is not possible for him to handle and manage the vessel without sitting on the aforementioned seat. The bridge was built to be completely surrounded by rectangular portholes to provide 360-degree vision. There are perpendiculars to separate the portholes and carry the flying bridge. One of these perpendiculars is in front of the master's seat approximately 1-1.5 meters away, on the slightly right side, and have about 30 cm width. It is stated by the master that this perpendicular creates a blind spot for ships and vessels, especially small sized ones on the starboard bow.

**Figure 13:** The Perpendicular Causing Blind Spot on the Bridge of SULTANAHMET

It was observed also by us that onboard SULTANAHMET, among the perpendicular built to separate the portholes on the bridge and to carry the flying bridges, the perpendicular, which is on the right side of the master's seat, may create a blind spot for ships and vessels, especially small sized ones on the starboard bow. The shipmasters have to turn their heads to both sides in order to see the area at sea which is behind this perpendicular during the navigation. It is considered that this situation constitutes a problem for shipmasters both in terms of ergonomics and lookout. In this context, it is considered that if the classification of the vessel is appropriate and requires this, making a modification on the vessel and making smaller or removing this perpendicular to solve this problem will contribute to the ergonomics and effective lookout by the shipmasters.

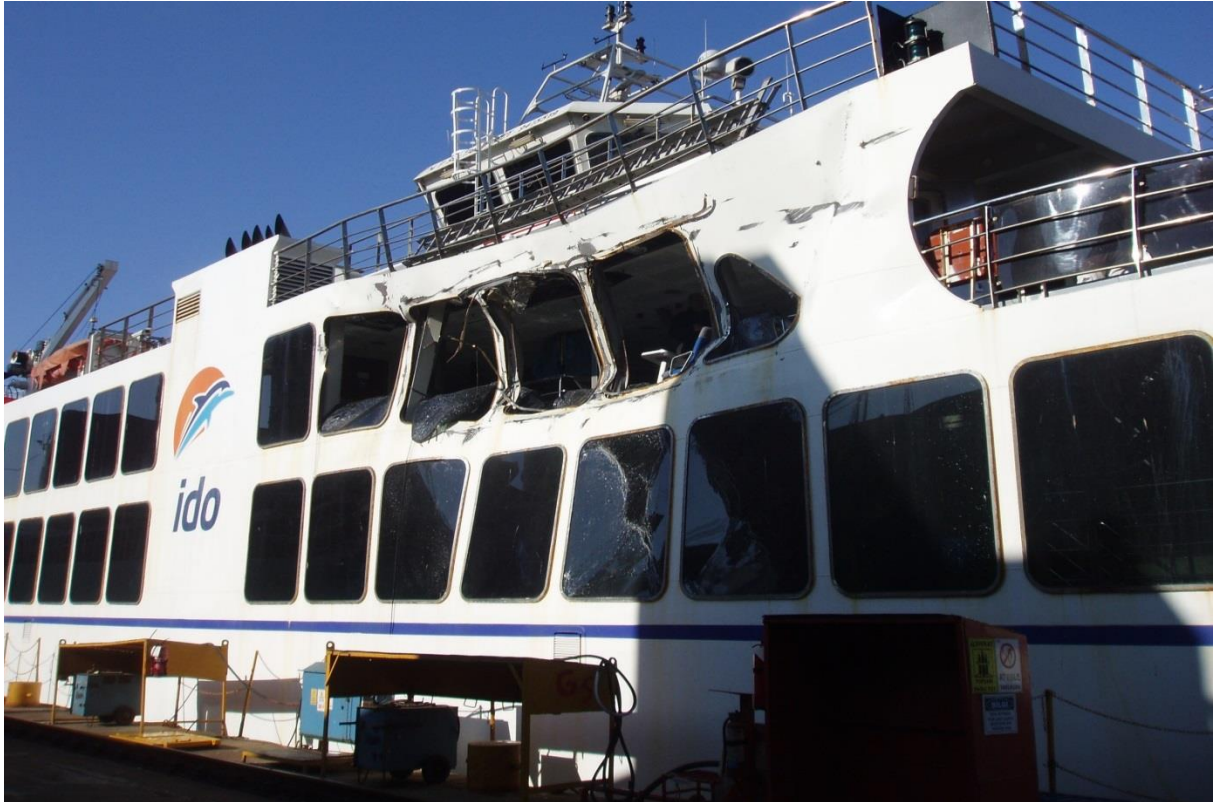
There are bends and tearing on the portside shell plate and frames of passenger deck and damage to portholes, insulating coating, cables and seats. There is slight bend on shell plate and its' structural members, which is under the passenger deck, and slight damage to the cables and insulation materials. There are also bends on the guardrails on the portside.

**Figure 16:** The Damage to the Board of SULTANAHMET

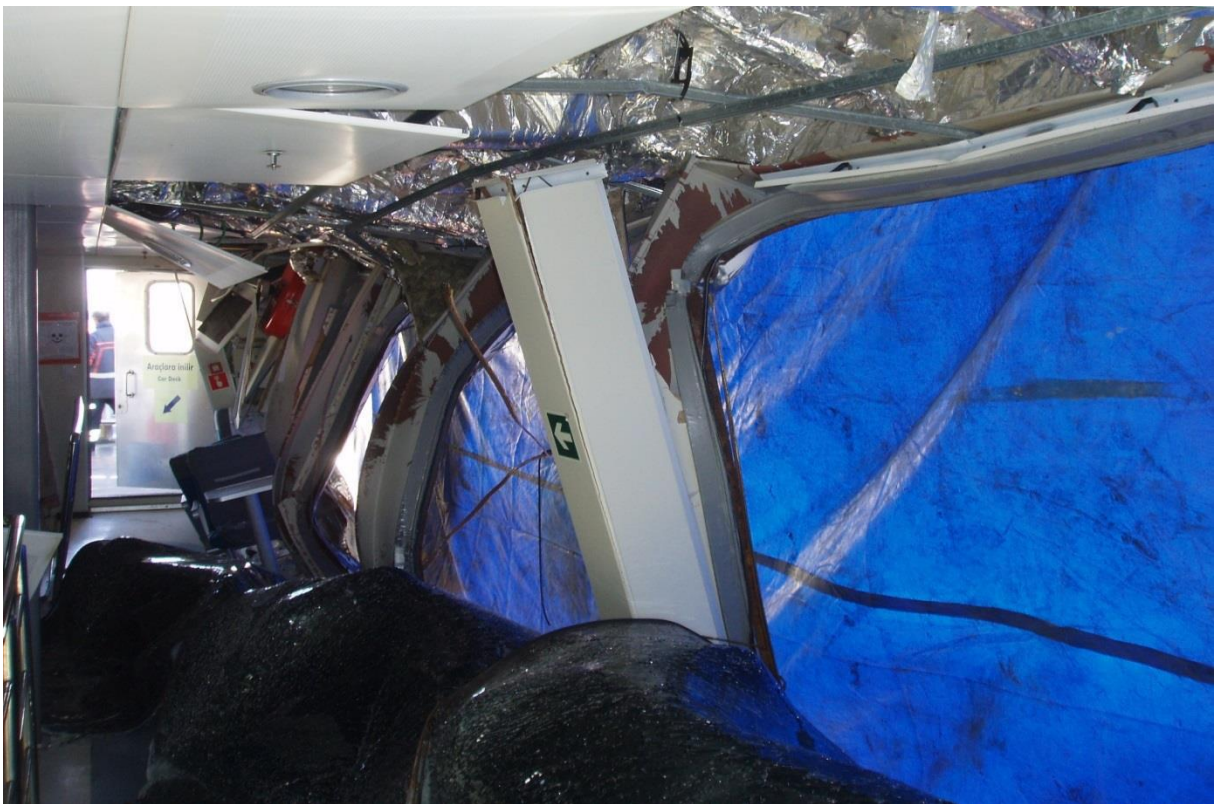
**Figure 17:** The Damage to the Lower Deck of SULTANAHMET

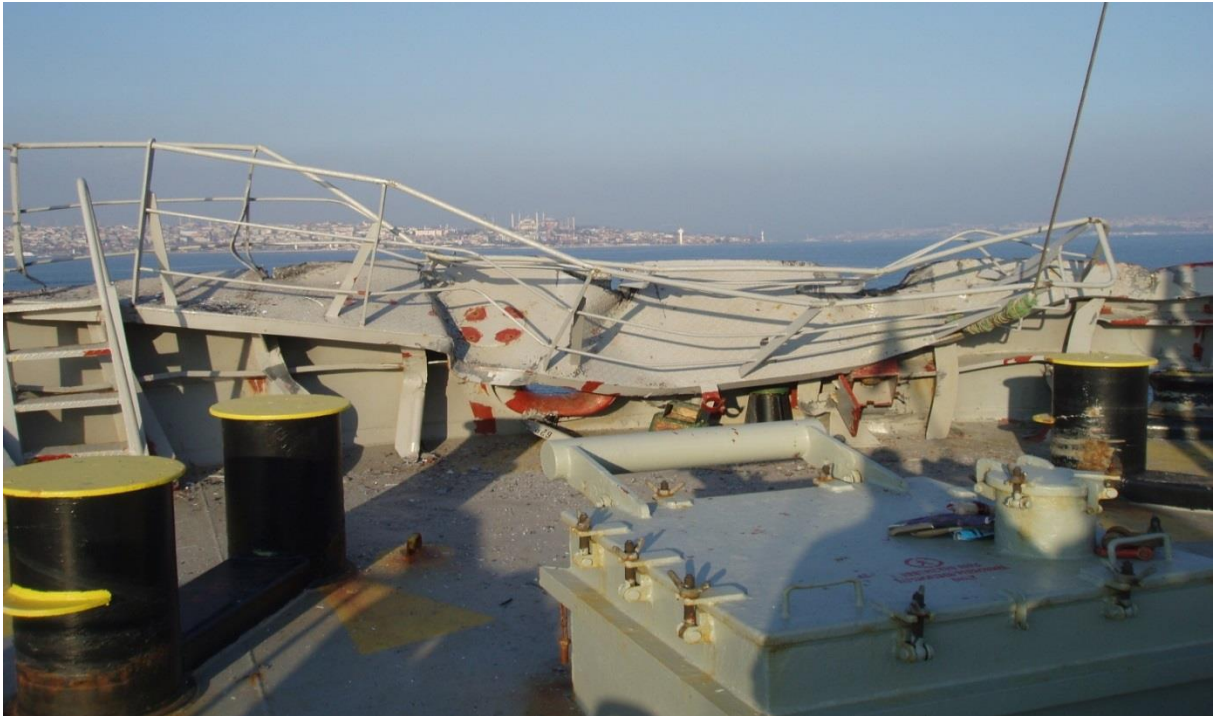
**Figure 18:** The Damage to the Forecastle of TANAIS DREAM

At the forecastle of the vessel, there are inward bends of about 4-5 meters on bulwark between starboard hawse and center hawse and on its structural members, and bends on the guardrails and the pillars which are above these, and inward dent of 4 meters on shell plate which is right below this.

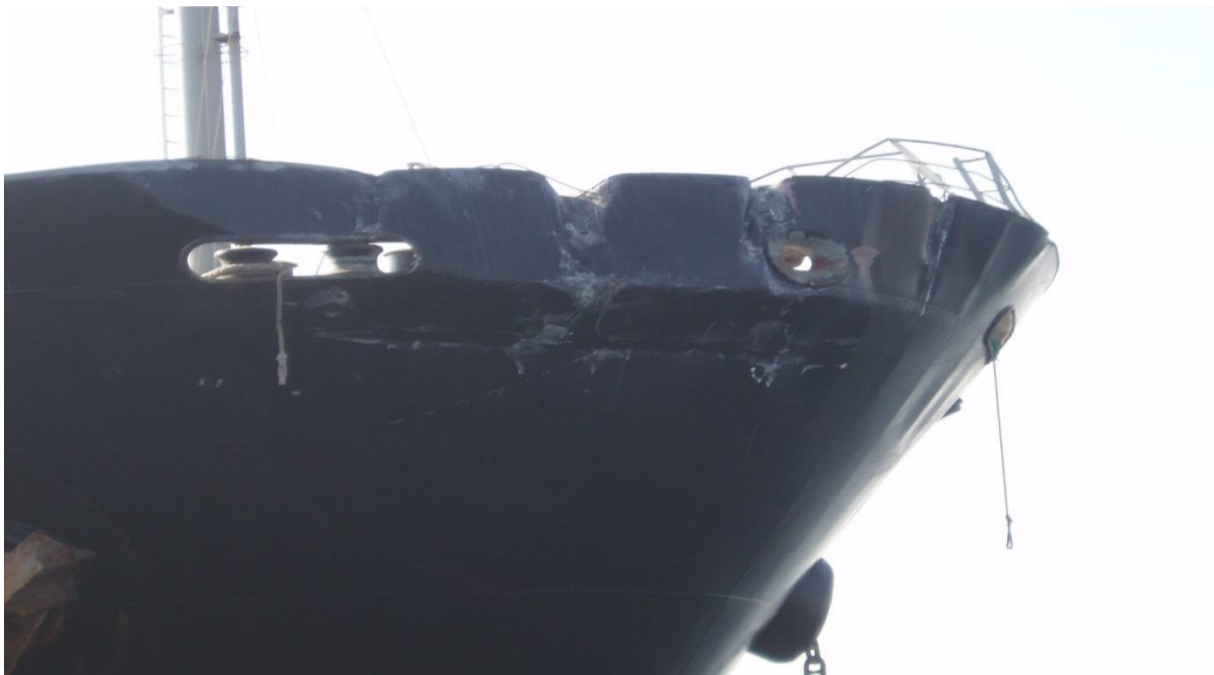
**Figure 19:** The Damage Occurred at the Bow of TANAIS DREAM

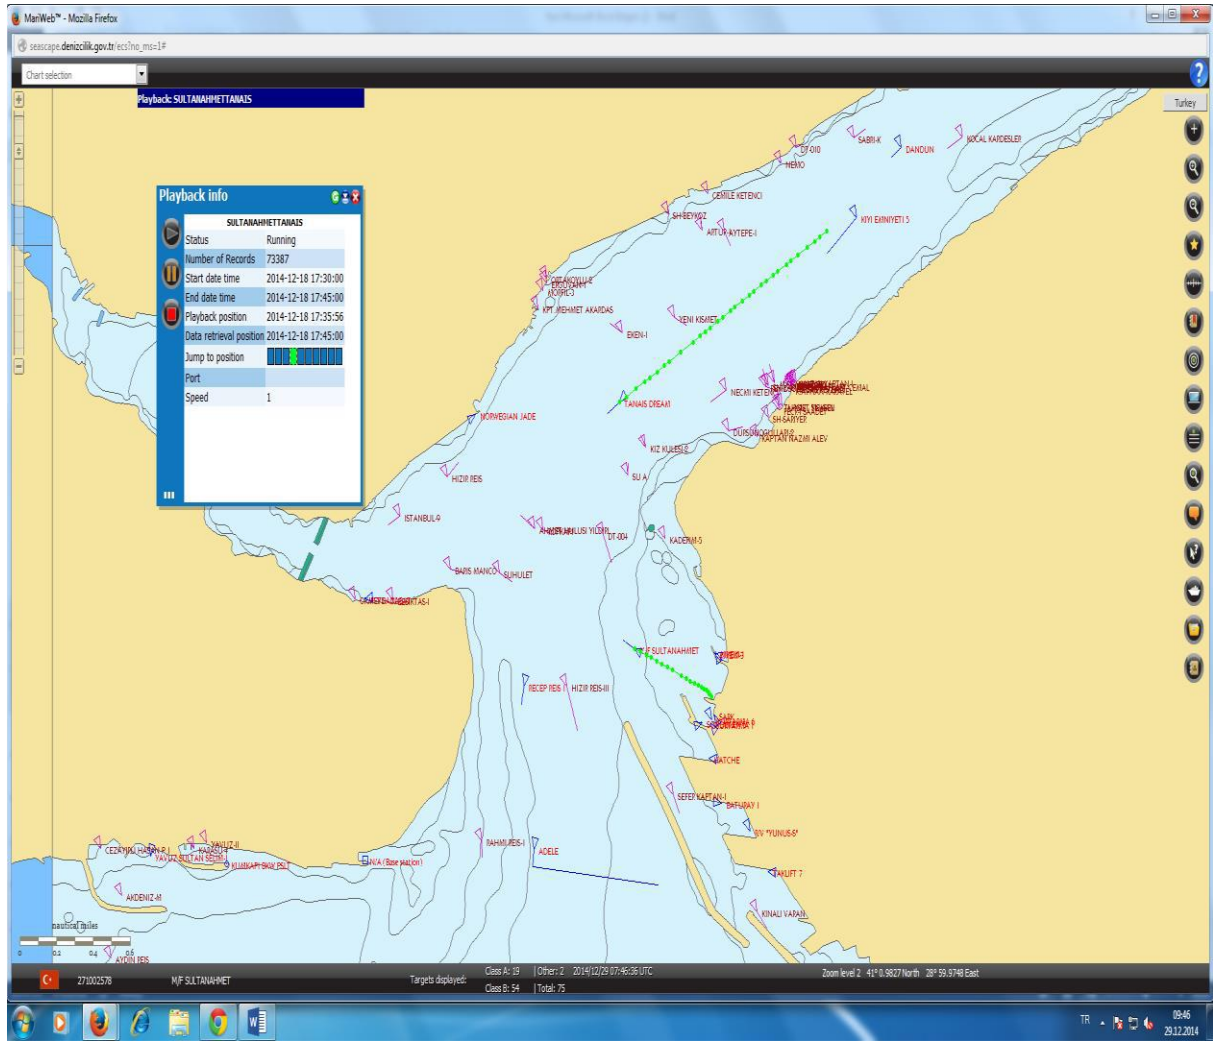
**Figure 20: 19:35:56 AIS Image**

This is the reason why the master of the vessel SULTANAHMET realized other vessel too late; VTS images mainly display vessels with AIS class A, and the vessels with AIS class B such as city line ferries, small passenger boats etc., which are called local vessel traffic, are not displayed on the VTS screen. In Figure 21 of the AIS system established by our Ministry, it can be seen that a large number of vessels in the local vessel traffic were present in the region. Therefore, considering the fact that there is a very heavy vessel traffic between the two coasts due to the time that the accident occurred corresponds to the rush hour (the time people get off work), it is considered that this may be a big factor for the master in realizing the vessel TANAIS DREAM too late.

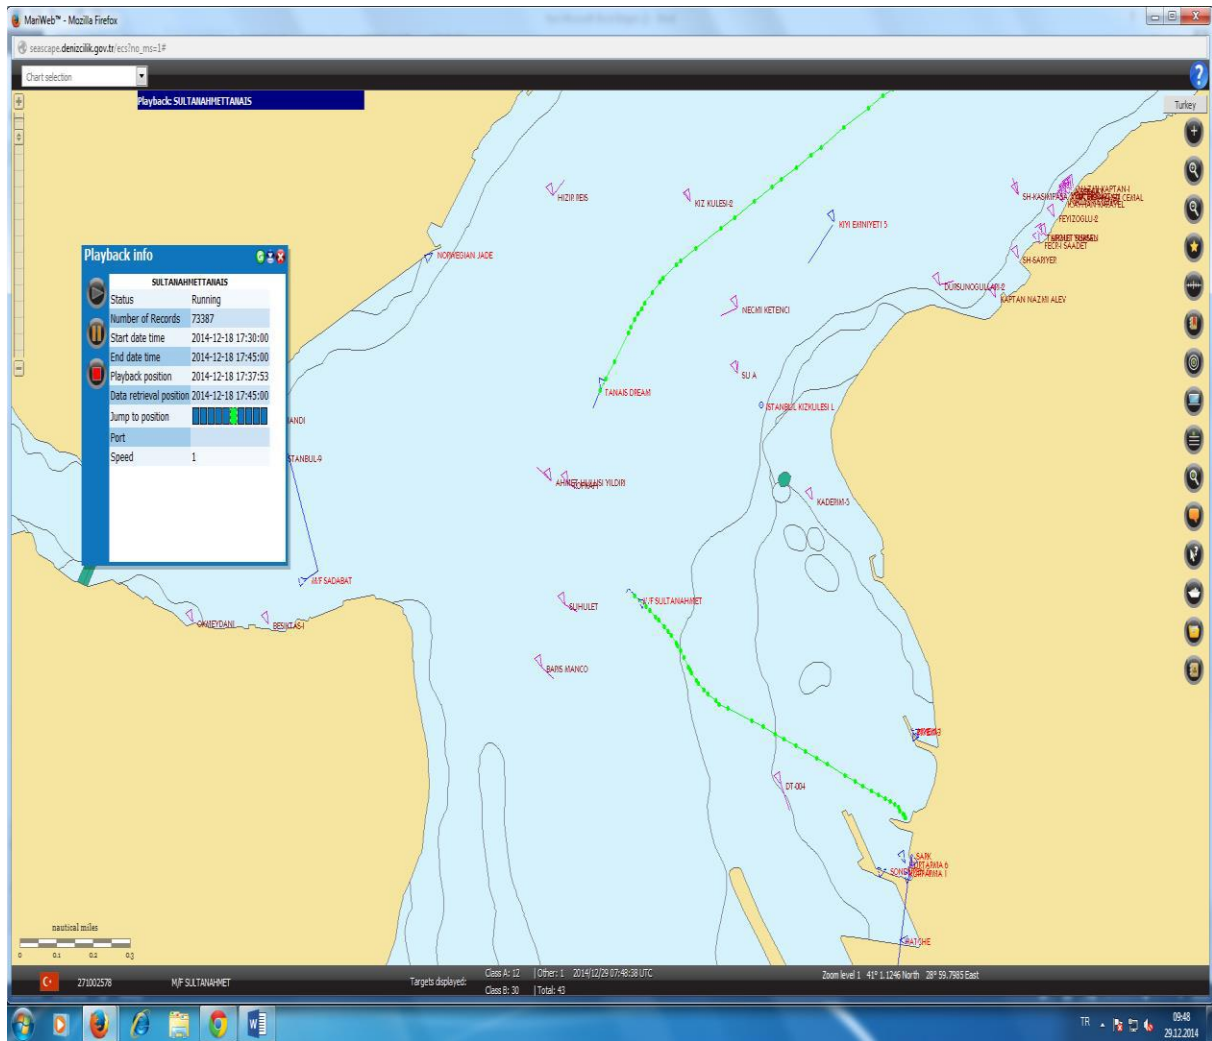
**Figure 21: 19:37:53 AIS Image**

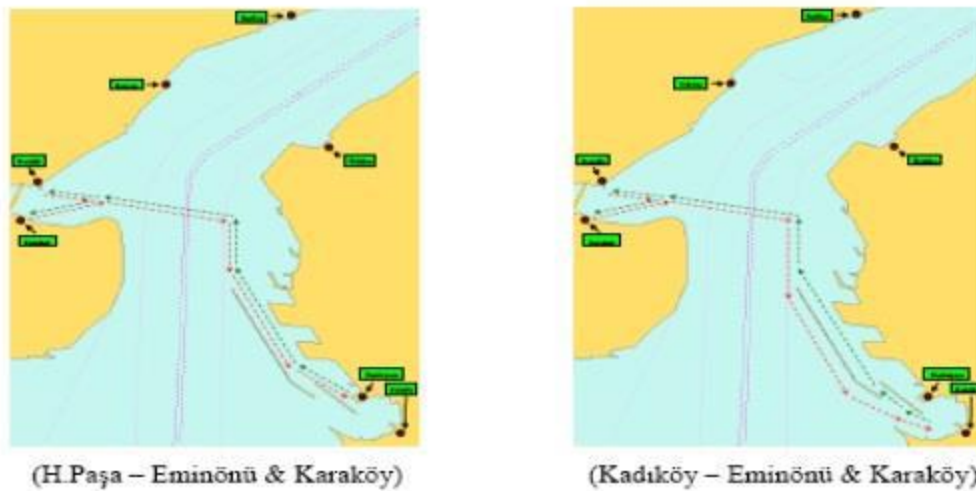
**Figure 22:** Courses Recommended for Some Lines in Local Traffic Guide

As it can be seen in the courses recommended with departure from Haydarpaşa and Kadıköy and destination as Eminönü-Karaköy in Figure 22 in the Local Traffic Guide, it is recommended that the vessels rise up to offshore of the Maiden's Tower, observe the traffic of the vessels crossing the Istanbul Strait and then turn back the pier/port and cross the traffic separation lanes at a right angle as much as possible according to the traffic flow direction. In fact, the vessel SULTANAHMET tried to cross the traffic separation line using the shortest way.

**3.6** As it can be seen in the courses recommended with departure from Haydarpaşa and Kadıköy and destination as Eminönü-Karaköy in Harbour Master of Istanbul Local Maritime Traffic Guide, although it is recommended that the vessel rise up to offshore of the Maiden's Tower, the vessel SULTANAHMET tried to cross the traffic separation lines using the shortest way,

**4.7** A constitution should be founded to govern and to supervise whether the vessels navigating in local traffic comply with the recommended courses and the instructions related to the navigation specified in Harbour Master of Istanbul Local Maritime Traffic Guide,
