**REPUBLIC OF TURKEY**  
**MINISTRY OF TRANSPORT, MARITIME AFFAIRS AND**  
**COMMUNICATIONS**  
**Accident Investigation Board**

**Marine Casualty Safety Investigation Report**  
**The Collision Between M/V TOLUNAY and**  
**the Coast Guard Boat TCSG-25**

**Istanbul Strait South Entrance**  
**17<sup>th</sup> August 2016**

**37/DNZ-06/2017**

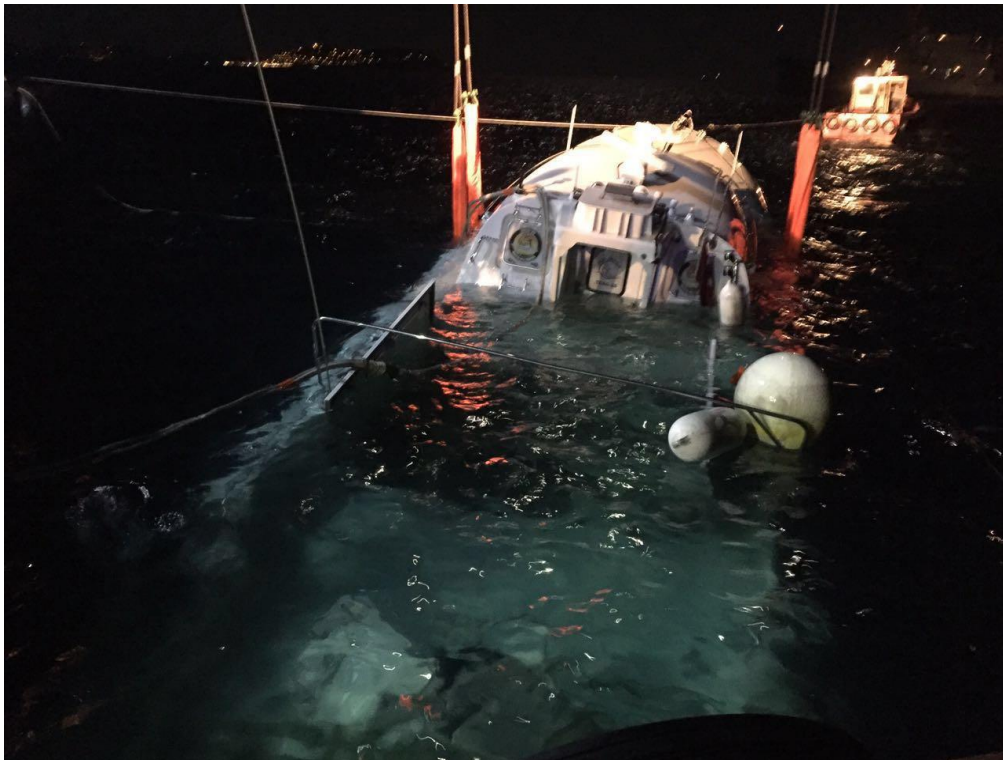
**Picture 11:** *Recovery of TCSG 25 Boat from the sea*

As a result of TOLUNAY's collision into the port quarter of TCSG 25 Boat, TCSG 25 Boat capsized, outer surface of the starboard quarter of the Boat was broken, both propellers and the propeller system was damaged. In addition, all electrical and electronic navigational aids equipments of the TCSG 25 Boat, located in the living quarters and in the engine room, as well as all materials and equipment that enable a ship to be in a viable state became unusable. *(Pictures 11,12,13)*

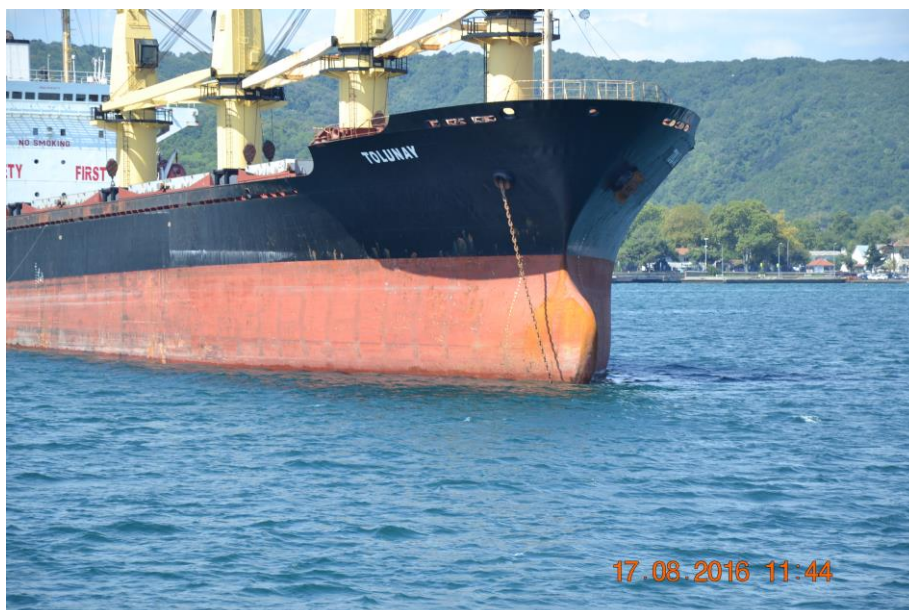
*Picture 15: The damage at the Bulbous Bow of MV TOLUNAY after the collision*

As a result of the accident, the only damage at TOLUNAY was on the paint of the bulbous bow, where the collision had occurred (**Picture 15**).

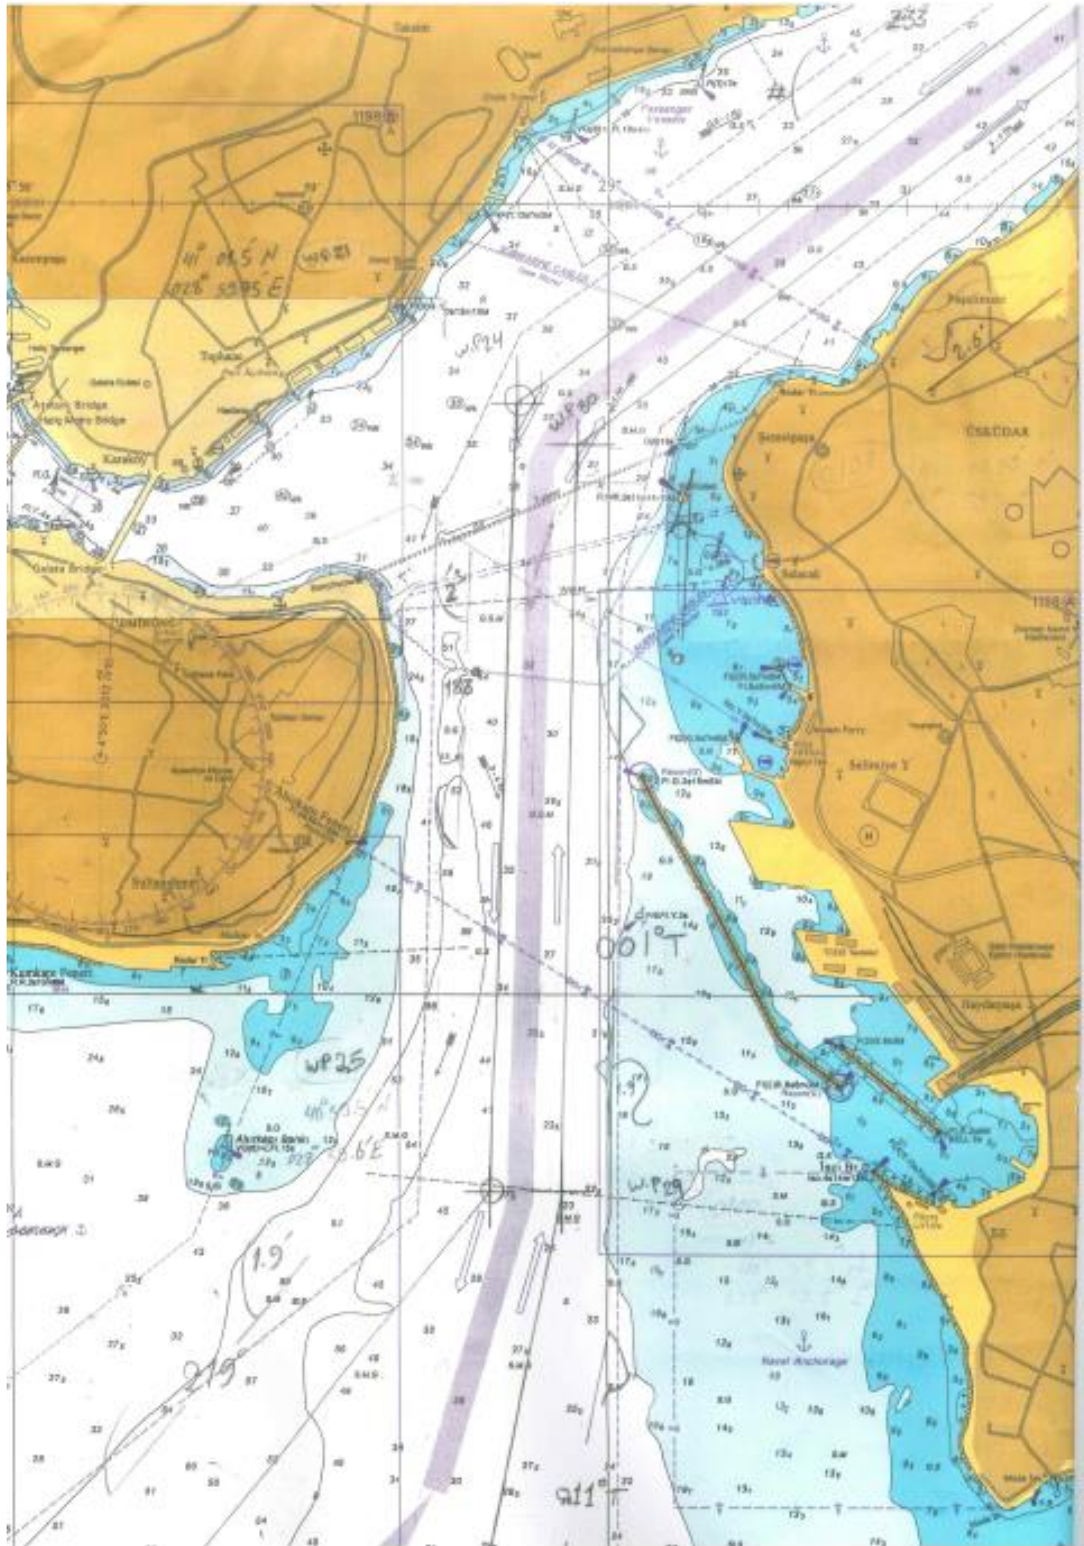
**Picture 16:** Navigational Chart Which was Used By MV TOLUNAY At the Time of the Accident

British Admiralty navigational charts were used on the ship. Chart No. 1159 of the southern entrance to İstanbul Strait was present on the ship, and it is seen that a route planning was made for the İstanbul Strait passage. However, when the map was studied, it is detected that the coordinates related to the ship's navigation were not plotted on the map (*Picture 16*).

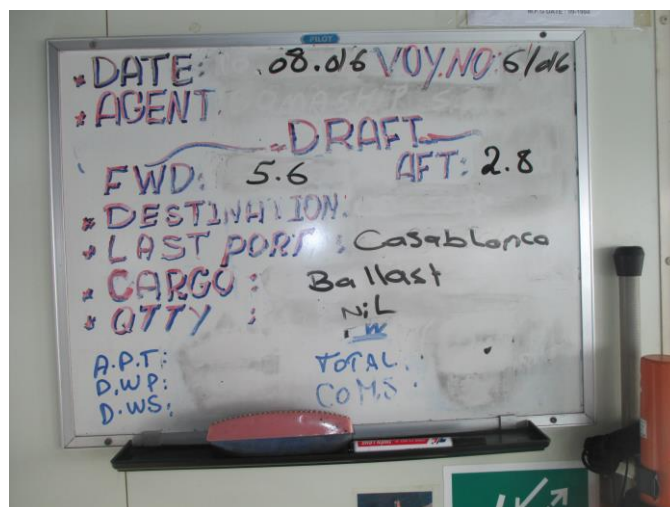
**Picture 21:** MV TOLUNAY's Drafts

The draft values on the bridge panel (**Picture 21**) were; Forward Draft: 2.8 metres, Aft Draft: 5.6 metres

In view of the present draft values, it is observed that the ship was trimmed 2,8 metres to aft. From the table which is drawn for the calculation of the blind sector starting from the ship's bow due to the draft difference (Annex-3:Table of Obscured Distance) when the mean draft and trim value is entered and after the necessary corrections are applied, it is determined that there is a blind sector of **332,28** metres starting from the bow of the ship. It is obvious that this value is going to increase even more according to the pictures taken on 26th August 2016. In SOLAS Part 5, Regulation 22 "Ships of not less than 55 m in length, as defined in Regulation III/3.12, constructed on or after 1 July 1998, shall meet the following requirements:

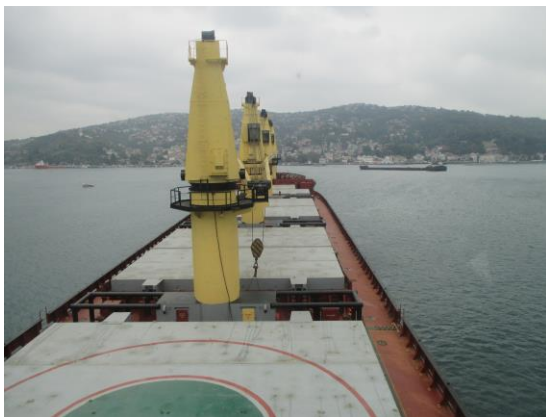
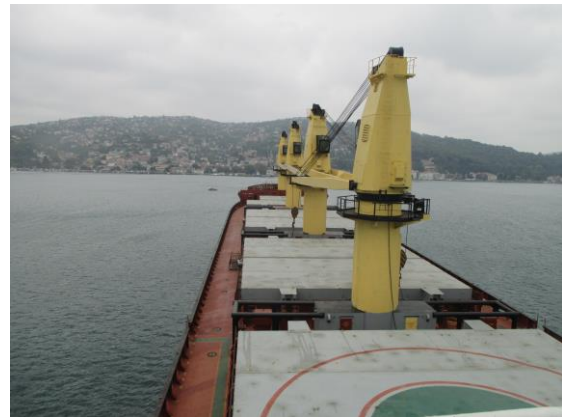
***Pictures 22-23: Blind Sectors Formed By the Ship's Cranes***

Over the forward to aft line of MV TOLUNAY, between the cargo holds, there are four cranes. These cranes constitute obstacles against the sight when looked from the bridge. *(Pictures 22,23)*

In the framework of these regulations, and especially considering the dense traffic conditions and the blind sector at the forward part of the vessel, it is regarded that posting of an additional lookout on the bridge for the purpose of establishing the safe navigation of the ship would be useful. Moreover, even if an additional lookout would not be posted, it is obvious that the bosun at the forecabin of the vessel could contribute to the bridge lookout duties.

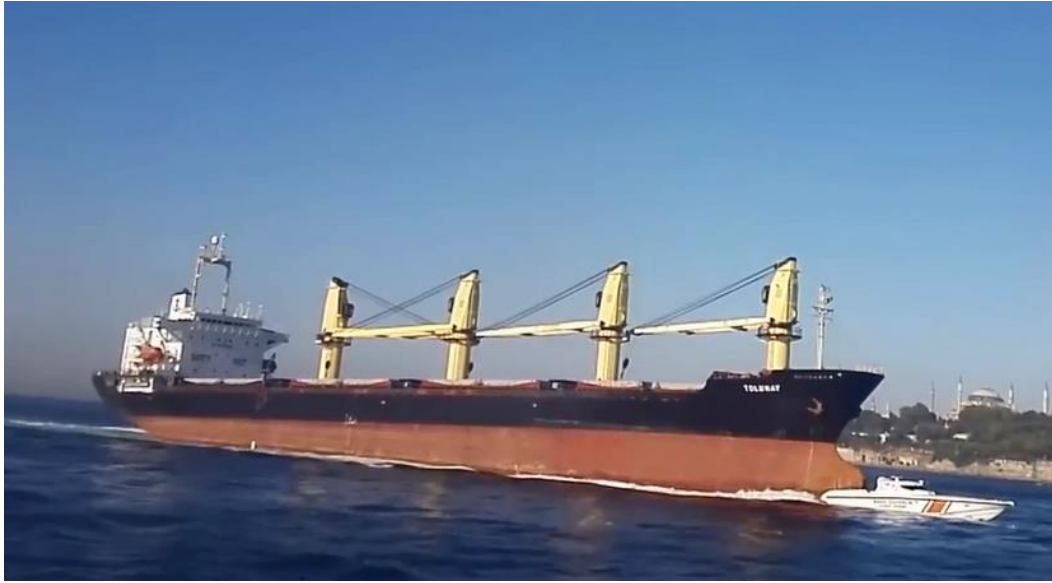
**Picture 26:** *MV TOLUNAY Colliding with TCSG 25*

Captain stated that he saw TCSG 25 Boat approximately 1 minute before the collision and warned them with the ship’s whistle blast and that as the vessel was in ballast condition (empty-unloaded) and thier draft was high, he could not see the collision event from the bridge. Chief Officer stated that he was at the chart table when he was called by the Captain to be in charge of the ship’s whistle, TCSG 25 Boat approached them from their starboard side and the collision occurred 20 seconds after they blowed the ship’s whistle. However, according to the video records taken from the Russian federation Navy Ship, at the time when MV TOLUNAY collided with TCSG 25 Boat (**Picture 26**), one ship whistle

blast (5 seconds/long) was heard. After this first blast, 12 seconds later a long blast (7 seconds long) and 20 seconds later a short blast (2 seconds long) were heard.<sup>6</sup>

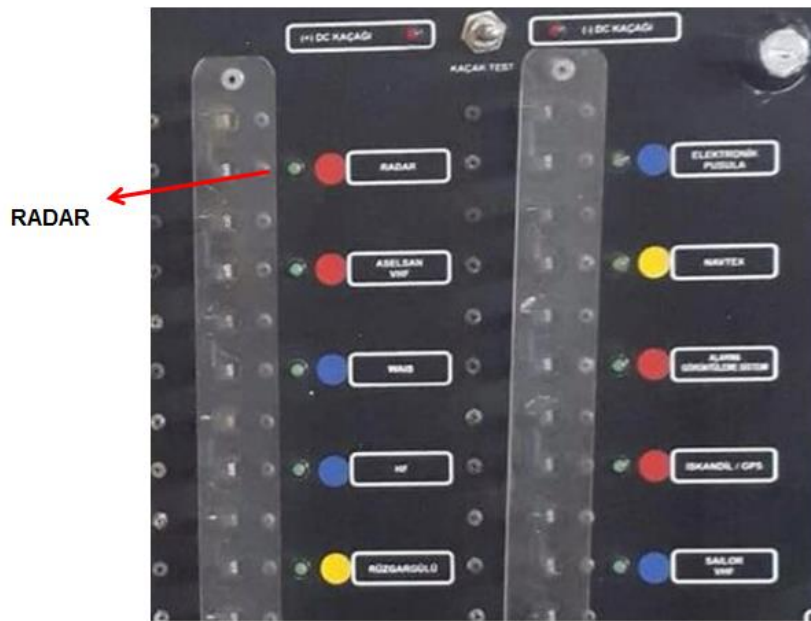
**Picture 28:** TCSG 25 Boat's Electric Feed Panel

In the investigation on TCSG 25 Boat after the collision, it is observed that the power unit on the panel which shows the electric current that feeds the electronic devices on the bridge was green (**Picture 28**) and therefore it is concluded that TCSG 25 Boat's radar was not out of order. Although there is not a clear information about whether TCSG 25 Boat's radar was operating actively during her navigation, from the video display that was recorded by the Russian Federation navy ship which shows the last one minute before the collision, it is observed that TCSG 25 Boat's radar antenna was not rotating and therefore it is considered that it was not operational.
