Accident Investigation Report On
The Explosion Onboard TIBIL

Sea of Marmara / Tuzla Anchorage Area
20th of January 2014

Report No: 01/2014

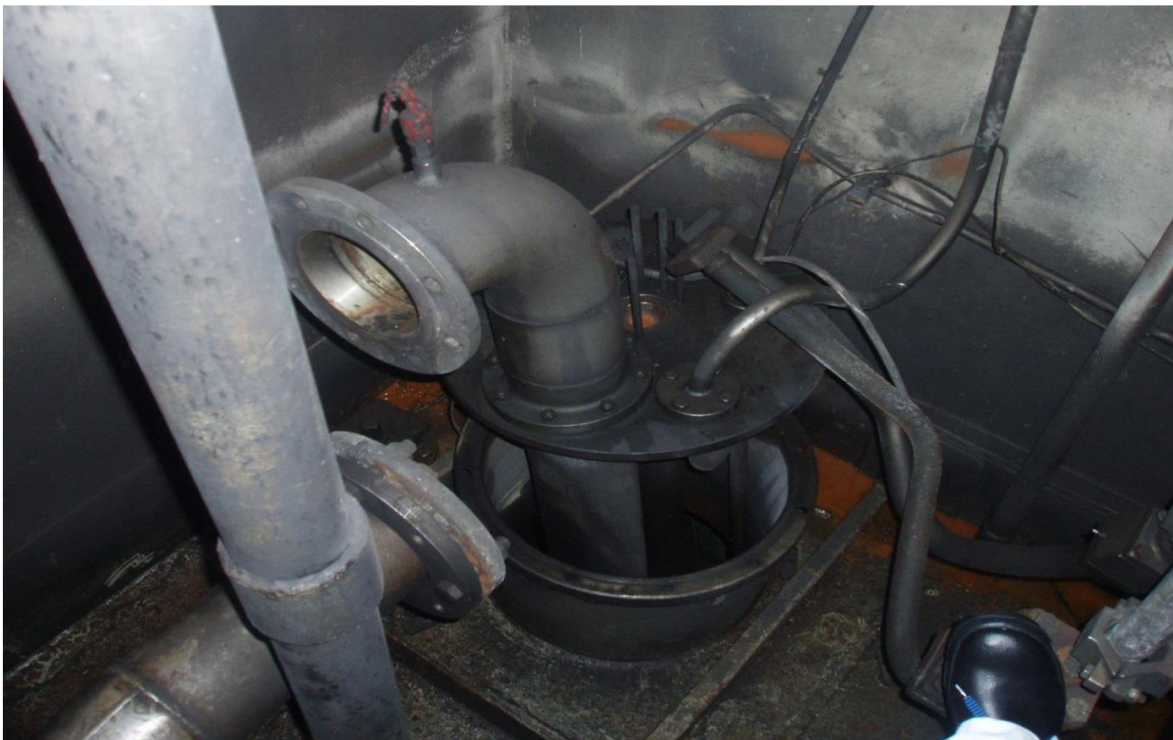
Figure 3: Cofferdam of No.2 Starboard Side Tank

It was observed at the inspection of cofferdam where the No.2 starboard side tank pumps and lines located that cargo pipe line which was coming from tweendeck was closed but tubulure which was going inside the tank was left open. Additionally, it is observed that there is a 30 cm gap in the section where the structure consisting subject lines passing inside from and other lines are placed normally required to be bond with a bolt in order to ensure tightness. It could not be decided definitely whether this gap was formed during the explosion or it was like that previously. During the inspection carried out after the explosion, it could not be observed that there was a physical change in these lines and this strengthens the possibility that this gap was present before the explosion.

It was also observed that inside the cofferdam connections of hydrolic pipes of the pump coming from tweendeck and entering the subject cofferdam were cancelled with the thought of them being out of use. Taking into account that there were leakages at some

parts of cargo lines placed at tweendeck, it is considered that, air/gas transfer at these pipes between tweendeck and cofferdam was likely possible.

In the light of the observations mentioned above, it is thought that the subject cofferdam and the tank below became as integral, therefore gas transfer was ensured easily and contacting of the sparkle formed by cutting the air duct with the possible accumulated gas inside the tank resulted in the explosion.

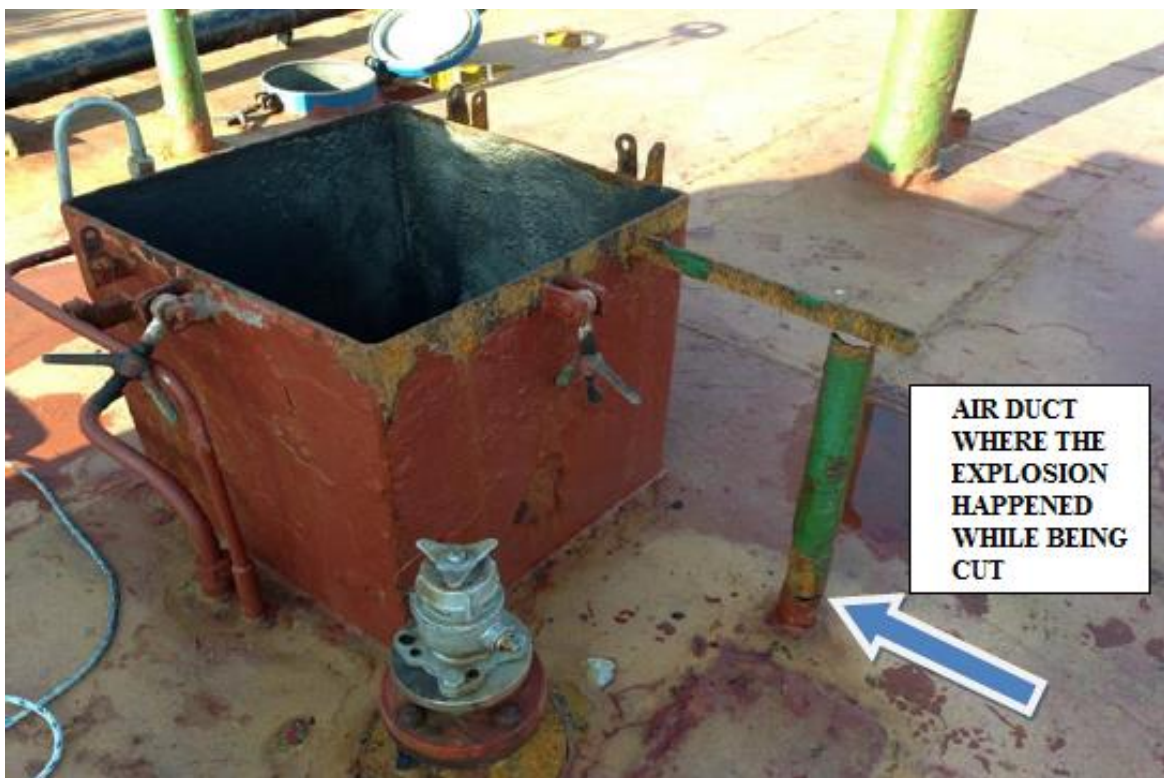
Figure 4: Entrance Manhole of the No.2 Starboard Side Tank Cofferdam

Deck personnel stated that, before the accident firstly a washing operation was carried out for 6 hours for a total of 7 tanks, during the night only the tanks that were loaded with cargo were ventilated (natural ventilation was carried out, ventilation with portable fan was not done), on the following day morning firstly eject operation was carried out inside No.1 center tank, while eject operation was being carried out inside No.2 center starboard tank the operation was cancelled by the chief mate, thereby, the ship was not gas freed completely.

It was stated by the lower level deck crew that, side tanks and cofferdams' manhole and tank washing covers were closed excluding center cargo tanks before the explosion, and it was observed in the inspection onboard that, the bolt which was holding manhole cover of the No.1 center cargo tank was buckled but the manhole cover was in its' place, No.1 starboard, No.2 starboard and No.3 starboard cargo tank's manhole covers were not in their place, No.2 starboard cargo tank's tank washing covers were not also in their place.

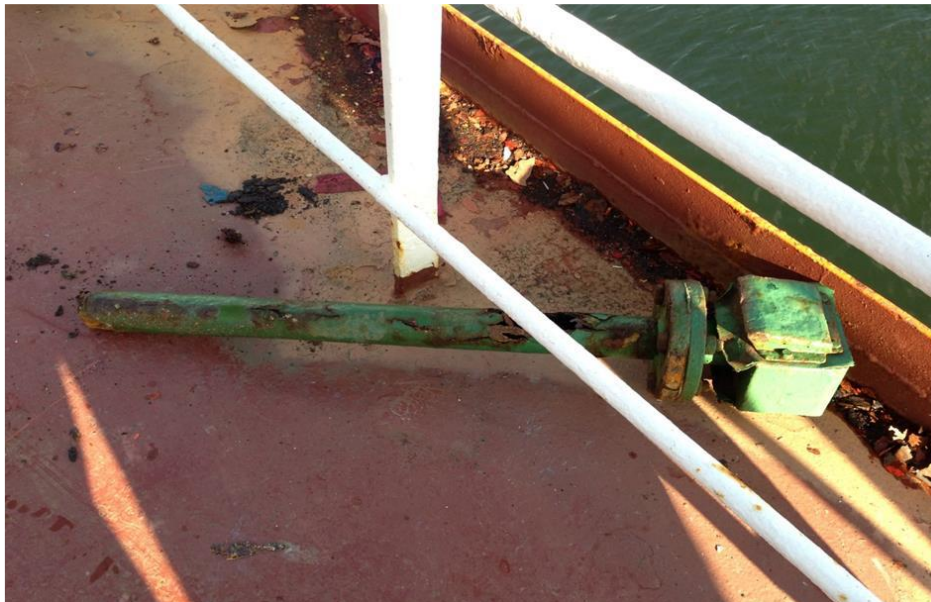
Figure 5: Air Duct of No.2 Starboard Side Tank Cofferdam

port. In the interview that was done with low level deck crew after the accident, one of the crew stated that he had not known that the air duct pipe they were cutting with the spiral motor was belonging to cofferdam where No.2 starboard side tank pump lines were located and he added that he learned this issue after the accident. Within this context, during the general inspection onboard it was detected that mostly markings were inadequate and there was no marking on the air duct and neighbouring manhole where the explosion happened.

3.8 During the general inspection carried out onboard the ship, it was observed that markings were inadequate, there was no marking on the air duct that explosion happened and on the neighbouring manhole, deck crew had no knowledge regarding the deck structure that they were carrying out cutting operation before the accident.

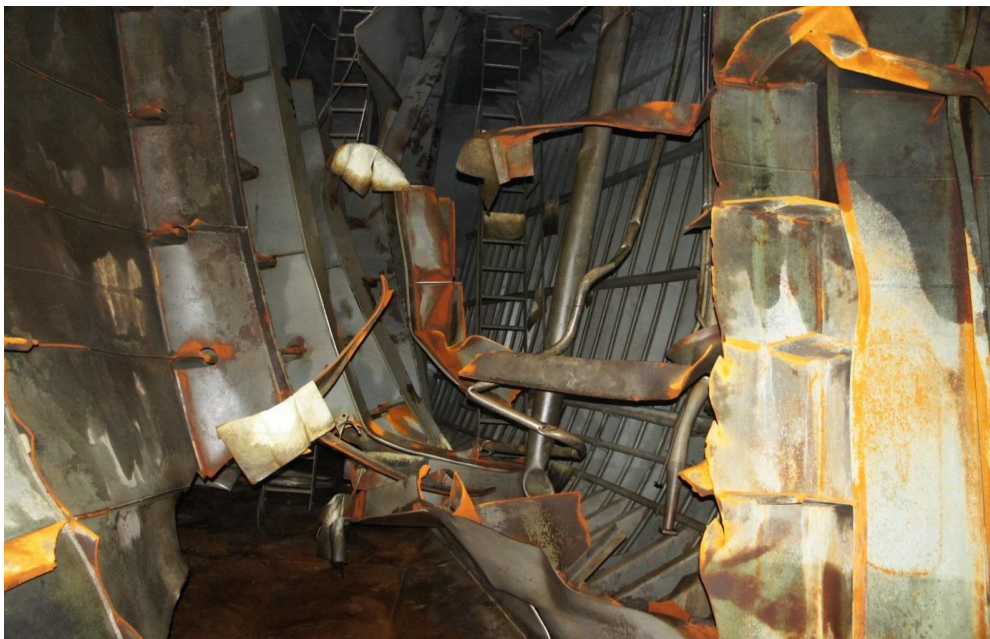
Figure 6: Damage of No.2 Starboard Side Tank

above the pump room with the spiral motor, after completing the work, with 2 ordinary seaman went to fore and started cutting the marked air duct of cofferdam where the No.2 starboard side tank pump lines located. Boatswain firstly cut the clamp of the air duct and then left the cutting of the air duct to fitter by fitters' request who came by. Fitter started to cut the pipe with the spiral motor and when he completed cutting approximately half of the pipe, a big explosion occurred at 13:25 with the effect of sparkles that spiral motor emitted, and one of the able seaman died because a leaping up hard object hit his head with the effect of explosion and one crew became ill from his ear. After the explosion a big rupture on the side wall and very large tears on the bulkheads of the cargo tanks occurred.

It was observed that there were deformations, ruptures and bulgings in various sizes in No.2 center port and starboard cargo tanks, No.3 center cargo tank and No.2&No.3 side cargo tanks' bulkheads onboard. Although it was stated by lower level deck personnel that there were leakages from center tanks to side tanks, during the inspection carried out onboard mentioned situation could not be detected because of the damage occurred inside the tanks. Taking into account the effect of the explosion, it comes to mind that, the explosive gas that ACN emitted was not only present in No.2 starboard side tank and had the possibility of being leaked to another damaged tanks and thus damaged other tanks by increased effect. This situation justifies the determination of the possibility of the gas that ACN emitted can transfer to far distances by leaking.

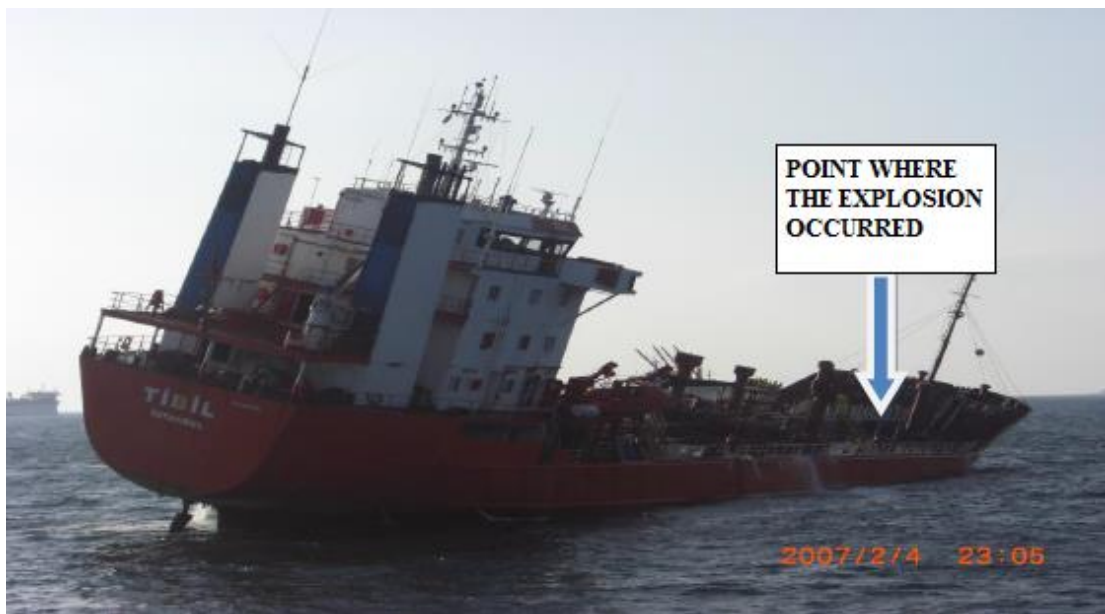
Figure 7: Location Where the Explosion Occurred onboard

On 20th of January 2014, around 13:25 a big explosion happened with the effect of sparkles while cutting the air duct which belonged to the cofferdam¹ of No.2 starboard side tank and where the pump's lines are placed, with a spiral motor with a team of 4 deck crew. One deck crew died because a hard object hit his head and one crew became ill from his ear. After the explosion, a big rupture on the side wall and very big ruptures on the bulkheads of cargo tanks occurred. After the accident, the ship first heeled on the port side, afterwards port upper-side tanks were discharged to sea, and this time the ship heeled between 30 – 35 degrees to starboard side. A couple of crew including the master, who left the ship after the explosion returned to the ship and the ship was righted near stable position with the ballast operation and then towed to shipyard with the help of tugs.

On 20th of January 2014, while anchored at Tuzla Anchorage Area, on Turkish flagged chemical tanker TIBIL, a big explosion happened around 13:25 while an air duct on the deck was being cut with a spiral motor and one crew lost his life.

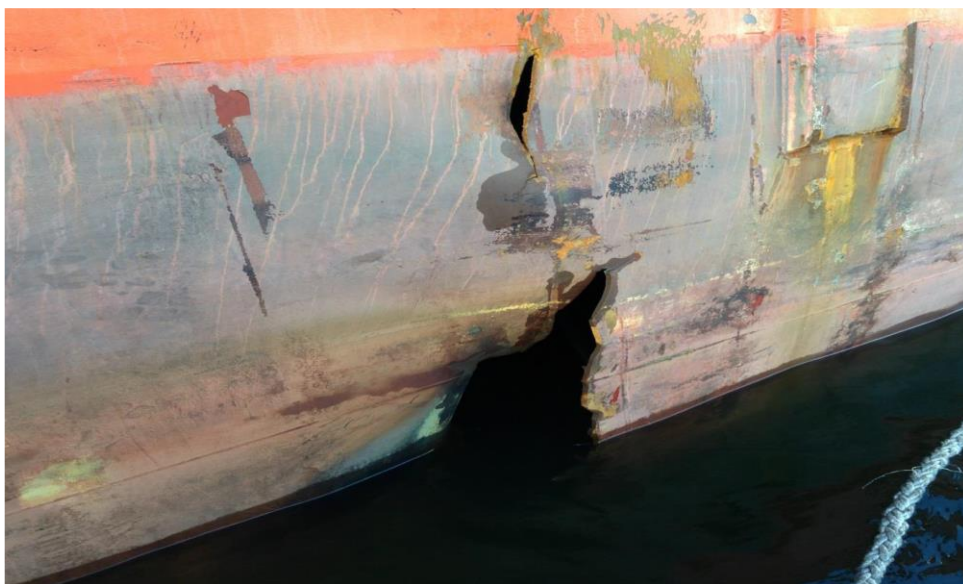
Figure 8: Fracture Which Was Formed on the Starboard Side Wall After the Explosion

As stated in section 1.6, the cofferdam where the explosion happened became integral with the bottom neighbouring tank and the situation became as the gas transfer could easily be provided between these compartments. However, it is considered that as the master and the chief mate were not so familiar with the ship, they were not aware of this situation. It is considered that, the chief mate should have thought the possibility that the gas that ACN emitted could leak to all neighbouring tank and compartments which were not filled with cargo by passing from all the possible holes and cracks and maybe accumulate there, therefore he should have provided that gas freeing operation was carried out in all neighbouring tanks and compartments in accordance with the procedure mentioned in ISGOTT and ISM Manual and he should have done the oxygen and explosive gas measurements but he acted as imprudent and caused the possibility for the accident. Additionally it is considered that, as it is understood from the statements of the crew that chief mate and deck crew were affected from some of the attitude and behaviours of the master and this situation might likely caused the chief mate to apply the rules regarding safety hesitantly.
