**REPUBLIC OF TURKEY**  
**MINISTRY OF TRANSPORT AND INFRASTRUCTURE**  
**Accident Investigation Board**

**Accident Investigation Report On**  
**The Foundering of TINAZTEPE S**

**Bay of Sirte / Libya**  
**16<sup>th</sup> of March 2017**

**04/DNZ-01/2018**

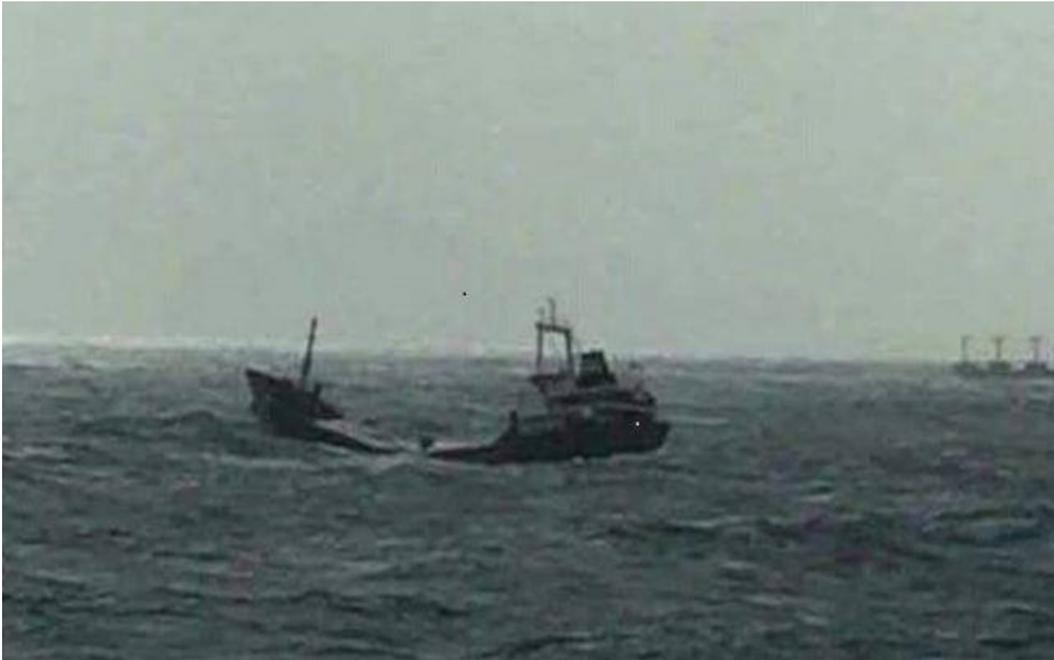
*Figure 5: Snapshot of the Moment of the Ship While Broken*

During the email correspondences between the management company of the ship and Misurata agent, it was asked whether the ship could able to berth as the ship would arrive on 15<sup>th</sup> of March 2017 at late hours and on 16<sup>th</sup> of March 2017 the weather would get worse. The agent replied that the ship could berth on 18<sup>th</sup> of March 2017 as the set loading commencement, in case of early berthing they would be obliged to pay 3000 USD per day. TINAZTEPE S arrived to Misurata port on 16<sup>th</sup> of March 2017 and anchored on 08:30 by dropping 7 shackles. Although the ship requested to berth from port authority several times because of difficulty to stay on anchor as a result of severe weather, it could not receive a positive response. Afterwards, the master heaved up the anchor by his own initiative and ordered the crew to berth the port. Meanwhile the ship was broken by sagging from the mastory with the effect of heavy waves. (*Figure 5*)

However it is assessed that, the cargo was dispersed near midship section and when taking into account the condition and age of the ship, the weather conditions forced the ship to experience structural stresses and created additional stresses on ships' structural integrity and consequently ship was deformed close to the midship section and was broken.

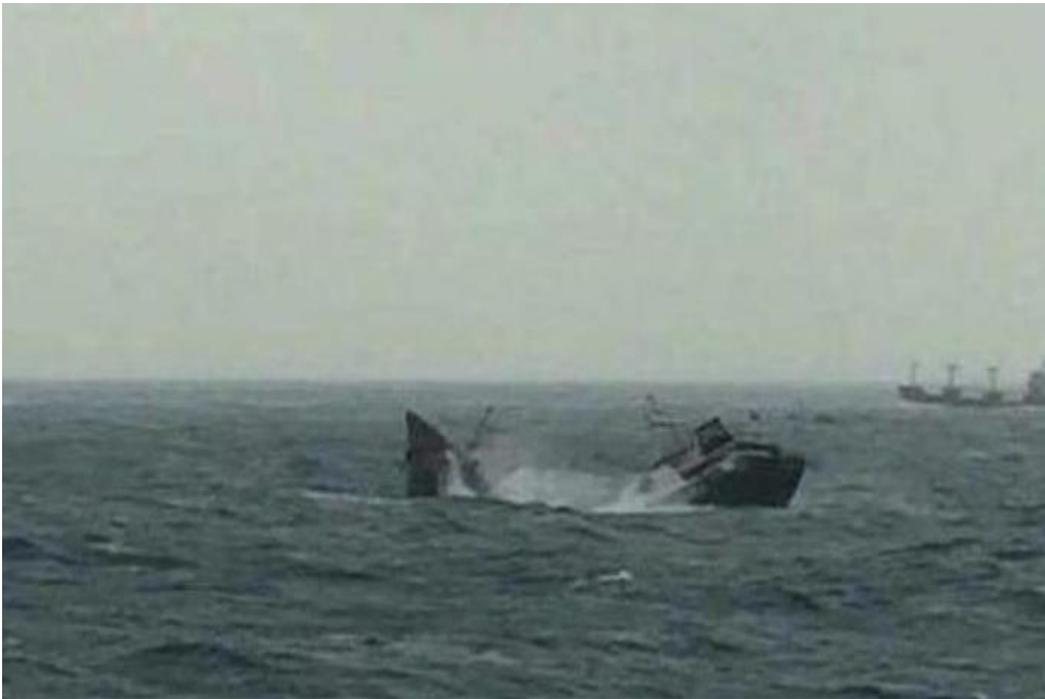
*Figure 6: Snapshot of the Sinking After the Ship Broken*

approximately 2 nautical miles off the Misurata port around 11.50 after a short while following the crew abandoning the ship. (**Figure 6 - 7**)

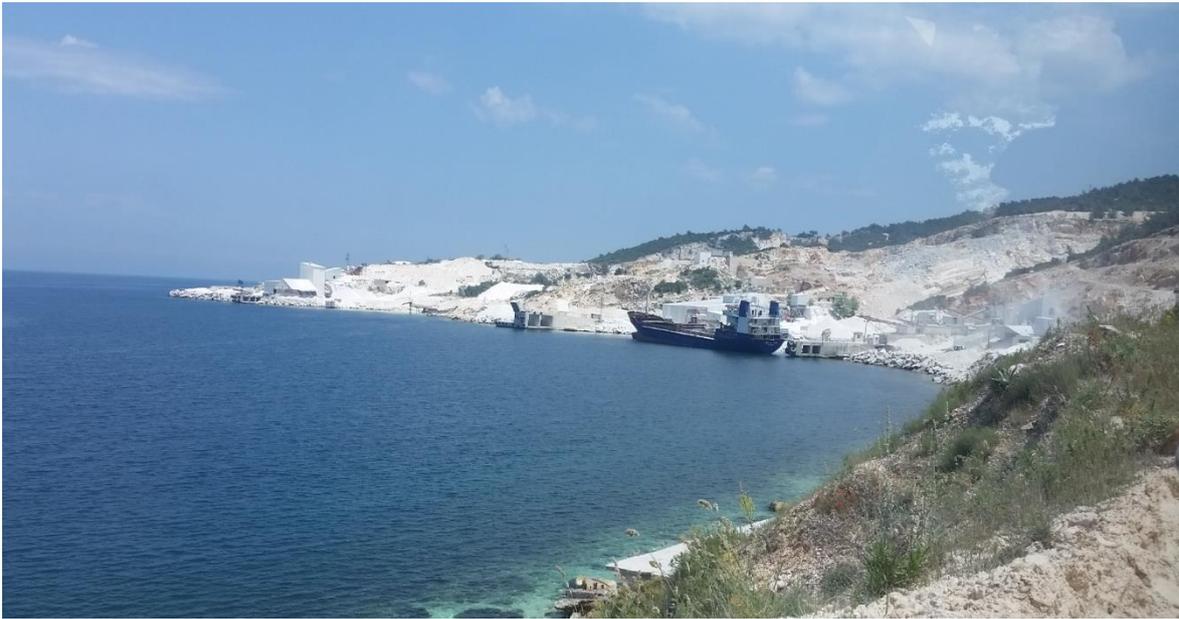
**Figure 10:** A View of Badalan Bay and the Piers

TINAZTEPE S berthed to ERS pier on Marmara Island, Badalan Bay for the loading of dolomite (**Figure 10**). There are 3 piers in the region including ERS pier. These piers are also used for dolomite loading like ERS pier.

ERS pier and the other two piers' operation permits expired and were not renewed. The reason for the piers' operation permits not being renewed was non conformity with the safe loading operations and revised legislation of pier structures. It is stipulated on By-law on Ports which was published on 8<sup>th</sup> of April 2017, Article 20, first paragraph and subparagraph (ğ) that: *“Wharf or pier length shall be at least 10% longer than the ship and sea craft that will berth coastal facility for loading/unloading. Water depth at these facilities shall be at least 0,5 meters more than the loaded draft of the ships that will berth. Ships that are not complying with the length and other conditions, can berth according to harbour master's written approval. Ships which will berth these facilities, shall be in compliance with additional measures that will be determined by the harbour master, such as not creating an obstacle to maritime traffic and maneuver and permitting safe mooring*

- 4.1** It is stipulated by adding (ğ) subparagraph to by-law on ports with the by-law on revising the by-law on ports which was promulgated on the official gazette on 8th of April 2017 that; “Pier or wharf length, which the ship and water crafts will berth with the aim of loading/unloading, shall be at least 10% longer than the ships’ length. Water depths at these facilities shall be at least 0,5 metres more than the ships’ loaded draft that will berth. Ships not meeting the length requirements and not carrying the required conditions stated above, can berth with respect to harbour masters’ written approval. The ships that will berth these facilities shall be in compliance with additional measures that will be defined by the harbour master such as; not posing an obstacle to maritime traffic and maneuver, providing a safe mooring and making the entry and exit safely.”

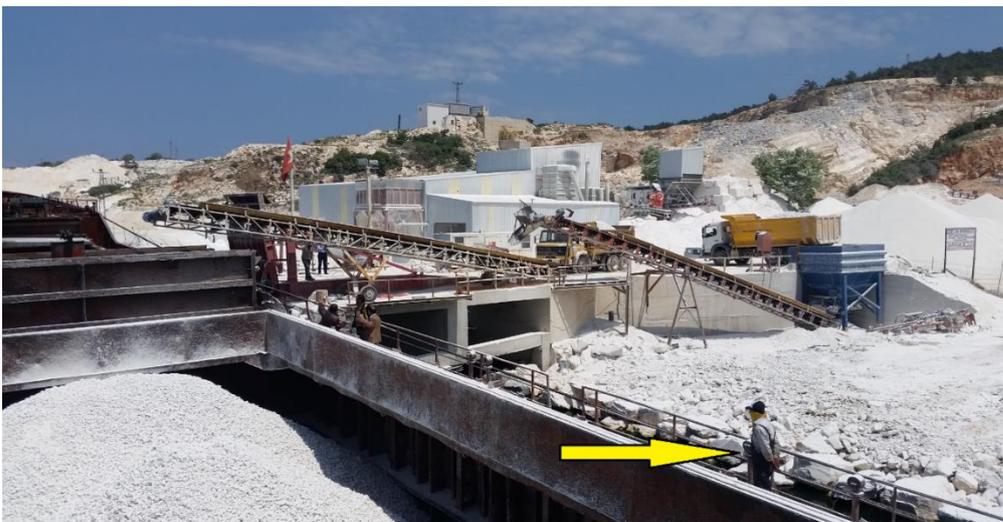
*Figure 11: Terminal Personnel Having a Duty on Loading Operation*

And when taking this provision into account, it was detected that terminal personnel who was on duty at loading operation at the terminal was not equipped with appropriate personal protective equipment (*Figure 11*).

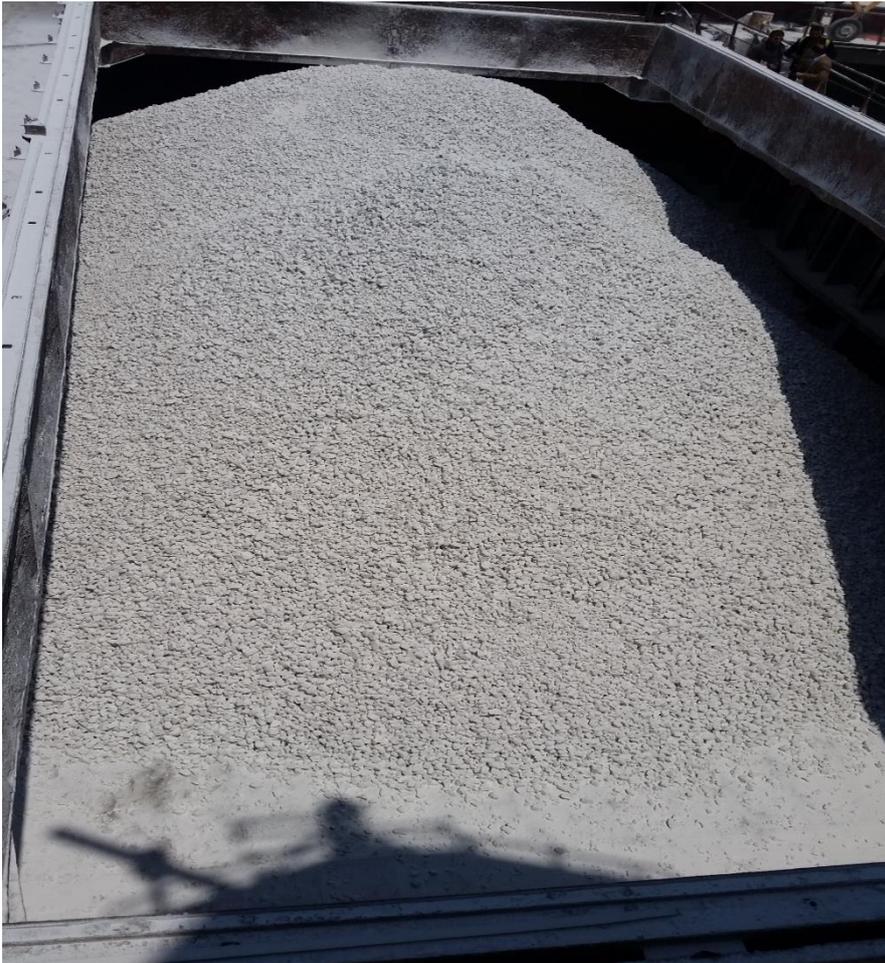
**Figure 12: Cargo Dispersion in Another Ships' Hold While Loading 2.2.2 Effect of Trimming (Cargo Dispersion)**

It is assessed from casualties' statements that, the cargo was loaded by lifting the truck dumper suddenly instead of loading with a conveyor extending over a period of time in order to speed up the loading but the master and the terminal representative did not take any measure against this situation. It is assessed that this kind of loading can result in stress and fatigue over the ships' structure and can increase the effects of possible external forces while navigating.

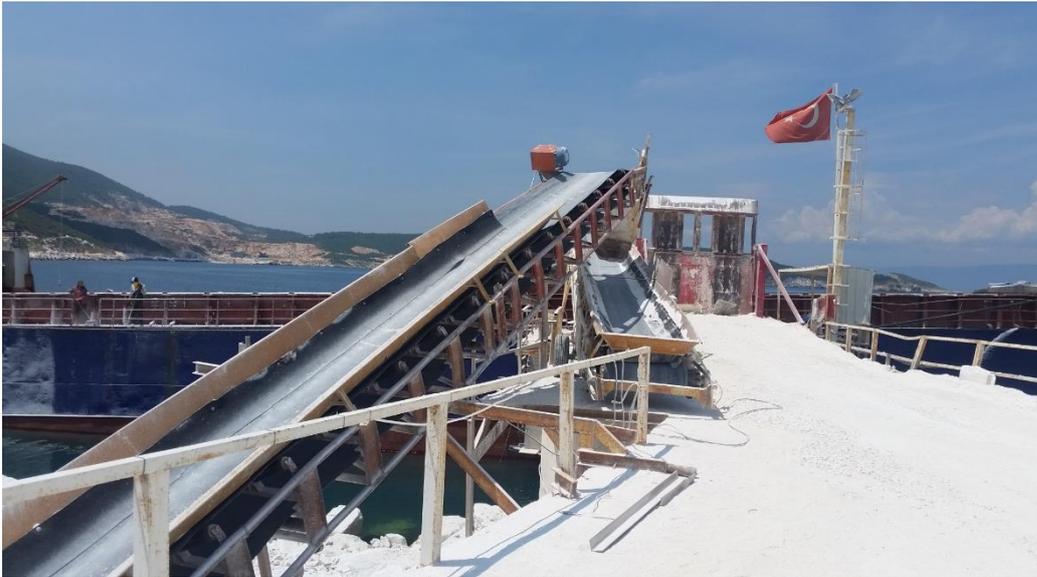
**Figure 13:** Fixed Conveyor at ERS Pier

There is a fixed conveyor at ERS Pier and the cargo is loaded to ship with this conveyor (*Figure 13-14*). Under IMSBC Code Section 5 Trimming<sup>4</sup> procedures it is stipulated that;

The status of conveyor as being fixed creates the risk of cargo not being dispersed homogenously inside the holds. It is known that when the cargo is not dispersed homogenously inside the hold, this will create non-uniform effects on longitudinal forces affecting on ship while enroute. In order to prevent this situation, the masters must act

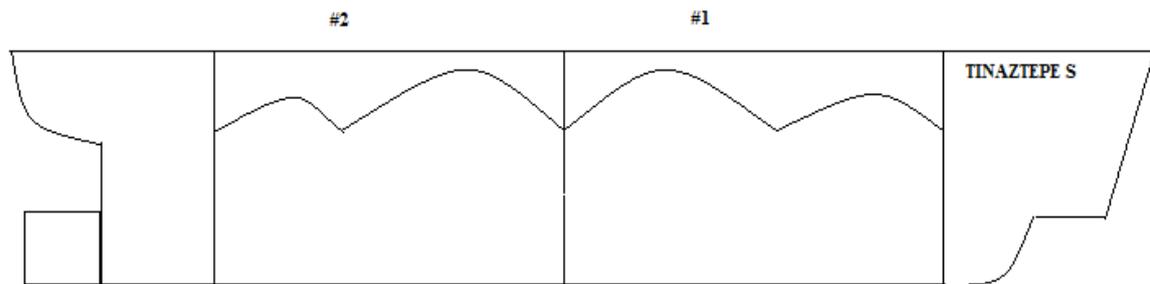
**Figure 15:** An Illustration of Cargo Dispersion Inside the Holds Post-Loading

As a result of the statements received from the witnesses it was determined that, the cargo was dispersed nonuniformly towards completion of the loading of TINAZTEPE S (**Figure 15**) and the master did not request the cargo to be dispersed inside the hold in the context of above mentioned provision from the terminal representative. Terminal representative stated that they had dispersed the cargo via the shore winch shown in **Figure 16** after the loading operation.

Assuming that cargo distribution inside the holds of TINAZTEPE S is at the condition observed in **Figure 15**, as a result of ships' hull form to be regenerated according to the new software used by Turkish Lloyd and taking the allowable maximum longitudinal strength values from the "Bulk Cargo Loading Booklet", it was observed that inside hold number 1 between frame number 68 and 111, 1300 tons of dolomite and inside hold number 2 between frame number 23 and 68, 1820 tons of dolomite was loaded and under these loading conditions, the ship was inside the limits of allowable shearing force and bending moments. (*Annex-3*)

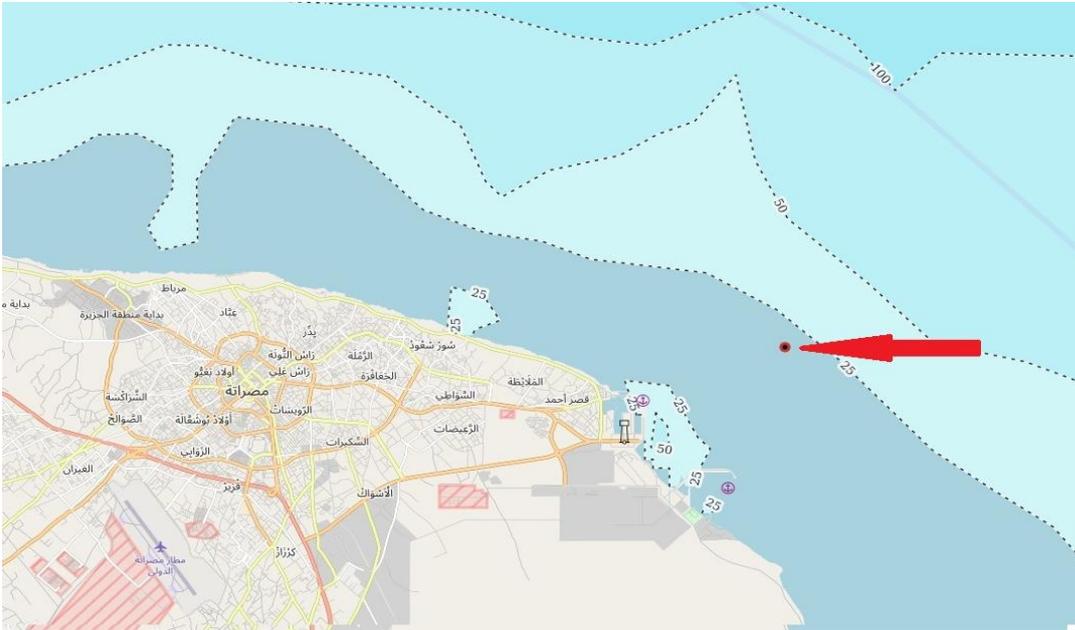
**Figure 18:** TINAZTEPE S's Anchored Position at Misurata Port Anchorage

As there was no navigation plan prepared by the ship and could be understood from the correspondences between the ship manager and Misurata agent, the receiver of the cargo would be ready on 18th of March 2017, that's why anchoring plan was made taking into account the factor that the ship would arrive the destination port earlier. Later on at correspondences, storm is expected at the region, therefore it was informed that berthing would be appropriate by the ship manager.

It is considered that stand on anchor at severe sea conditions affected the structural integrity deterioration of the TINAZTEPE S near the amidship.
