**REPUBLIC OF TURKEY
MINISTRY OF TRANSPORT, MARITIME AFFAIRS
AND COMMUNICATIONS
Accident Investigation Board**

**Report on the collision between
the RO/RO ship UND EGE and the fast ferry OSMAN GAZİ-1**

**Sea of Marmara / Off Sivriada Island
December 26, 2011**

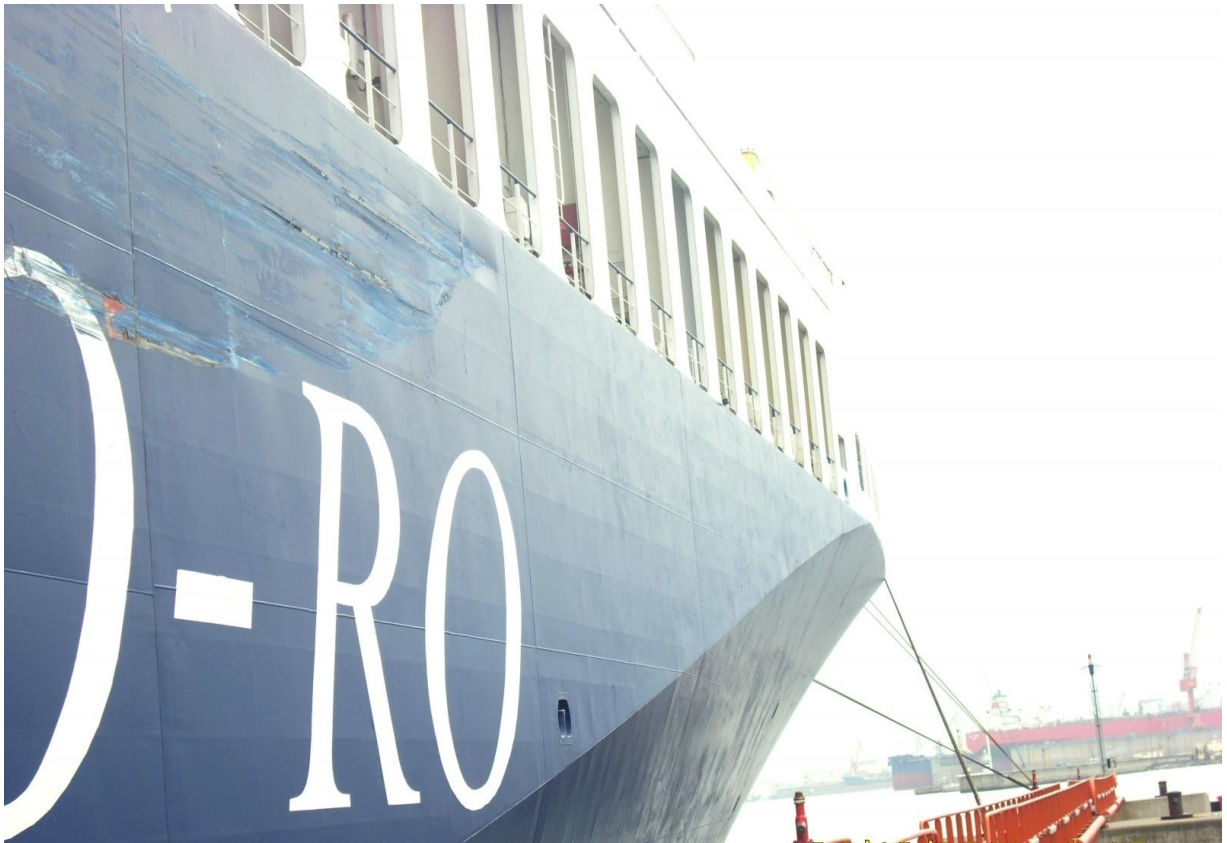
Since he thought that the voice of the watchkeeping officer calling him sounded not too much worried, the master of UND EGE went to the bath to wash his face and 45 seconds after the phone call, he went up to the bridge. When he arrived on the bridge, the master realised that the vessel OSMAN GAZI-1 was on the starboard side within very close distance and the third officer went into shock, losing all the control. The master immediately changed the helm from automatic to manual steering mode and put the helm hard to port. However, due to high speeds of both vessels and very close distance between them, it could not be avoided that a few seconds thereafter, at 08:41 hours, the collision occurred about 4 nautical miles southwest from the Island of Sivriada (located at 40° 50,5 N / 028° 54,6 E). The vessel UND EGE, from its starboard beam to stern, scraped past the starboard bow of the vessel OSMAN GAZI-1.

Figure 4: Damage to starboard beam of UND EGE

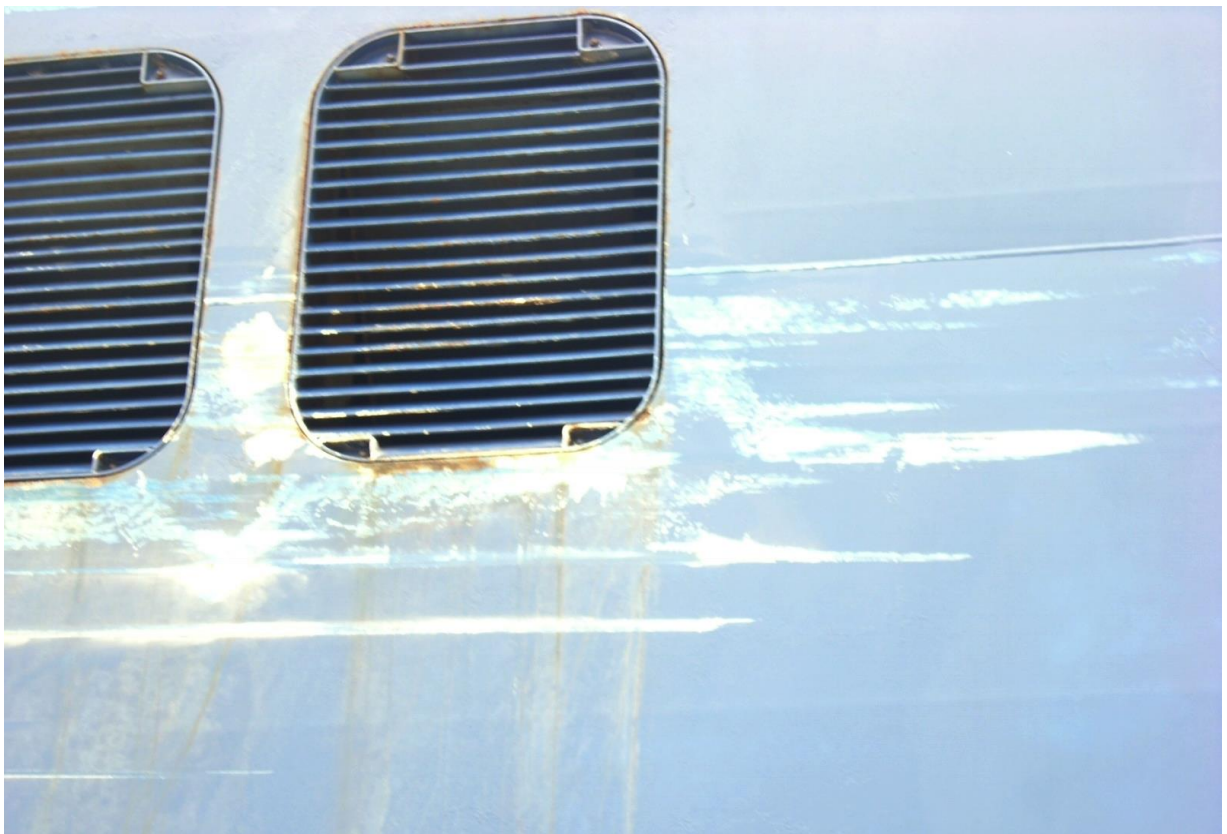
Figure 5: Damage to starboard stern of UND EGE

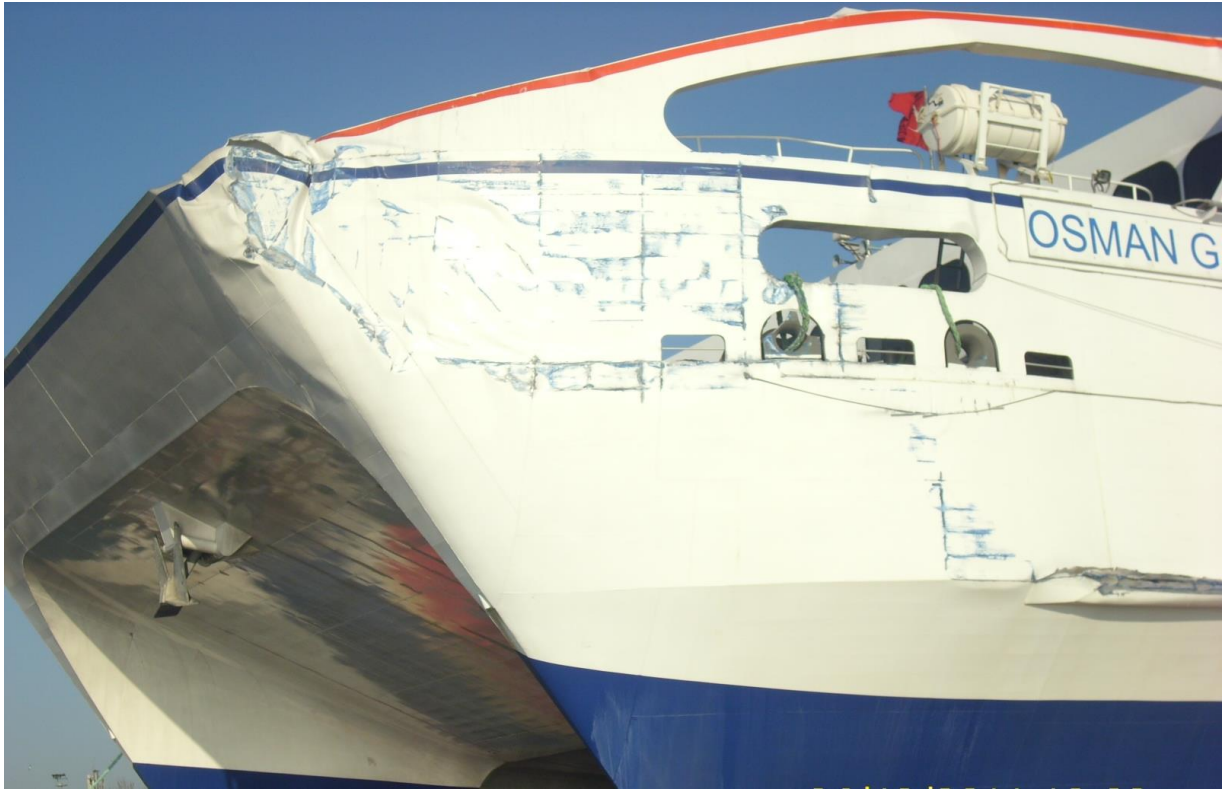
Figure 6: Damage to port bow of OSMAN GAZI-1

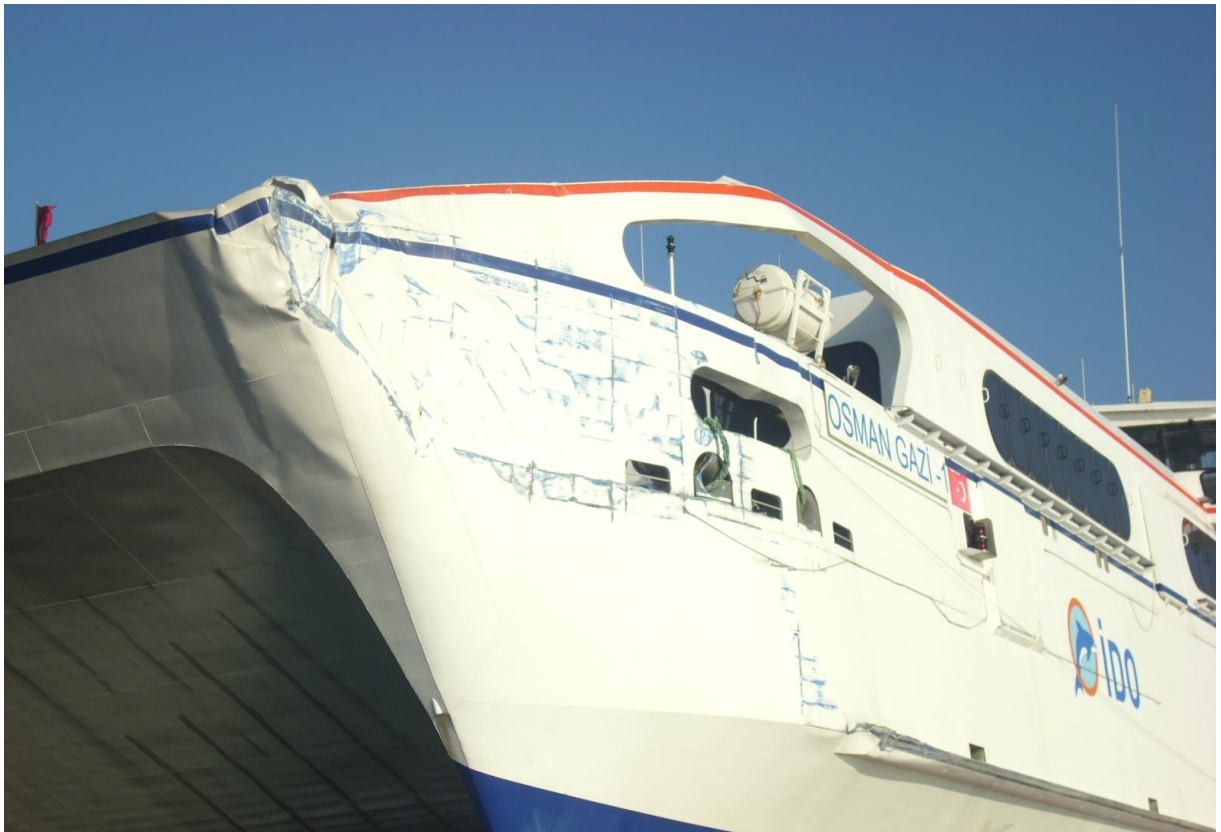
Figure 7: Damage to starboard bow of OSMAN GAZI-1
