**VITASPIRIT  
Marine Safety Investigation Report**

**Due to the Striking Mansion on the Eastern Bank of the Strait**

**Strait of Istanbul**

**07 April 2018**

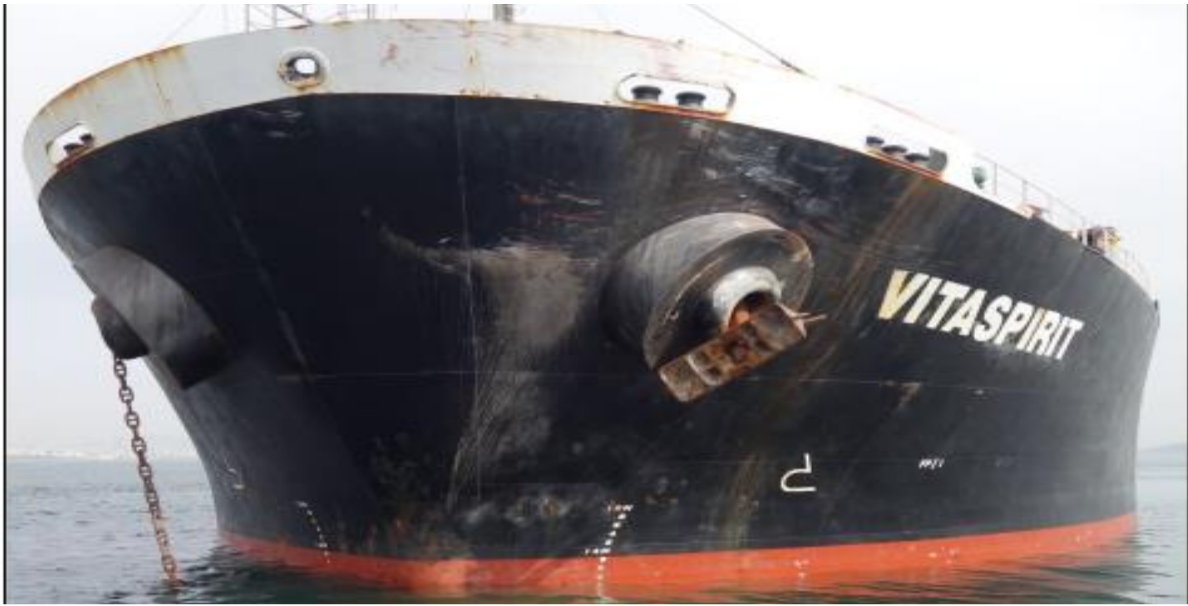
The vessel sustained superficial damage to the bow above the waterline (Figure 10) and significant damage to the shell plating below the waterline, the bulbous bow and the internal structures, in way of the fore peak tank (Figure 11).

Figure 10: Superficial bow damage

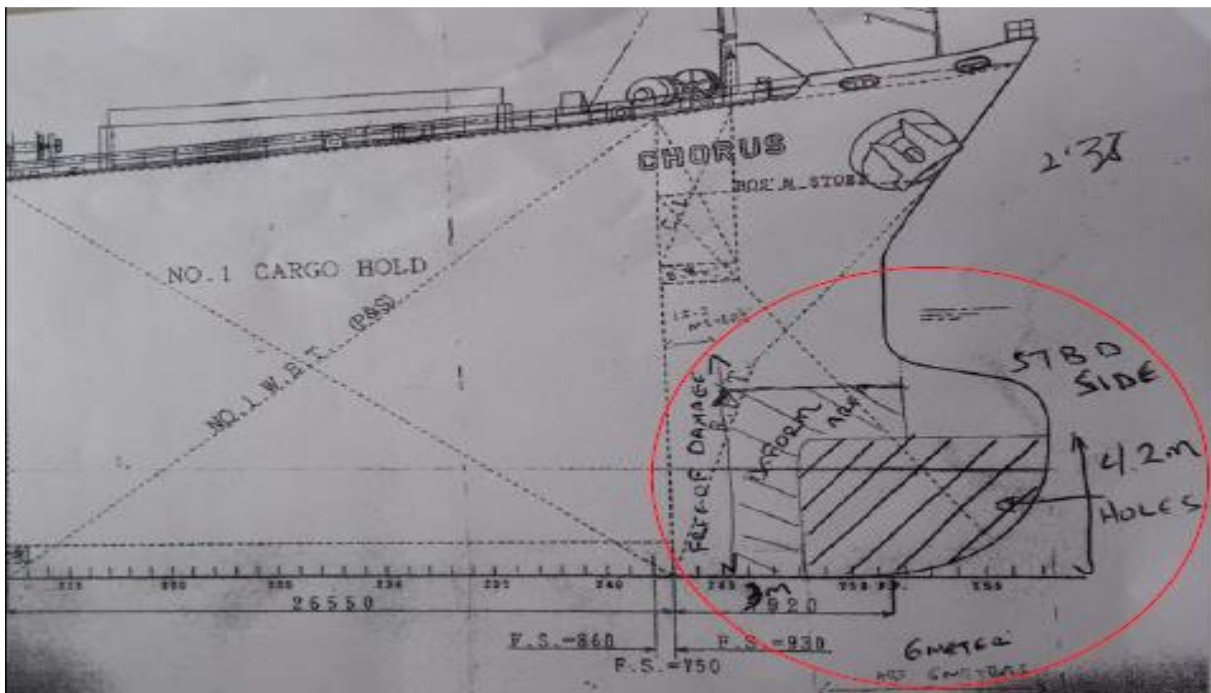
Figure 11: Sketch showing area of bulbous bow and forepeak damage

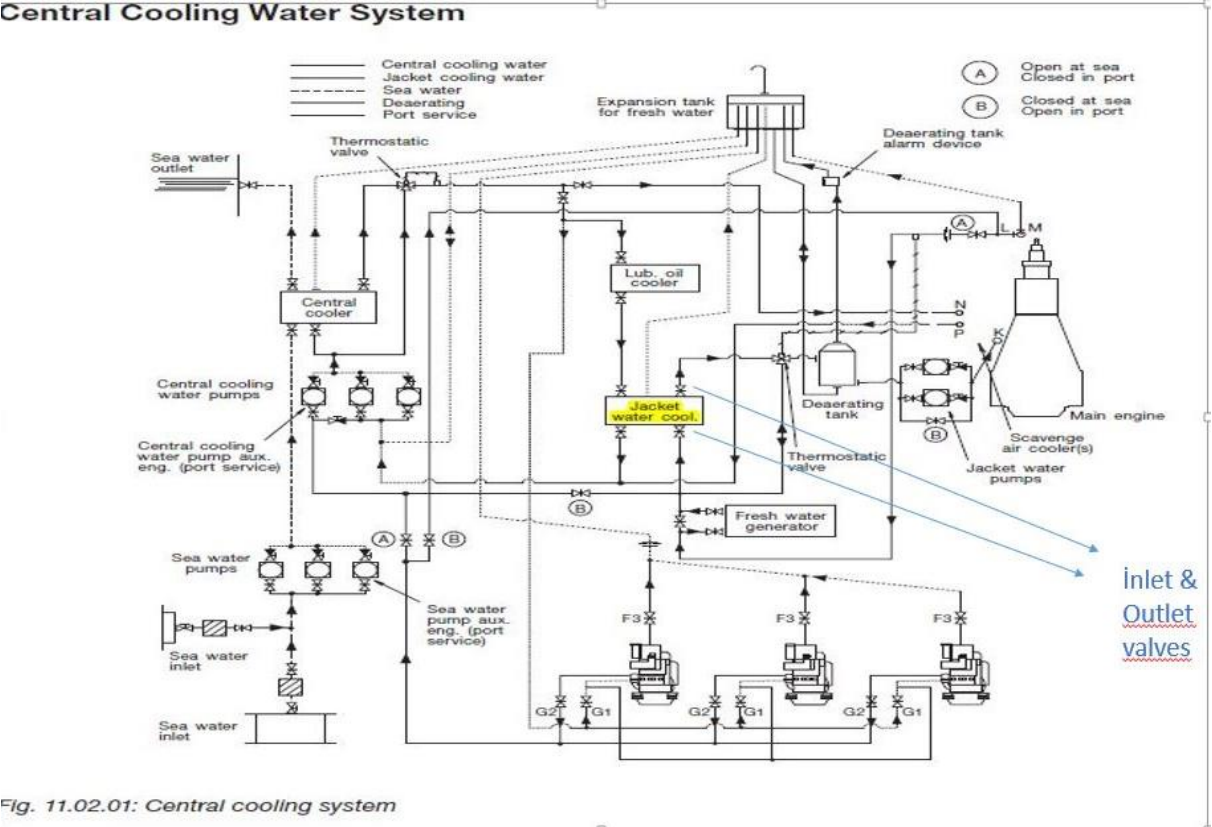
**Figure 12: Diagram showing Central Cooling water system taken from manufacturer guide**

The main engine on *Vitaspirit* had seven units. Each unit comprised of the cylinder liner, cylinder head, cooling water jacket and a transition piece between the cylinder head and the cylinder liner. Two ‘O’ rings, formed a seal between the cylinder head and the cylinder transition piece. The cooling water jacket was held in position by four bolts threaded into the cylinder head. The inlet line of the cooling water system had an isolation valve. Although outlet valves are available (shown Figure 12) in the manufacturer guide<sup>9</sup>, there is no any outlet valve equipped in the central cooling system on board. Cooling water jacket did not have individual isolating outlet

valves. The outlet from each cylinder, which returned to the expansion tank, could only be isolated through a spectacle blind. In view of this arrangement, any cylinder affected by cooling water jacket leakage, could only be isolated when the main engine was not in operation.

- 17/04-19** Disseminate this safety investigation report to surveyor for the application of Engine manufacturer's recommendations regarding the presence of valves at each piston outlet and carrying out their operational tests during hull and machinery surveys.
- 18/04-19** Make verification and control on making risk assessment during ISM Audit regarding to preventing or reducing the water loss in Expansion tank whether Engine Manufacturer's recommendations are being implemented or not

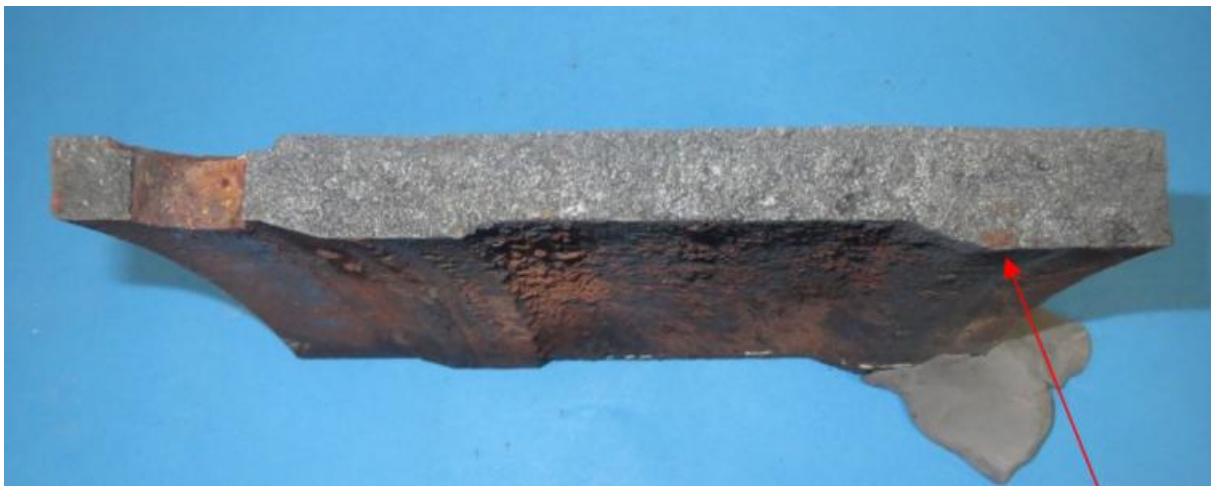
**Figure 13a: Fracture surface after flash, inhibited acid cleaning (Clarke Solution). Rust was removed save for a small area close to the lower seal end.**

The fact that the rust came off almost immediately from a significant majority of the fracture surface (Figures 13a and 13b), indicated that rust on the surface in these areas was of a superficial nature only *i.e.* it was not long standing. This, in turn, indicated that a significant majority of the crack had formed in one-moment-in-time. The small area that has remained rusty is indicative of longer standing corrosion certainly compared to the remainder of the fracture surface *i.e.* a small crack of some nature emanating from the bore of the water jacket, likely existed at this location.

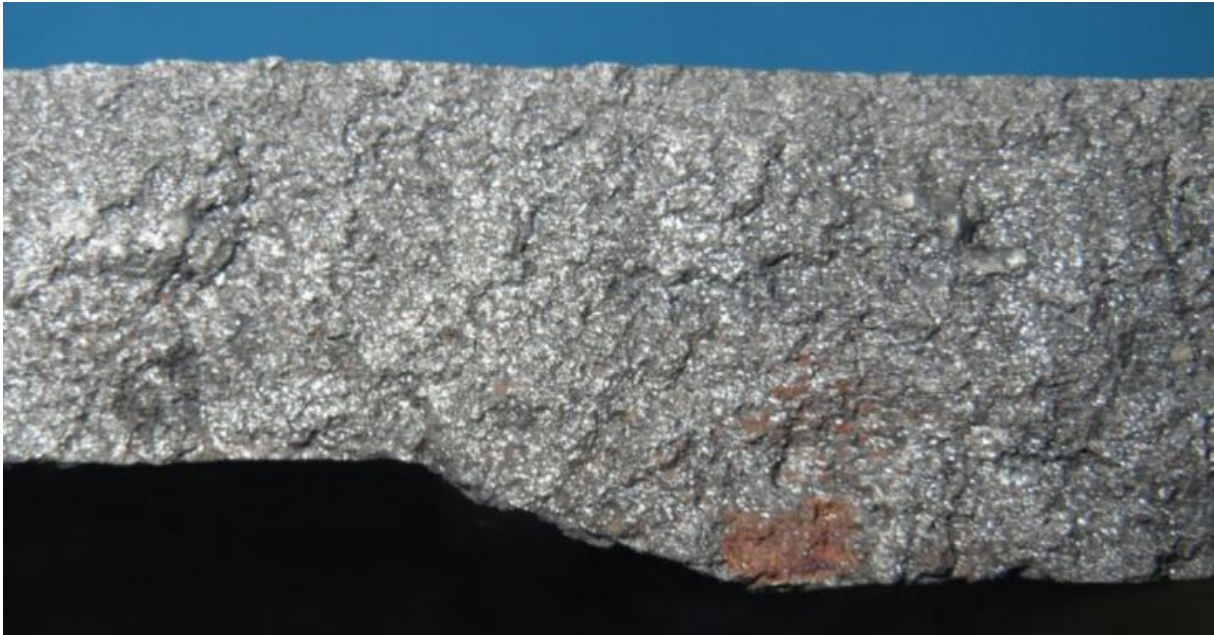
**Figure 13b: Closer view showing the fracture surface after flash, inhibited acid cleaning and the small area of rust-affected fracture surface**
