MARINE SAFETY INVESTIGATION REPORT ON A VERY SERIOUS MARINE CASUALTY

VESSEL NAME : YILMAZ KAPTAN
IMO NO : 8132598
FLAG OF THE VESSEL : Türkiye
LOCATION OF THE CASUALTY : Antalya / Türkiye
DATE & TIME OF THE CASUALTY : 19 September 2013 - 16:12 (GMT +3)
FATALITY / INJURY : 1 dead - 2 injured
DAMAGE CONDITION: : There was material damage on board YILMAZ KAPTAN and SEAGULL EGE-7.
ENVIRONMENTAL POLLUTION : None

Board Decision No: 09 / D-04 / 2023

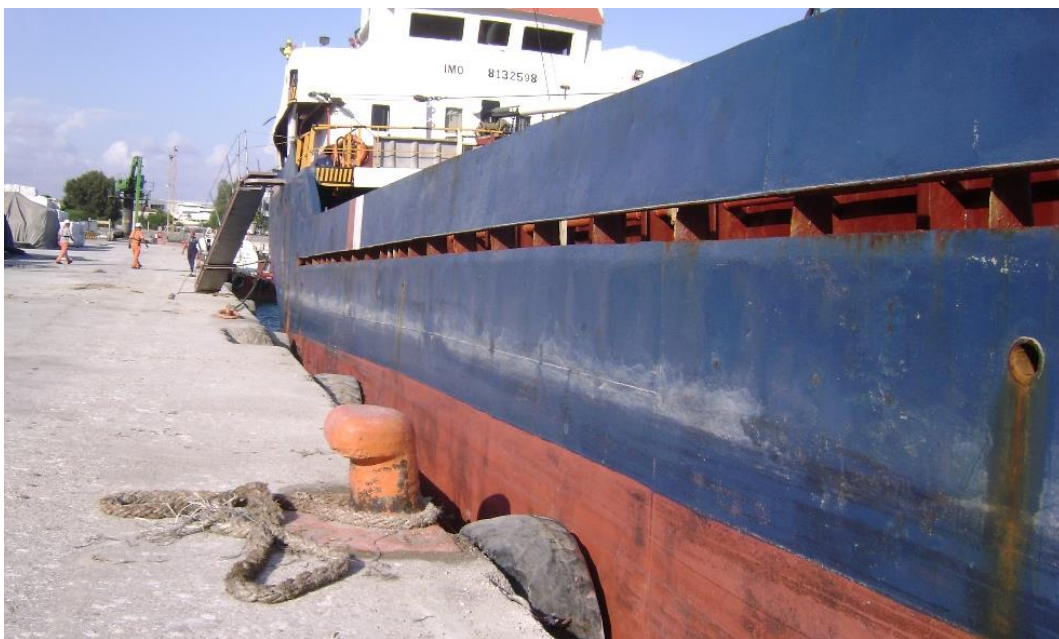
Image 3 Vessel Aboard The Berth And Parted Rope

The over-taut rope broke after the vessel had moved about 10 metres further and the tension on the drum disappeared.

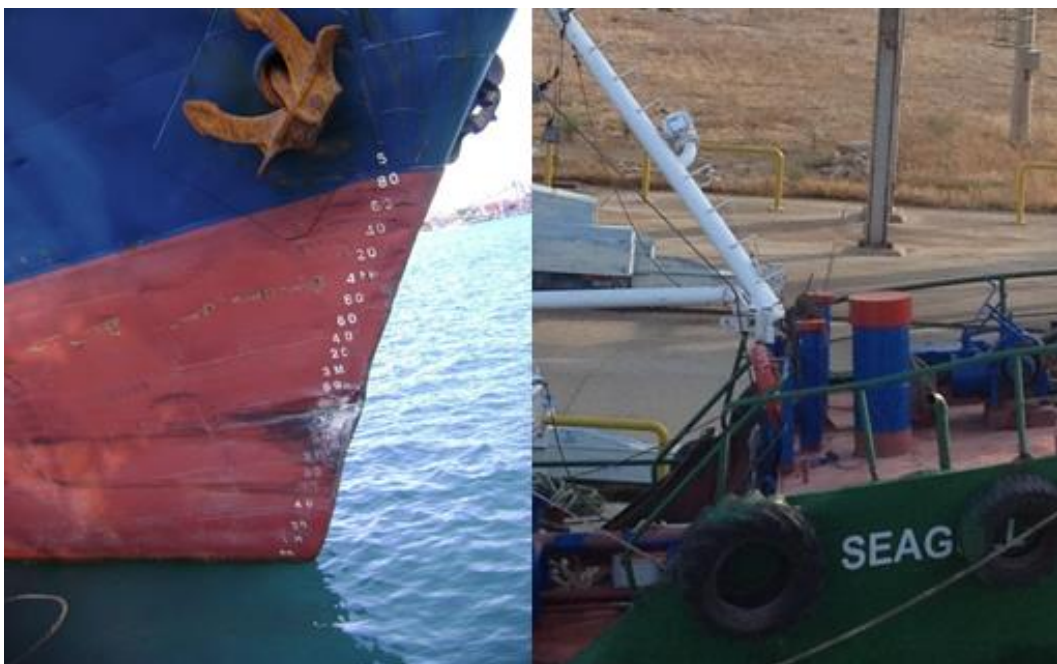
Date / Time of Casualty	: 19 September 2013 - 16:12 (GMT+3)
Casualty type classification	: Very Serious Marine Casualty
Type of Casualty	: Manoeuvring Casualty
Location of Casualty	: Port of Antalya
Dead - Injured	: 1 Dead - 2 Injured
Damage	: Rupture in the bow and deformation on the guard rails of the vessel YILMAZ KAPTAN. Break in the fore mast and guard rails of the vessel SEAGULL EGE 7.
Pollution	: N/A

The vessel continued to sail ahead and collided with the waste collection vessel SEAGULL EGE 7, which was moored at the berth.

Image 5 Damages To YILMAZ KAPTAN And SEAGULL EGE 7

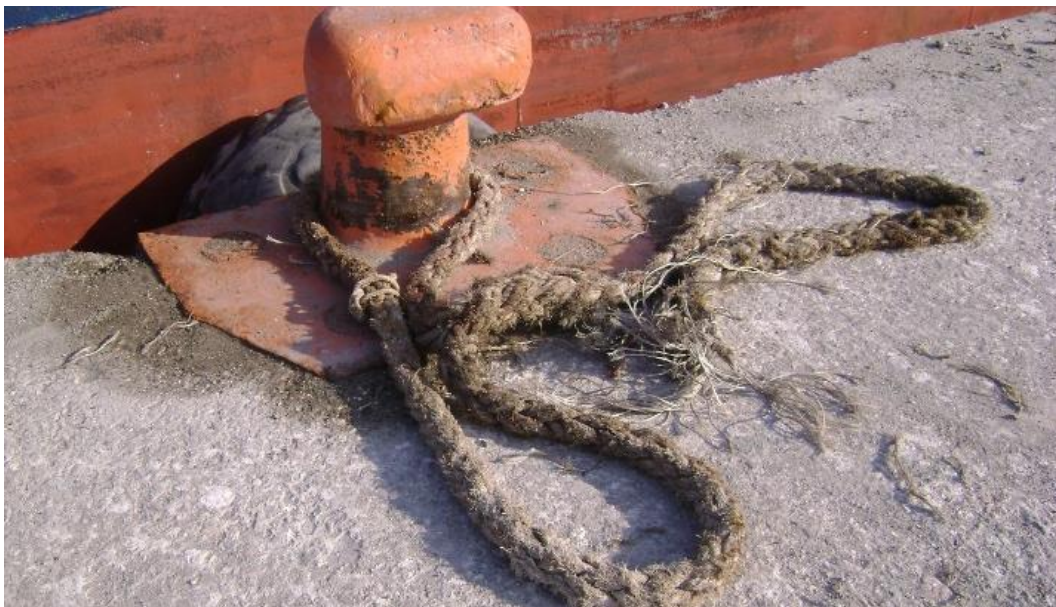
Image 6 The Part Of The Broken Rope Remaining On The Bollard

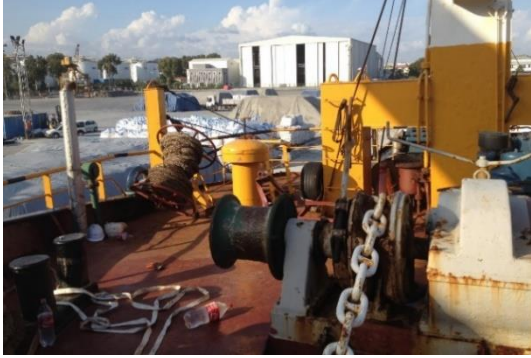
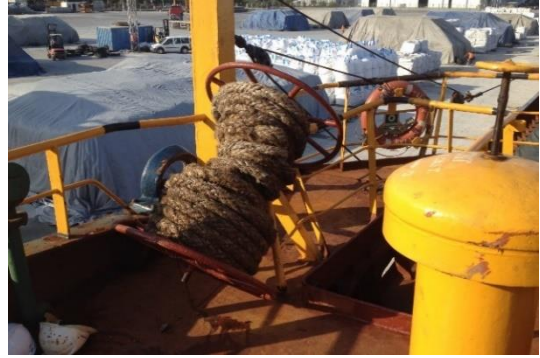
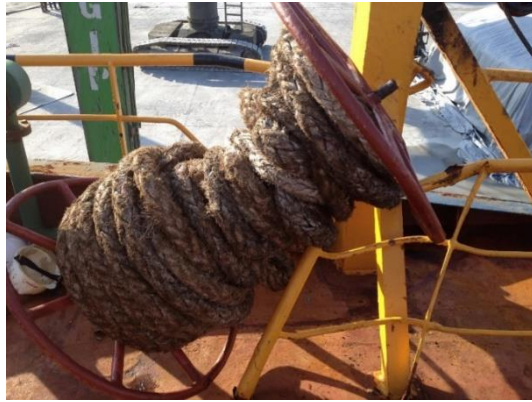
The crew involved in the manoeuvre on the forecastle tried to make fast the rope to the bollard on the vessel by slack away rope on the drum to avoid any load on the rope given to the bollard on the shore, but they failed to catch the running of the rope. When the manoeuvring crew on the forecastle noticed that the rope was rapidly running and tautening, they realised the danger and tried to escape. However, the drum on which the taut rope was wrapped broke off from its place and hit the first officer and injured him, and the cadet was seriously injured by getting stuck between the drum and the pillars.

Image 7 Drum Causing The Casualty By Being Broken Off

Since there was no planning for safe manoeuvring on the forecastle of the vessel in the casualty that occurred, the mooring ropes were hauled out directly from the drum without made fast the bollards, which endangered the safety of manoeuvring on a vessel with a track on it.

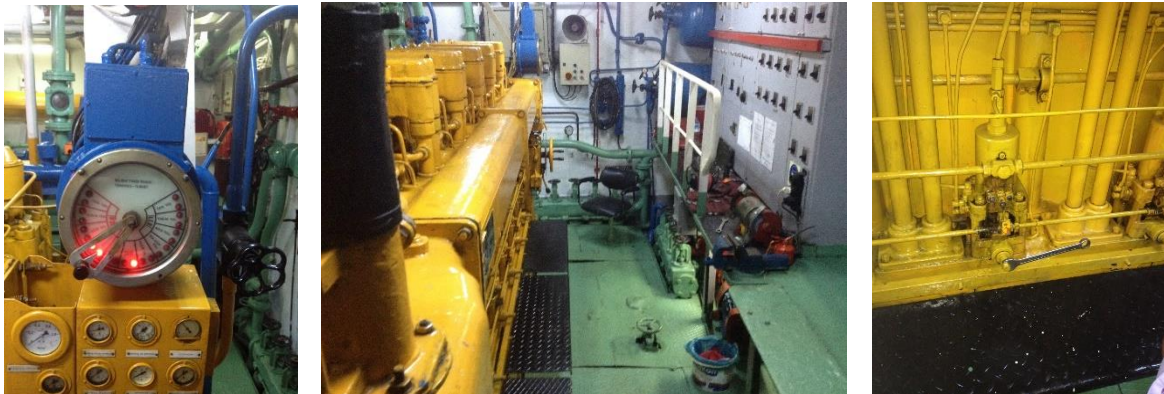
However, the intervention of the oiler and chief engineer with a hammer to stop the fuel pumps after the main engine failed to stop due to the malfunction of the fuel pumps no 1 and 3 to cut off the fuel despite the command to stop indicates that the vessel was not prepared for unexpected malfunctions. This not only suggests that the main engine malfunctioned due to the maintenance and overhaul deficiencies but also indicates the lack of preparation and precautions to be taken against emergencies.

On the other hand, a similar malfunction occurred about a month ago during the mooring manoeuvre. However, there was no evidence of any serious maintenance of the fuel pumps. Also, on the casualty day, the engine astern propulsion tests that should have been run before the manoeuvre was omitted. It is considered that the maintenance and overhaul of the main engine was not performed on time and the necessary engine tests were not carried out on the

day of the casualty, which were among the factors that contributed to the process leading to the casualty.

Image 8 Engine Telegraph, Main Engine and Fuel Pump
