### VERY SERIOUS MARINE CASUALTY FINAL REPORT

| NAME OF THE VESSEL | : EPHESOS / POLATBEY 1 |
| LOCATION OF ACCIDENT | : Off the Port of Karataş - MEDITERRANEAN |
| DATE OF ACCIDENT | : 11/11/2020 / 05.46 LT |

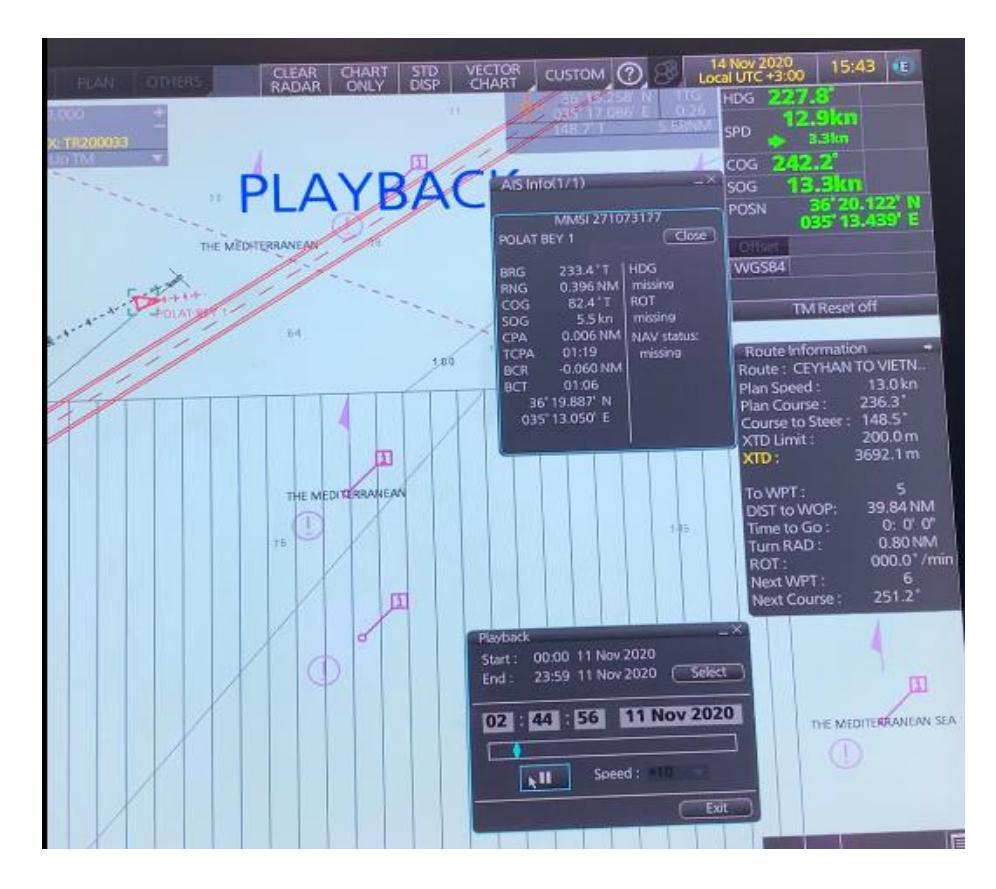
20 seconds later at 5:44:56 AM (Image 22), approximately 1 minute before the collision, while the tanker was continuing to execute the port 20 degrees order, POLATBEY-1 suddenly manoeuvred by altering her course to starboard by 66 degrees course change. Meanwhile, as the tanker headed towards the port with her inertial force, her course was 227.8 and her speed was 12.9 nautical miles. The distance between the two vessels was 0.396 nautical miles.

Image 22: ECDIS Image When POLATBEY-1 made 66 Degrees turn to Starboard.

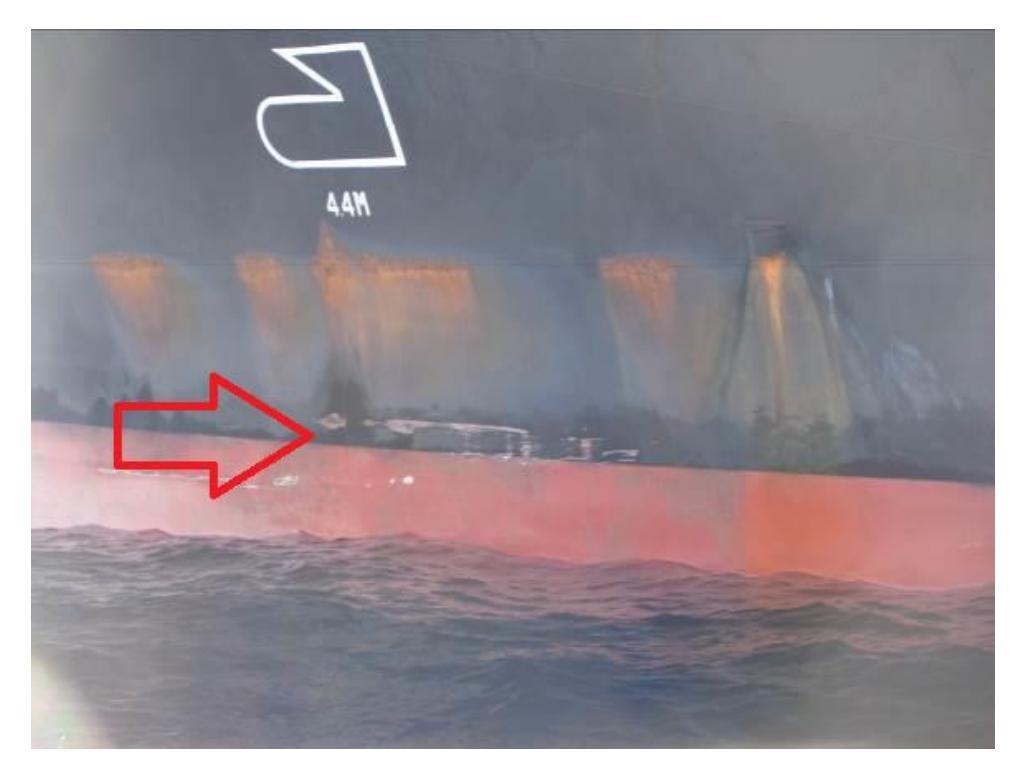
During the accident investigation on the tanker, EPHESOS, which was anchored, a paint scratch was noticed below the hawse pipe of the port anchor. However, as the tanker anchored by the port anchor instead of starboard, the location of the impact was not been clearly identified in the examination of damage at the anchor site.

Image 24: The Paint and Hull Scratches on The Port Bow of The Tanker, EPHESOS

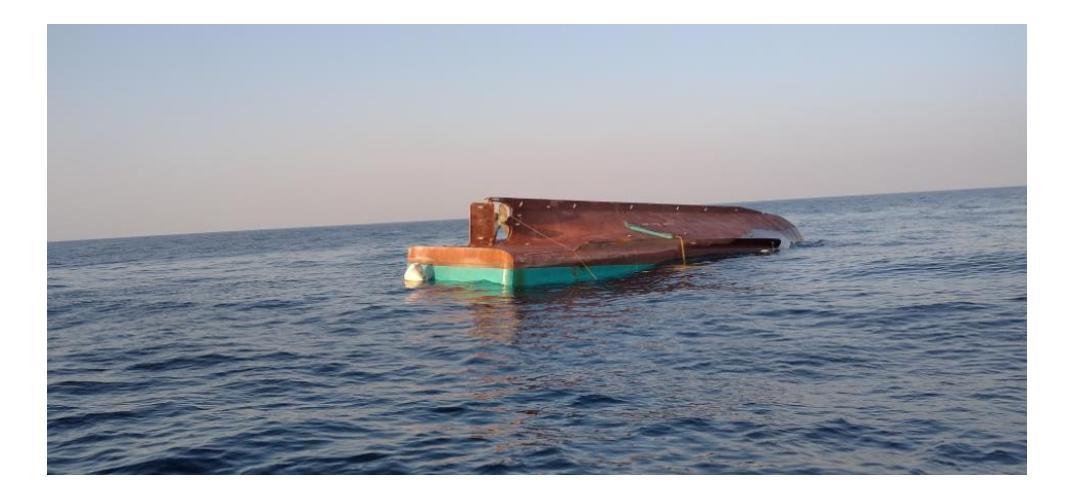
The damage on the standard compass deck of the fishing vessel, POLATBEY-1 and the ECDIS images later indicated that the tanker collided with the fishing vessel with her port anchor. As a result of the collision with the port hawse pipe of the tanker, the fishing vessel, POLATBEY-1 was severely damaged and capsized and became unusable. (Image 23-31)

Image 25: The Fishing Vessel, POLATBEY-1, Which Had Capsized, After the Accident

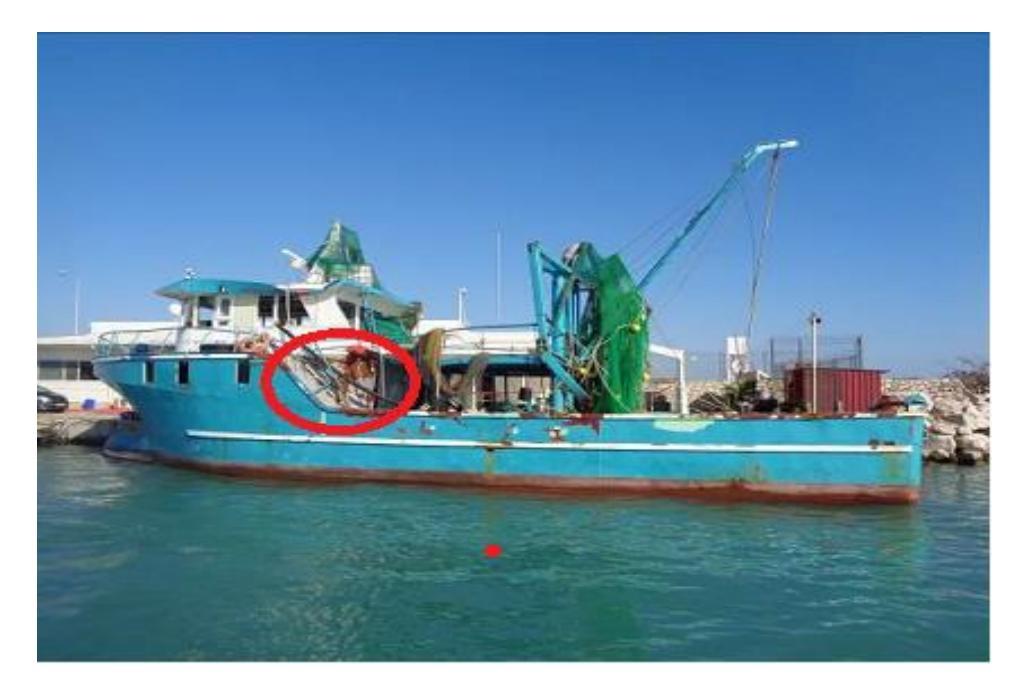
Image 26: Damages on the Compass Deck, Bridge and Superstructure of the Fishing Vessel, POLATBEY-1, which Had Become Afloat After the Accident

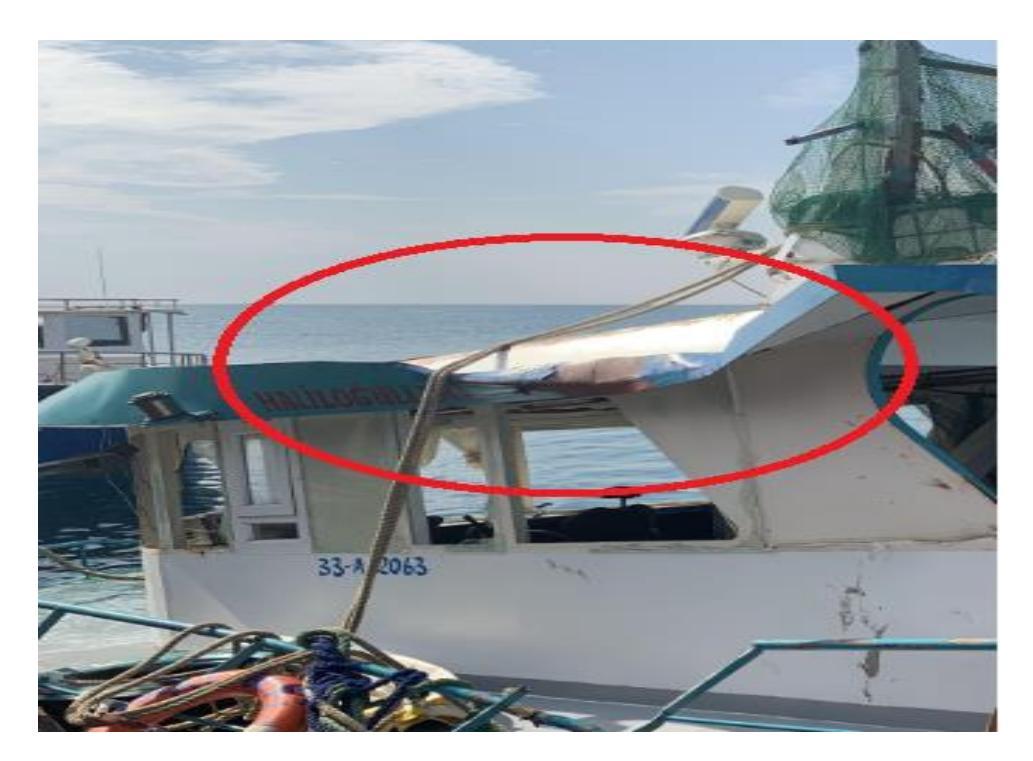
Image 27: Damages on the Compass Deck, Bridge and Superstructure of the Fishing Vessel, POLATBEY-1, which Had Become Afloat After the Accident

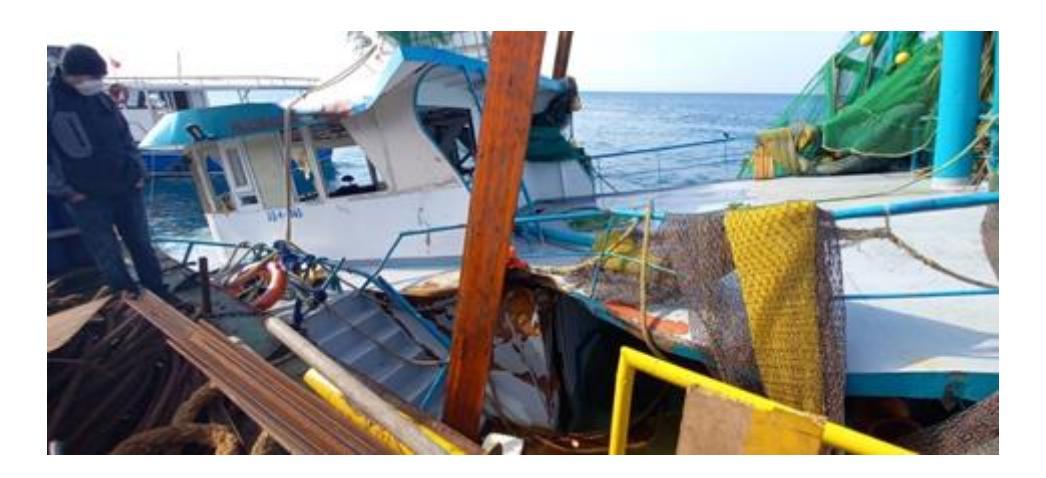
It was detected that the port side, starting from the standard compass deck up to the midship of the main deck, was deformed and ruptured; the bridge windows exploded; the net davit on the port side was broken; the crane net on the port side was detached; there was still water in the engine room and the engine and navigation devices were inoperable. (Images 29, 30, and 31)

Image 29: Damages Sustained by the Fishing Vessel, POLATBEY-1

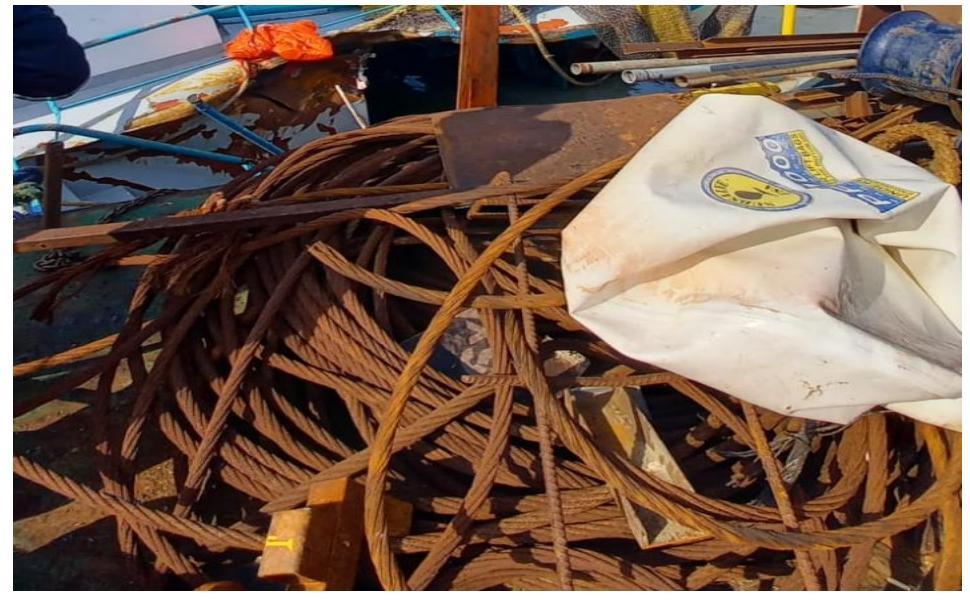
Image 30: The Damage to The Fishing Net Equipment of The Fishing Vessel, POLATBEY-1

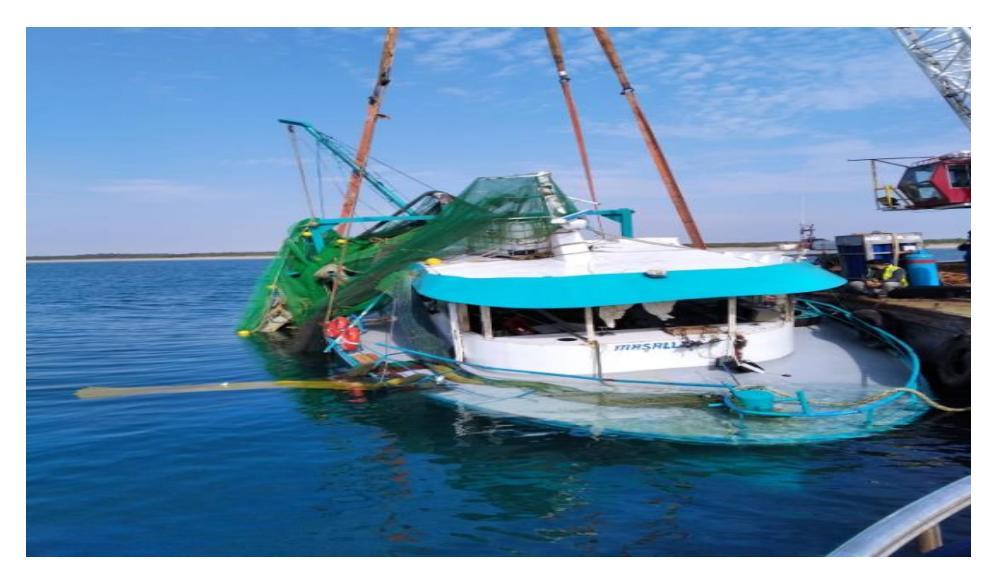
Image 31: The Damage to The Fishing Net Equipment of The Fishing Vessel, POLATBEY-1

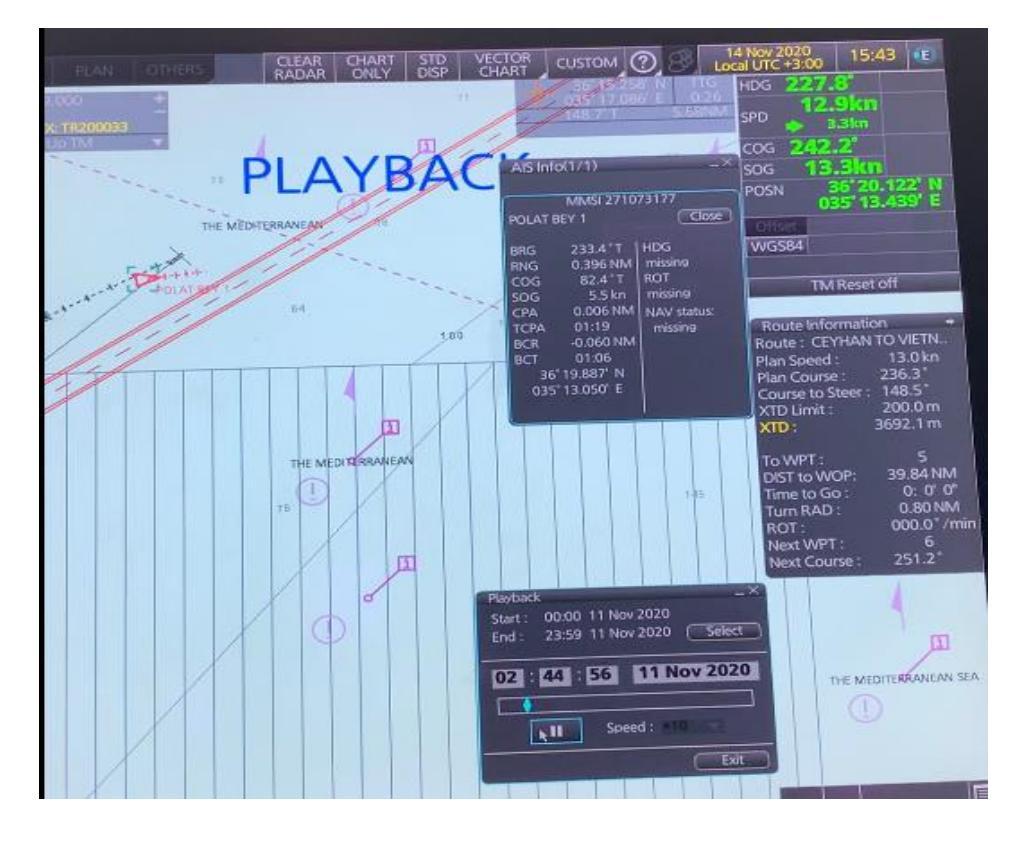
The screenshot captured from ECDIS (Image 40) displays that 20 seconds later at 5:44:56 AM, approximately 1 minute before the collision, while the tanker was executing port 20 degrees order, POLATBEY-1 suddenly manoeuvred by altering her course to starboard 66 degrees. Meanwhile, while the tanker was heading towards the port, her course was 227.8 and her speed was 12.9 nautical miles. The distance between both vessels was 0.396 miles.

Image 40: Screenshot from ECDIS When POLATBEY-1 Headed to Starboard 66 Degrees.

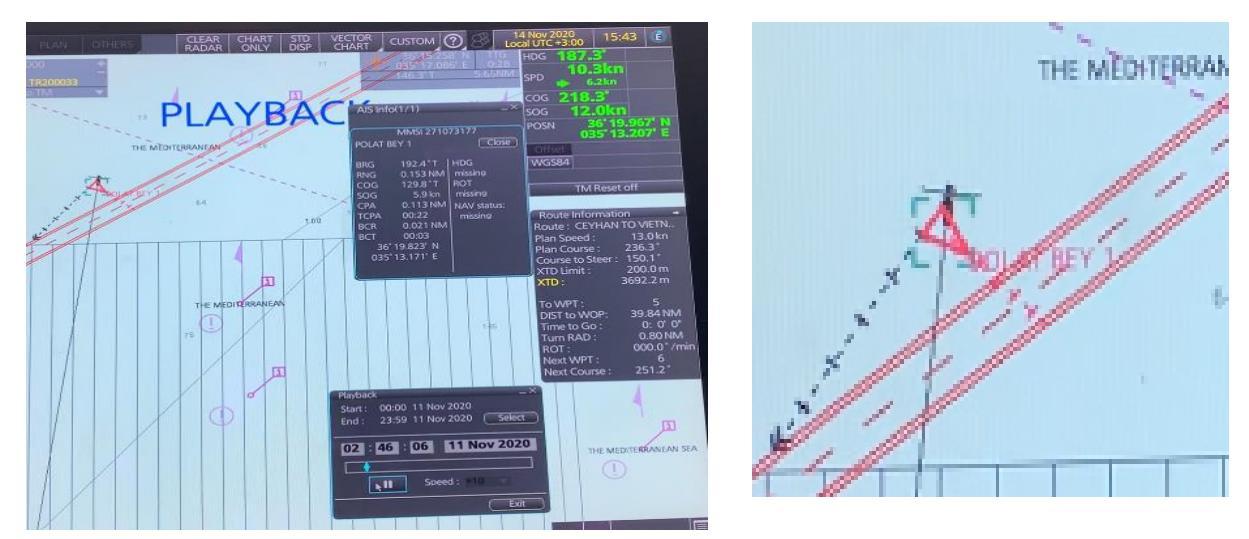
Image 41: The Collision Time of The Vessels According to Screenshot From ECDIS

At 5:46:06 AM (Image 41), POLATBEY-1 altered her course from 36 degrees to starboard relative to her previous course, while she was sailing at a speed of 5.5 nautical miles on her course of 116.6 degrees. Meanwhile, the tanker manoeuvred to the port and the collision took place. At the time of the collision, the tanker was on the course 187.3 and at a speed of 10.3 nautical miles.
