## MARINE SAFETY INVESTIGATION REPORT

**SHIP NAME** : FG SEVIL  
**IMO NO** : 9548665  
**FLAG OF THE SHIP** : Panama  
**CASUALTY EVENT** : Fire  
**LOCATION OF CASUALTY** : Southeast of İstanbul / Büyükada  
**DATE and TIME OF CASUALTY** : 31 October 2024 - 11:13 (GMT+3)  
**FATALITY / INJURY** : 2 / -  
**DAMAGE DEGREE** : The ship's engine room has caught fire.  
**ENVIRONMENT POLLUTION** : N/A

Board Decision No: 04 / D-01 / 2026

Date: 05 February 2026

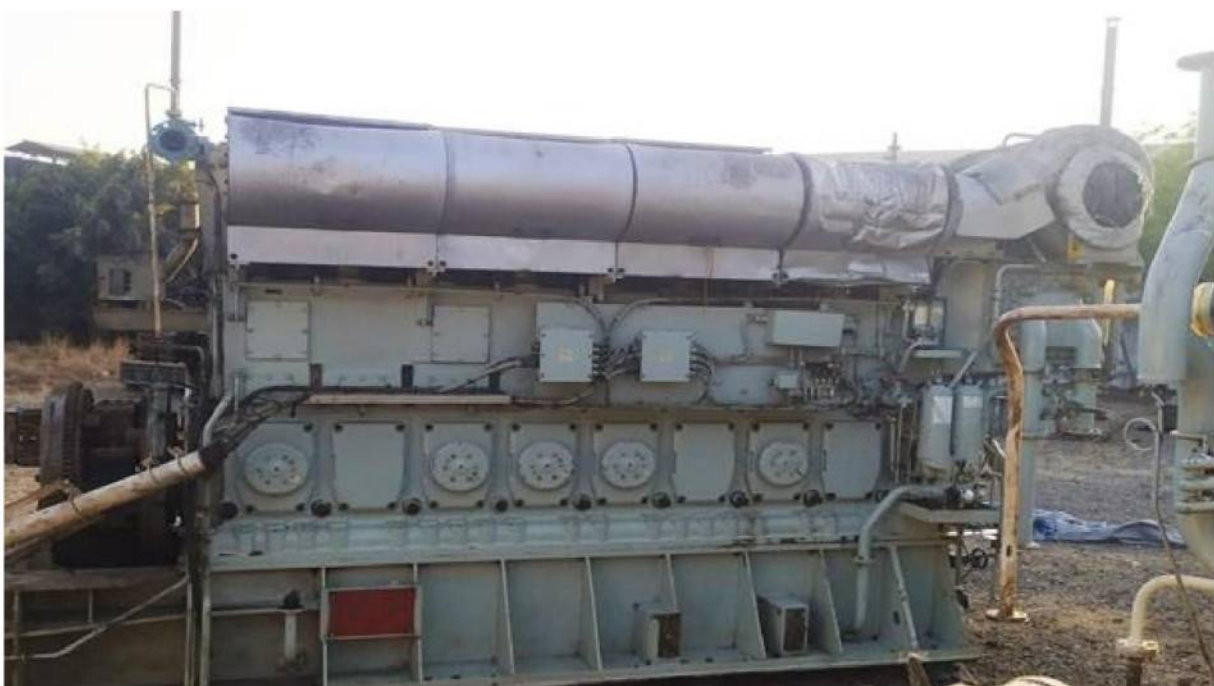
**Image 9** Example for insulated twin main engine of FG SEVIL

However, it was determined that the exhaust circuit insulation of the main engine, of the ship, which was proceeding its normal voyage, had not been installed at all, the exhaust pipe circuits were completely exposed, and the manifold guard plates that should have been present on the exhaust circuits were also missing.
