FINAL MARINE SAFETY INVESTIGATION REPORT

OWNER	: BASIC ETERNITY LINE SA
MANAGER	: MINAMOTO KISEN CORP LTD.
NAME of SHIP / IMO No	: M/V CAPE HENRY (9648879)
FLAG	: PANAMA
SCENE of ACCIDENT	: Martas Marmara Ereglisi Port Facilities / Tekirdag-Turkey
DATE and TIME of ACCIDENT	: 5 December 2017 / 15:06 (GMT +3)
FATALITY / INJURY / LOSS	: 1 / - / -
DAMAGE / POLLUTION	: -

Board Resolution No: 22 DNZ - 02 / 2020

Date: 10/02/2020

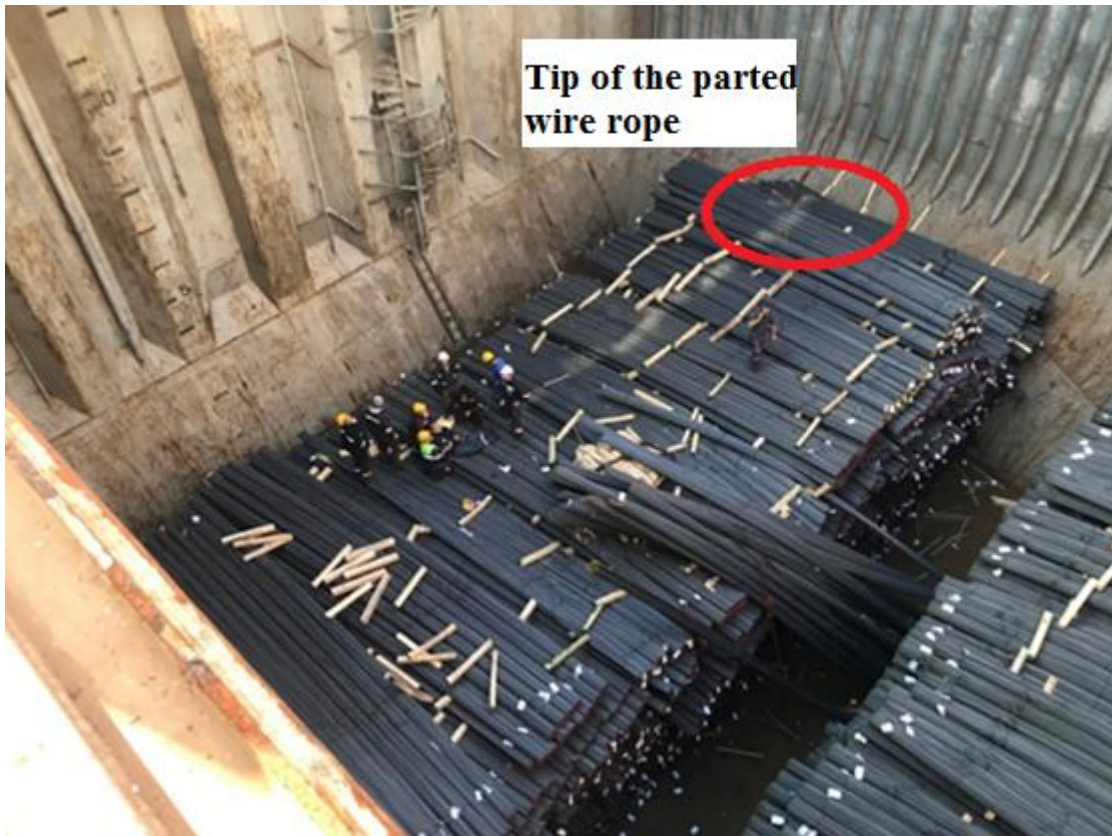
Figure 7: Photograph of the injured worker, parted wire rope and steel rebars inside the cargo hold

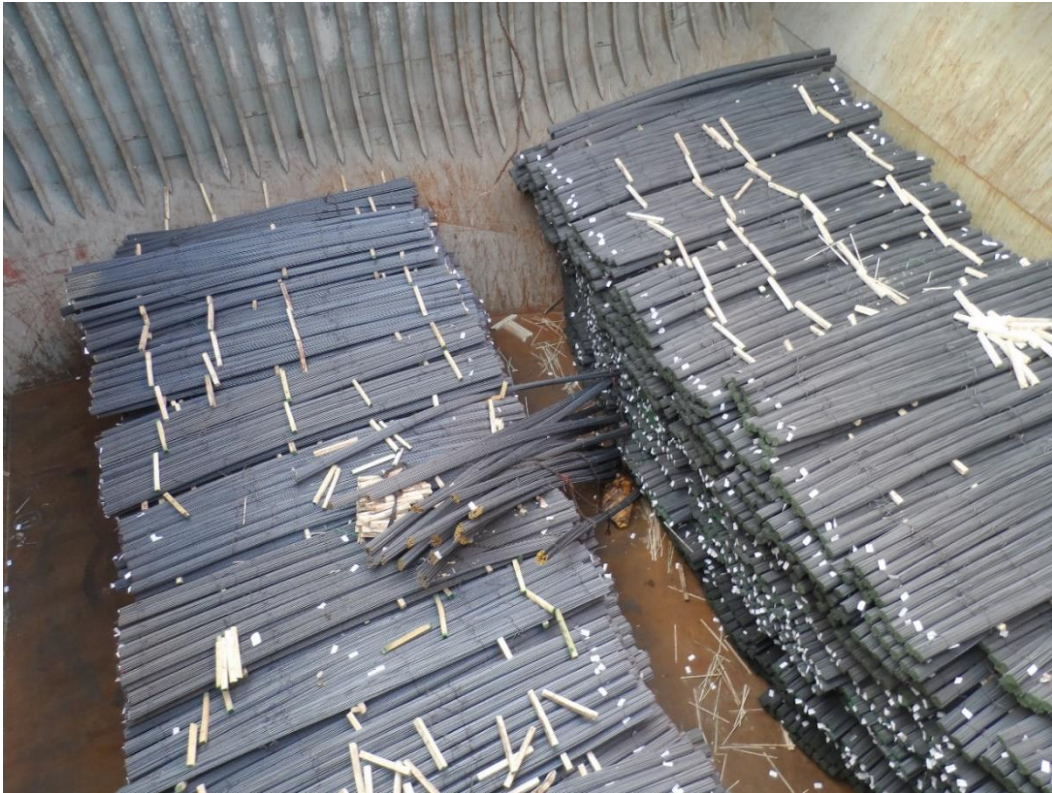
Figure 8: Photograph of the parted wire rope and steel rebars inside the hold after the accident

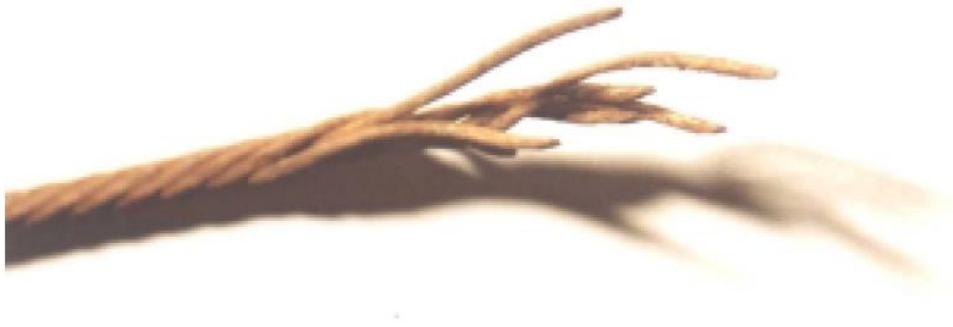
Figure 10: Typical View of the Parted Wire Rope Strand Caused By Corrosion Induced Wear ²

It draws attention that the image of a rope that parted due to corrosion in the Figure 10 bears a resemblance to the post-accident image of the wire rope that parted onboard CAPE HENRY below, and the wires of the rope show a tendency to be scattered.

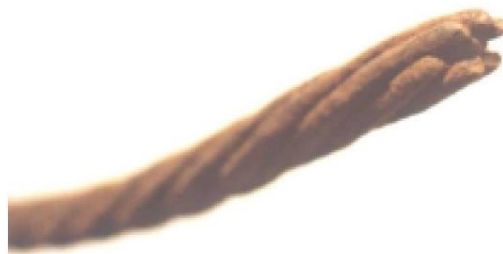
Figure 14: Typical View of Parting of a Wire Rope By Tensile Stress

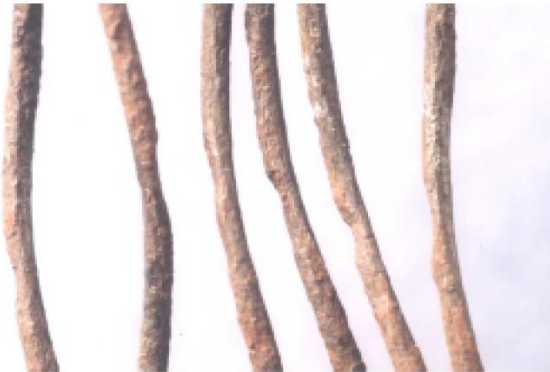
The following photo also shows corrosion-caused wears on each wire of the steel rope.

Figure 15: Wearing of the Metallic Part of the Wire by Corrosion Induced Wear

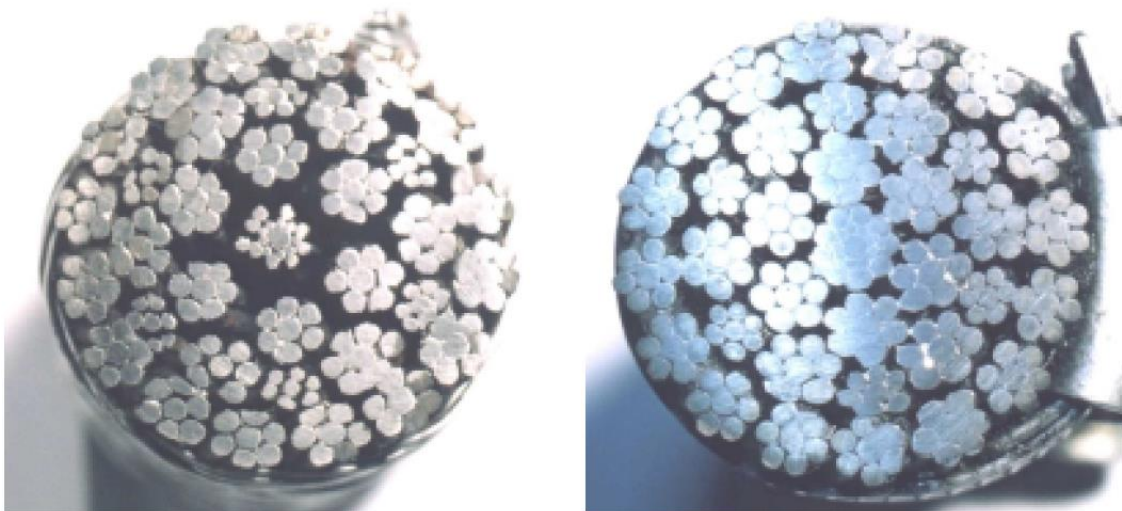
If an analysis to be done with the data taken from a similar accident by reviewing a rope strength report of a non-rotating type, 26 mm diameter, 34x7 + core, galvanized, minimum breaking load (MBL) 50 tons; it was seen that a cut of 100 mm length weighted 218g/100mm of corroded part and 281g/100mm of as new part. It is seen that rope has lost approximately 22% of its metallic area due to corrosion. As a first approximation, the rope strength will be reduced proportionately, i.e. the corroded rope strength would be 39 tonnes. This calculation assumes that the corrosion is evenly distributed through the rope and along each wire; if proportionately more metal was lost from the outer strands then the strength of the rope could be degraded further.

Figure 16 shows a comparison of the cross section of the rope removed from near to the failure (left) and from the end of the rope stored on the winch drum, which may be considered to be representative of the rope in the “as new” condition. Attention is drawn to the extraordinary loss of metallic cross section on the core strand, especially considering that this is at the heart of the rope where galvanising and residual lubricant are most likely to remain.⁵

Figure 16: Cross sections of corroded (left) and "as new" (right) rope ⁶

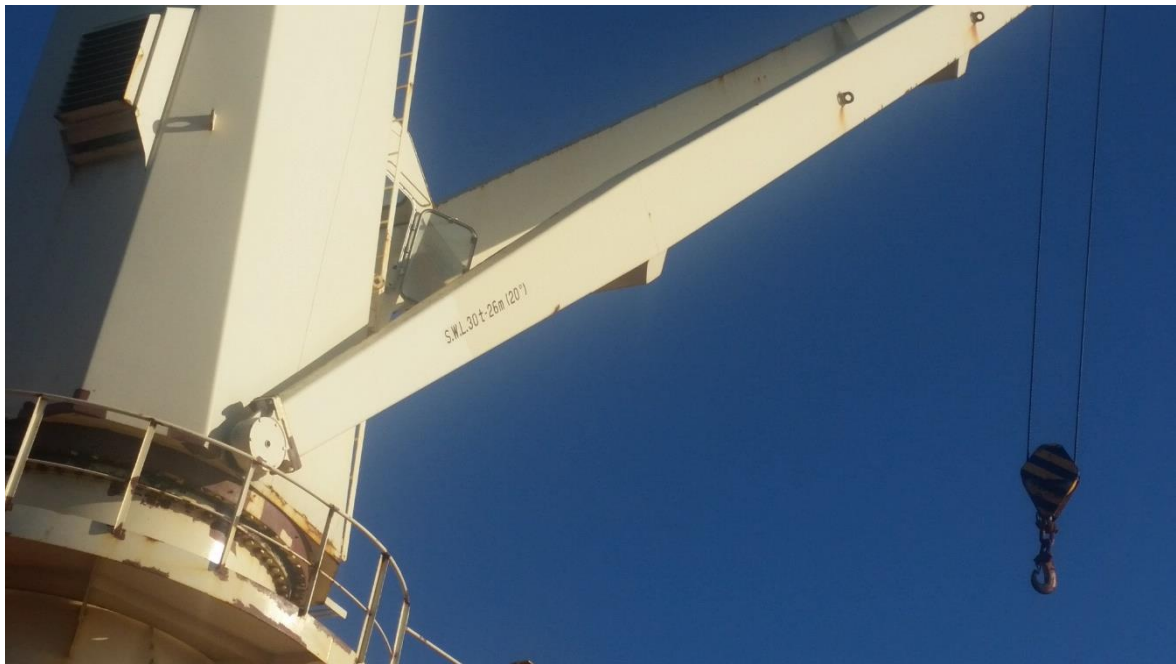
There are 4 deck cranes and they have a lifting capacity of 30 tons at an angle of 20 degrees at a reach of 26 meters (radius). (Figure 20)

Figure 20: Safe Working Load and Radius of Deck Crane No.4 SWL 30t - 26m (20°)

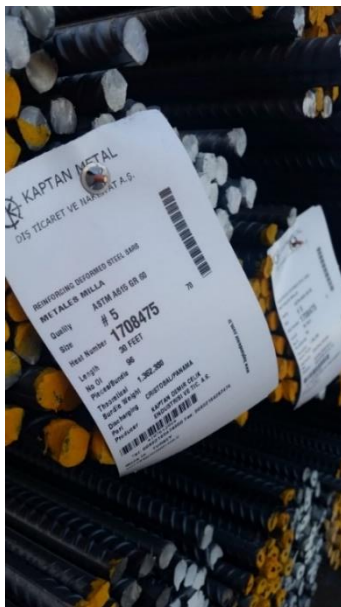
Figure 21: Label showing the properties and weight of one bundle of steel rebars

Figure 21 shows a label showing the weight and properties of one bundle of steel rebars. This label shows that the theoretical weight of a bundle is 1.362,380 kg.

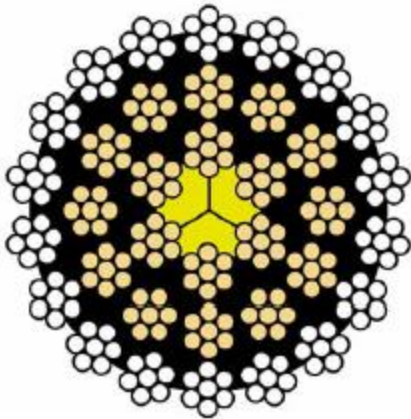
Figure 23: Cross section of a rope 36 × 7
The core, which makes up about 50% of the metallic area of the rope, cannot be visually inspected.

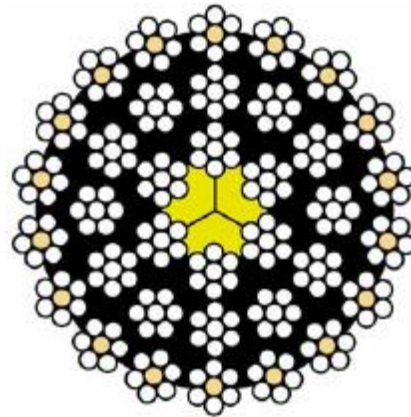
Figure 24: Cross section of a rope 36 × 7
The centre wires of the outer strands, which make up about 10% of the metallic area of the rope, cannot be visually inspected.

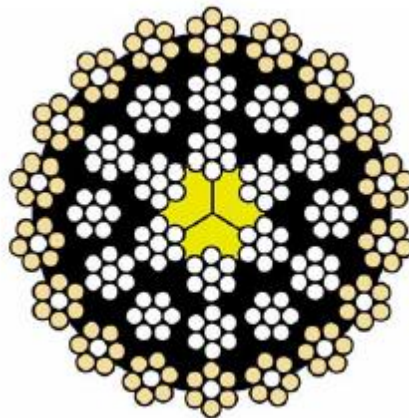
The only wires which can be visually inspected are the outer wires of the rope. These represent about 40% of the metallic cross sectional area. But even these wires disappear inside the rope on about half of their lengths, leaving only about 20% of the rope's cross section accessible for a visual inspection (Figure 25).

Figure 25: The outer wires, which make up about 40% of the rope, can only be inspected on about half of their lengths

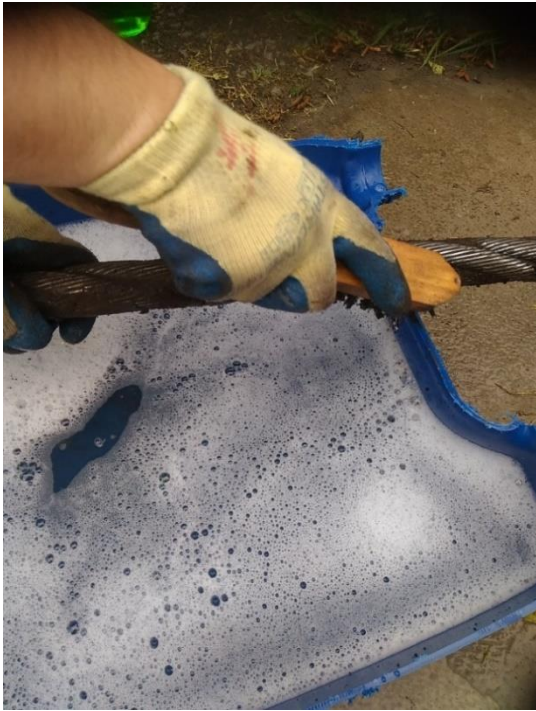
Examination on the sample wire showed that the wires on the strands were parted. In order to understand the situation better, the wire rope was cleaned by washing with detergent water. When the clean wire rope was examined, it was seen that interestingly, more than one wire was parted on each strand and there were breaks on the same strand with intervals.

Figure 28: Cleaning of the lubricated wire rope with detergent

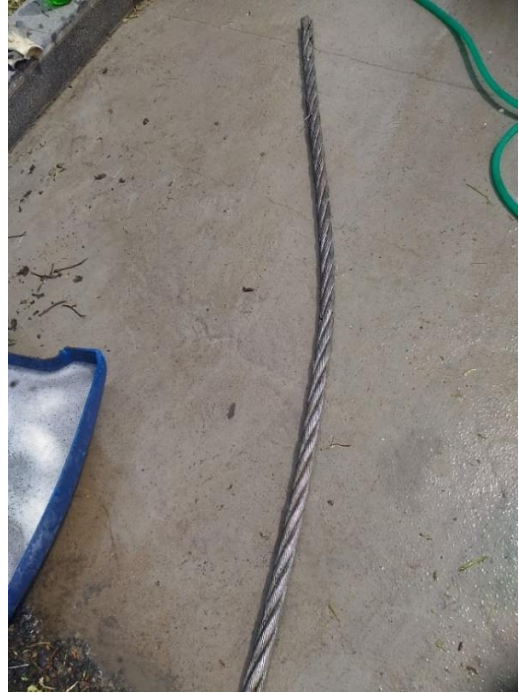
Figure 29: Cleaned wire rope

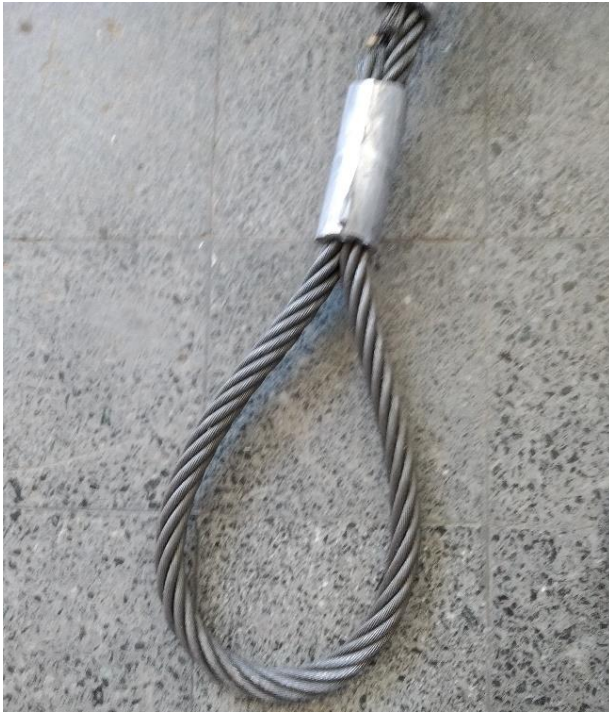
Figure 32 shows the fixed eye made on the additional wire rope, and Figure 33 shows the fixed eye made on sample wire rope. When the sample rope was twisted to eye splice, the broken wires were exposed apparently.

Figure 32: Photograph of the additional wire rope

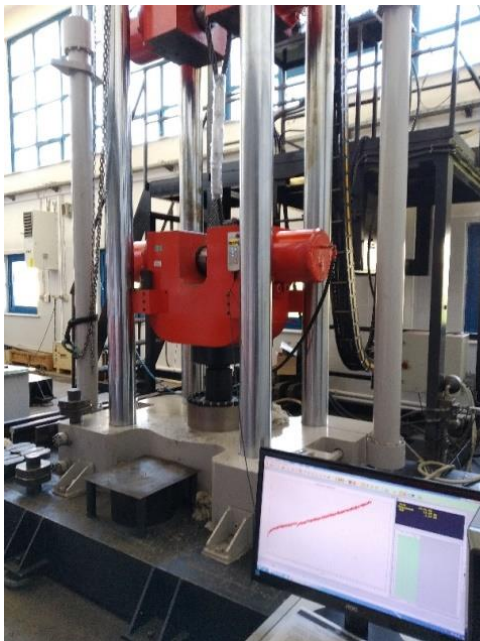
Figure 34: Test equipment used at TSE

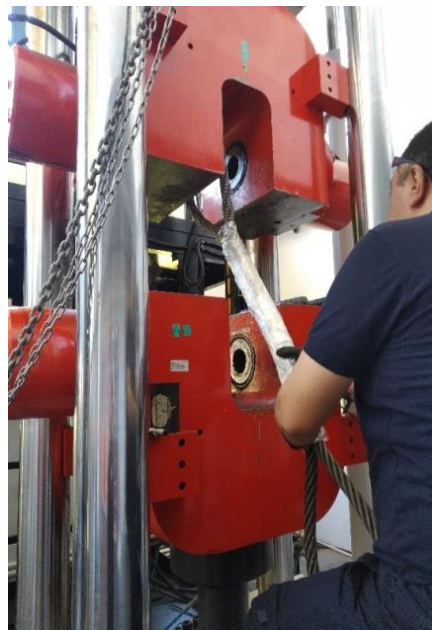
Figure 35: Preparation of the wire rope for the test

In the test carried out at TSE, the breaking load was measured as 467,17 kN, approximately corresponding to 47,64 tons, however, as the wire slipped out of thimble, it was noted in the TSE report that it did not break in accordance with the standard when it got free. As there were many broken wires on the wire rope, many cut wires corresponded under the alloy pressed for making the eye splice (case). As these wires slipped out during tensioning, no uniform parting occurred, but the wire rope eventually parted. The note in the TSE report indicates this condition.
