REPORT ON SERIOUS MARINE CASUALTY

NAME & IMO No	: BENITAMOU / 9439046 BC VANESSA / 9426855
FLAG	: Panama Barbados
LOCATION OF ACCIDENT	: The Northern Entrance of Çanakkale Strait / Türkiye
DATE OF ACCIDENT	: 24.10.2021 / 06:07 LT
FATALITY&INJURY	: - / -
DAMAGE&POLLUTION	: Extensive damages on both vessels / NIL

Board Decision No: 13 /D-6 /2023

Date: 19 / 06 / 2023

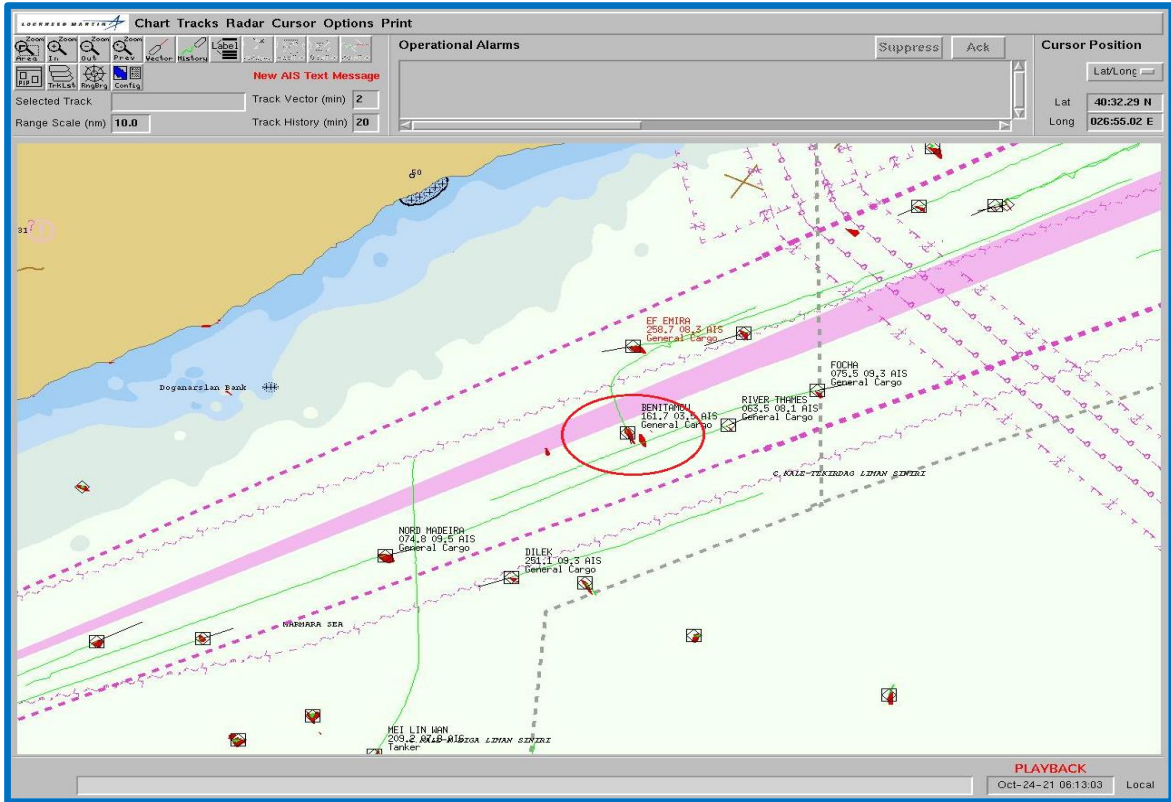
Figure 16: VTS Monitor Snapshot (Ship’s Movements Post-Accident) - 1

Around an hour later from the collision, BENITAMOU proceeded to outside the Traffic Separation Scheme (*See Figure 16 and 17*). At 08:45 BENITAMOU temporarily anchored outside the TSS as seen the position on *Figure 18*.

BC VANESSA proceeded with full speed and anchored in the No 7 anchorage area safely around one hour later and waited for instructions of the company and the authority. (*See Figure 16, 17 and 18*)

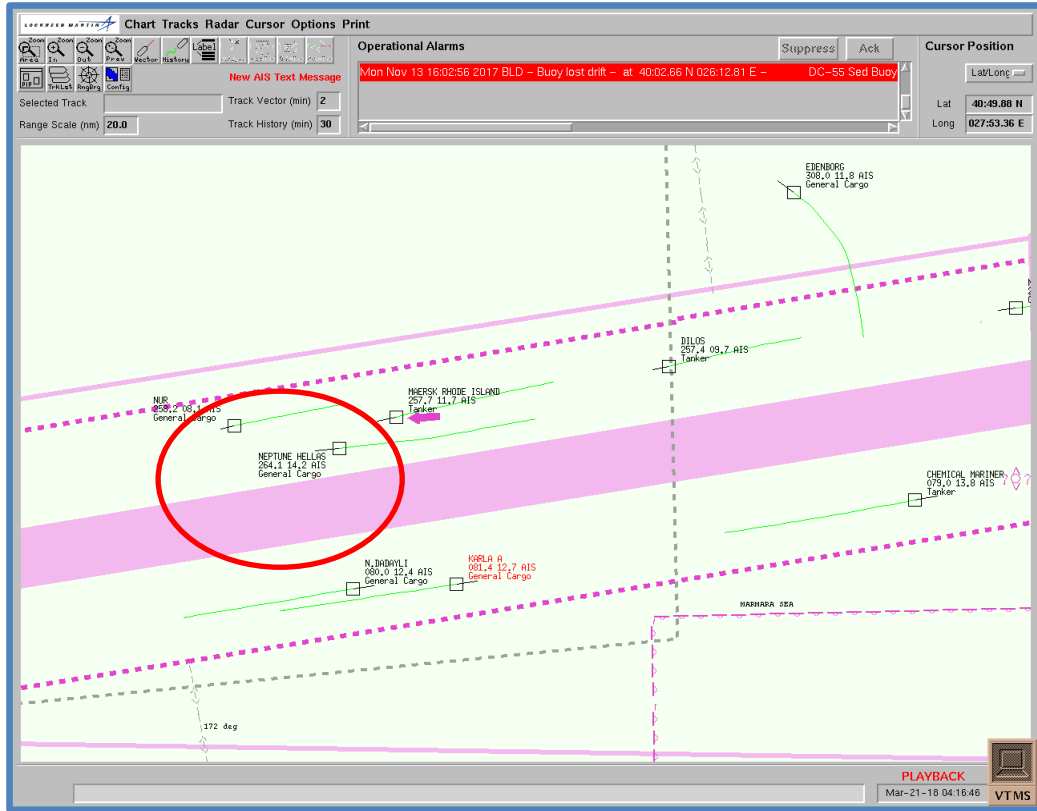
Figure 21: VTS Monitor Snapshot – 1

Prior to collision, both NEPTUNE HELLAS and NUR were proceeding on a southwesterly course towards the Çanakkale Strait. At the time of the collision, NEPTUNE HELLAS was making approximately 13.8 knots and NUR was proceeding in the same direction with a speed of about 8.0 knots. The collision happened when NUR turned to port when she was being overtaken by NEPTUNE HELLAS from the former's port side. (*See Figures 21 – 22*)

As a result of the investigation, it was stated in the report a technical malfunction in the steering gear caused NUR to change its course unintentionally towards overtaking vessel NEPTUNE HELLAS.

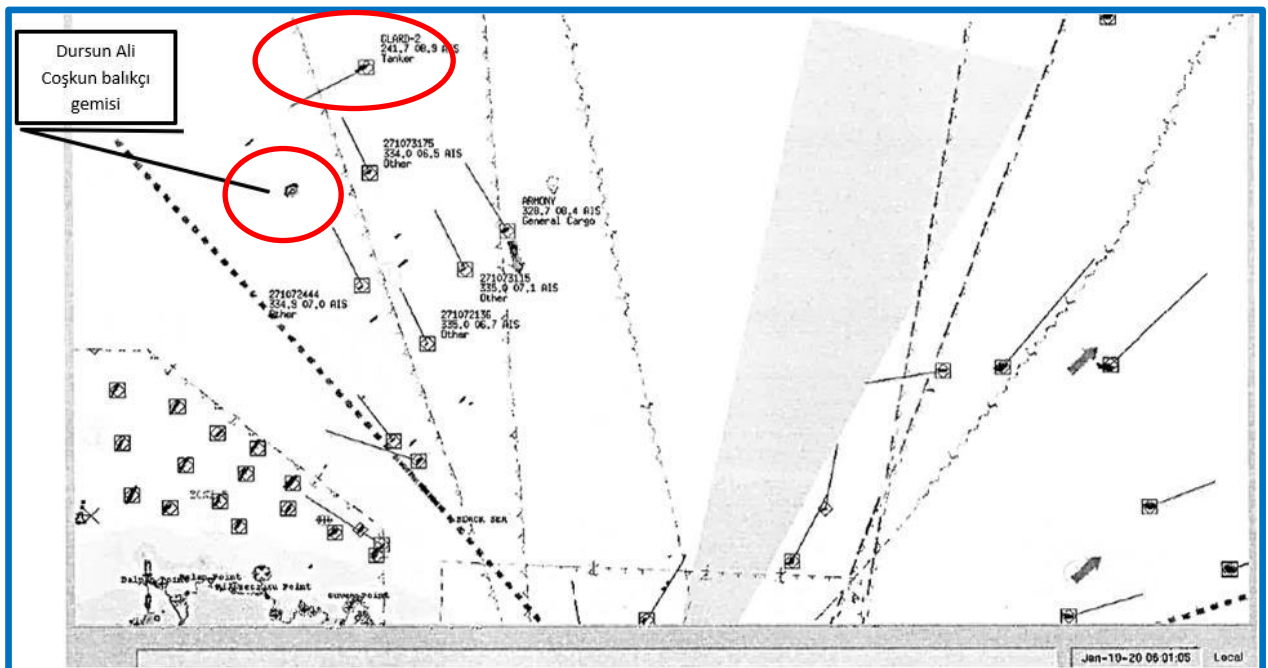
Figure 23: VTS Monitor Snapshot

Having considered the consequences of the investigation, violation of the COLREGs rules and failed to keep an appropriate lookout are fixed. Based on the conclusions, owners/operators of the both vessels were recommended.

Either of the investigations are similar to each other is that the lack of DURSUN ALİ COŞKUN's AIS data, apart from the other fishing vessels in the vicinity. (See **Figure 23**) Naturally, it stands out as a deficiency in terms of raising awareness prior to the collision.
