**Accident Investigation Report On**  
**The Fatal Man Overboard From The Fishing Vessel**  
**BURHAN KAPTAN 1**

**Off the Rumeli Lighthouse / Istanbul**  
**23<sup>rd</sup> of September 2014**

**22/DNZ-03/2017**

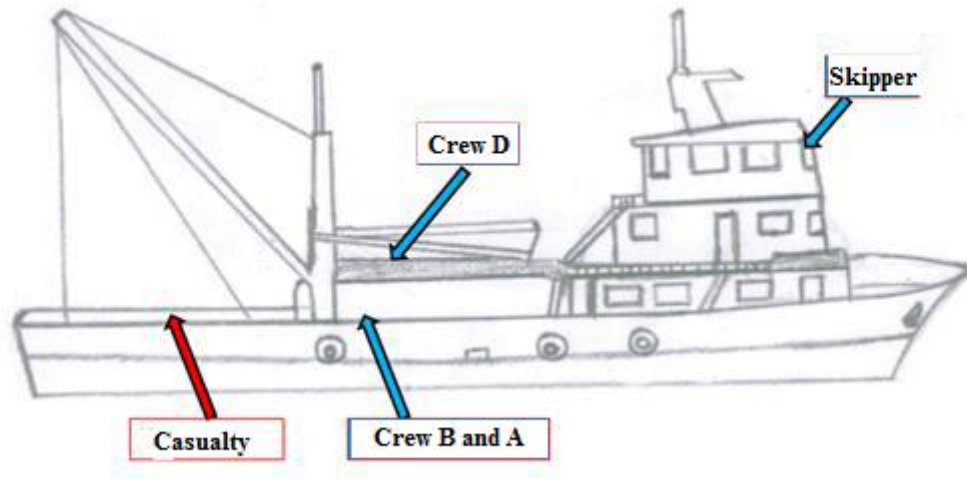
**Figure 4:** *Locations of the Crew at the Time of Accident*

deck (Figure 4). Casualty crew working at the extreme edge of the aft deck informed the master by hand signal that the waterspout was coming.

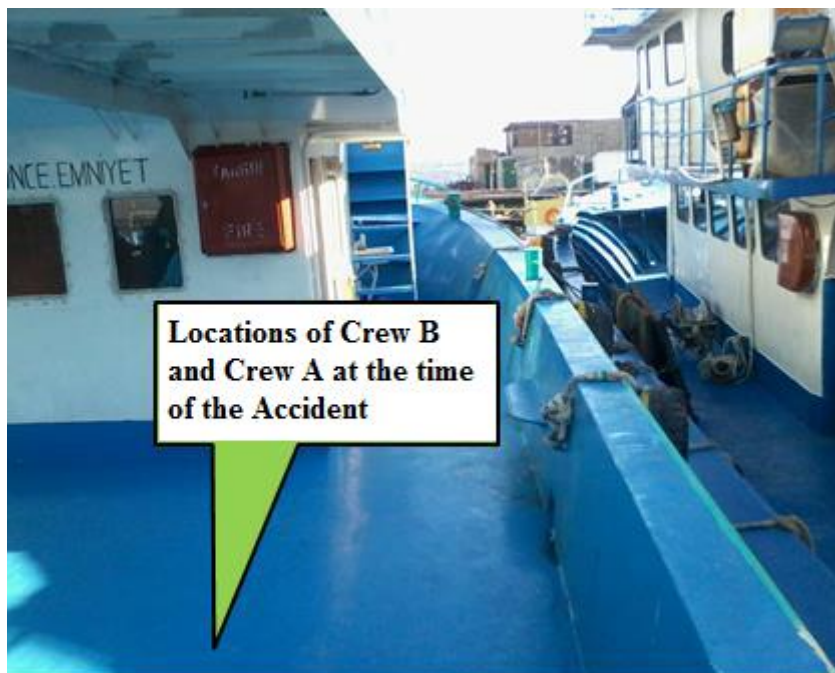
**Figure 5:** *Locations of the Two Crew at the Time of the Accident*

The crew, working at the lower deck saw that waterspout was approaching the vessel and started to run towards the superstructure. Waterspouts hit the vessel with a roar and the vessel inclined dangerously towards the forecastle. Meanwhile crew member A pushed crew member B with his hand inside the superstructure and right after the door was closed with the strenght of wind. Crew member A fell to the floor with his face looking towards the hand rails as a result of inclining of the vessel or hitting of someone/something hardly himself. While he was falling, he hit a stair on the deck; (three of the ribs on the left was cracked) but he succeeded to enter into the superstructure by crawling on the floor with his own efforts. When the crew member A got inside the superstructure, crew member B stated that crew member C hit the crew member A with the effect of rising aft of the vessel and afterwards crew member C fell overboard 4-5 meters forward of starboard bow. When the crew member A learned that crew member C fell overboard, he informed the crew member D, who was collecting the nets at the upper deck and immediately he rushed the bridge and informed the master.

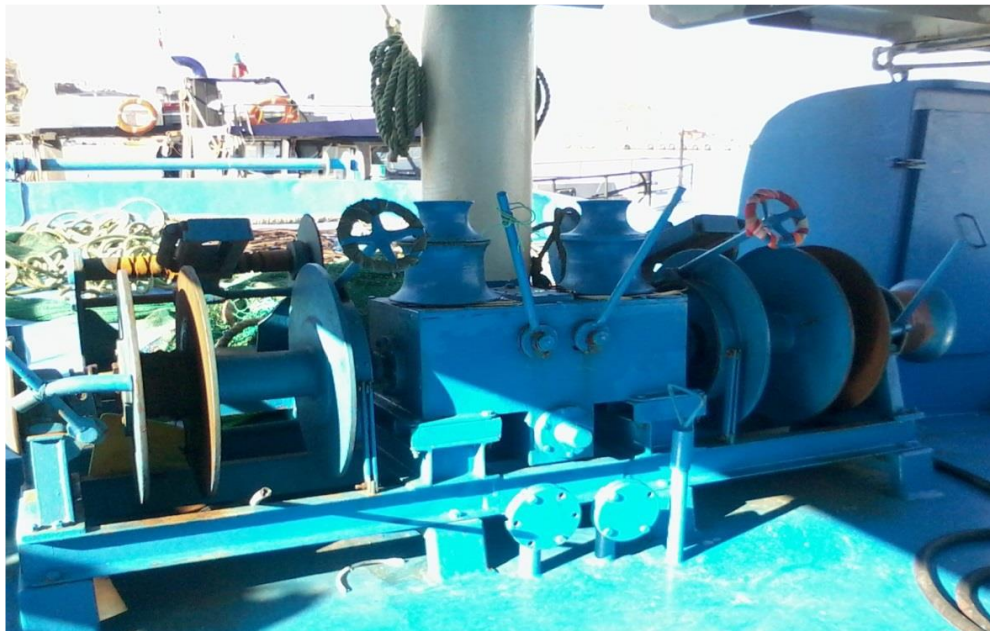
*Figure 9: Windlass Used for Pulling the Nets*

With the effect of generated wind and waves and as a result of rising the aft of the vessel 5 meters (**Figure 8**), windlasses normally used to pull the nets, tightened backwards and damaged the pipes behind by moving approximately 2 centimeters from its' original position. (**Figure 10**)
