MARINE SAFETY INVESTIGATION REPORT

NAME OF SHIP AND IMO NUMBER : DÜZGİT ENDEAVOUR (9581007)
FLAG : TURKEY
LOCATION OF ACCIDENT : ANTALYA
DATE OF ACCIDENT : 11.09.2019 / 08:42 (LT)
CASUALTIES : 1 INJURED
DAMAGE/POLLUTION : -/-

**DÜZGİT ENDEAVOUR
Marine Safety Investigation Report**

**Deck Cadet Was Stuck Between The Rope And The Roller Fairlead Of The Ship
Off Port Akdeniz/Antalya**

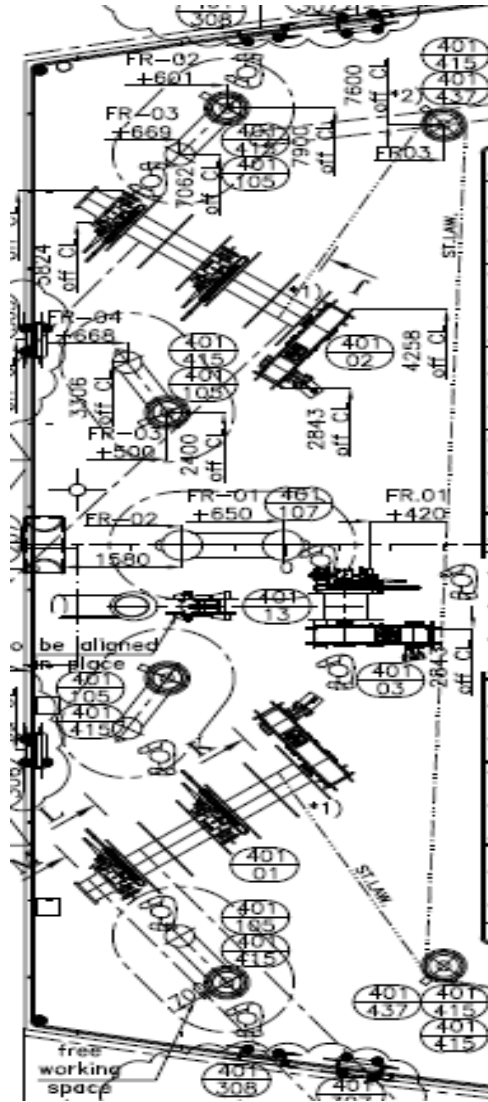
Figure 2: Layout of the Rope Drum, Mooring winch and Pedestal roller fairlead on the Poop deck

There are four rope drums on the poop deck of the vessel, Düzgit Endeavor; two on the starboard and two on the port. There are one pedestal roller fairlead pedestal roller fairlead and one roller fairlead right across each rope drum. One of those pedestal roller fairlead fairlead rollers is designed to be located on the double bollard system. The rope drums are controlled by the mooring winch that align with them. In addition to these rope drums, there is also one rope drum for each mooring rope on the starboard and port side that does not have a mooring winch system for winding ropes (Figure 2, Appendix-1). Also, an additional mooring winch controls the kedge anchor located on the poop deck centreline.

In the accident investigation conducted at the accident scene right after the accident, it is found that both the mooring ropes on the starboard and port stern drums touched/rubbed the rope drum disks (Picture: 7-8).
