**MARINE SAFETY INVESTIGATION REPORT ON A
VERY SERIOUS MARINE CASUALTY**

VESSEL NAME	: ENKİ / HÜRKUŞ
IMO NUMBER	: 9237864 / -
FLAG OF THE VESSEL	: SAINT KITTS&NEVIS / TURKISH
LOCATION OF ACCIDENT	: Anchorage Area C at the Southern Entrance of the Istanbul Strait
DATE and TIME OF ACCIDENT	: 03/03/2022-12:15 (GMT +3)
DEAD / INJURED	: 1/-
DAMAGE CONDITION and POLLUTION	: -/-

Board Decision No: 07 / D-03 / 2023

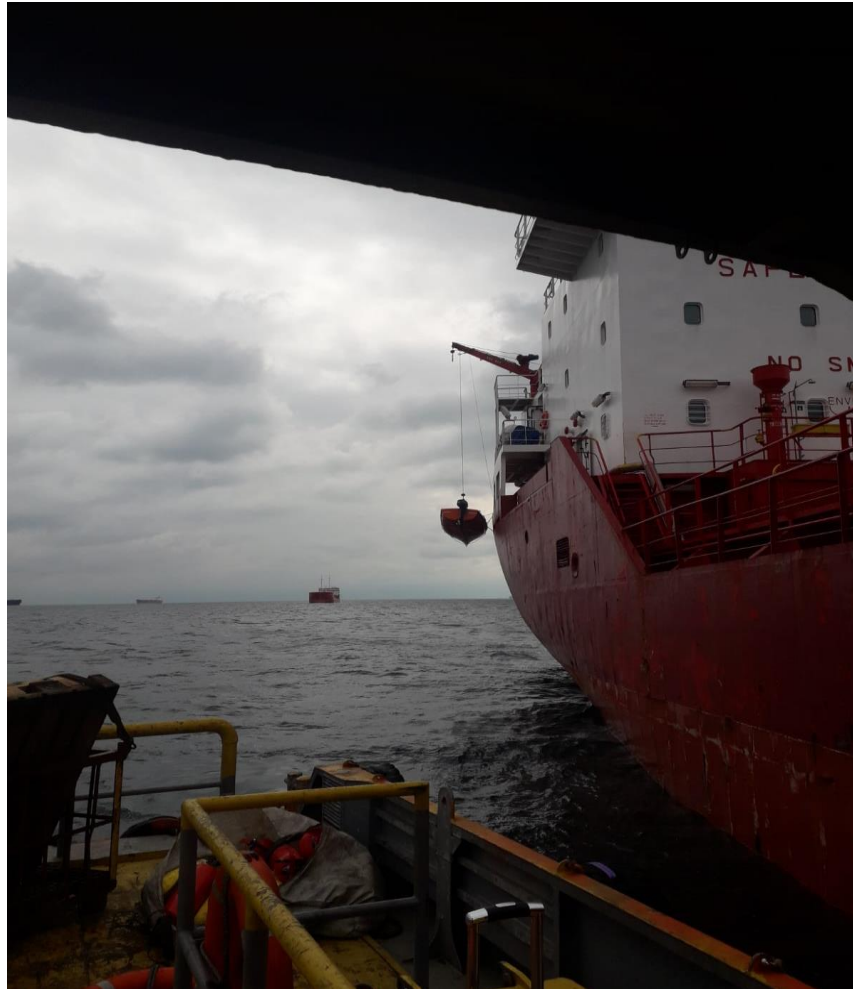
Image 8 Launching of the lifeboat

Meanwhile, a “Man overboard” alarm was raised on the tanker, and a lifeboat was launched (Image 8). The adrift casualty was reached approximately 25 minutes after the accident and

taken into the rescue boat. Although the first aid and resuscitation, airway, breathing and circulation (ABC) procedure was performed when the casualty was taken into the rescue boat, it was found out that the casualty had drowned² and died.

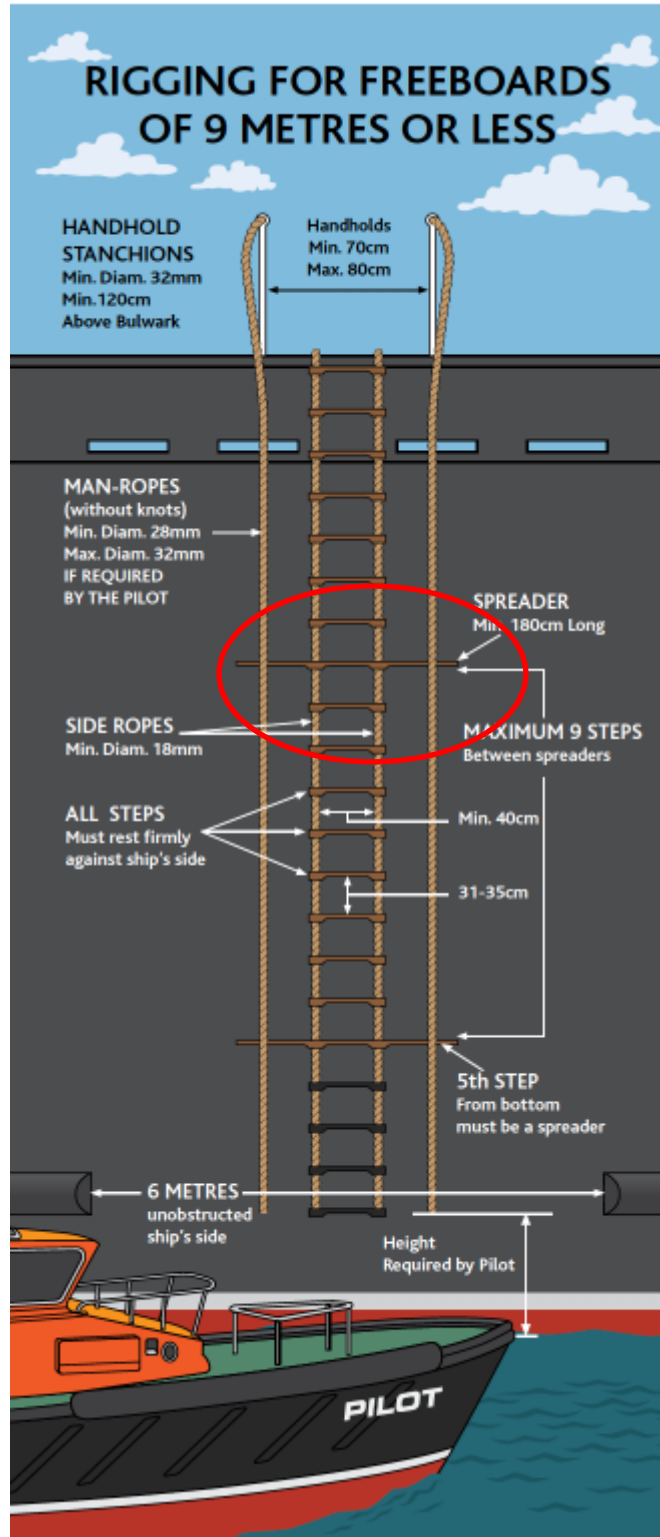
Image 9 Application of a side ladder on the IMO Poster

Generally, crew and pilots embark and disembark on commercial vessels offshore through the side ladders. Since many accidents have taken place worldwide during the transfer of crew through this means, it has been regulated by Rule 23, Chapter V of SOLAS 74 Convention. Also, the International Maritime Organisation (IMO) Resolution A.1045 (27) sets out the technical specifications of the side ladders and the requirements for their installation on board for the use of the side ladders in crew transfers. A poster prepared by the IMO lists the characteristics that a side ladder should have (Annex 1). As clearly illustrated in Figure 9, the height of the side ladder from the boat during crew transfer should be adjusted according to the request of the pilot boarding the tanker and it should be higher than the deck of the boat where the transfer will take place. When the height of the side ladder is required to be adjusted, the vessel should be informed and the transfer should be stopped until the side ladder has been adjusted to the correct height. There must be permanent communication between the vessel and the boat during the transfer. All steps of the side ladder should rest on the side of the vessel to maintain stability of the side ladder (Figure 9).

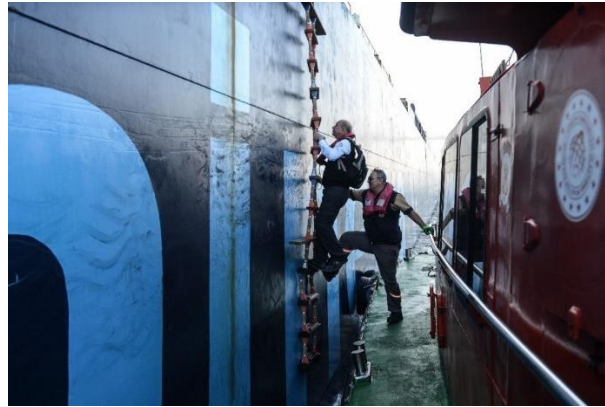
Image 10 Stabilising the side ladder and accompanying the pilot

In best maritime practices, the boat crew should stabilise the side ladder as far as possible by holding the side ladder, as shown in Image 10 while the crew is boarding a vessel, and the boat crew should continue to supervise the crew until the crew can climb the side ladder safely.

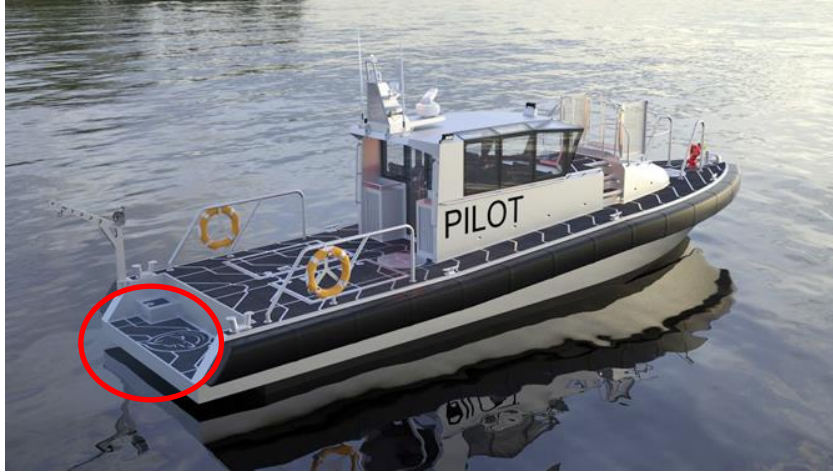
Image 18 Pilot boat⁴

When the video footage of the accident is analysed, it is observed that the ordinary seaman of the boat tried to rescue the casualty who went overboard by dangling from the boat with a freeboard of approximately 1,7 m, but he could not succeed despite all his efforts (Image 14). When the agency boat is structurally examined, it is observed that it was designed mostly for carrying provisions and materials to the vessels. It is considered that the use of boats with a freeboard and a platform for intervention at the stern as in the case of Image 18 for crew transport would enable easy rescue in case of a man overboard.

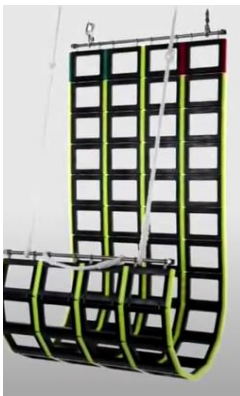
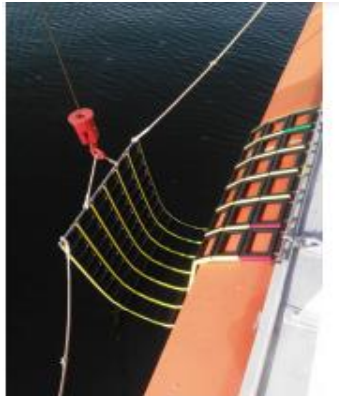
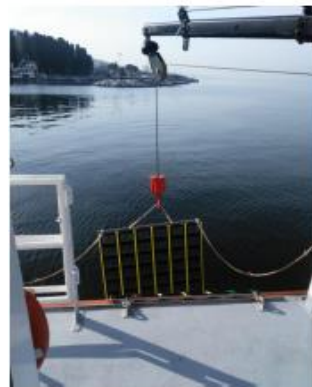
Image 20 Jason's Cradle

It requires a lot of effort and physical strength to take the man overboard into the lifeboat or boat due to sea conditions and the reason of casualty becoming heavier by wetting of the clothes. It is considered that it would be more effective to respond with equipment such as a bulwark ladder (Image 19) and Jason's Cradle (Image 20) etc., which provide easier rescue from the sea since they have high freeboard (1,7 m) in case of a man overboard in the existing agency boats that do not have such a platform and also carry seamen.
