RETROSPECTIVE MARINE SAFETY INVESTIGATION REPORT

VESSEL NAME	: EREN TURGUT
IMO NO	: 9422342
FLAG OF THE VESSEL	: Turkish
LOCATION OF CASUALTY	: Strait of Dover
DATE and TIME OF ACCIDENT	: 24.11.2010 – 15:55 (GMT+0)
FATALITY / INJURY	: 1 Dead - 2 Injured
DAMAGE DEGREE	: Damage to the engine room
ENVIRONMENT POLLUTION	: Not reported.

Board Decision No: 20 / DNZ – 08 / 2023

Date: 23.10.2023

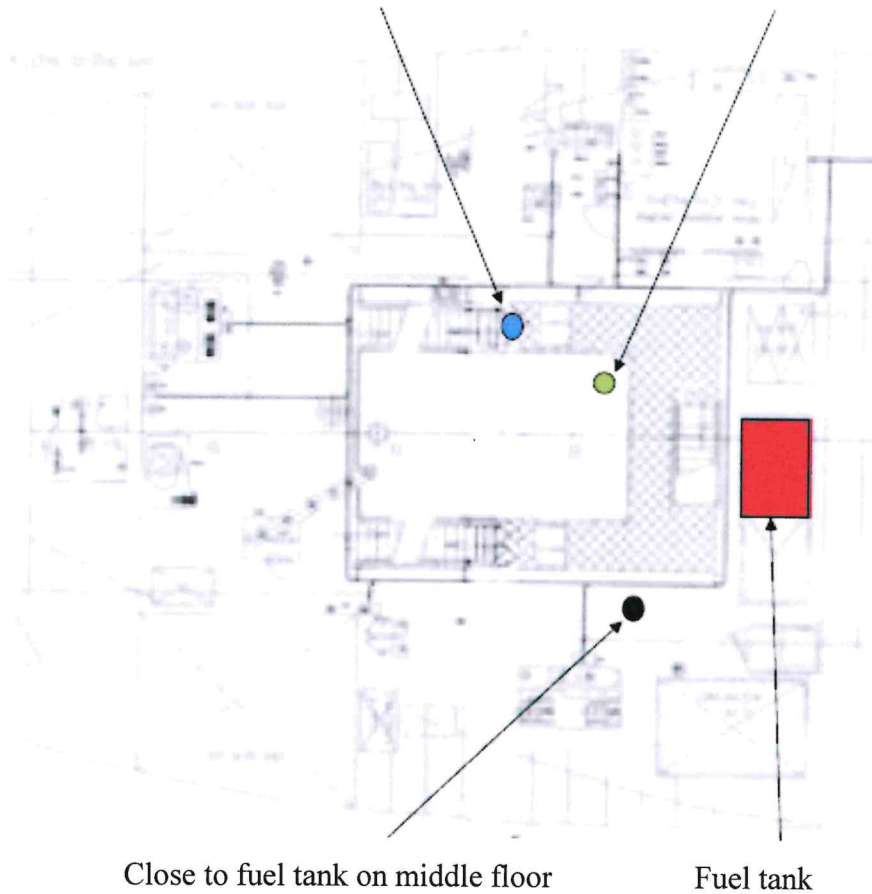
Image 3 Location of Engine Room Personnel on Board Before the Explosion

explosion and after the explosion. Image 3 also shows the fuel tank and machinery personnel positions before the explosion at 15:55 on 24.11.2010.

3rd engineer on the middle floor 2nd engineer on the ground floor

Oiler-B

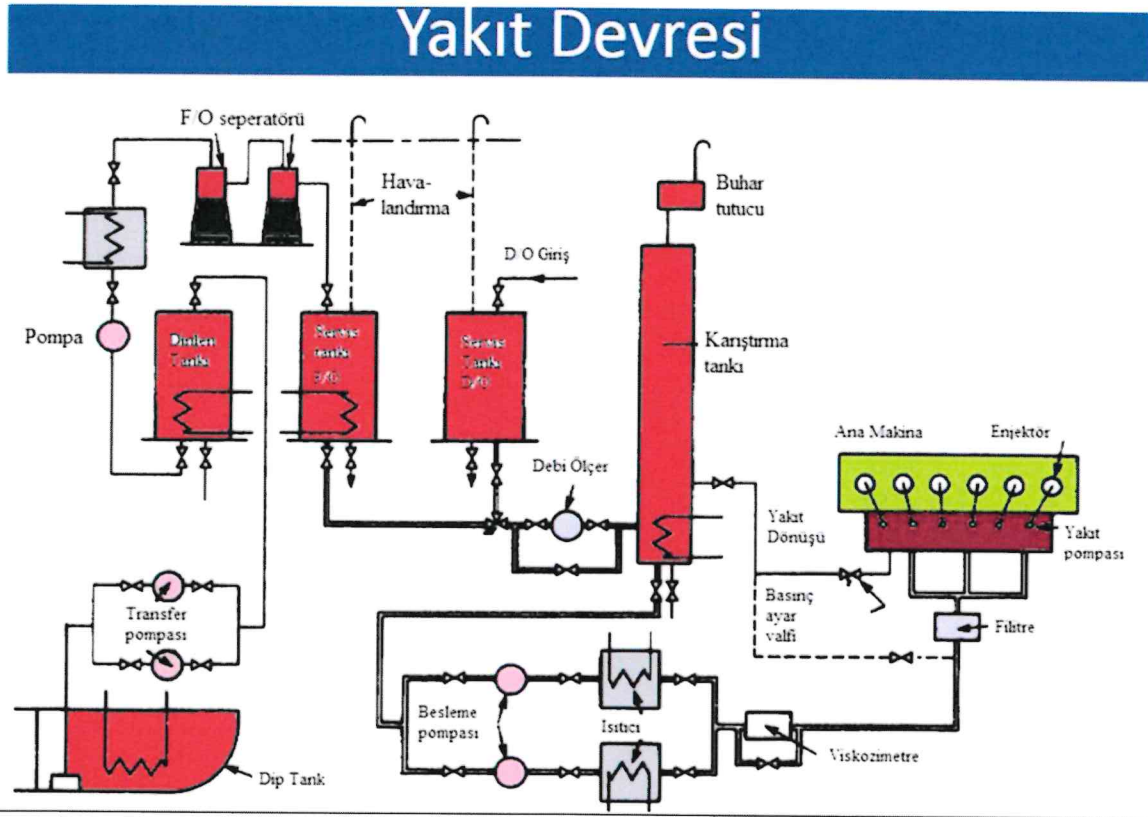
Image 6 General Vessel Fuel Circuit

In general, the fuel to be used in marine diesel engines are as shown in the diagram below (as Image 6), works with a classical circuit diagram consisting of a bottom tank, settling tank, transfer pump, separator, service tank, supply pump, heater, viscometer, filter and valve systems.

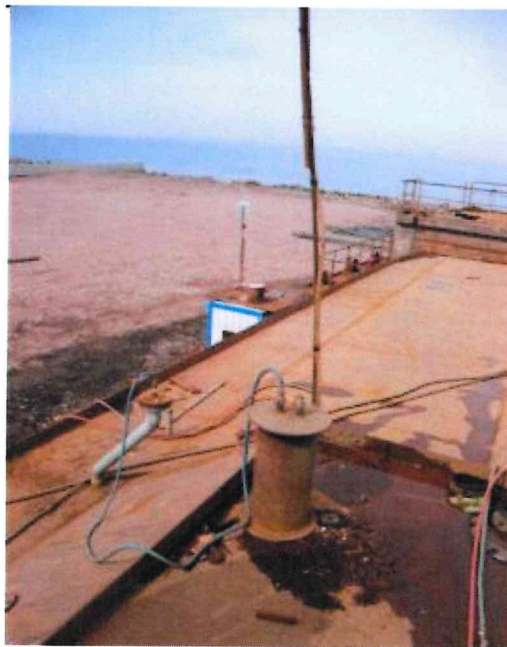
Image 7 Tank Testing by Air on New-Built Vessels

After the welded fabrication is finished, the tightness of the tanks should be tested with air. Tank air tests are performed with 0.2 bar pressure. It will be useful to use two calibrated manometers or water level bottles during tank tests in terms of the safety and quality of the test. (Image 7)
