**REPUBLIC OF TURKEY
MINISTRY OF TRANSPORT, MARITIME AFFAIRS AND COMMUNICATIONS
Accident Investigation Board**

**Marine Accident Investigation Report on the Investigation of
The Capsizing of Dry Cargo Vessel
EROL ŞENKAYA**

**Off Zakynthos Island / Greece
19th May 2012**

Report No: 4/2012

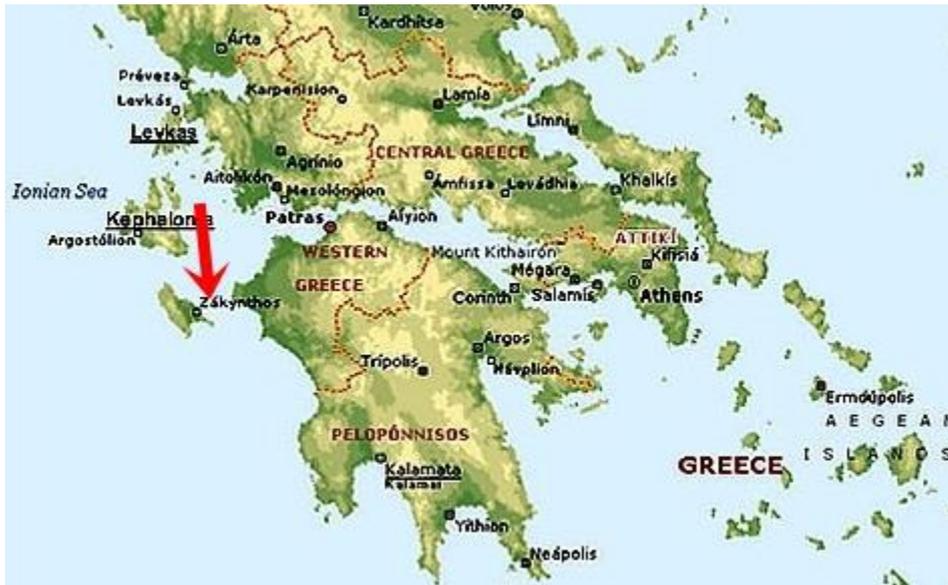
Picture 1: Location of the Accident

Date and Time	: 19 May 2012 / 01:30
Location of Incident	: 7,5 nautical miles east of Zakynthos Island
Coordinates	: 37° 51.6 N, 020° 59.1 E
Fatalities / Injuries / Missing	: 3 fatalities / 1 missing
Damage	: Vessel capsized (semi-submerged) Completely sank during towing, on 16th June 2012.
Pollution	: None

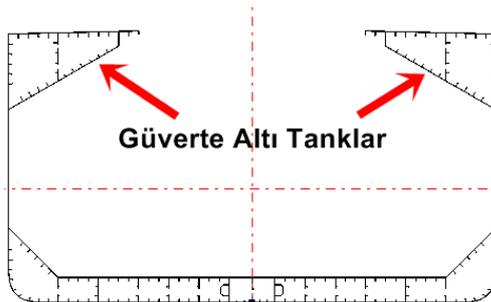
Picture 10: Hold Design of Bulk Carrier 11: Hold Design of General Cargo Vessel

Topside / upper wing tanks at both sides of the hold in bulk carriers has a function to prevent / reduce the movement of cargo. However, the holds of the vessel in question has a straight form as been in a large portion of general cargo vessels of such tonnage and this form causes easy progress of the moving cargoes to the sides during heeling.
