## FINAL REPORT ON VERY SERIOUS MARINE CASUALTY

<b>NAME &amp; IMO No</b>	: ESRA C
<b>FLAG</b>	: Panama
<b>LOCATION OF ACCIDENT</b>	: Diliskelesi / KOCAELİ
<b>DATE OF ACCIDENT</b>	: 9/8/2021 / 14:12 LT
<b>FATALITY/INJURY</b>	: 1/-
<b>DAMAGE&amp;POLLUTION</b>	: - /-

*Board Decision No: 09 / D-03 / 2022*

*Date: 16 / 05 / 2022*

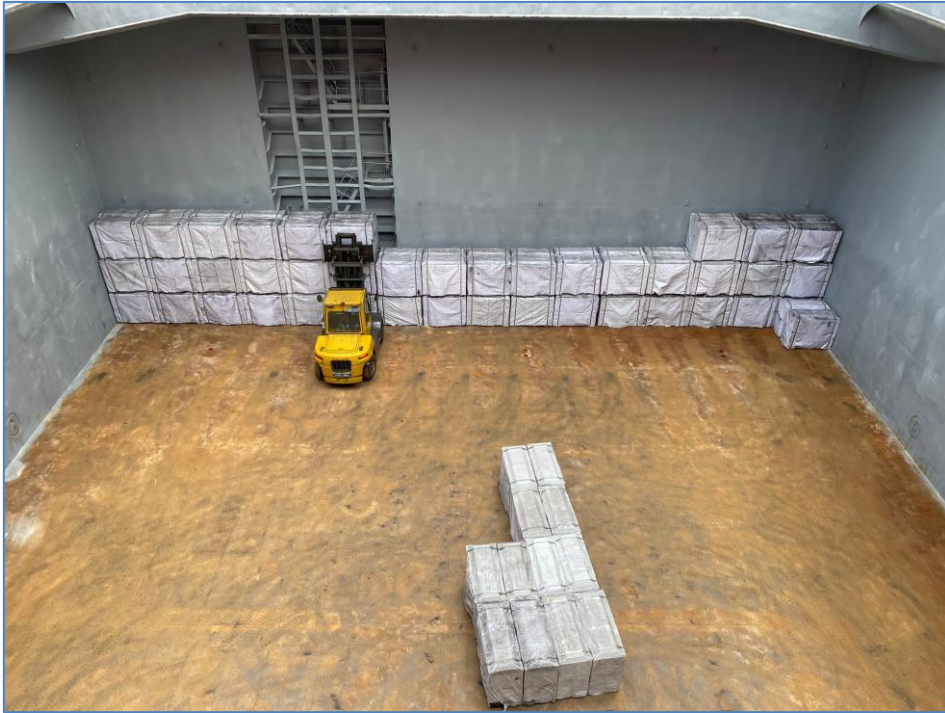
**Image 4:** A View from the loading operation

The ship was loaded with four distinct types of cargo from various Chinese ports. As shown in *Image 4*, the block carbon anode, which fell over during the accident, was loaded aboard the vessel in two sizes, weighing roughly 1 and 1,5 tons each.
