**REPUBLIC OF TURKEY**  
**MINISTRY OF TRANSPORT, MARITIME AFFAIRS AND**  
**COMMUNICATIONS**  
**Accident Investigation Board**

**Report on the Investigation of**  
**The Collision Between**  
**M/V GÖKBEL and M/V LADY AZIZA**

**ITALY / Off Ravenna Port**

**02/DNZ-02/2016**

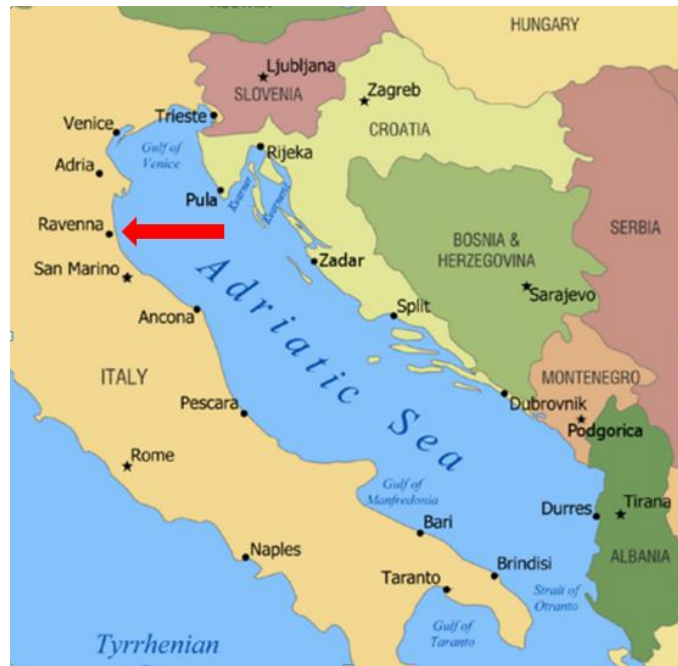
*Picture 1<sup>1</sup>: Location of the accident*

Turkish registered dry cargo vessel GÖKBEL and Belize registered dry cargo vessel LADY AZIZA collided in 2,5 miles east of Italy / Ravenna port entry on 28.12.2014 at 08:37:58. As a result of the collision, GÖKBEL sank while LADY AZIZA experienced minor damage.

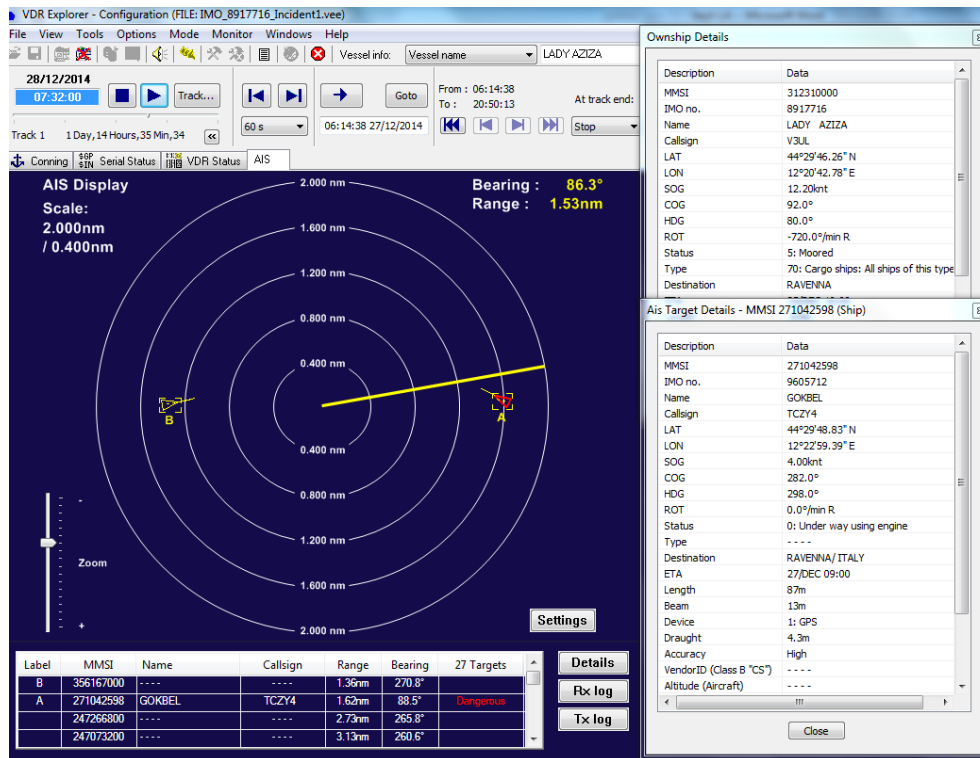
**Figure 3: Positions of Both Ships at 08.32 (VDR-AIS)**

LADY AZIZA was noticed first by the crew of GÖKBEL at about 08:32 at the portside of forecastle line of the portside radar as a radar echo which darted in and out. This echo was considered by the chief officer as that it might belong to a pilot boat.

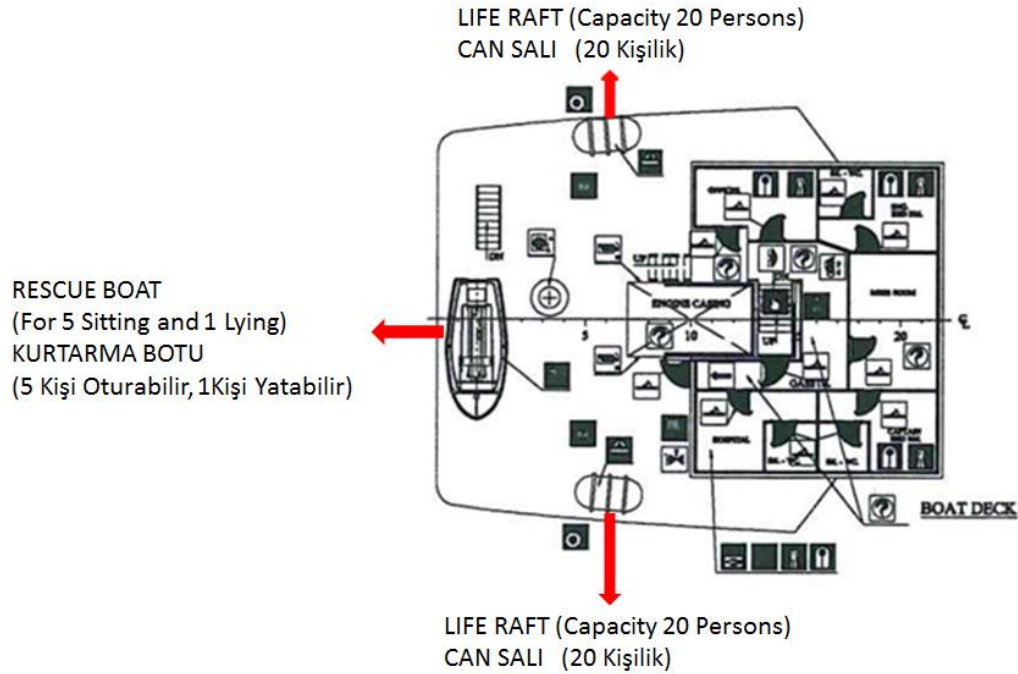
**Figure 11:** Location of Rescue Boat and Life Rafts on GÖKBEL

Rescue boat davit was tested on 21.11.2014 and it was determined suitable for use as the result of the performed test and a certificate was issued. The materials within was checked on 12.11.2014 and the engine and lowering mechanisms were checked on 24.11.2014 and entered to ISM documents. The location of the Rescue Boat, Life Rafts and Personal Life Saving Equipment on board of GÖKBEL are shown in Figure 1 and Figure 2.

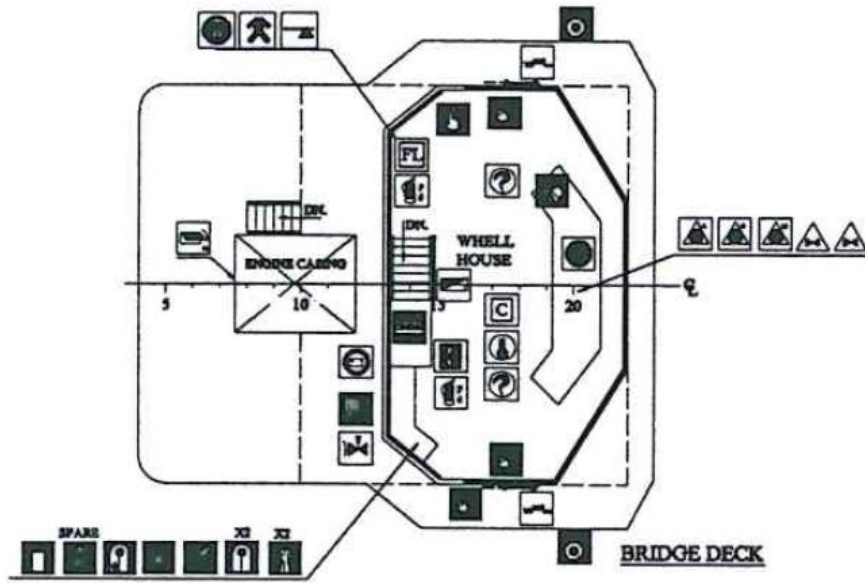
**Figure 12:** Location of Personal Life Saving Equipment on GÖKBEL

19 Immersion suit, 19 life jackets and 2 child life jackets available on GÖKBEL. The personal life saving equipment was checked by the authorized firm on 08.08.2014 and a certificate was issued upon determining that they were in good condition.

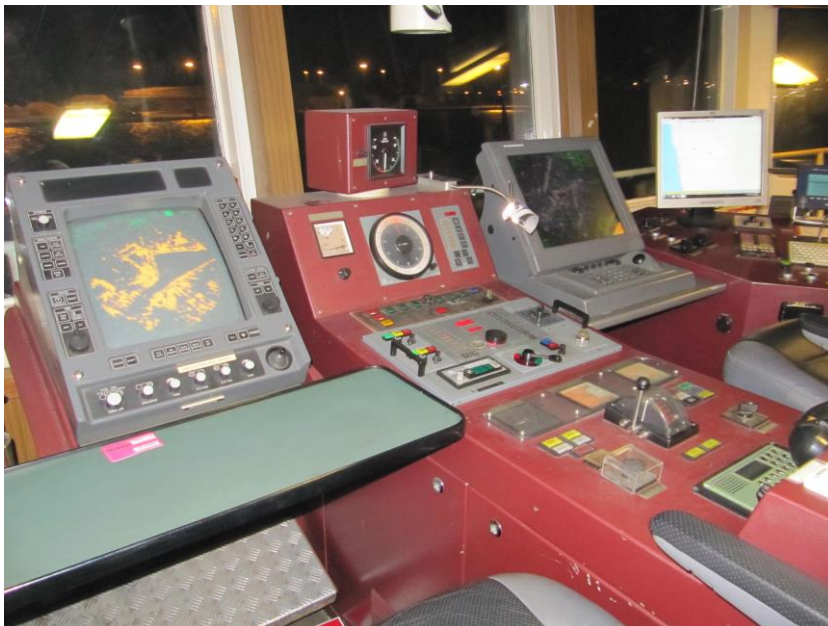
**Picture 26:** View from the Bridge of LADY AZIZA

There were 2 radars at starboard and portside of the central axis of the bridge of LADY AZIZA. These radars are X band and S band, respectively, and both didn't have ARPA feature (feature of plotting a selected target / following the target).

It is seen in the photos taken from the bridge of LADY AZIZA after the accident that it has two radars and both were in operating condition. The section related to sea meteorology was left empty in deck logbook records. However, it is observed from the photos taken at the incident scene after the accident that visibility is close to zero. Since an interview couldn't be made with the master of LADY AZIZA, the subject who was present on the bridge couldn't be clarified. In the interview made with the pilot who disembarked, he stated that he informed the ship master that GÖKBEL and MSC ELONARA were navigating towards the port entrance that the bridge devices were running and the ship master was left alone on the bridge when he was leaving the bridge. In addition, the sections about who were the watchman and person at the rudder at that moment were left empty in deck logbook records of LADY AZIZA. Again according to the logbook records, the existence of GÖKBEL and it formed a danger of collision was understood upon the notice to the bridge of chief officer present at the forecandle. On the other hand, when VDR records of LADY AZIZA were listened, not hearing anything else on the bridge before the collision except the sounds from VHF's supports that the master of LADY AZIZA was alone on the bridge.

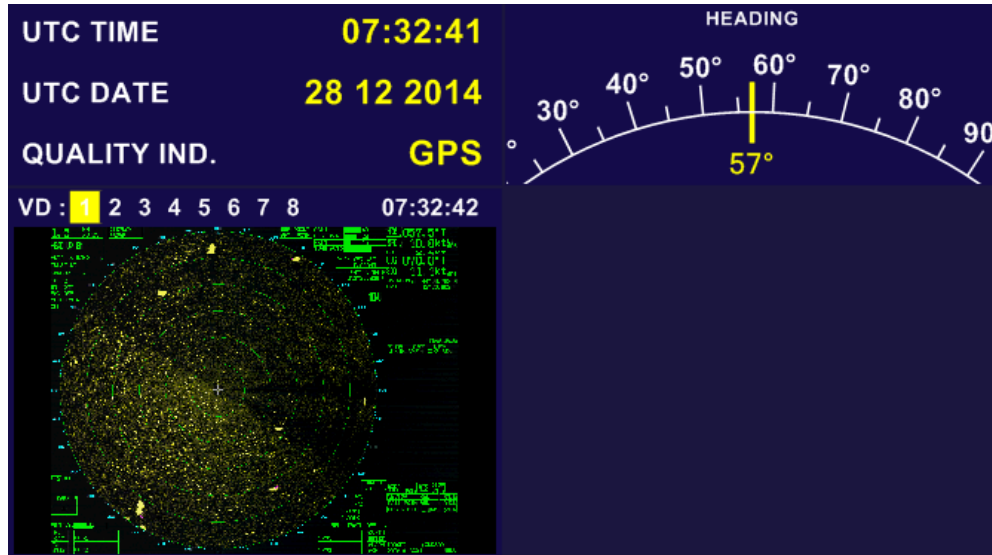
**Figure 13:** Radar View of LADY AZIZA (VDR-AIS)

According to VDR records of LADY AZIZA, one of the radars is operated in course above position. Again according to VDR records, GÖKBEL started to appear on the radar screen of LADY AZIZA from 08:32:41. In this meantime, there was 1,44 miles distance between GÖKBEL and LADY AZIZA. Starting from this point, it is understood that the range of one of the radars of LADY AZIZA was adjusted to 1.5 miles.

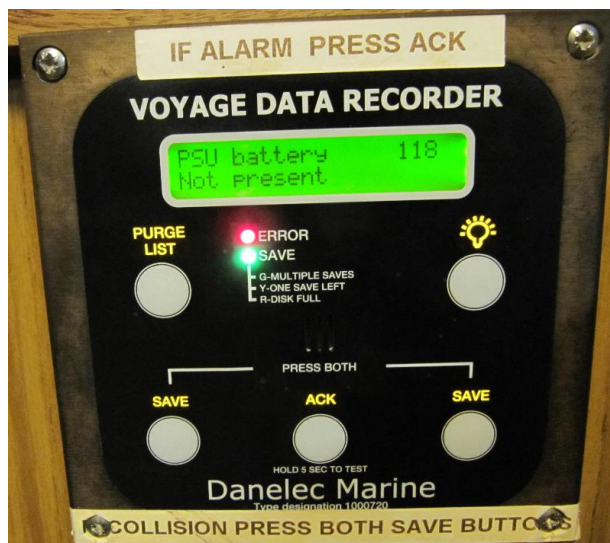
*Picture 27: VDR Panel of LADY AZIZA*

3828 GT LADY AZIZA had VDR in accordance to A.861(20) of IMO which is enforced on July 1, 2002. After the accident, VDR records of LADY AZIZA were taken and the photos of VDR units were taken. It is seen in the photos that VDR device of LADY AZIZA gave error warning and VDR battery expiry date passed. But it was observed from VDR records taken from the ship that VDR records were healthily kept before and after the accident.

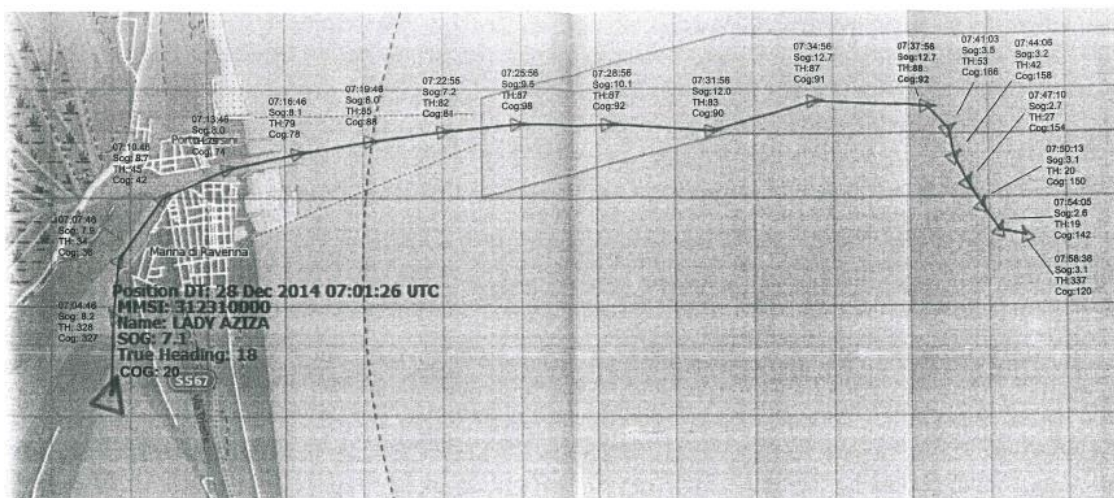
**Figure 16: Course Followed by LADY AZIZA**

In the examination of the course followed by LADY AZIZA after it left the breakwater, it is assessed that it couldn't recognize until the moment of collision the existence of GÖKBEL progressing in the collision course. When it recognized GÖKBEL, it was too late to make the collision avoiding manoeuver.

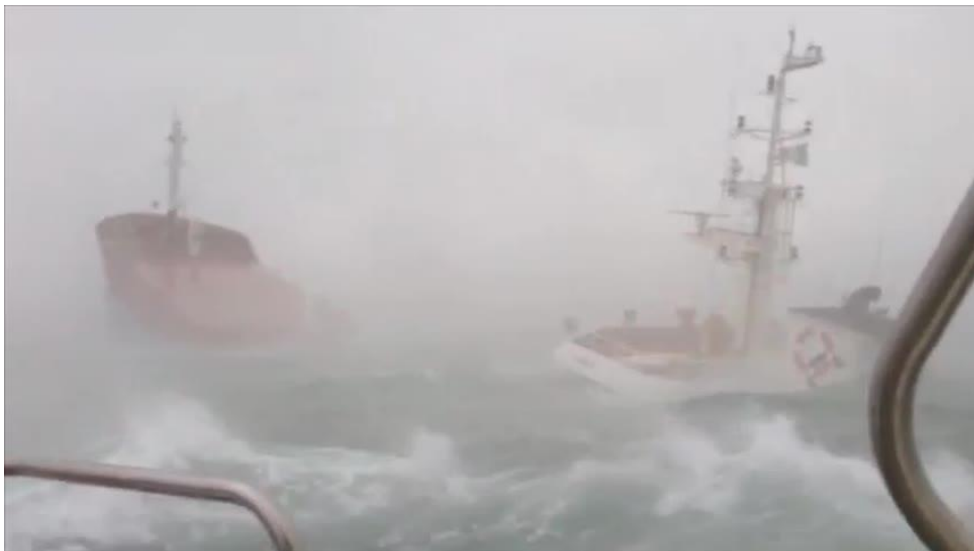
**Picture 29<sup>16</sup>:** Visibility at the Collision Region

Although it isn't seen possible for LADY AZIZA to perform full look-out due to the reason that the visibility in the region was close to zero, it is assessed that the ship didn't fulfill the condition of sight and hearing look-out specified in COLREGS/Rule 5.

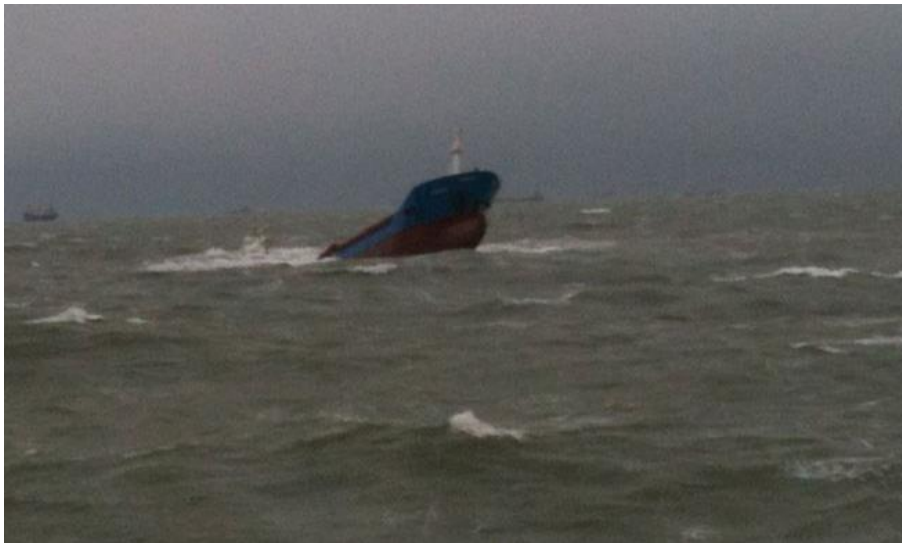
*Picture 30: GÖKBEL*

Another important matter which attracts attention on the subject of abandonment is that the depth of sea where the ship sank was 11,9 meters. When the ship flooded and started to sink, its stern sank, but its forecastle was left on water for a long time and then the ship sank completely. The accident victim personnel couldn't abandon the ship with a rescue boat or life raft because of quick sinking of the ship and weather conditions. When the ship started to flood and an important portion of the superstructure was flooded, the personnel tried to survive by jumping into the sea. In this case, it is assessed that the accident victims who had no chance to abandon the ship in dry conditions with their personal life saving equipment might increase their chance of surviving by not abandoning the ship until the last moment by considering the temperature of the sea water and depth of sea.

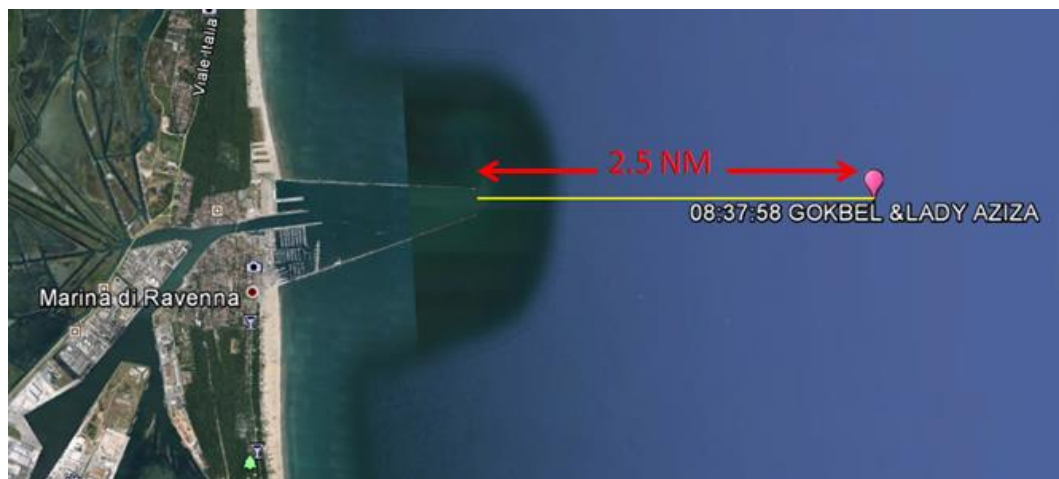
**Figure 19:** Collision Location of Ships

GÖKBEL was lost from AIS screen of LADY AZIZA at 09:02:28 after the collision when there was a distance of 0,54 miles between the ships.

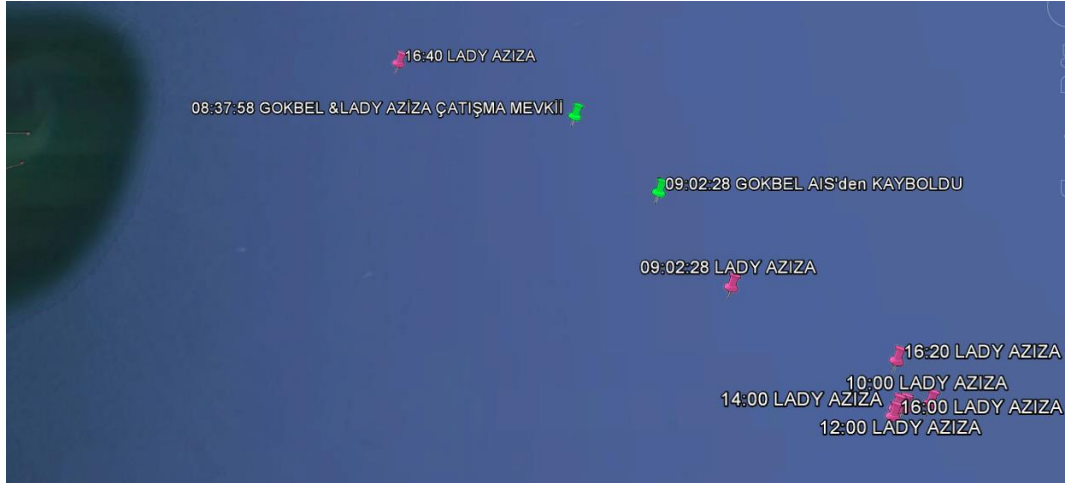
**Figure 20:** *LADY AZIZA's Course Following The Collision*

After the collision, LADY AZIZA separated astern from GÖKBEL. The distance between two ships increased to 1 cable about 7 minutes after the collision. LADY AZIZA waited about 1,5-2 miles away from the collision location until it entered the port, directed to the port at about 16:20, entered the breakwater at 15:49 and berthed at the dock at 17:20.

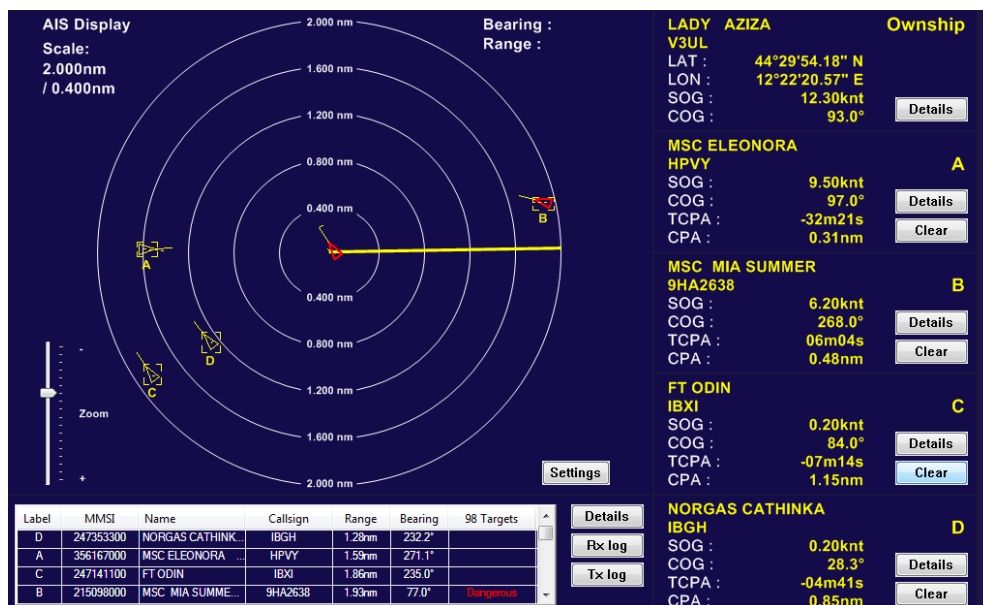
**Figure 21:** The Other Ships Around The Moment of Collision, 08:37:58 (VDR-AIS)

There exist other ships around the collided ships which are navigating and on anchor. The ship called MSC MIA SUMMER which is navigating to enter Ravenna port is at a distance of 1.93 nautical miles from the incident scene. MSC ELONORA has exited from Ravenna port under LADY AZIZA and is only 1,59 nautical miles away from the collision location. From the other ships close to the collision location, NORGAS CATHINKA is on anchor at south west 1,28 miles and FT ODIN 1,86 miles away.

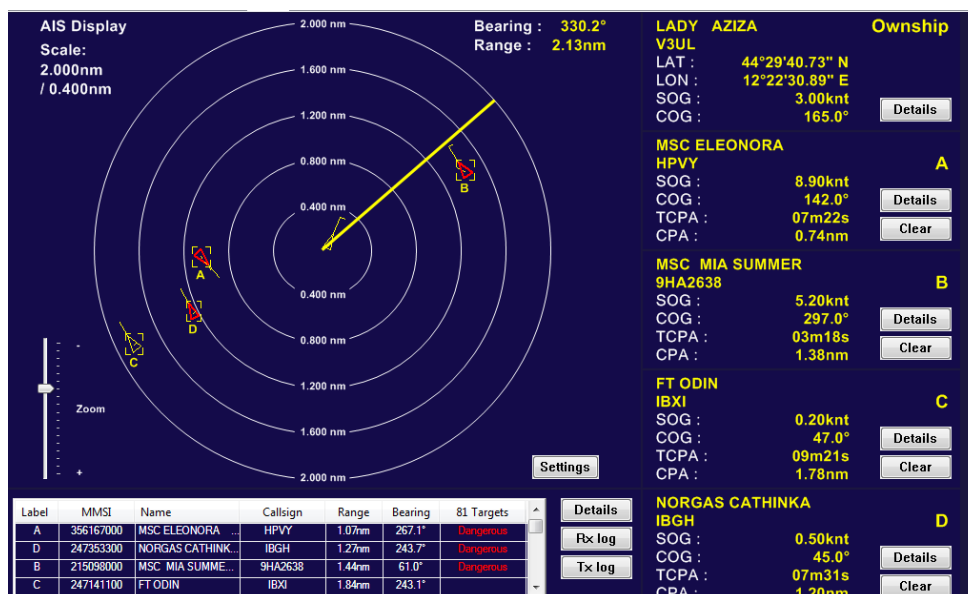
**Figure 22:** Positions of MSC ELONARA and MSC MIA SUMMER at 08:43:04(VDR-AIS).

MSC ELONORA which was proceeding to course 089 and MSC MIA SUMMER which was proceeding to course 283 before the collision quickly changed their courses to their starboards after the collision. MSC ELONORA started to navigate to course 139 and MSC MIA SUMMER to course 329 5 minutes after the collision (08:43:04).

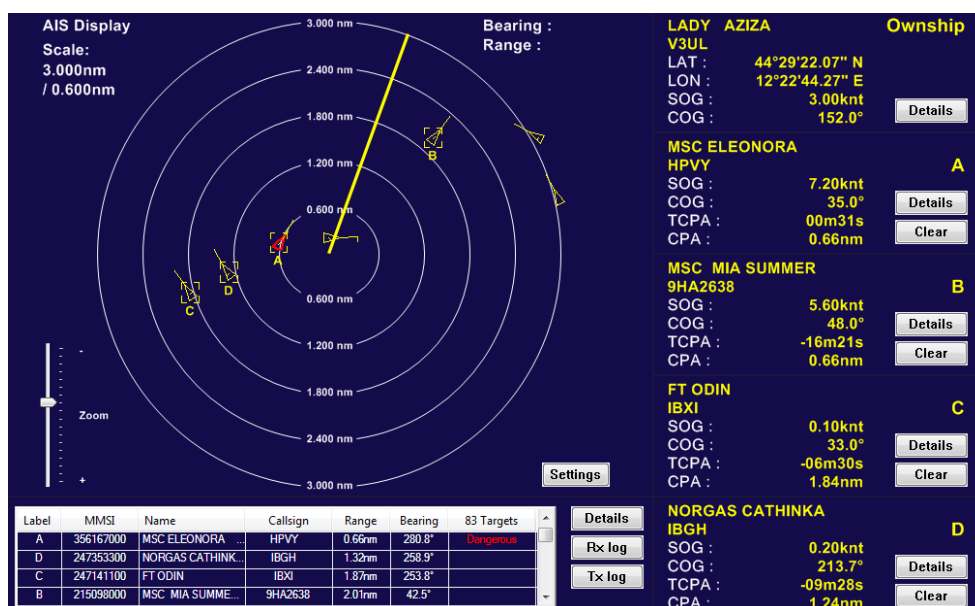
**Figure 23:** Positions of MSC ELONARA and MSC MIA SUMMER After Collision(VDR-AIS).

When MSC ELONORA passed only 0,66 mile by the collided ships at 08:50:00, MSC MIA SUMMER was directed to anchor area of Ravenna port.

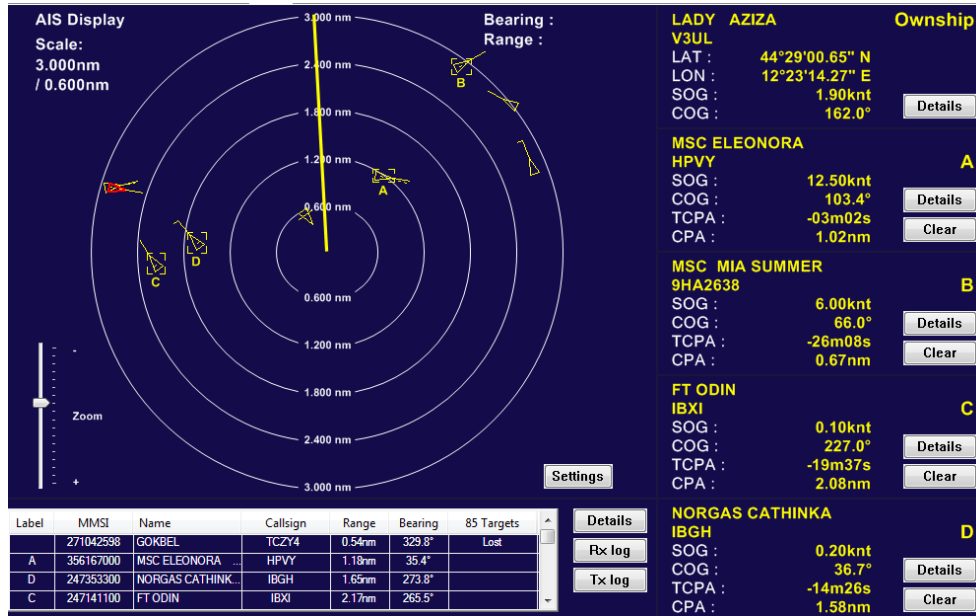
**Figure 24:** Positions of Other Ships Just Before GÖKBEL Is Lost On Screen (09:02:27)

Then, when MSC MIA SUMMER dropped anchor at about 09:20 in the anchor area of RAVENNA port, MSC ELONORA continued navigating towards VENICE port. FT ODIN and NORGAS CATHINKA protected their position on anchor.

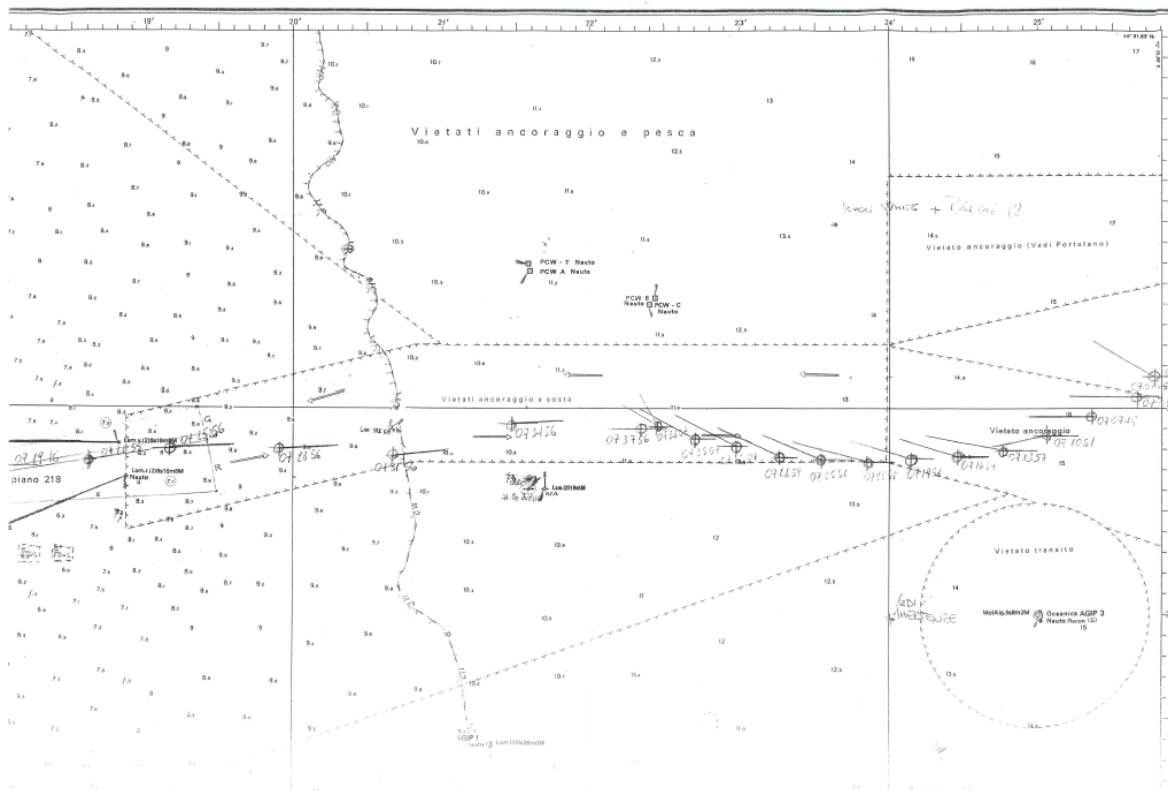
**Figure 25: Chart**

When the mentioned chart is examined, it is seen that the chart belongs to the coastal state. In both ships, the charts prepared by Britain hydrographic office were being used. When Ravenna approach chart (Admiralty Chart 1467: Approaches to Ravenna) which should be used for the region where the accident occurred is examined (Publication Date of Chart: 18.06.2015), it is observed that the mentioned traffic separation scheme is not present in this chart. In this respect, the accident is assessed as per the charts used in the ships. Accordingly, GÖKBEL took its course to its starboard as a result of warning by the pilot while it was navigating the outer boundary of portside of the mentioned region. The ships collided at a place near to the portside central line in the port entrance direction of the mentioned region.
