Accident Investigation Report On
Fire Onboard of M/T HABAŞ

Habaş Platform / İzmit /Turkey
29 April 2017

DNZ-04/2018

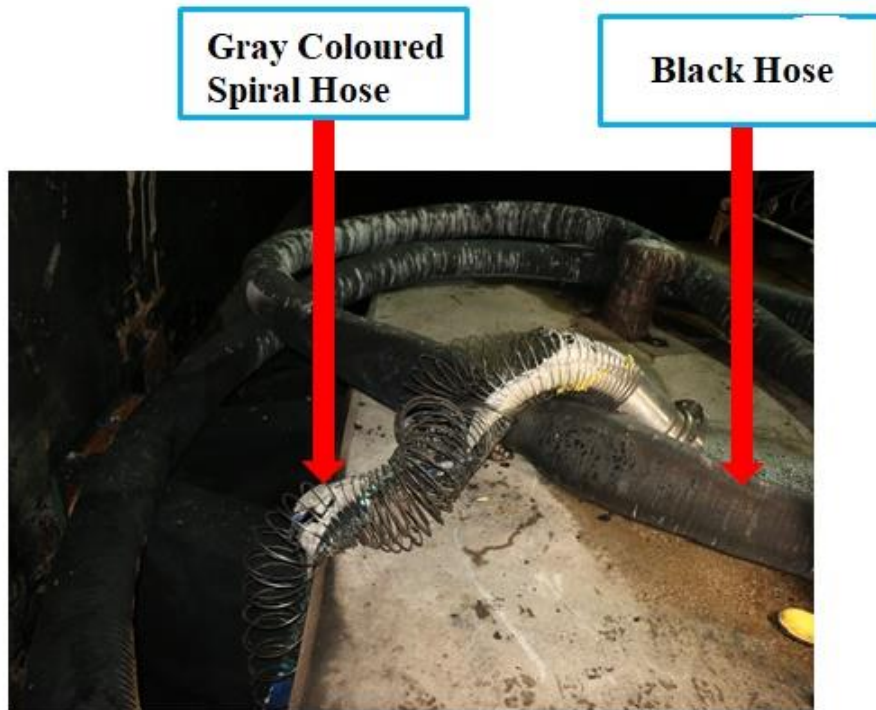
Figure 6: Hoses used in the Vessel in Cargo Unloading Operation

The gray hose, which is used to especially releasing the remaining gas in the vessel's tanks into the sea and which was attached to the vessel's manifold at the time of the fire, was completely burned (Figure 6). The black rubber hose used in unloading the vessel's cargo and the platform fenders was partially burnt (Figure 7).
